SCRAM SUMMARY 91-01

At 0548 on August 13, 1991, Nine Mile Point Unit Two experienced a turbine trip and automatic reactor scram when the Main Transformer Phase B developed an internal fault (Main Transformer fault details discussed in separate report). The transformer fault created an electrical disturbance throughout the normal electrical distribution system. This electrical disturbance caused UPS 1A-D and G to trip off, de-energizing their respective loads. (Details of UPS trips and electrical system response are discussed in separate reports)

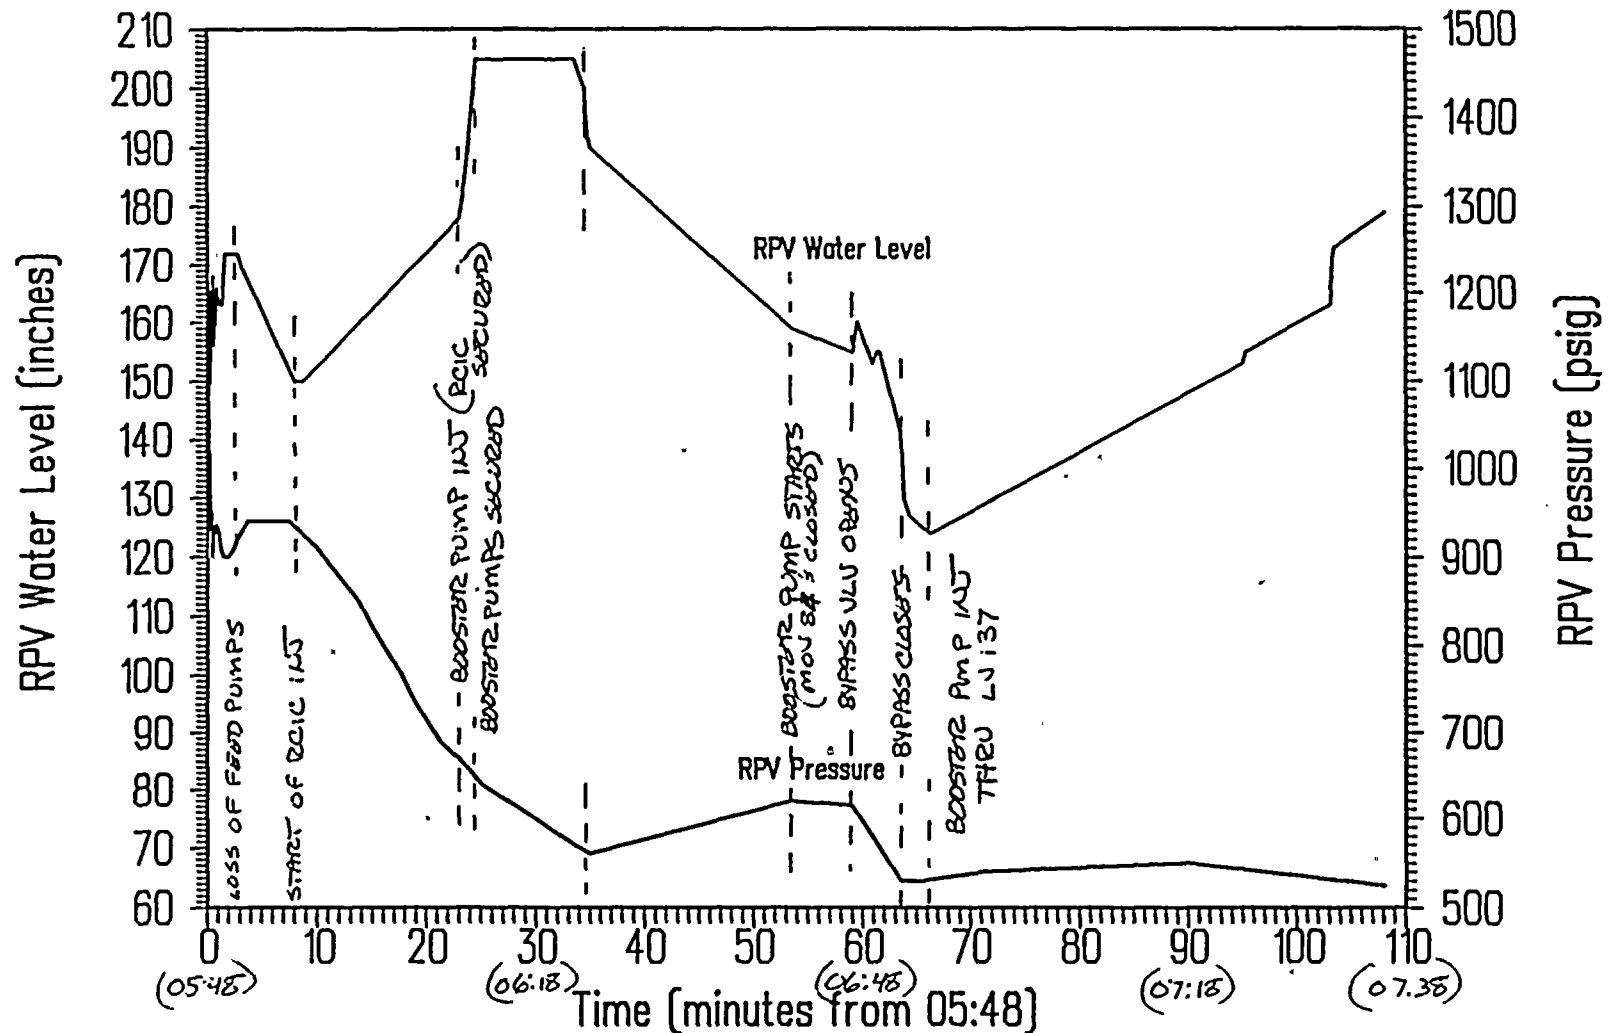
Nine Mile Point Unit 2 Reactor Pressure and Water Level vs Time

- 1) Reactor pressure rise as shown on both Post Accident Monitoring recorders is much less severe than the pressure rise shown on Figure 15.2-1 of the USAR (Generator Load Rejection with Bypass) 1070 vs 1150.

- 2) Reactor water level as shown on both Post Accident Monitor recorders is slightly lower than the USAR, however this discrepancy was due to all feedwater pumps tripping off.
