SCRAM SUMMARY 91-01

At 0548 on August 13, 1991, Nine Mile Point Unit Two experienced a turbine trip and automatic reactor scram when the Main Transformer Phase B developed an internal fault (Main Transformer fault details discussed in separate report). The transformer fault created an electrical disturbance throughout the normal electrical distribution system. This electrical disturbance caused UPS 1A-D and G to trip off, de-energizing their respective loads. (Details of UPS trips and electrical system response are discussed in separate reports)

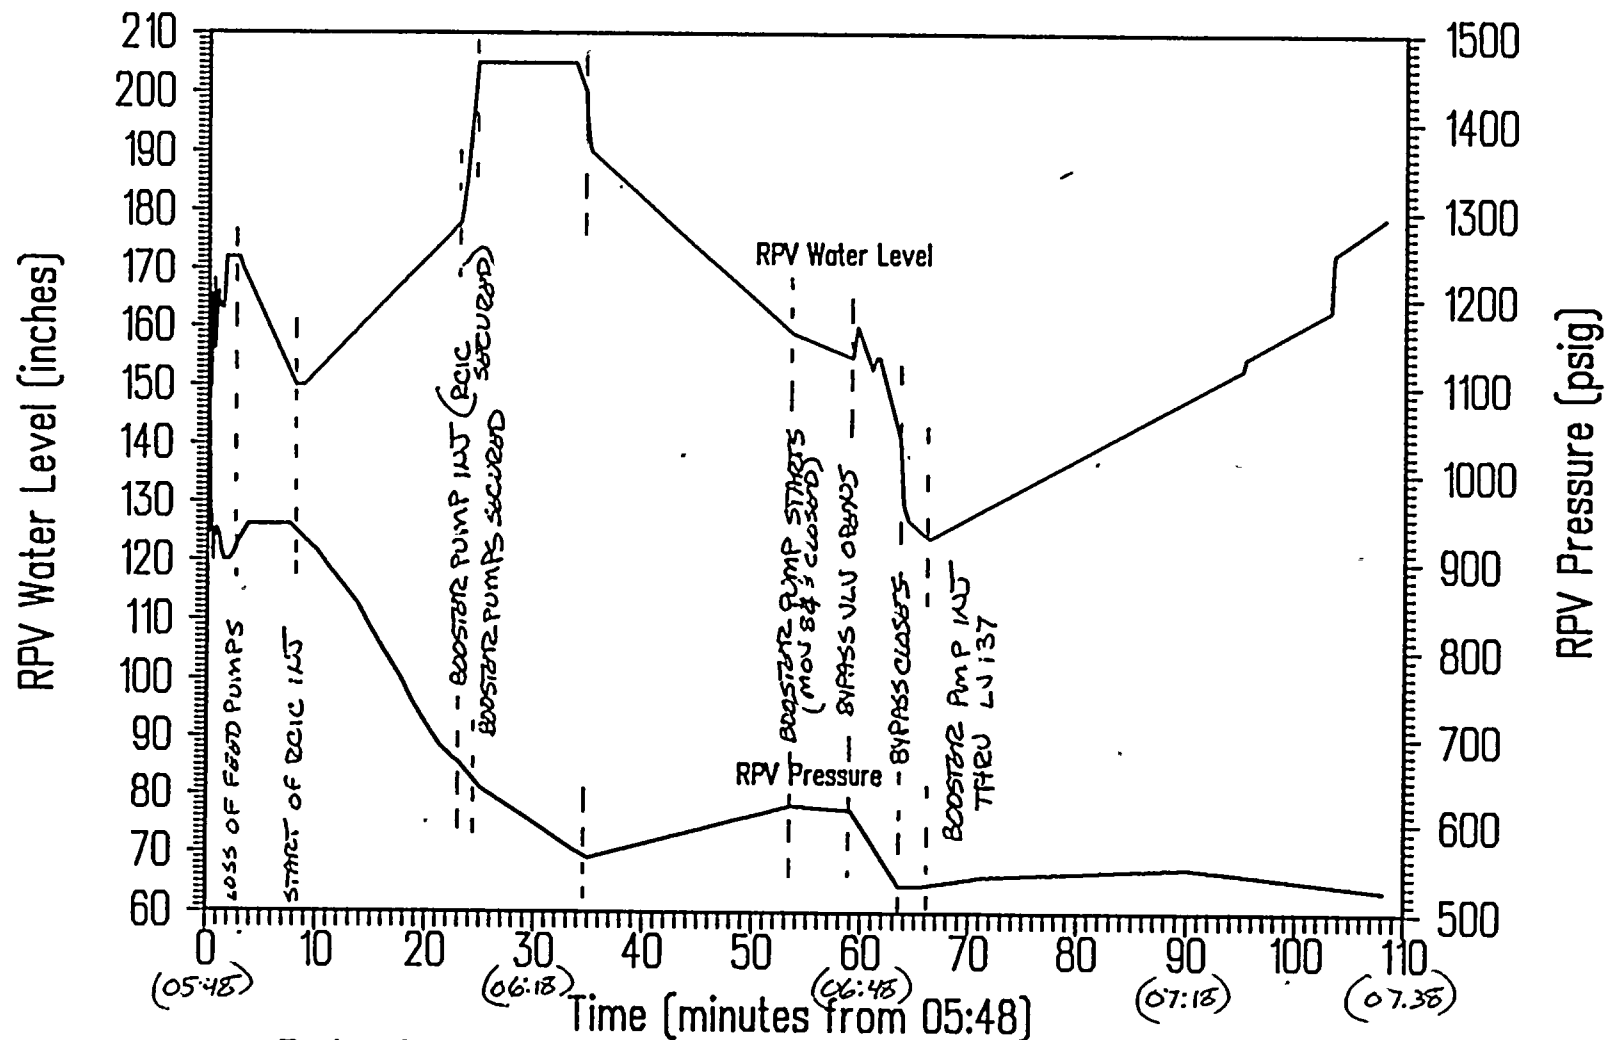
Nine Mile Point Unit 2 Reactor Pressure and Water Level vs Time

- 1) Reactor pressure rise as shown on both Post Accident Monitoring recorders is much less severe than the pressure rise shown on Figure 15.2-1 of the USAR (Generator Load Rejection with Bypass) 1070 vs 1150.

- 2) Reactor water level as shown on both Post Accident Monitor recorders is slightly lower than the USAR, however this discrepancy was due to all feedwater pumps tripping off.

Based on the above conclusions, the results of this transient were within the bounds of current transient analysis.
