Subject: 10CFR21 Reporting of Defects and Non-Compliance -
Engine Systems, Inc. Report No. 10CFR21-0120, Rev. 0

Report No. 10CFR21-0120

10CFR21 REPORTING OF DEFECTS AND NON-COMPLIANCE

COMPONENT: Thermostatic Valve Assembly
P/N 6BOCF14001

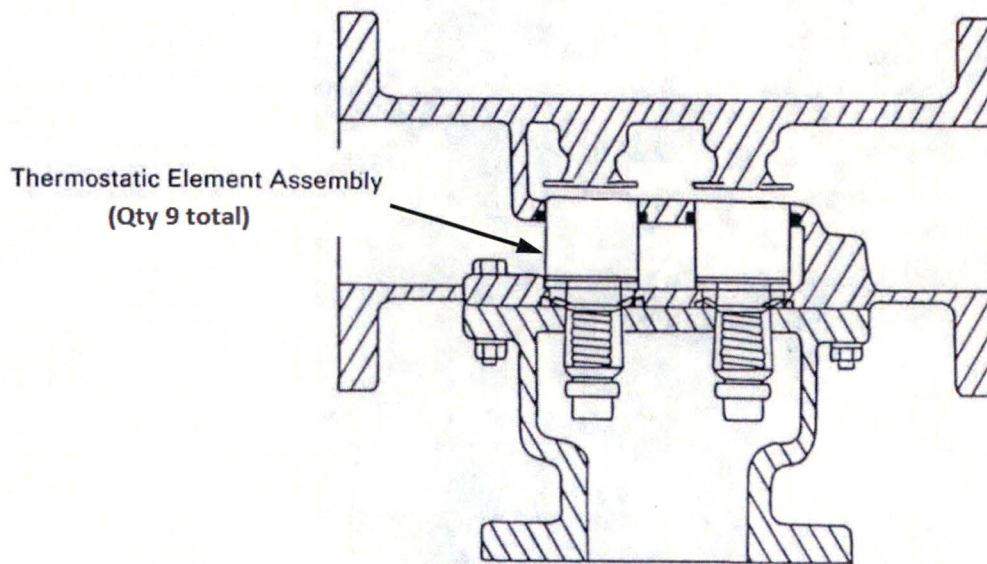
FIGURE 3
Thermostatic Valve Assembly

The thermostatic valve assembly is used on an emergency diesel generator set to regulate the temperature of lubricating oil (other EDGs use this same type of valve for jacket water temperature regulation). If one of the elements within the assembly were to fail, as is the case with a missing strap, regulating capacity of the thermostatic valve could be affected. However, the failure mode in the case of missing straps is in the open position (element does not return closed) and the remaining eight elements would compensate by closing to regulate the fluid temperature. More importantly, detached retaining straps could migrate to other components in the lube oil system. Acting as foreign material, the straps could adversely affect the ability of these critical components to perform their safety-related function within the emergency diesel generator's lube oil piping. The foreign material aspect of this defect makes it a reportable issue. See Figure 3 on the following page for an outline drawing showing typical installation of elements in the valve assembly. Appendix A contains photos of the assembly.

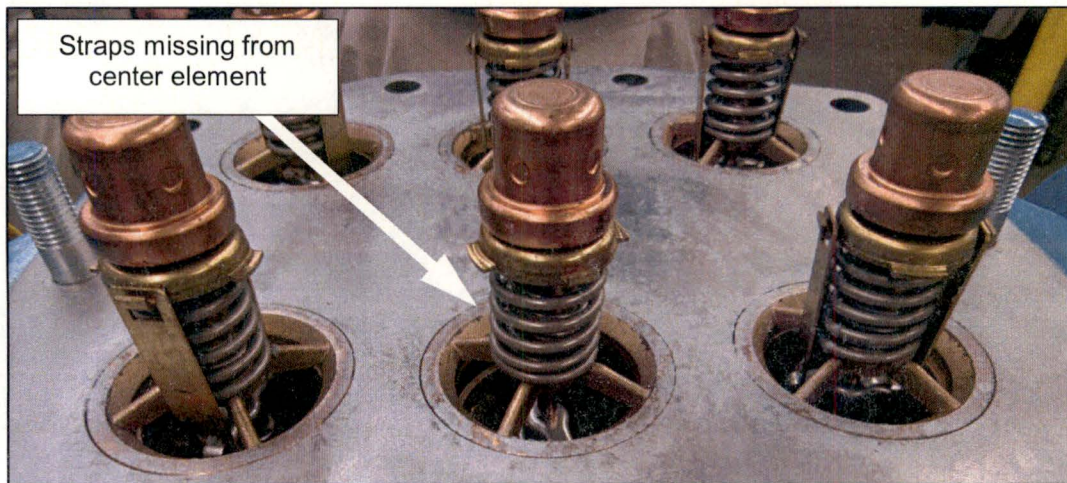
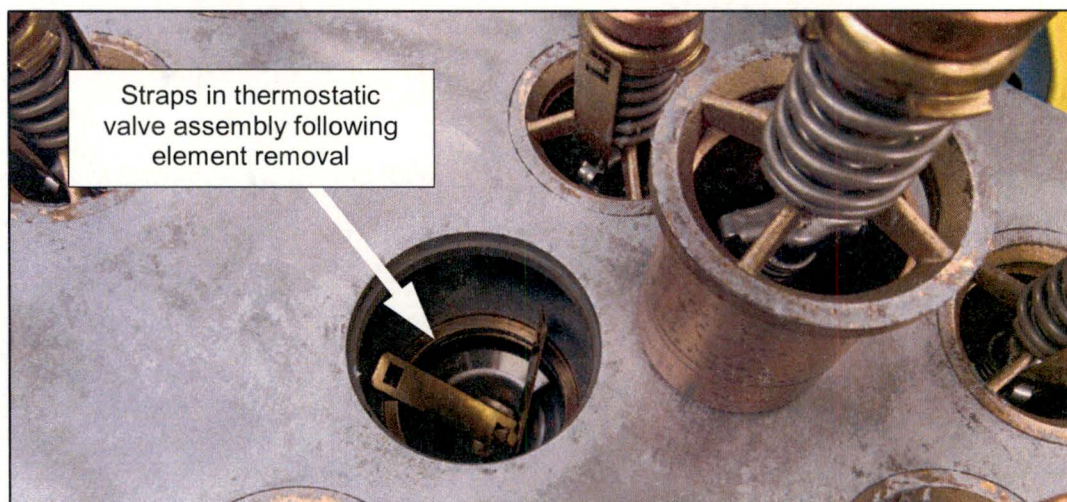
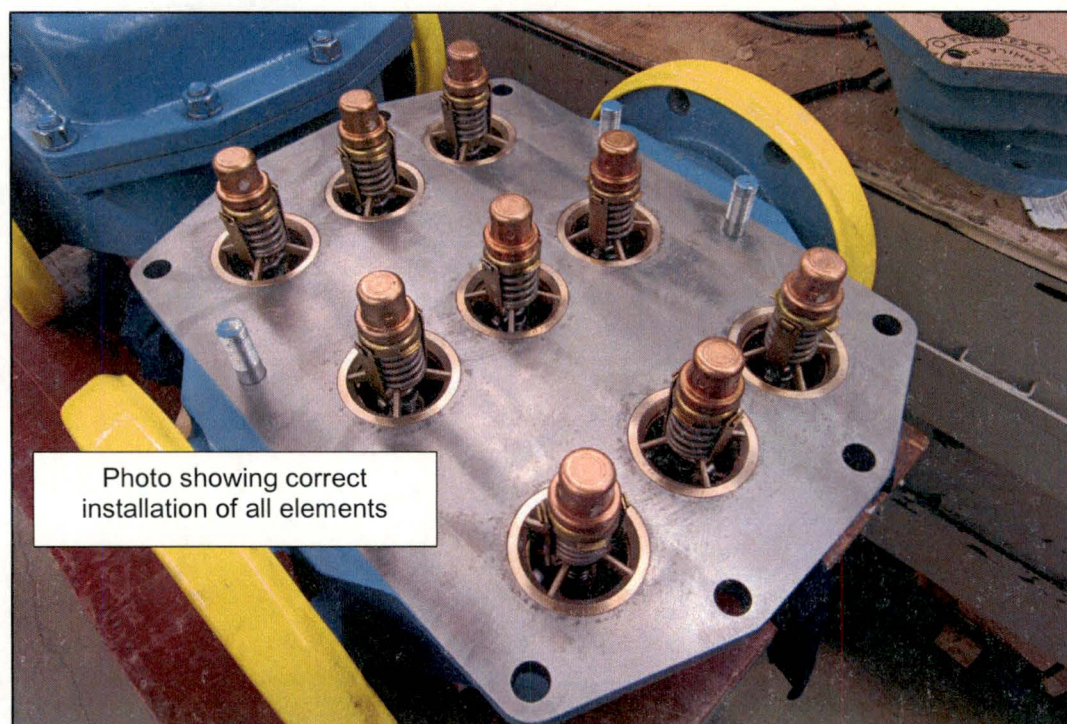
ESI's investigation revealed that this issue was induced by a test technician who, in an effort to minimize the amount of test fluid remaining in the assembly after pressure testing, manually actuated the center thermostatic element (there are 9 total elements) to drain a small pocket of residual fluid. This effort to prevent the formation of oxidation had an unintended consequence and resulted in a more serious issue. Though this is an isolated incident as it pertains to items supplied from ESI, this same model thermostatic valve assembly is used extensively on EDGs in the nuclear industry. Those customers that perform valve maintenance, including thermostatic element replacement, should be aware of the possibility of the straps becoming detached if care is not taken.

For ESI: The dedication package for this assembly has been revised to add inspection criteria for the strap inspection and clarification has been added to the functional test procedure to ensure the assembly is drained following hydrostatic testing by tilting the assembly, not by manually actuating the element.
