Watts Bar Nuclear Plant, Units 1 and 2  
Facility Operating License Nos. NPF-90 and NPF-96  
NRC Docket Nos. 50-390 and 50-391

Subject: **Licensee Event Report 390/2017-012-01, Error in Plant Emergency Procedures Leads to a Condition Prohibited by the Technical Specifications**

Error in Plant Emergency Procedures Leads to a Condition Prohibited by the Technical Specifications

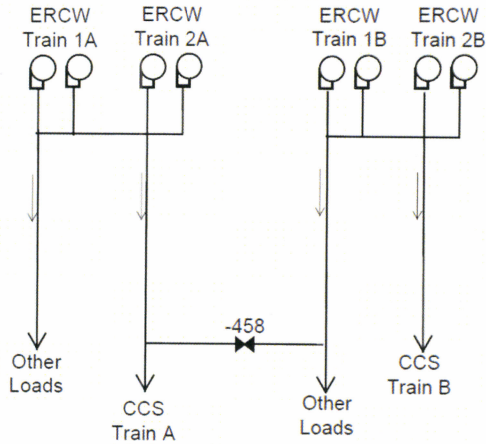
Simplified ERCW Figure

The WBN plant is provided with a common ERCW system serving both units (see Figure). Eight ERCW pumps are provided, with two pumps aligned to each 6.9 kV Shutdown Board (SDBD) and aligned to two ERCW trains A and B. The ERCW system supplies cooling water to the Component Cooling Water System (CCS) heat exchangers, the containment spray heat exchangers, the emergency diesel generators, containment coolers, and various other system loads.

A separate issue was identified in Condition Report (CR) 1331422 that is the subject of this report where incorrect change to procedures 1-E-1 and 2-E-1, Loss of Reactor or Secondary Coolant, were made prior to Unit 2 initial operation. Steps were added to both procedures where, for a LOCA concurrent with a loss of offsite power and a train failure while the other unit was on RHR cooling, an ERCW supply side cross connect between the A and B trains would be open. This erroneous change had the potential to reduce ERCW flow to the functioning train.
