Summary of LaSalle SIT exit (the team made it clear to the licensee that info presented was based upon management review)

Operating Experience Spring 2017 Counterparts Briefing

LaSalle 2 – HPCS Injection Valve Failure – Stem-Disc Separation

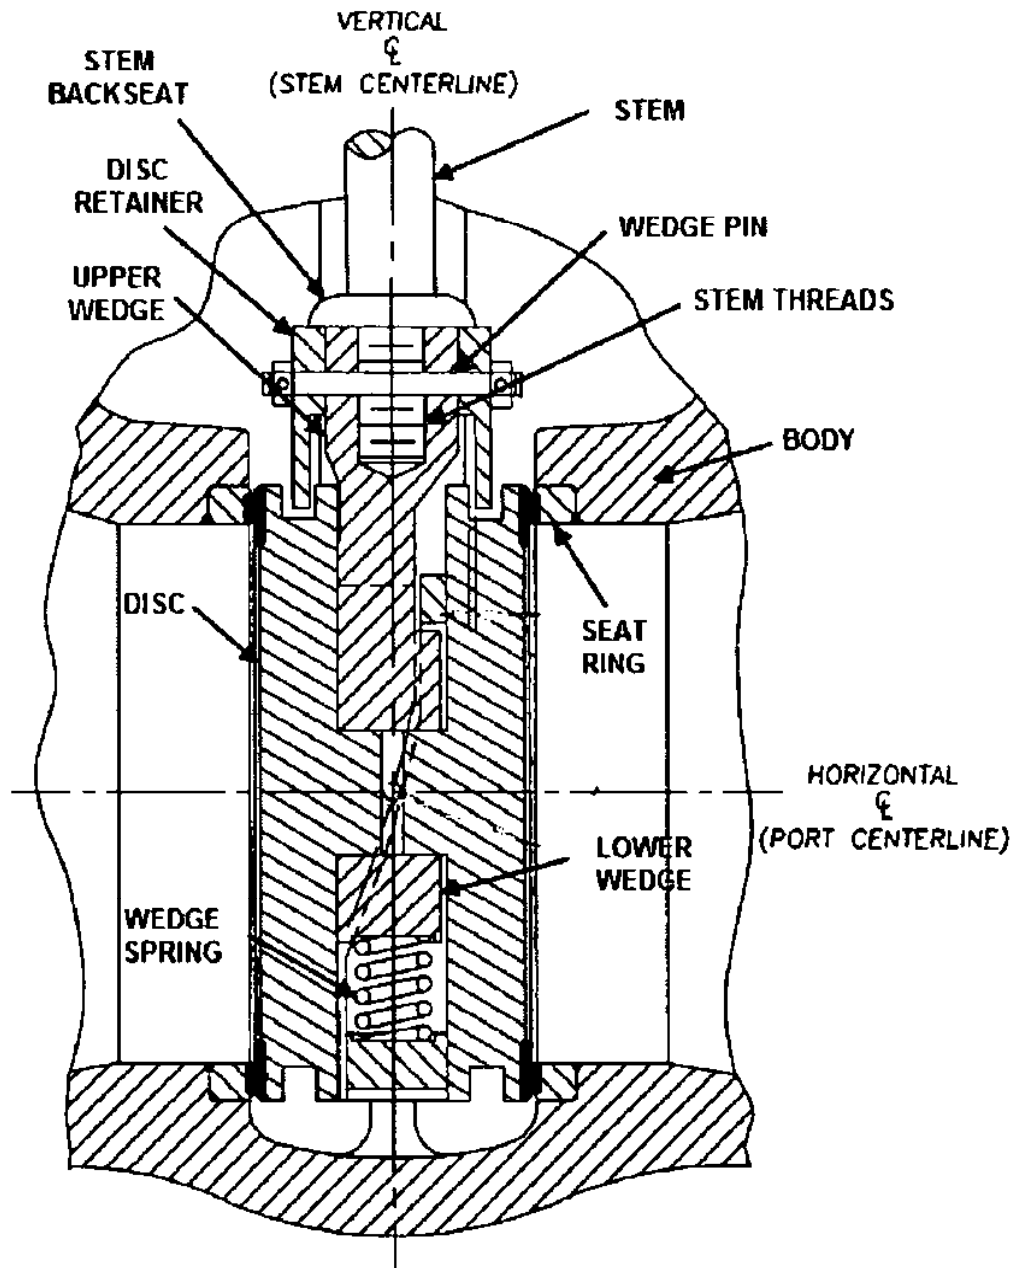
On February 11, 2017, the LaSalle Unit 2 HPCS injection valve stem was found to be separated from the upper wedge/disc assembly during a fill and vent activity. Prior to the failure, the valve had successfully passed a local leak rate test where the valve had cycled successfully several times. Valve disassembly and inspection revealed the wedge pin had sheared and the valve stem threads were damaged. This valve was an Anchor/Darling 12 inch Double Disc Gate Valve (ADDDGV) and was included in those valves associated with the Flowserve and Browns Ferry Part 21 reports submitted in 2013 (ADAMS ML13008A321 and ML13064A012). The licensee was addressing the Part 21 reports by using industry guidance provided by the Boiling Water Reactor Owners Group (BWROG) prior to the failure. Following the identification of the separation, the licensee redesigned and repaired the failed Unit 2 HPCS Injection valve.

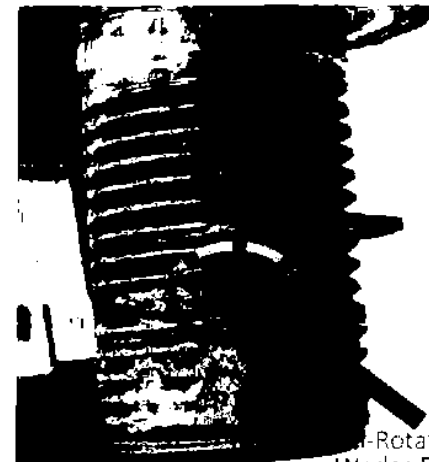
The analysis demonstrates that it is not a question of "if" the valve is going to fail, but "when" the valve will fail.
