SEQUOYAH NUCLEAR PLANT

RESOLUTION OF PRESSURIZER SAFETY VALVE
SEAT LEAKAGE CONCERNS

RICHARD G. SIMMONS
11/14/91

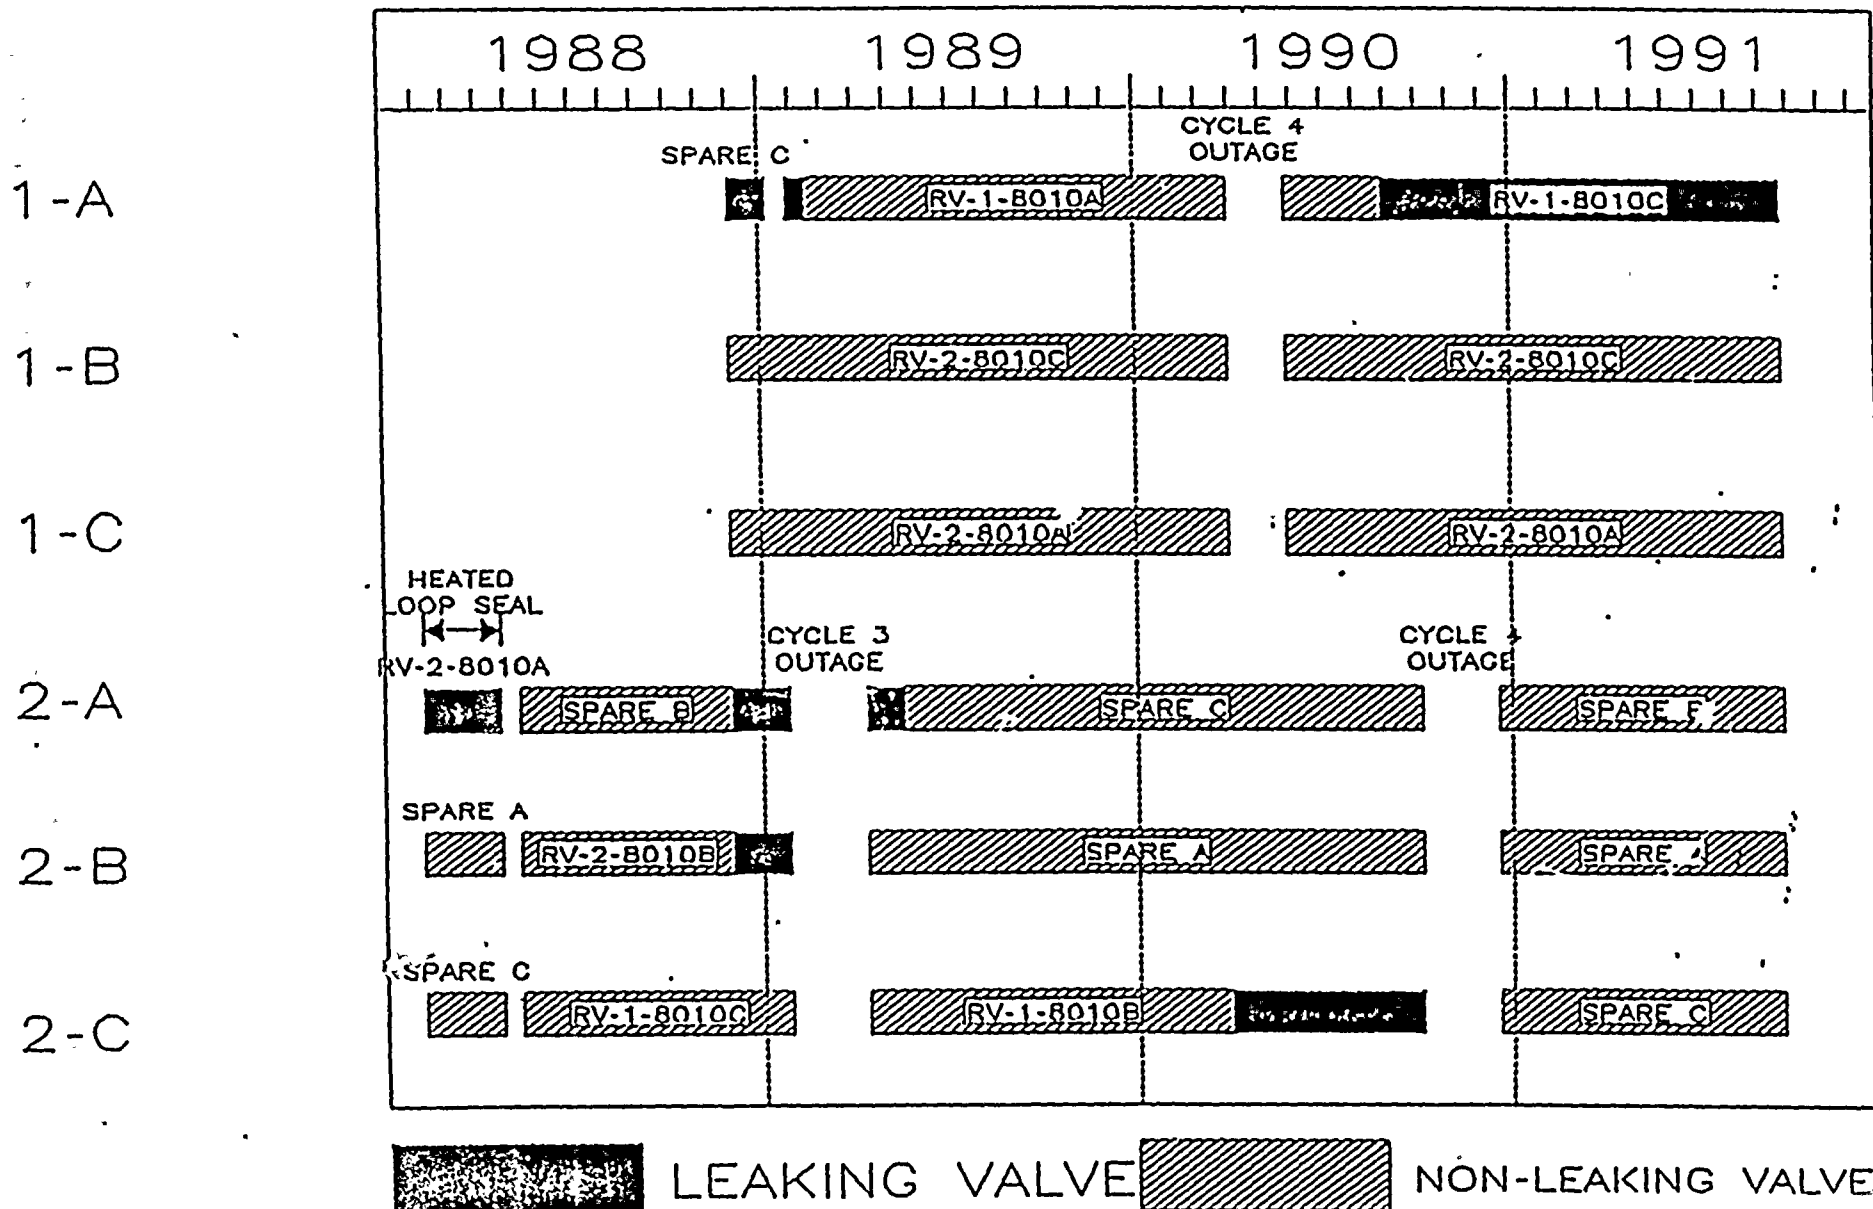
ATTACHMENT 1 SEQUOYAH NUCLEAR PLANT PRESSURIZER SAFETY VALVE LEAKAGE HISTORY

Since restart of units 1 and 2 there have been seven identified incidences of pressurizer safety valve seat leakage associated with steam service (drained loop seal). Two of these leaks were corrected with the valve successfully operating with no detectable leakage until the next refueling outage. A summary of these leaks follows and Attachment 1 graphically depicts incidences of pressurizer safety valve leakage.

<u>UNIT</u>	<u>VALVE S/N</u>	<u>POSITION</u>	<u>OPERATING CYCLE</u>
1	SPARE C	A	Cycle 3
1	RV-1-8010A ¹	A	Cycle 3
1	RV-1-8010C	A	Cycle 4
2	RV-2-8010B	B	Cycle 2
2	SPARE B	A	Cycle 2
2	SPARE C ²	A	Cycle 3
2	RV-1-8010B	C	Cycle 3
