NINE MILE POINT I
PIPE CRACK TASK FORCE REPORT

Approved: G. M. Gordon
G. M. Gordon, Chairman
Pipe Crack Task Force

On March 23, 1982, during a hydrotest at Nine Mile Point-1 (NMP-1) prior to startup, inspection revealed through wall leaking cracks in two of the ten furnace sensitized recirculation safe ends. On March 26, 1982, ultrasonic examinations on these two safe ends and one other confirmed crack-like indications. In mid-April, 1982, two boat samples were obtained from one of the safe ends in the vicinity of the through wall cracks. One each of these samples was sent to General Electric and Battelle Laboratories for evaluation. The results of those evaluations in mid-May confirmed the presence of intergranular stress corrosion cracking (IGSCC). Subsequent ultrasonic examination of the 28" recirculation piping revealed crack-like indications in many of the piping weld heat affected zones examined at both shop and field welds.

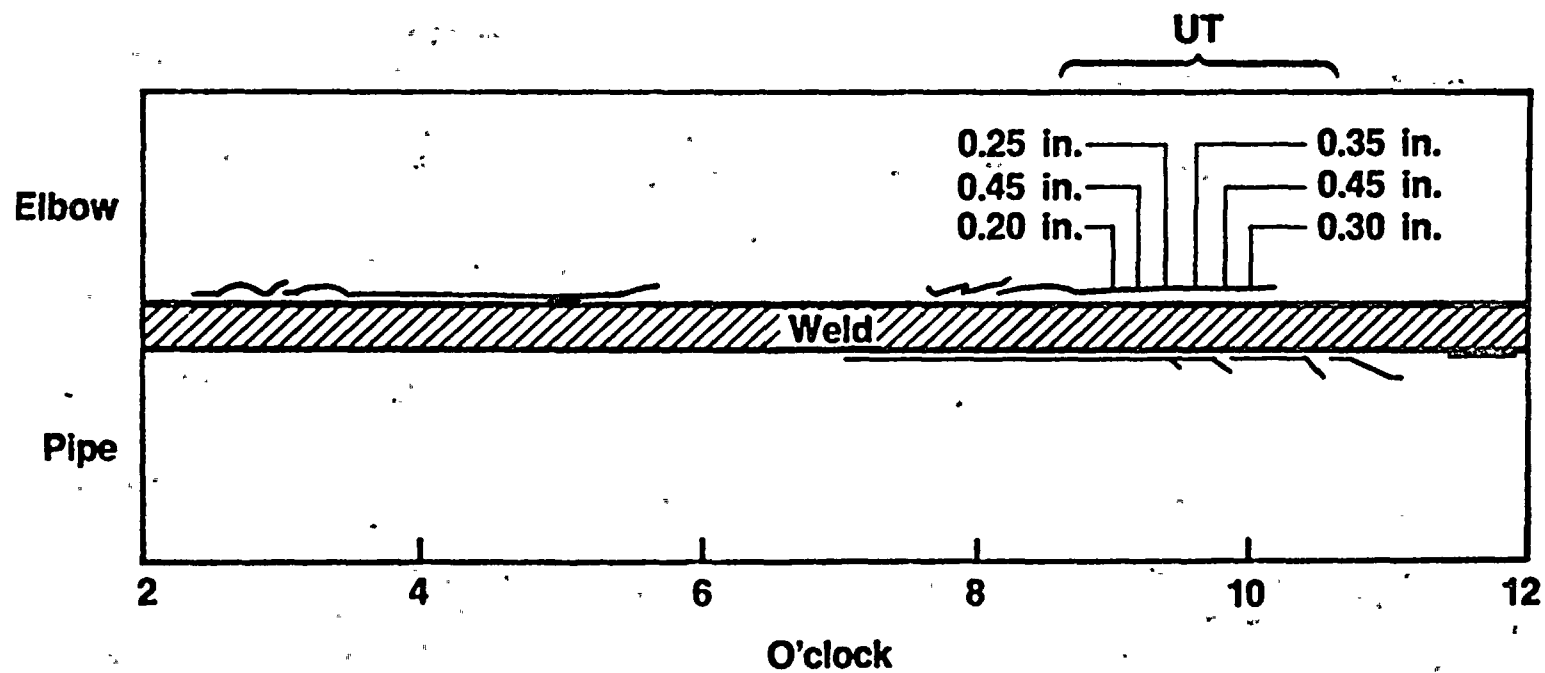
Figure S-2. Sketch of PT Indications in Loop 13 Suction Elbow/Pipe Weld

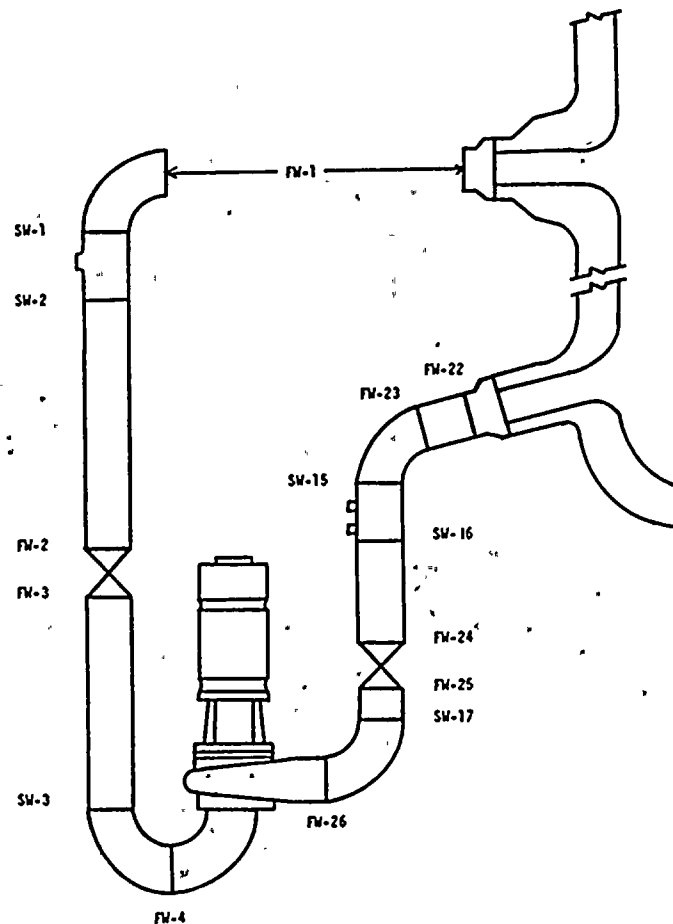
<u>Weld</u>	<u>HAZ</u>	<u>UT Results</u>	<u>PT Results</u>	<u>% Circ. by PT</u>
FW-1	Safe-End	---	No Indications	0
	Elbow	---	No Indications	0
SW-1	Elbow	---	No Indications	0
	Tee	---	No Indications	0
SW-2	Tee	No Indications	No Indications	0
	Pipe	Indications	No Indications	0
FW-2	Pipe	Indications	---	-
FW-3	Pipe	Indications	---	-
SW-3	Pipe	Indications	No Indications	0
	Elbow	Indications	Circ. Indications	0-5
FW-4	Elbow (Upstream)	Indications	Circ. Indications	5-10
FW-26	Elbow	Indications	Circ. Indications	0-5
SW-17	Elbow	Indications	No Indications	0
	Pipe	No Indications	No Indications	0
SW-16	Upstream Pipe	Indications	No Indications	0
	Downstream Pipe	Indications	No Indications	0
SW-15	Pipe	---	Circ. & Axial Indications	5-10
	Elbow	---	No Indications	0
FW-23	Elbow	---	Axial Indications	0-5
	Pipe	---	Circ. & Axial Indications	5-10
FW-22	Pipe	Indications	Circ. & Axial Indications	0-5
	Safe End	Indications	Circ. & Axial Indications, Leak	10-15

Figure 1. Recirculation Loop No. 11 Examination Results.

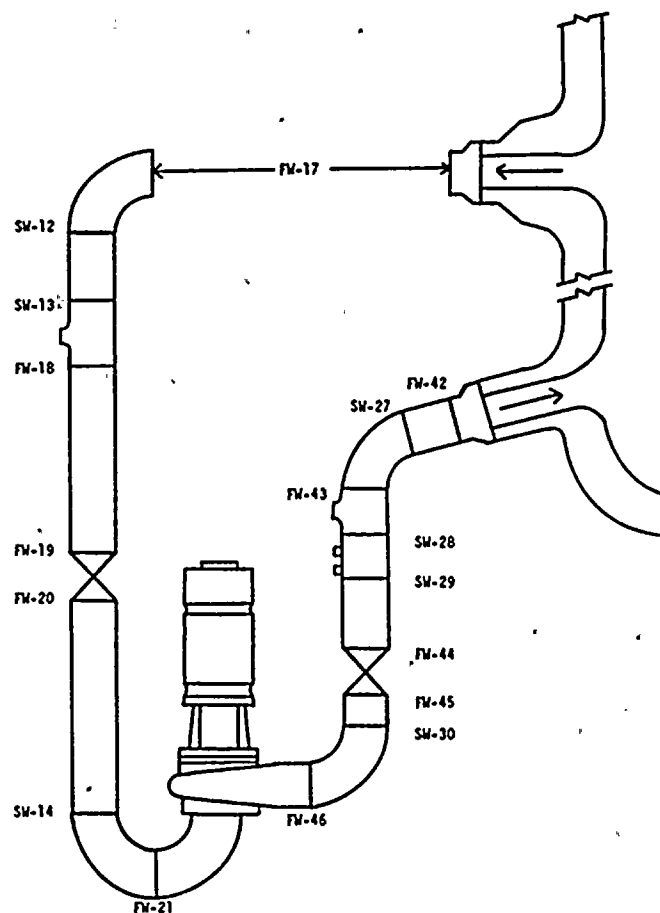
Weld	HAZ	UT Results	PT Results	% Circ. by PT
FW-17	Safe End	Indications	Circ. Indications, Leak	20-25
	Elbow	No Indications	No Indications	0
SW-12	Elbow	Indications	Circ. Indications	10-15
	Pipe	Indications	Circ. Indications	15-20
SW-13	Pipe	Indications	---	-
	Tee	No Indications	---	-
FW-18	Tee	No Indications	---	-
	Pipe	Indications	---	-
FW-19	Pipe	Indications	---	-
FW-20	Pipe	Indications	---	-
SW-14	Pipe	Indications	Circ. Indications	5-10
	Elbow	Indications	No Indications	-
FW-21	Upstream Elbow	Indications	Circ. Indications	0-5
FW-46	Elbow	Indications	Circ. Indications	20-25
SW-30	Elbow	---	Branched Circ. Indications	40-45
	Pipe	---	Branched Circ. Indications	20-25
FW-43	Tee	---	No Indications	0
	Elbow	---	No Indications	0
SW-27	Elbow	---	No Indications	0
	Pipe	---	No Indications	0
FW-42	Pipe	---	No Indications	0
	Safe End	---	No Indications	0

Figure 5. Recirculation Loop No. 15 Examination Results.

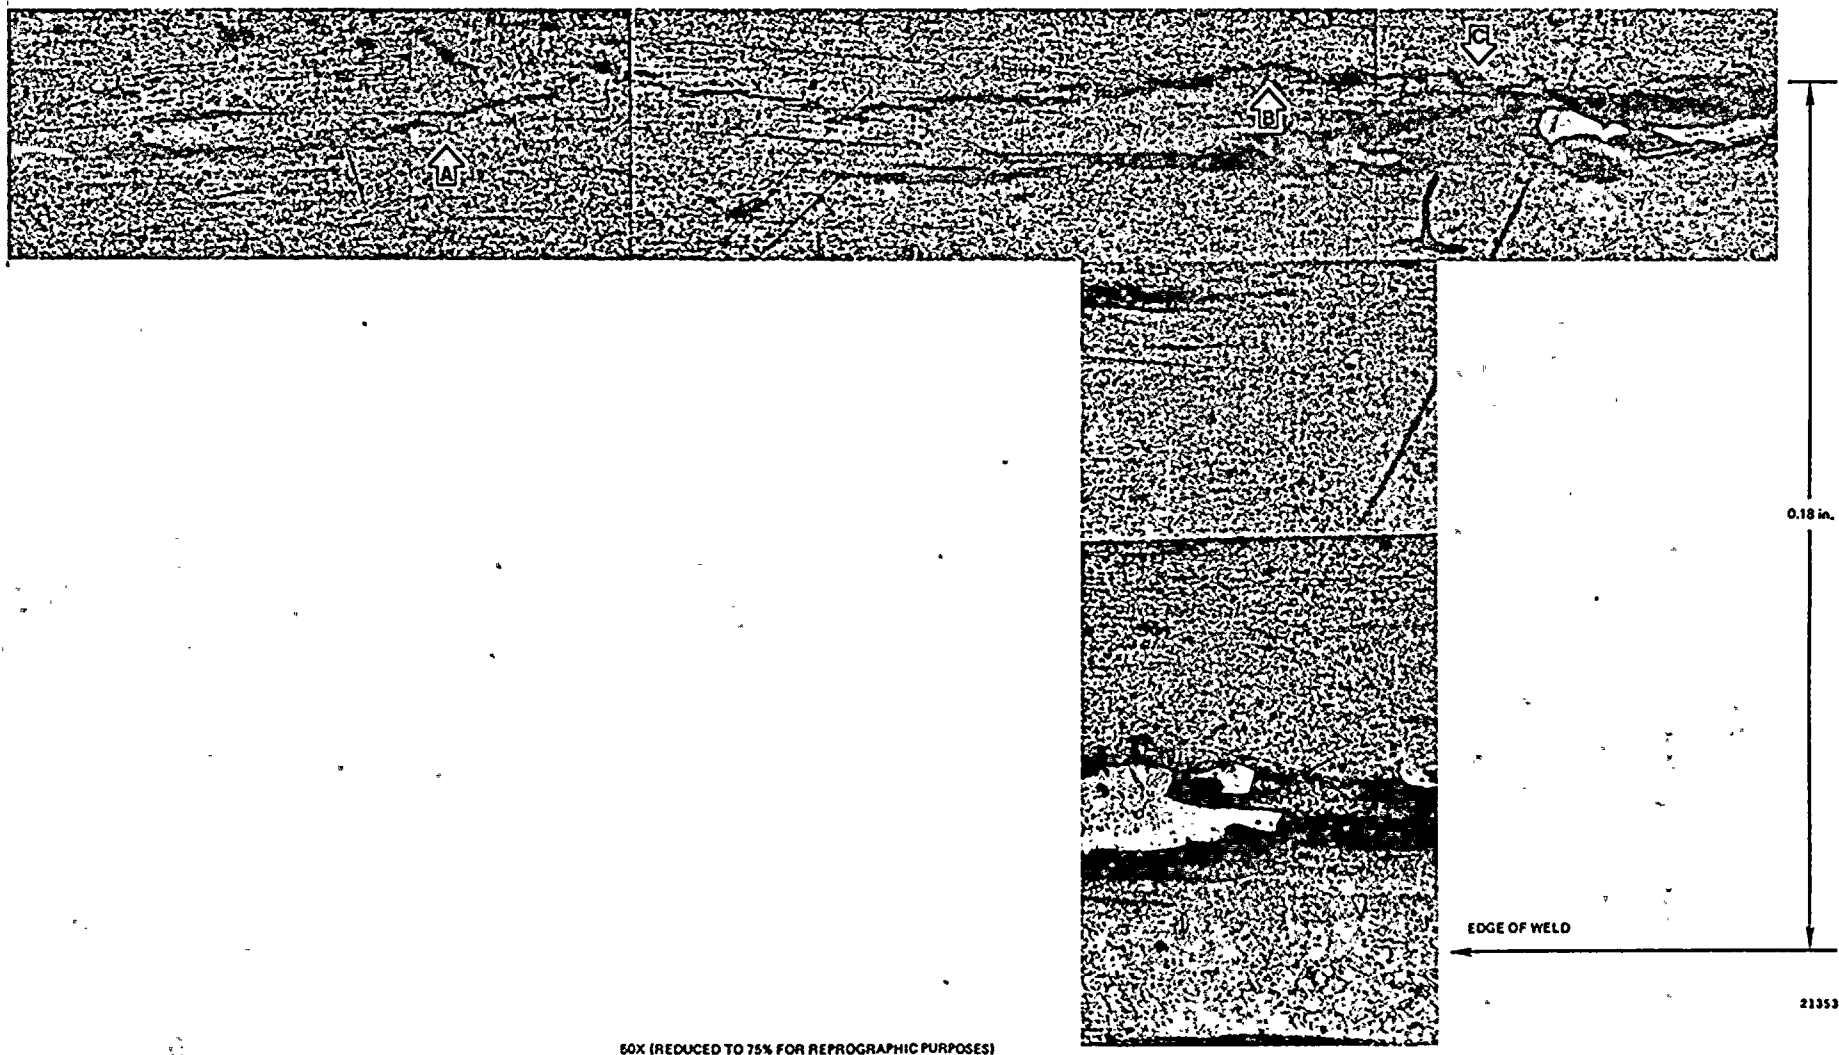
Figure 2. Composite Photograph of Intergranular Crack in Weld Heat Affected Zone (HAZ) at 9:00 Azimuth.

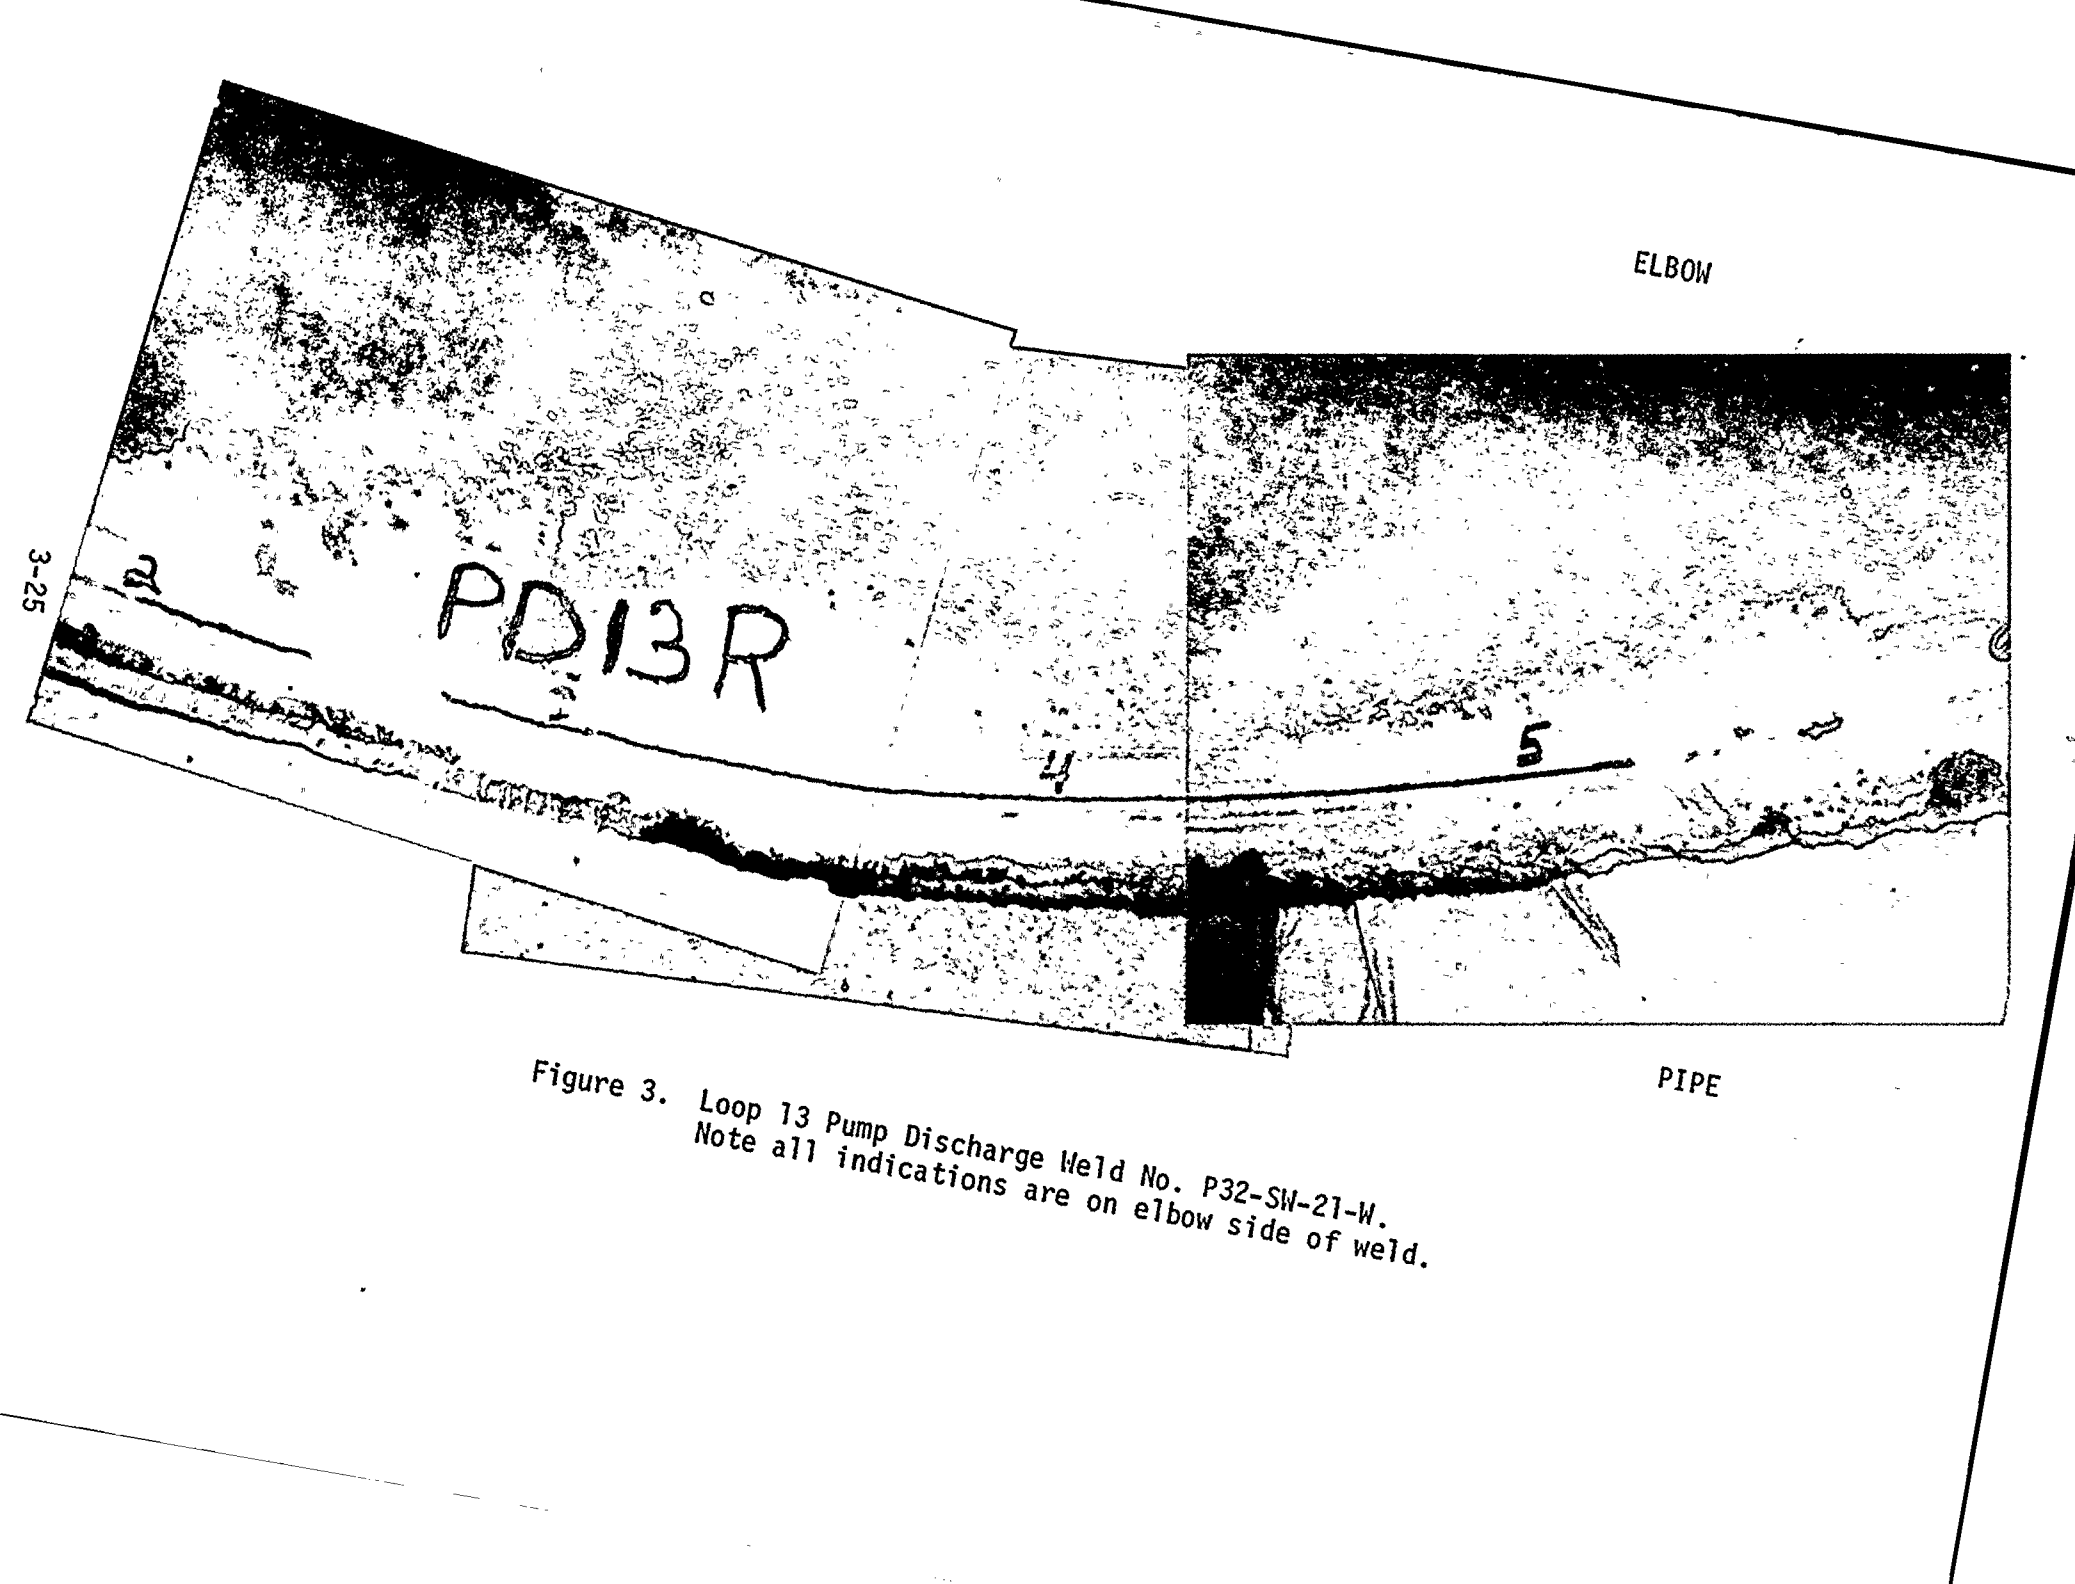
Figure 3. Loop 13 Pump Discharge Weld No. P32-SW-21-W.
Note all indications are on elbow side of weld.

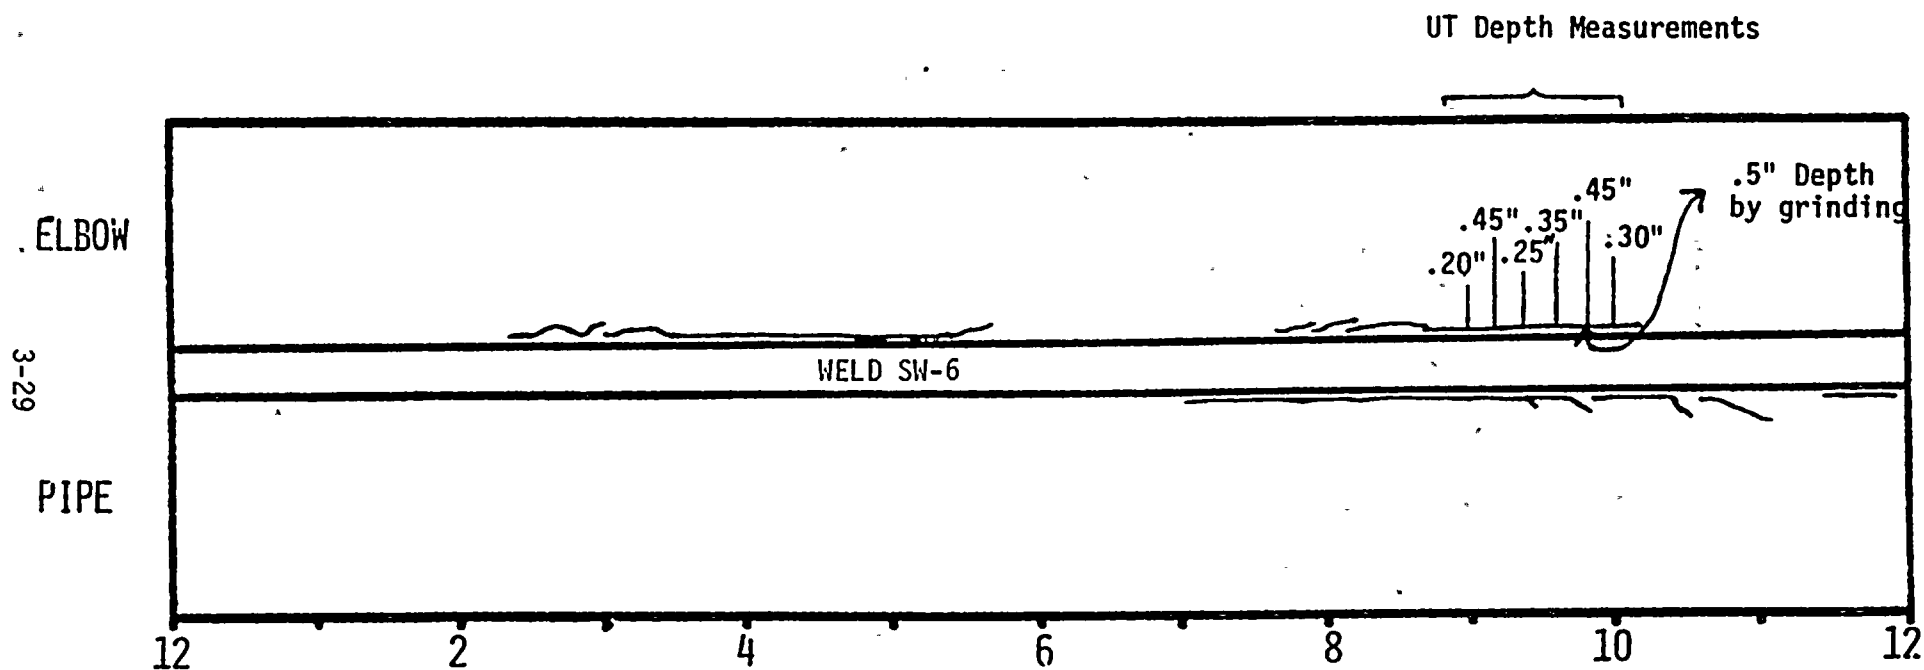
Figure 10. Loop 13 Suction Elbow/Pipe Weld, Showing Results of U.T. Depth Measurements.

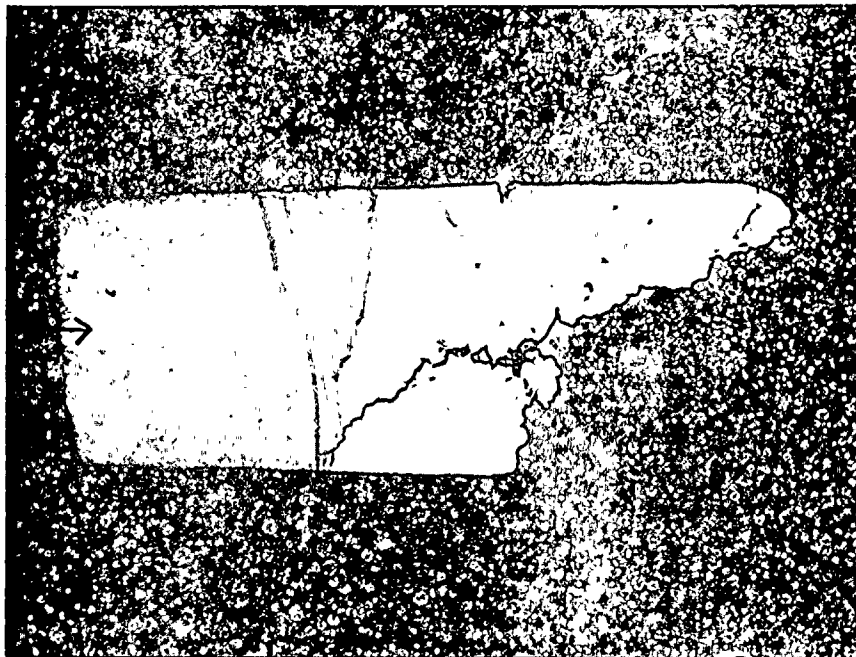
Figure 14. O.D. surface of Section A-1 after breaking open to reveal fracture surface, Oxalic Acid Etch. 15X

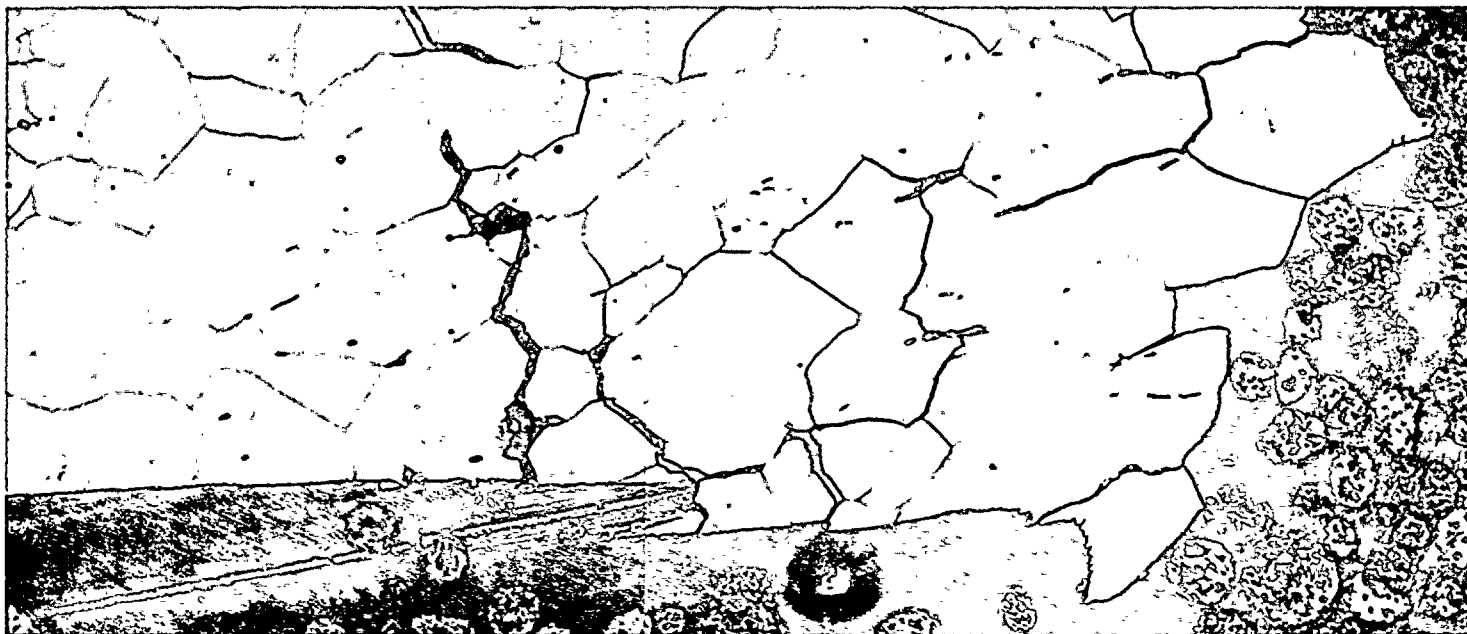
Figure 16. Lower left region of Fig. 15, showing intergranular cracking.
Oxalic Acid Etch, 125X.

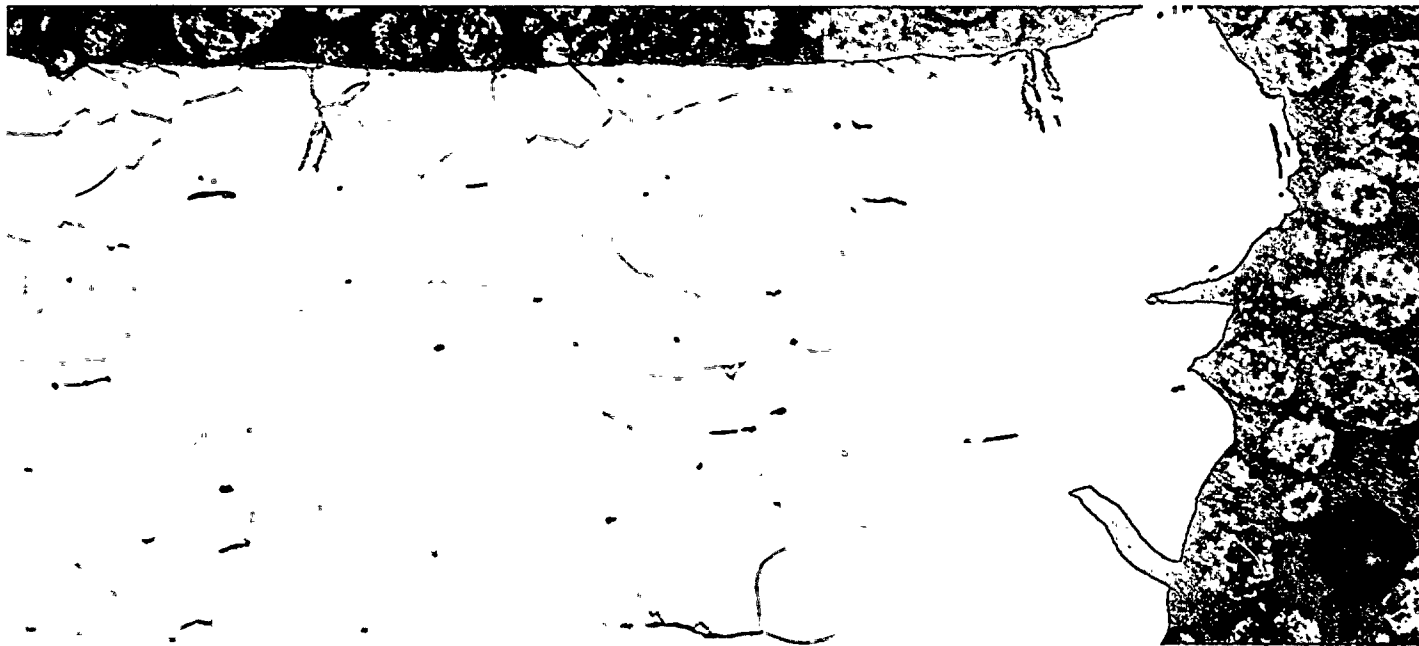
Figure 17. Outside-initiated transgranular cracking on upper left region of Figure 15, Oxalic Acid Etch, 125X.

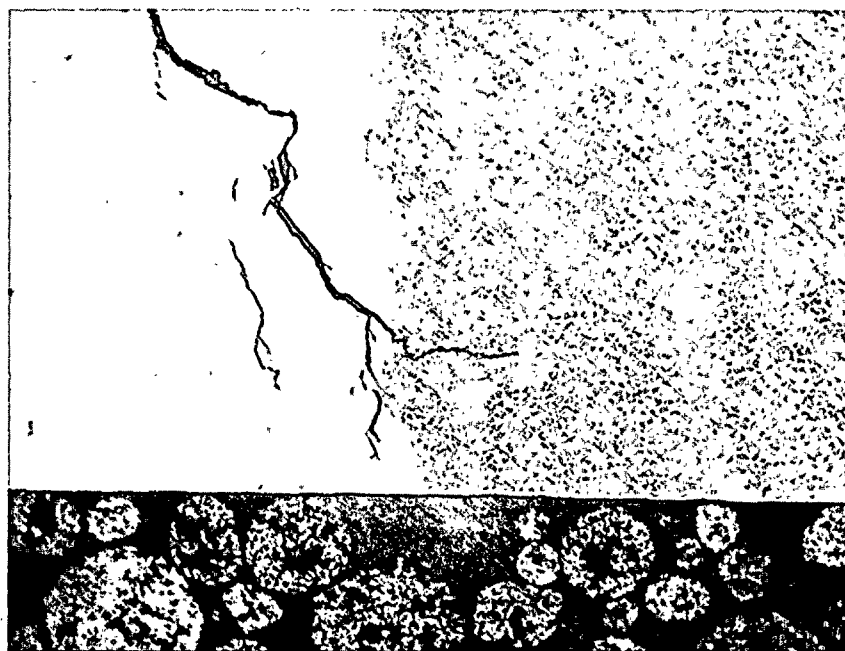
Figure 18. Crack arrest in weld materia, 125X
Oxalic Acid Etch.

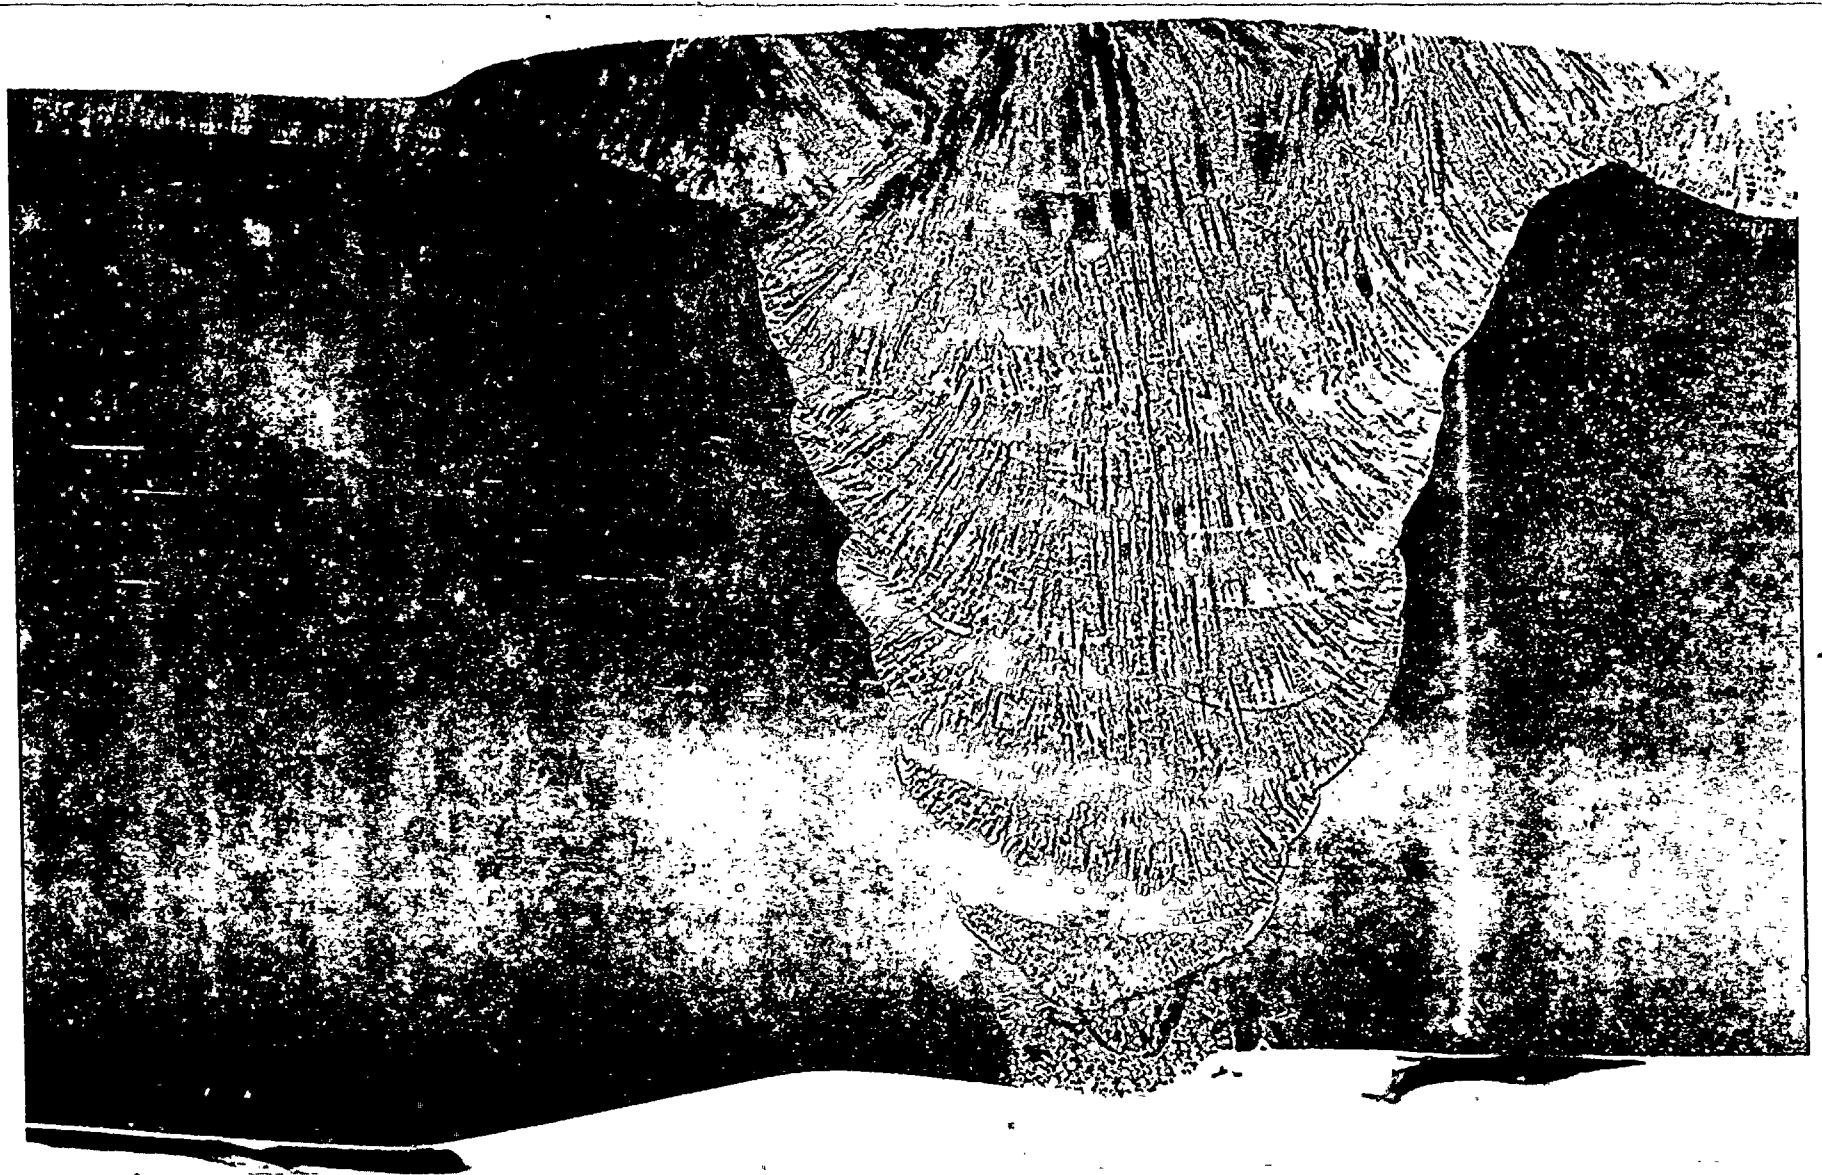
FIGURE 34. SAMPLE B1 SHOWING A SHORT CRACK NEAR THE WELD ROOT ON THE PIPE SIDE OF THE WELD.

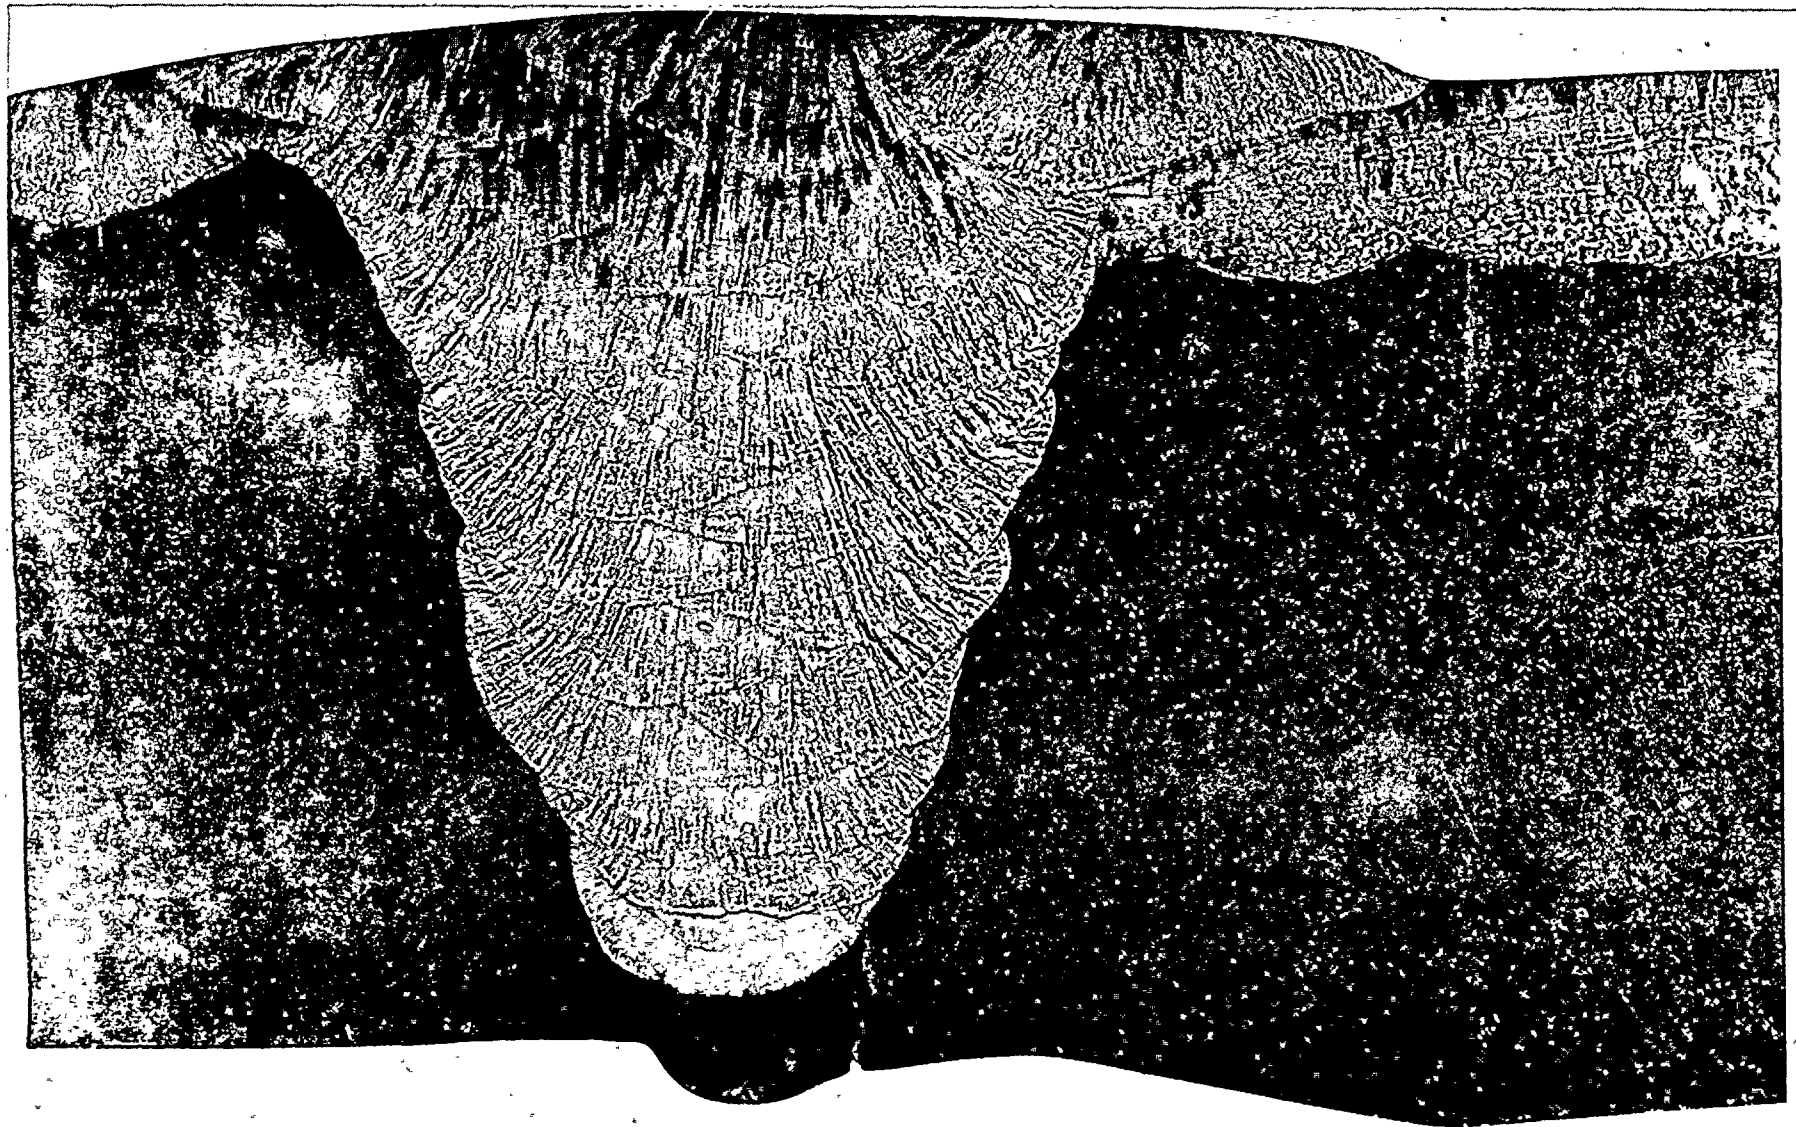
FIGURE 35. SAMPLE B2 SHOWING A CRACK NEAR THE FUSION LINE ON THE ELBOW SIDE TO THE WELD.

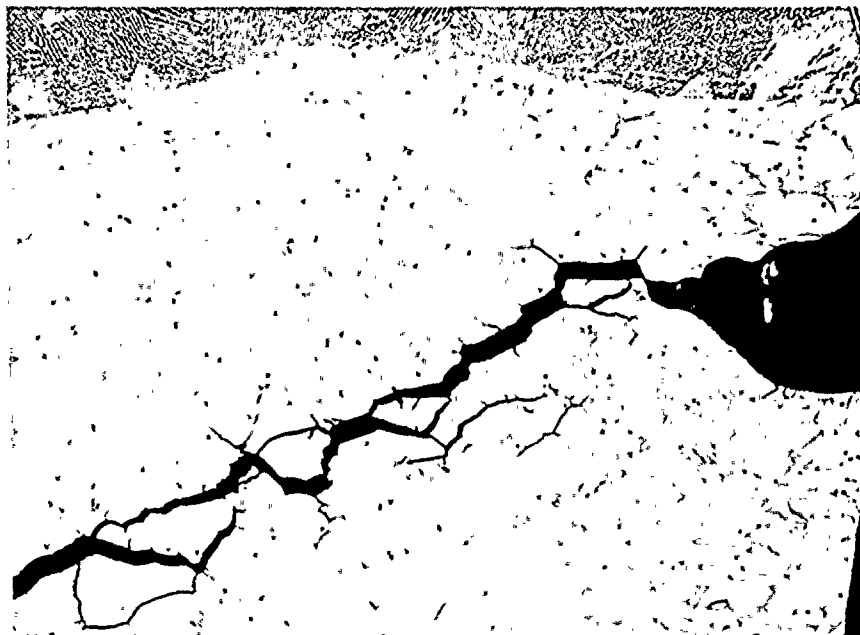
Figure 38. Etched
Crack on elbow side - Boat Sample C.

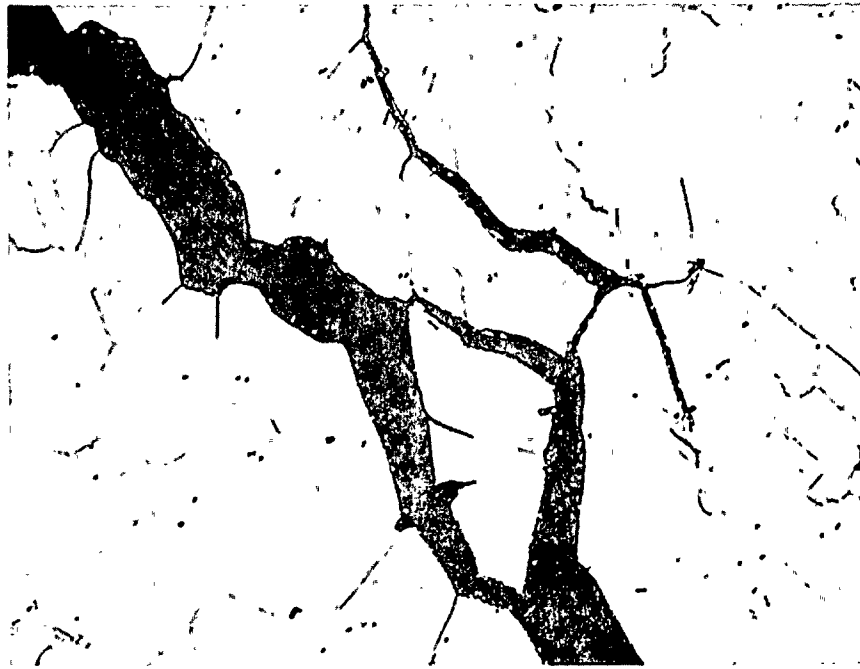
Figure 39. Etched - Boat Sample C
Detailed view, center portion.

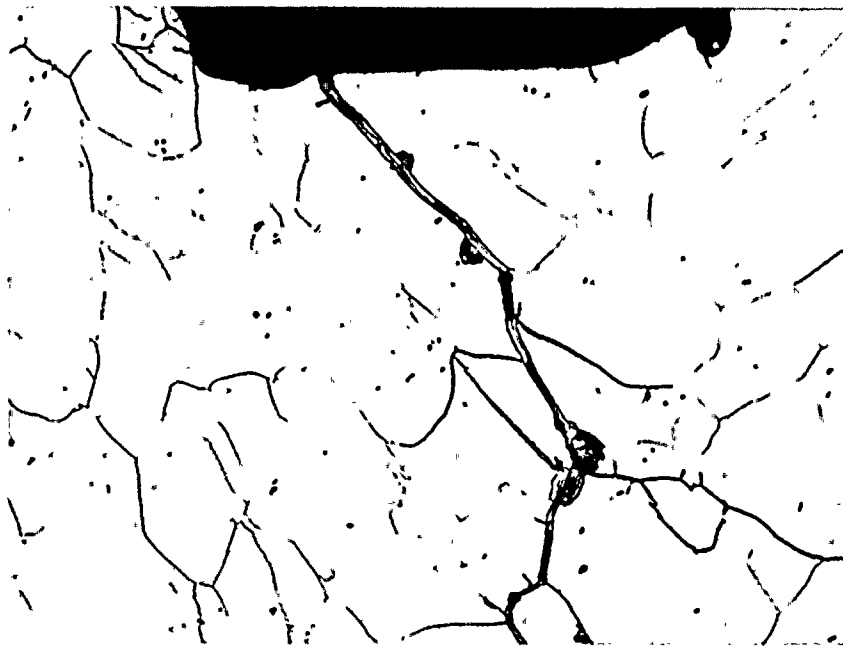
Figure 44. Etched view of Sample D containing
beginning of crack in Figure 43.

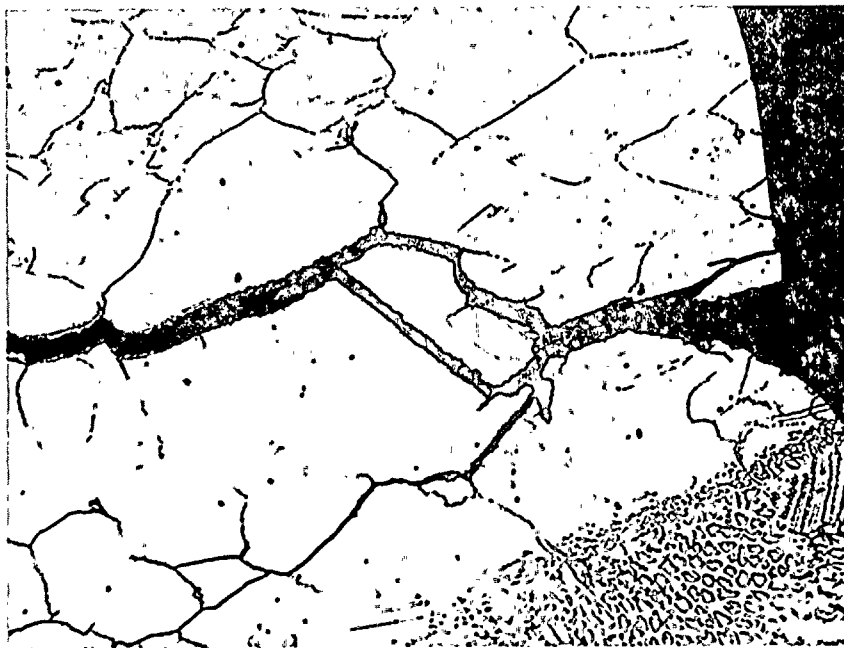
Figure 53. Etched view of beginning of crack in Figure 50.

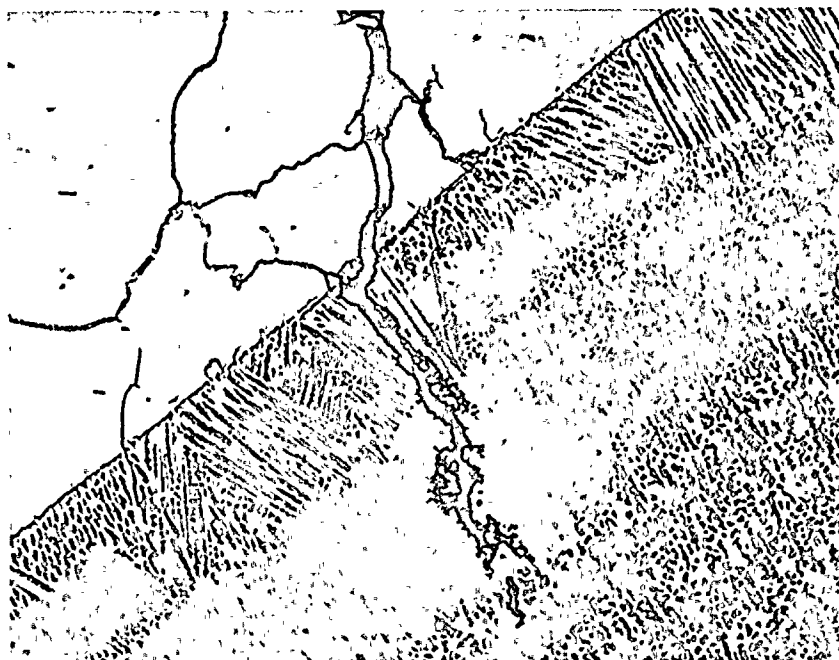
Figure 54. Kahling etched view of crack extending into weld. This view shows crack arrest in weld metal containing significant ferrite.

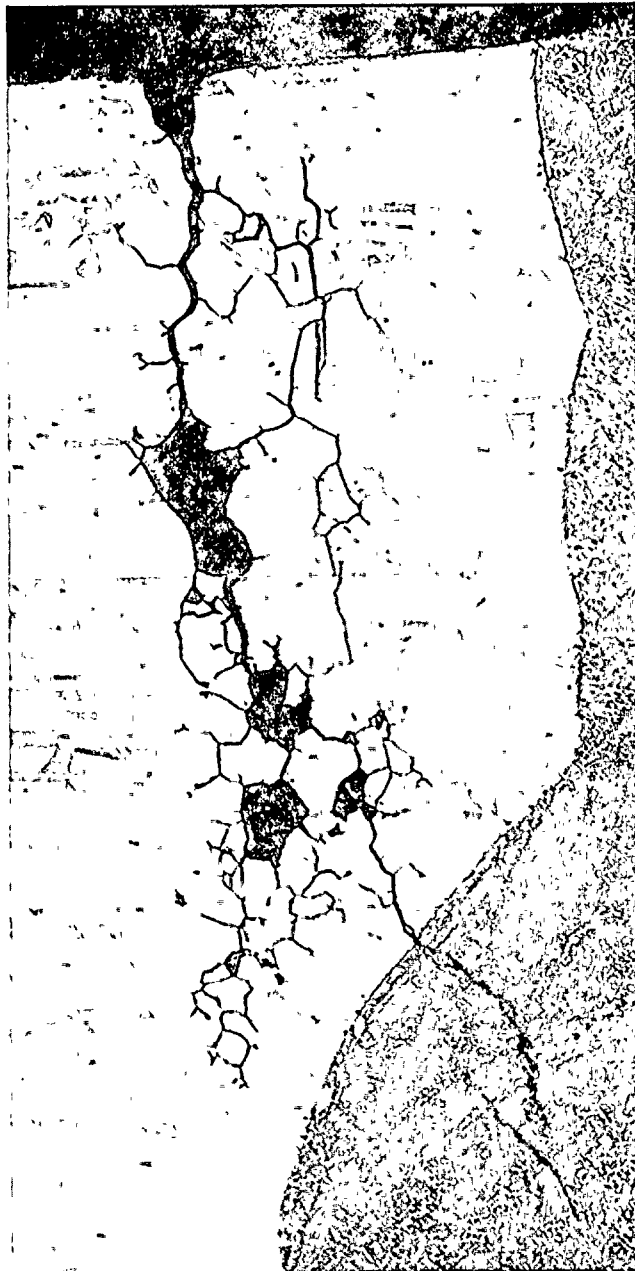
Figure 56. Etched view crack in pipe side. Sample was removed from shop weld SW-12 of Loop 15.

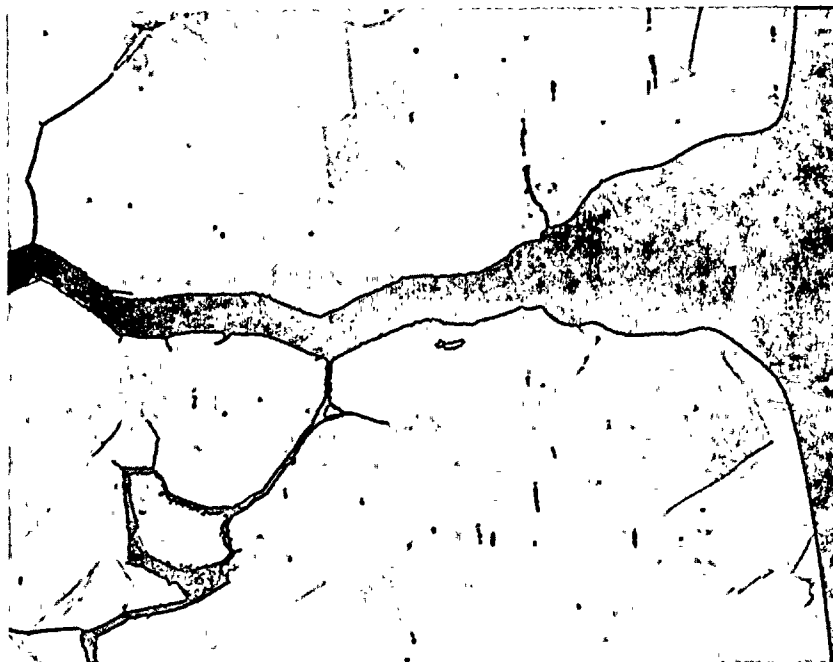
Figure 57. Etched view, beginning of crack
of Figure 56.

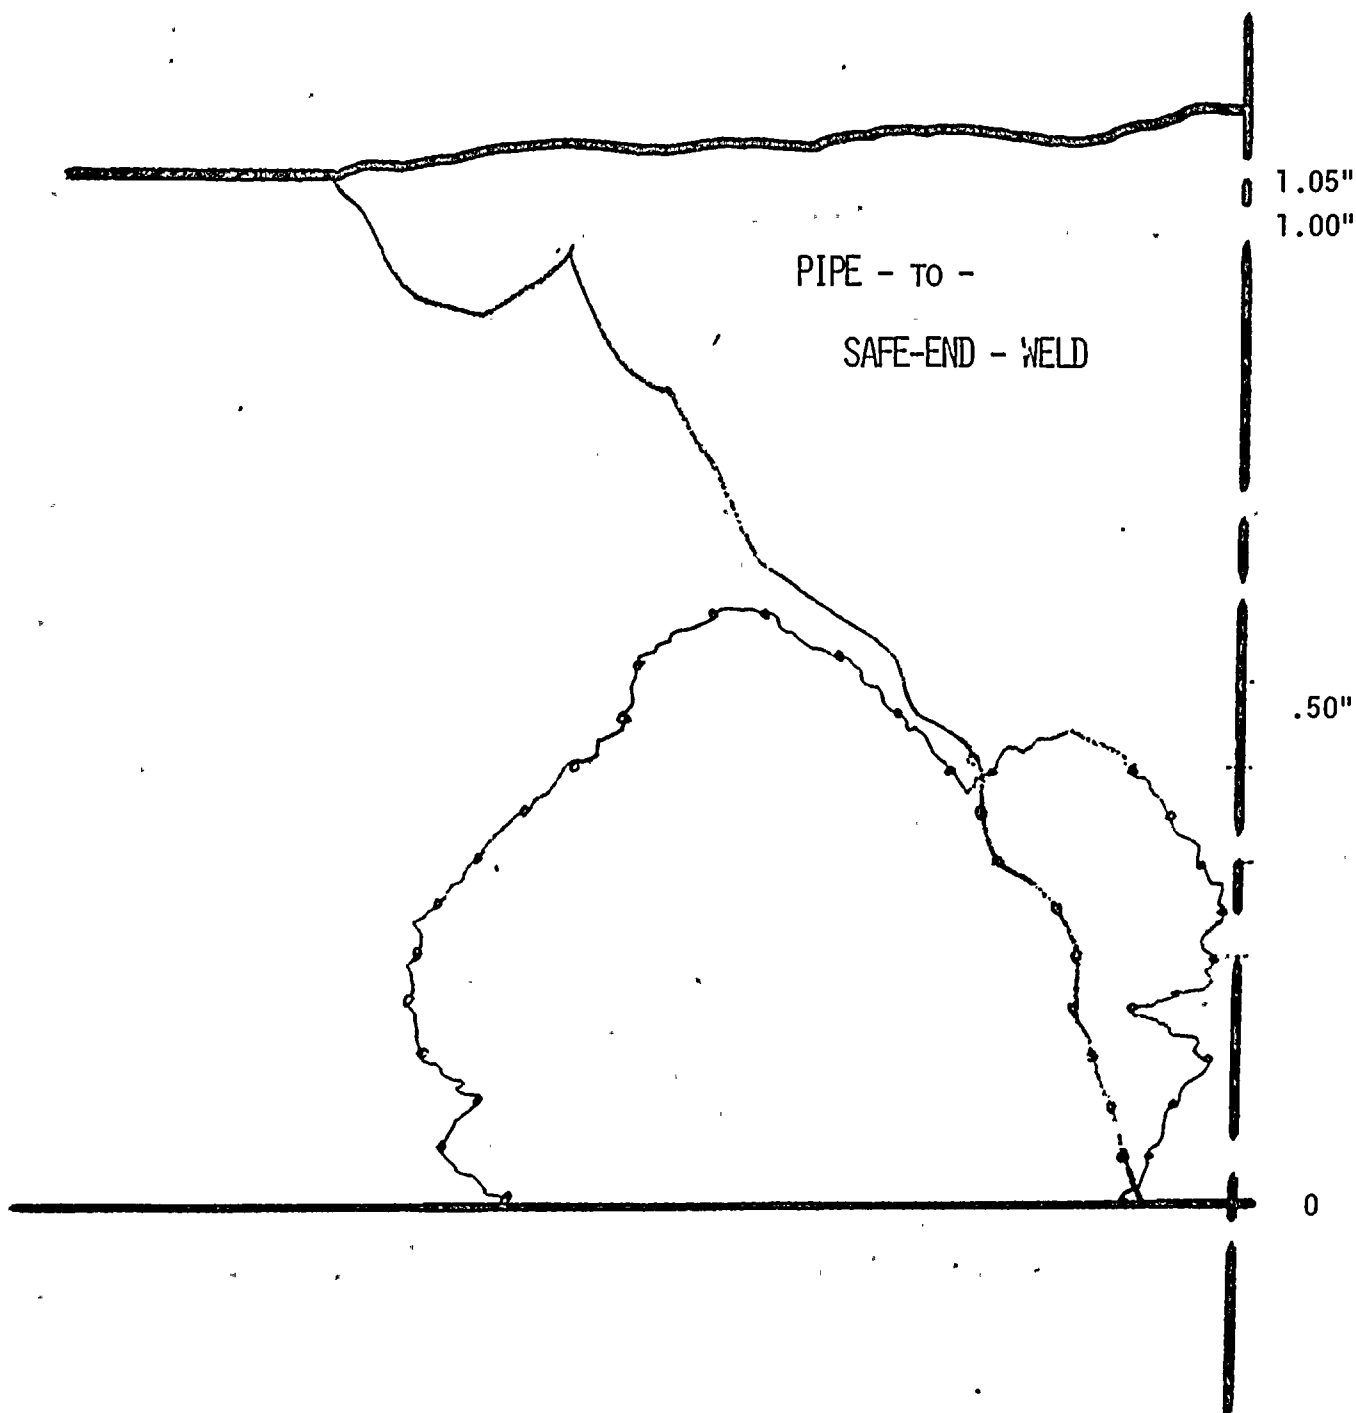
Figure 17. Profile of axial IGSCC crack #1 (of Figure 16) removed from the safe end side of safe-end-to-pipe weld FW-22 of NMP-1 recirculation loop 11. The crack, with a maximum depth of approximately 59% wall, is situated entirely below the weld crown. This crack would not have been a reportable indication as a result of the 1981 ISI examination.
