NINE MILE POINT I
PIPE CRACK TASK FORCE REPORT

Approved: G. M. Gordon
G. M. Gordon, Chairman
Pipe Crack Task Force

On March 23, 1982, during a hydrotest at Nine Mile Point-1 (NMP-1) prior to startup, inspection revealed through wall leaking cracks in two of the ten furnace sensitized recirculation safe ends. On March 26, 1982, ultrasonic examinations on these two safe ends and one other confirmed crack-like indications. In mid-April, 1982, two boat samples were obtained from one of the safe ends in the vicinity of the through wall cracks. One each of these samples was sent to General Electric and Battelle Laboratories for evaluation. The results of those evaluations in mid-May confirmed the presence of intergranular stress corrosion cracking (IGSCC). Subsequent ultrasonic examination of the 28" recirculation piping revealed crack-like indications in many of the piping weld heat affected zones examined at both shop and field welds.

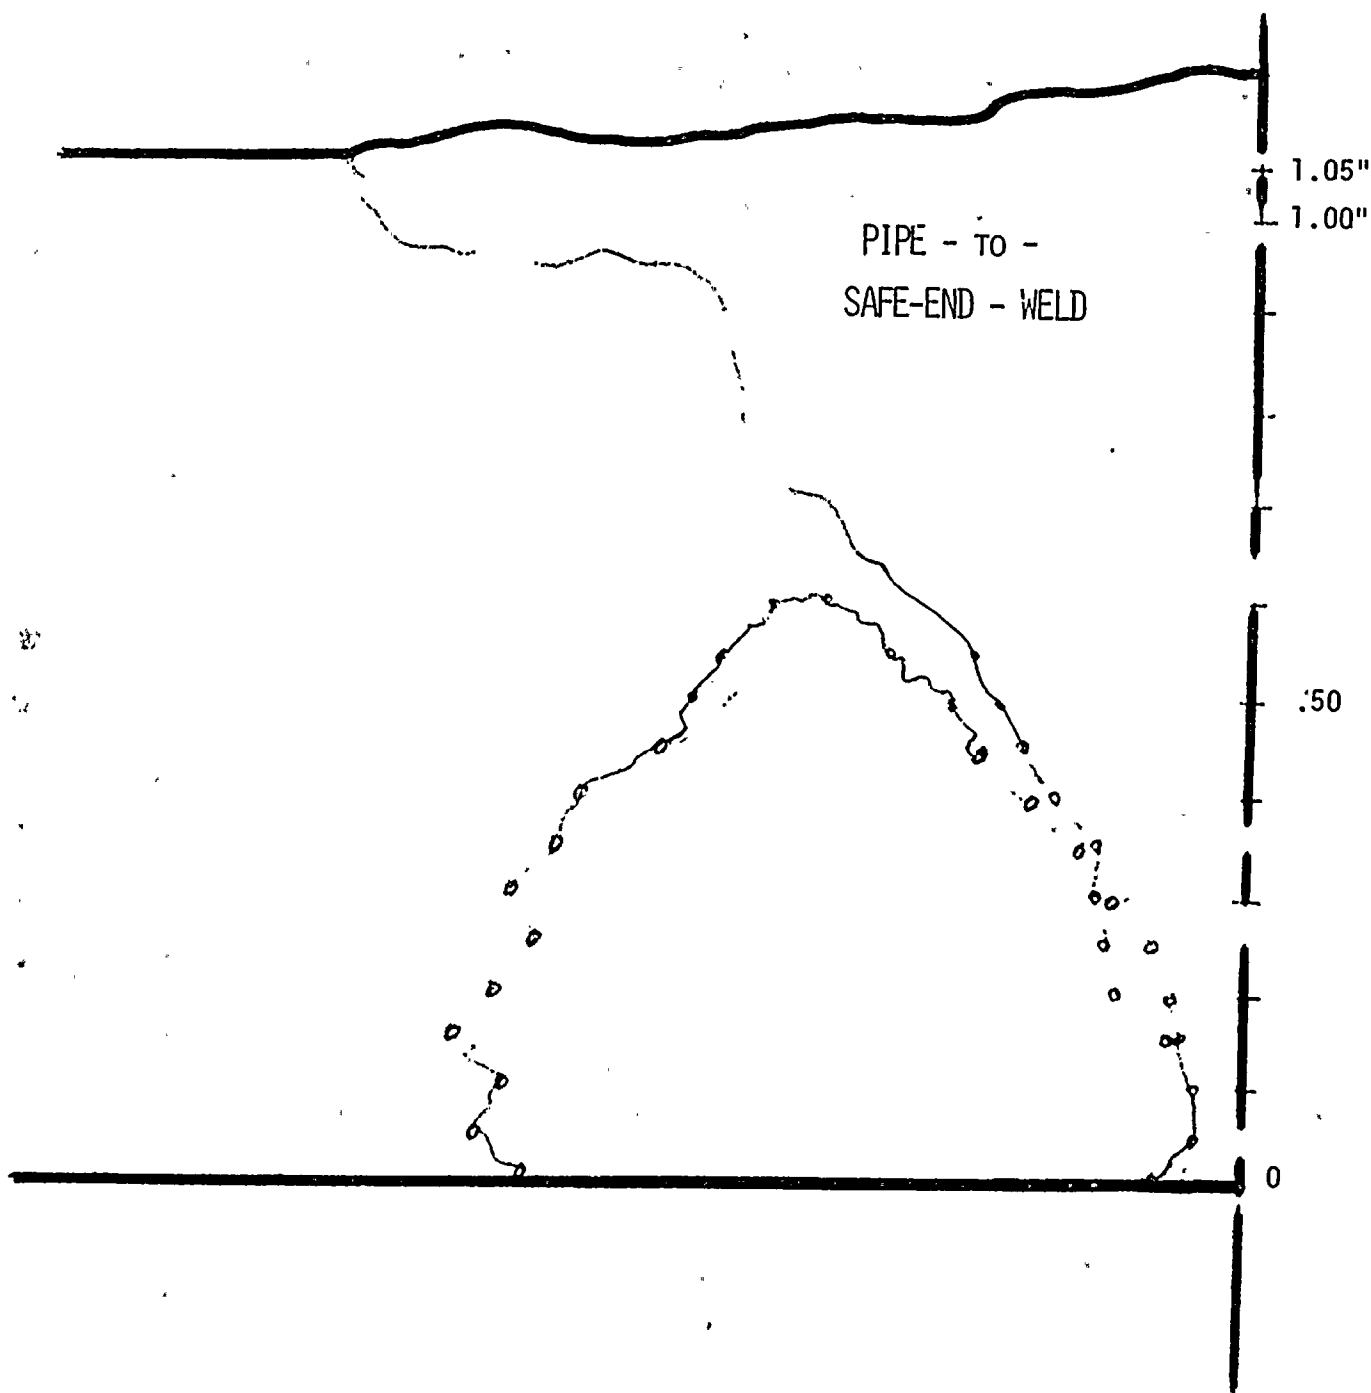
Figure 18. Profile of axial IGSCC crack #4 (of Figure 16) removed from the safe end side of safe-end-to-pipe weld FW-22 of NMP-1 recirculation loop 11. This crack, with a depth of approximately 58% wall would have been marginally detectable with the ISI procedures used in the 1981 examination.
