SUBJECT: Forwards reactor pressure vessel internals steam dryer rept summarizing indications found during Unit 1 refueling outage, per request. Indications will not impact safe operation of facility. Related info encl.

SUSQUEHANNA STEAM ELECTRIC STATION  
RPV INTERNALS/STEAM DRYER REPORT  
ER 100450 FILE 841-2, 203-11, 203-10  
PLA-2471

During inservice inspections (ISI) of internal components of the Susquehanna Unit No. 1 reactor vessel in Spring 1985, several visual indications were observed. The purpose of this report is to present results of the evaluation of indications observed in the steam dryer, steam dryer support bracket, core spray spargers, feedwater spargers, IRM/SRM instrument dry tubes, top guide, and in addition, jet pumps set screw gap sizes.

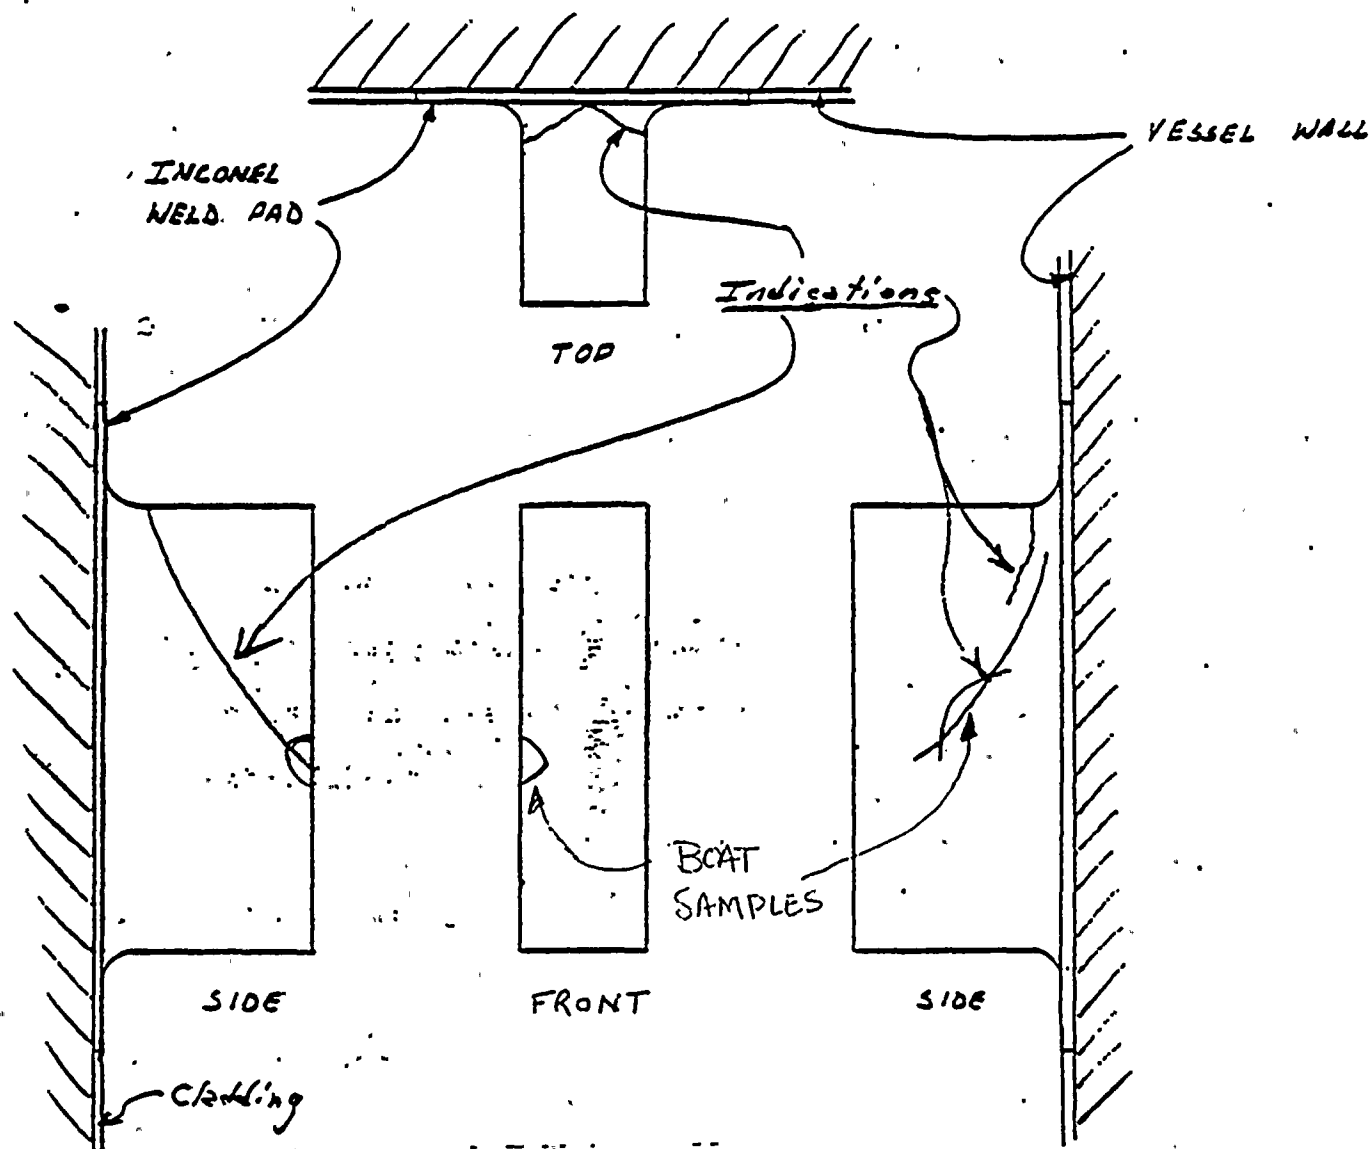
FIGURE 3 A-2

3.1.2 Indications: Remote underwater video viewing first revealed indications of cracking in the 184° bracket. On the top of the block near the RPV wall, a single indication crossed the 3" width of the block following the contour of the weld prep. On each side, the indication continued downward moving away from the RPV wall in a circular arc with center near the upper interior corner of the block. Fig. 3.A-2 shows the configuration of the indications. This indication was confirmed by local VT, PT, UT, and by physical separation of a portion during the bracket removal. The other three brackets were examined by remote VT, local VT, and PT with no indications.

The metallurgical analysis in the following section shows that the bracket failed by a fatigue mechanism. Since the initiation sites were found on the side surfaces of the bracket, the stresses had to be highest there. This implies that a flexural load was applied to the part in a horizontal direction. Vertical forces were also present, however a failure due to purely vertical forces, such as would be caused by lifting and dropping of the dryer on the bracket should

The dryer support bracket at 184° cracked due to fatigue, probably caused by a horizontal reversing load. The other three brackets' fatigue life were not significantly impacted because the load application point was closer to the RPV wall. The dryer will be instrumented before it is placed back into service in order to aid in investigating the source of the loading. In order to preclude the recurrence of bracket cracking during the next fuel cycle, the point of load application at the 184° bracket was moved by grinding out interference with the dryer support ring such that the seismic block bears the weight. The weld pad was carefully prepared for installation of the new bracket and the final surface was examined by VT, UT, PT, and etching for soundness of the material. The final thickness of the inconel weld pad was .130 inches which precipitated the use of special welding techniques in the repair. The new support bracket is identical to the original in every way except the bevel angle on the weld prep was increased to 45° to facilitate rewelding.

SUSQUEHANNA UNIT 1 DRYER SUPPORT BRACKET

INDICATIONS IN BRACKET AT 184° AZIMUTH

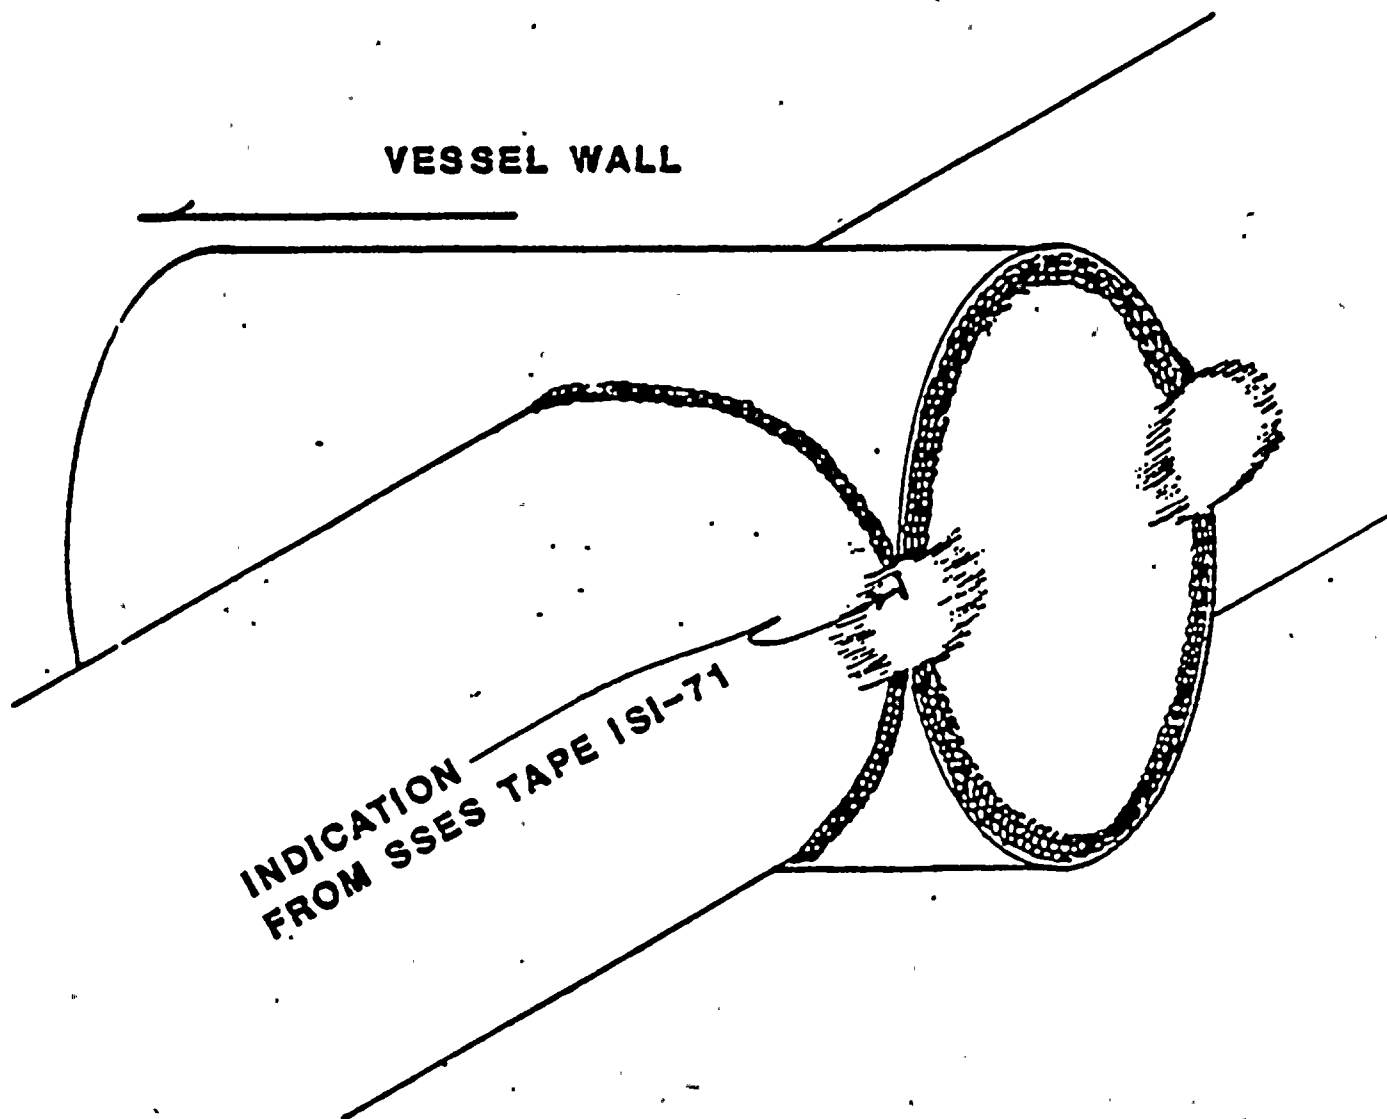
FIGURE 3 C-3  
C SPARGER INDICATION

A remote underwater TV examination of the accessible portions of the core spray spargers and corresponding internal piping was performed. Two indications were found. A 1/4"-3/8" indication was found in the "C" Sparger at 187°. (Figure 3 C-3) The location of the surface indication was possibly in the heat affected zone of the left sparger arm to junction box weld. Also, a 3/4" indication was found on the "D" Sparger at 172°. (Figure 3 C-4) The location of this indication was possibly in the heat affected zone of the right sparger arm to junction box weld. Cleaning of the affected areas was performed after which the "C" Sparger indication was

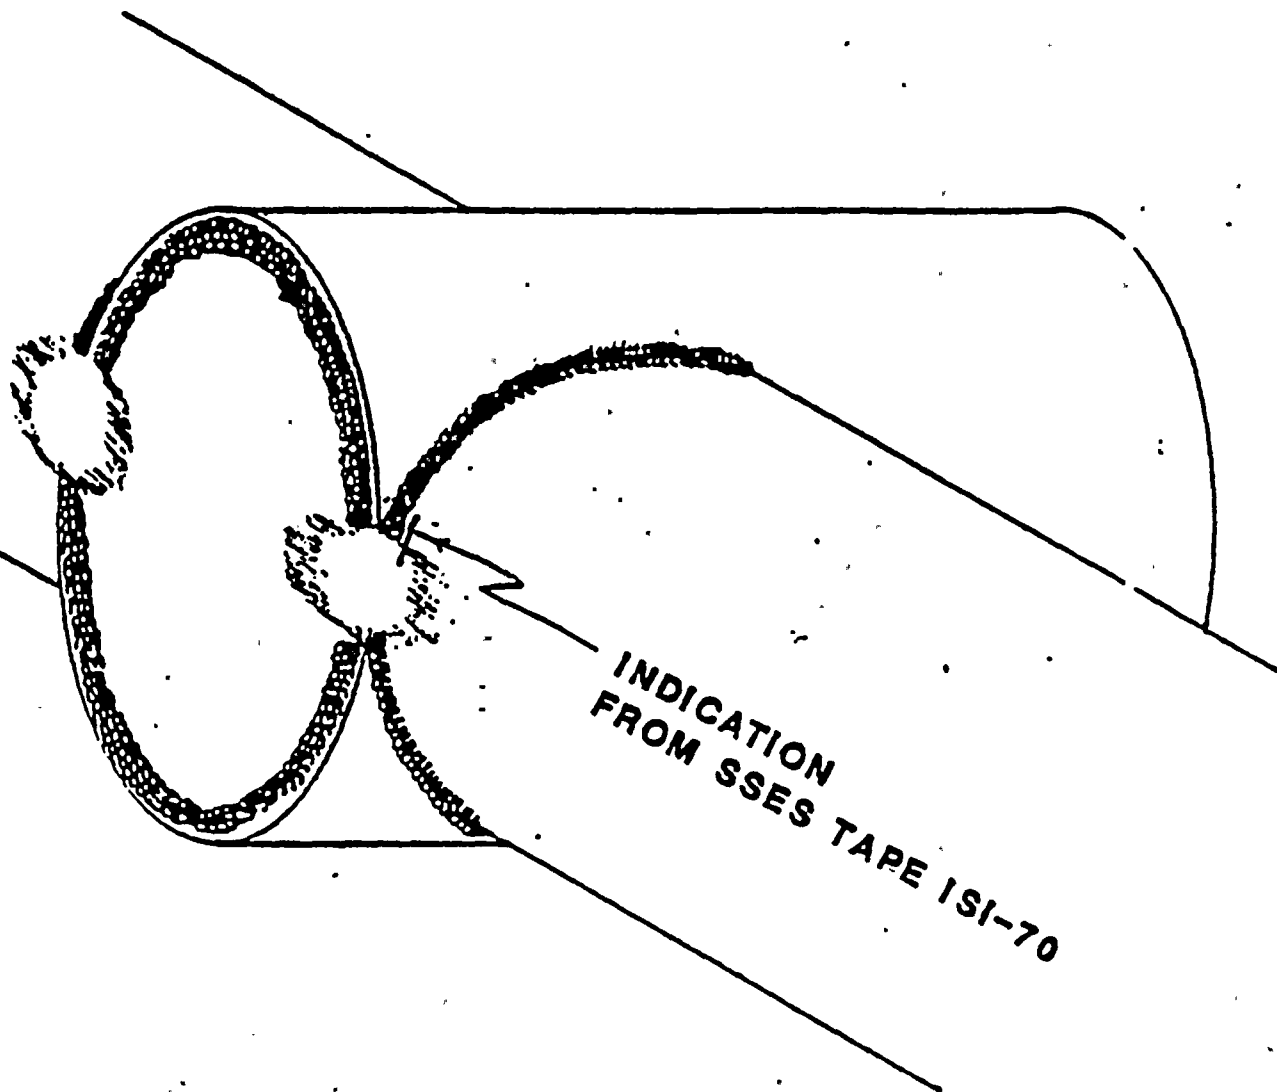
FIGURE 3 C-4  
D SPARGER INDICATION

grind mark. The indication in the D sparger may also be a surface scratch or grind mark. However, because of the crack-like appearance of the lower 0.25" of the indication (the entire indication is about 0.75" long) and the fact that cracks have been observed in other BWR core spray spargers, the indication in the D sparger is conservatively assumed to be a crack herein. Cracking has not been confirmed by means other than visual examination. The most likely mechanism for the observed crack in the "D" sparger is IGSCC due to cold work from pipe bending and grinding. Possible additional contributors are weld HAZ sensitization and residual weld stresses.

Results of evaluations indicate that the observed crack in the D sparger will have no effect on the structural or hydraulic integrity of the sparger even during core spray injection. The observed crack would not be expected to produce loose parts or adversely affect the LOCA analysis. As a result, no corrective action is required at this time.

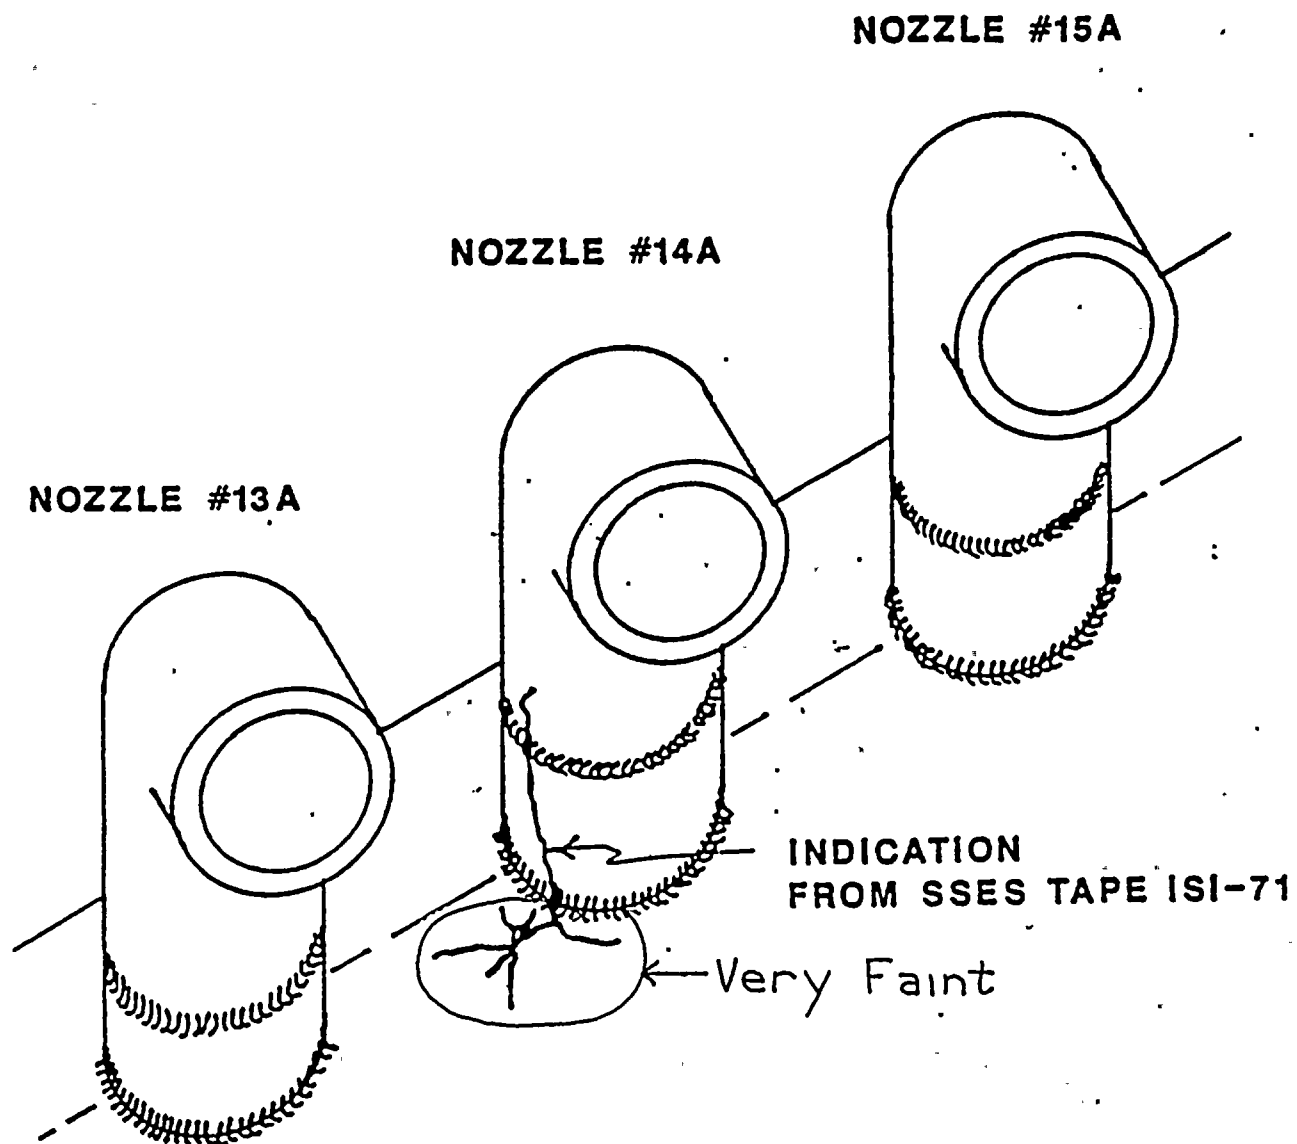
FIGURE 3 D-2  
FLOW NOZZLE INDICATION

A possible cause for initiation of the observed indication in flow nozzle 14A is high cycle fatigue due to thermal cycling in the sparger flow nozzles during low flow conditions. Indications have not been confirmed by means other than visual exam. It is conservatively assumed for analytical purposes to be a crack.

The results of the analyses indicate that a crack in a flow nozzle is not likely to propagate significantly into the sparger pipe.

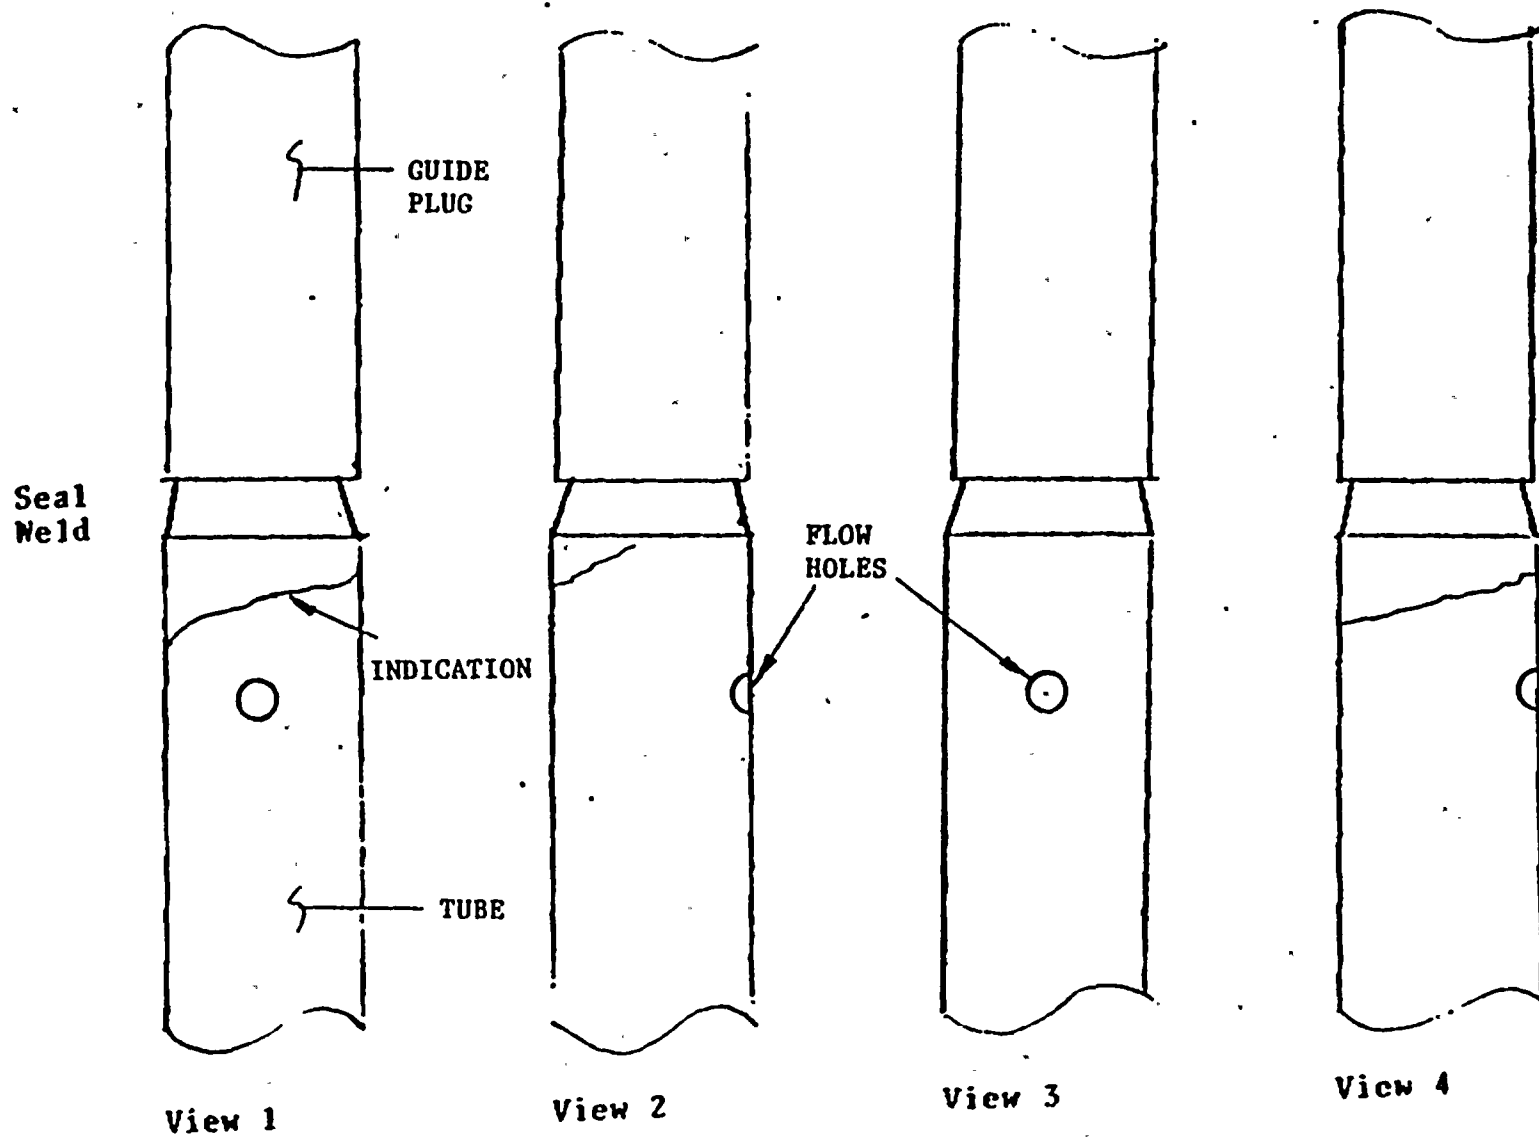
FIGURE 3 F-2  
NOT TO SCALE  
DRY TUBE LOCATION 16-13

Only one dry tube (16-13) has a long indication and it is less severe than those observed at several other reactors.

Based upon analyses performed by GE, the SRMs and IRMs can continue to function even with a 360° through wall crack of the dry tubes, because the two pieces will be held in functional alignment by support from the adjacent fuel bundles. Also, the support provided by the fuel bundles will prevent adverse safety consequences from loose pieces in the unlikely event the dry tube becomes completely severed.

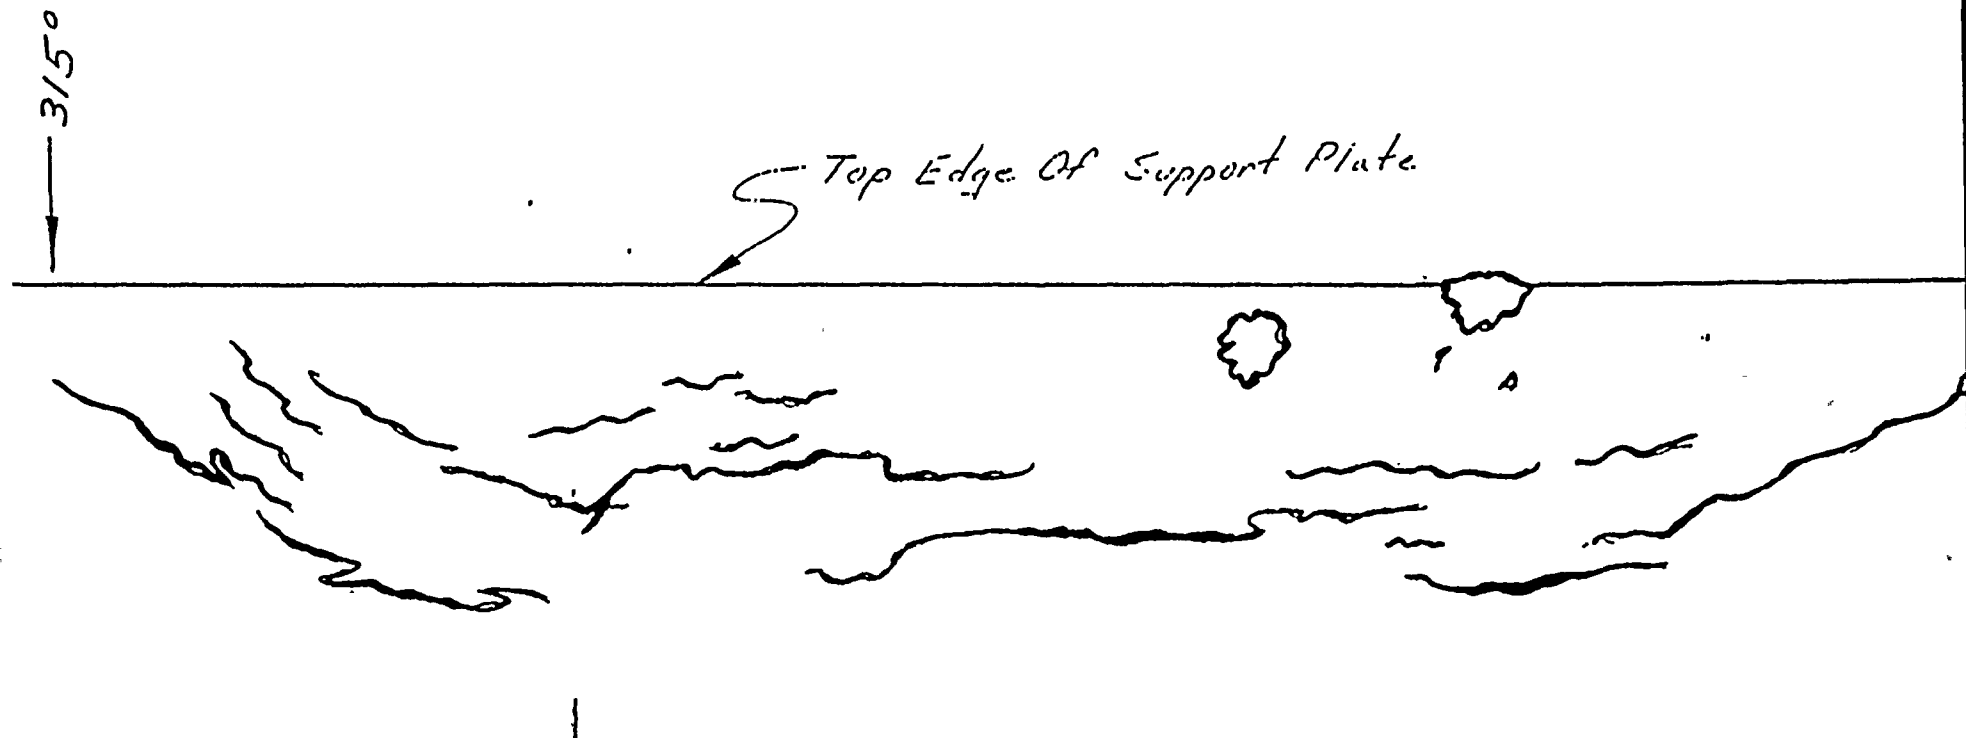
NO INDICATIONS ON TOP SURFACE
