File NC505-12
Project 84NK29824

FACT-FINDING
REPORT

AIR DUCT PENETRATIONS THROUGH ONE HOUR
FIRE RESISTIVE WALL ASSEMBLY

American Iron and Steel Institute
Washington, D.C.

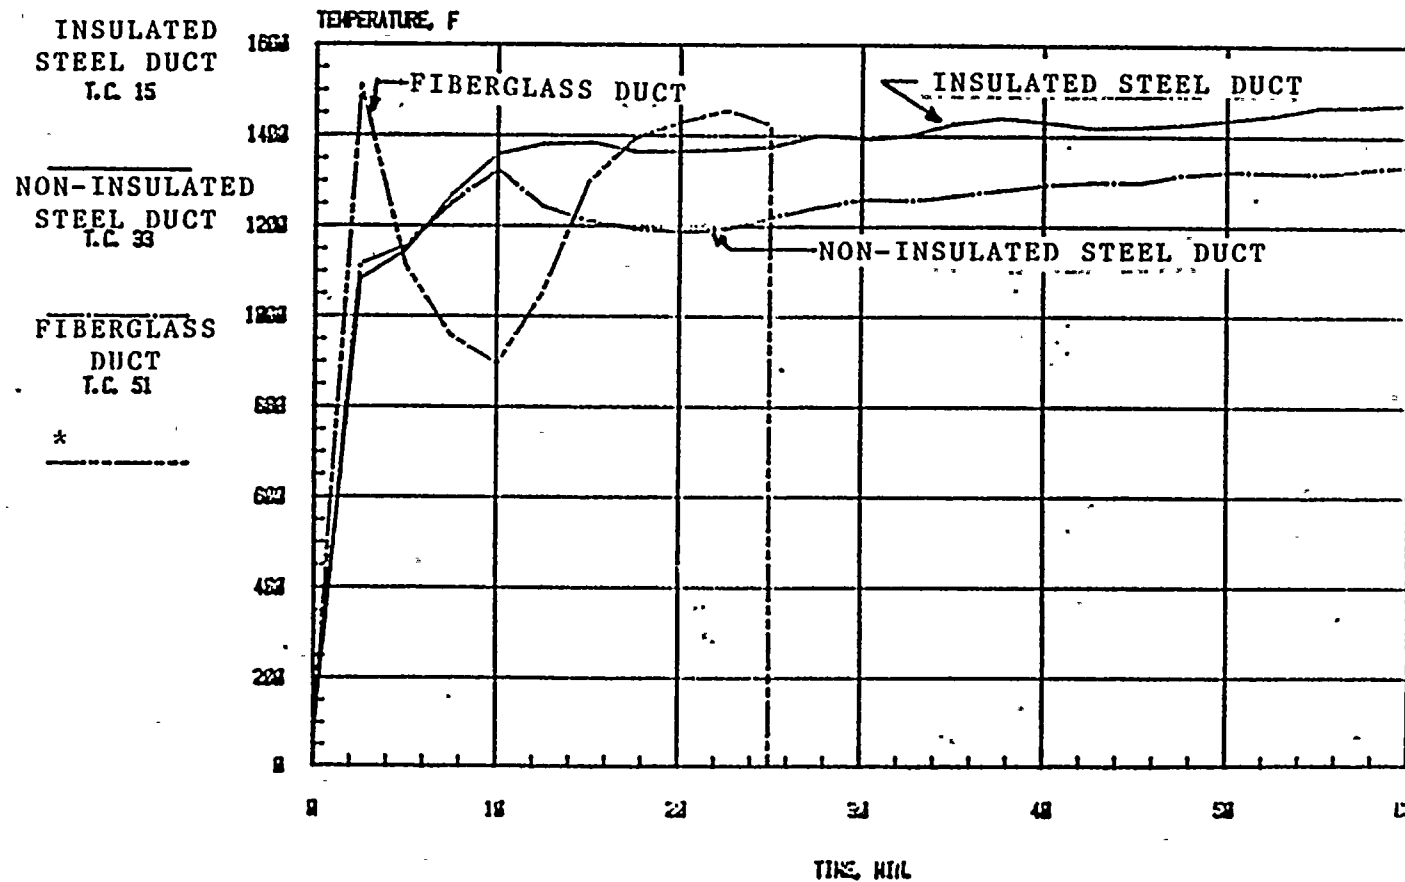
TEMPERATURES WITHIN DUCT ASSEMBLIES
THERMOCOUPLES LOCATED 3 IN. FROM
UNEXPOSED SIDE OF WALL ASSEMBLY

*SECTION OF FIBERGLASS DUCT IN AREA OF T.C. 51 COLLAPSED
AT 25 MIN.

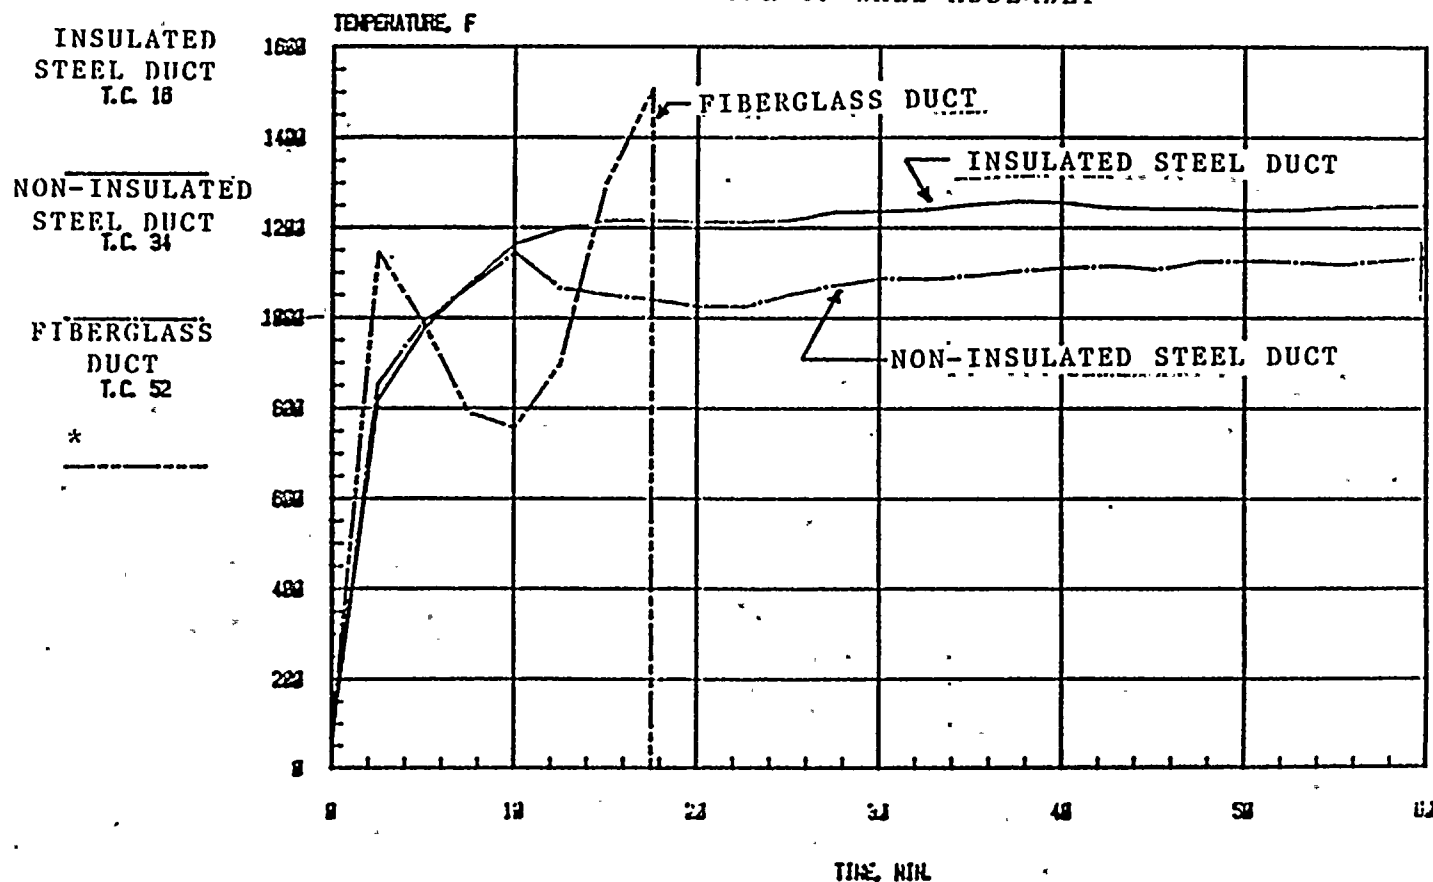
TEMPERATURES WITHIN DUCT ASSEMBLIES
THERMOCOUPLES LOCATED 6 FT. FROM
UNEXPOSED SIDE OF WALL ASSEMBLY

*SECTION OF FIBERGLASS DUCT IN AREA OF T.C. 52 COLLAPSED
AT 19 MIN.

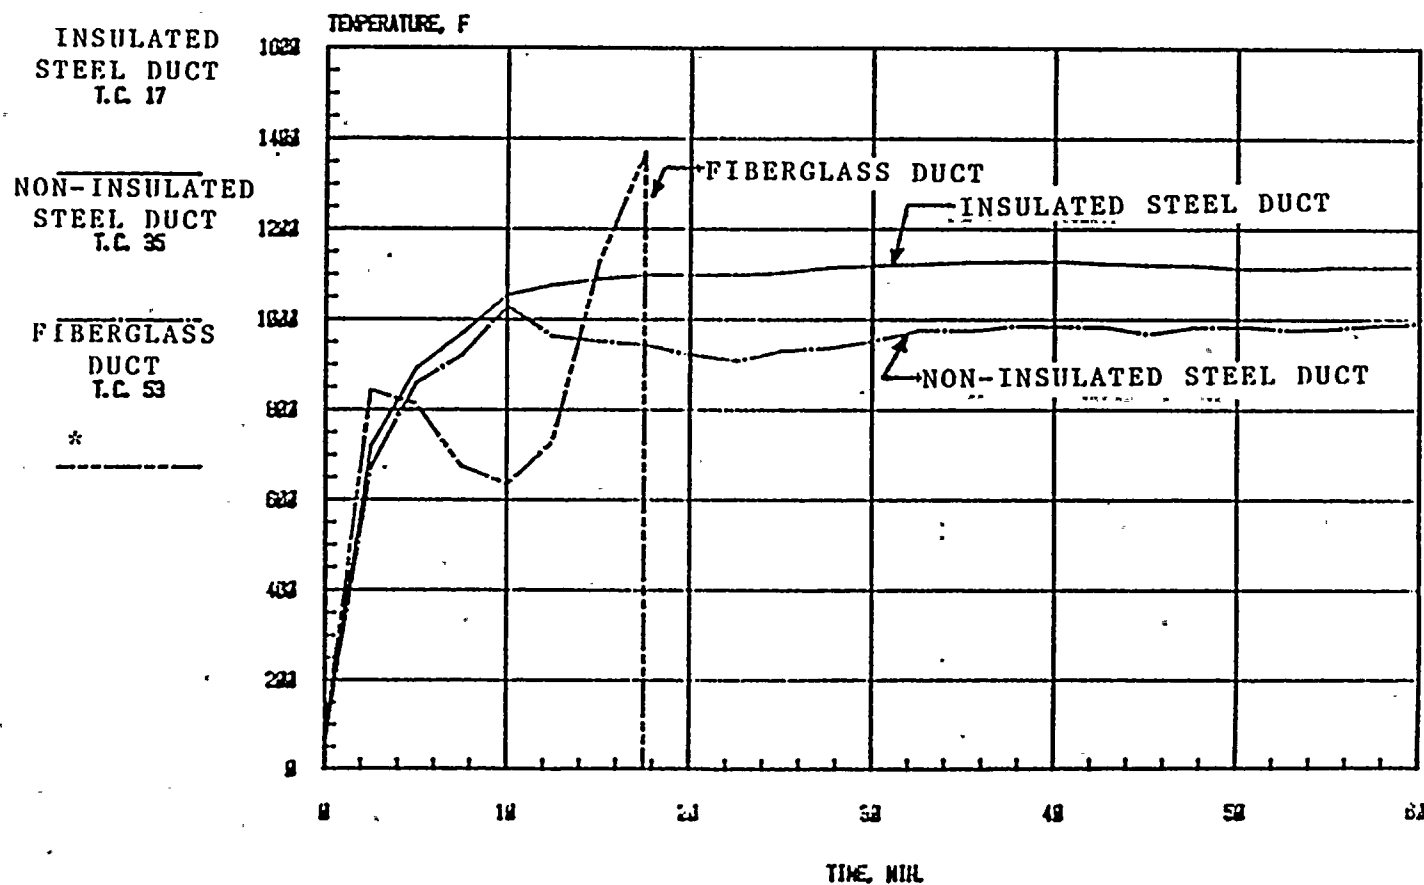
TEMPERATURES WITHIN DUCT ASSEMBLIES
THERMOCOUPLES LOCATED 9 FT. 3 IN. FROM
UNEXPOSED SIDE OF WALL ASSEMBLY

*SECTION OF FIBERGLASS DUCT IN AREA OF T.C. 53 COLLAPSED
AT 25 MIN.

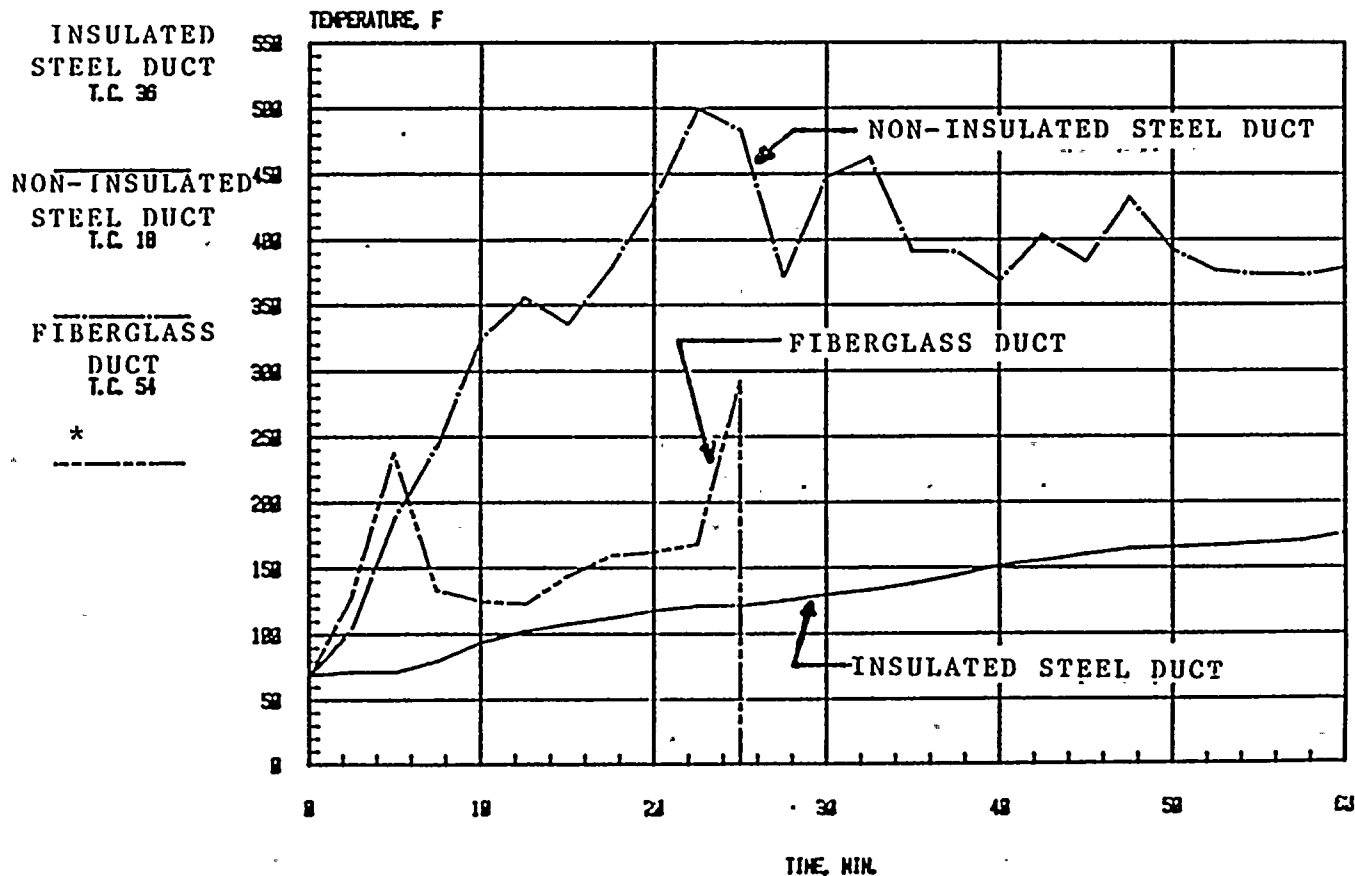
TEMPERATURES ON TOP SURFACE OF DUCT ASSEMBLIES
THERMOCOUPLES LOCATED 3 IN. FROM
UNEXPOSED SIDE OF WALL ASSEMBLY

*SECTION OF FIBERGLASS DUCT IN THE AREA OF T.C. 54 COLLAPSED
AT 25 MIN.

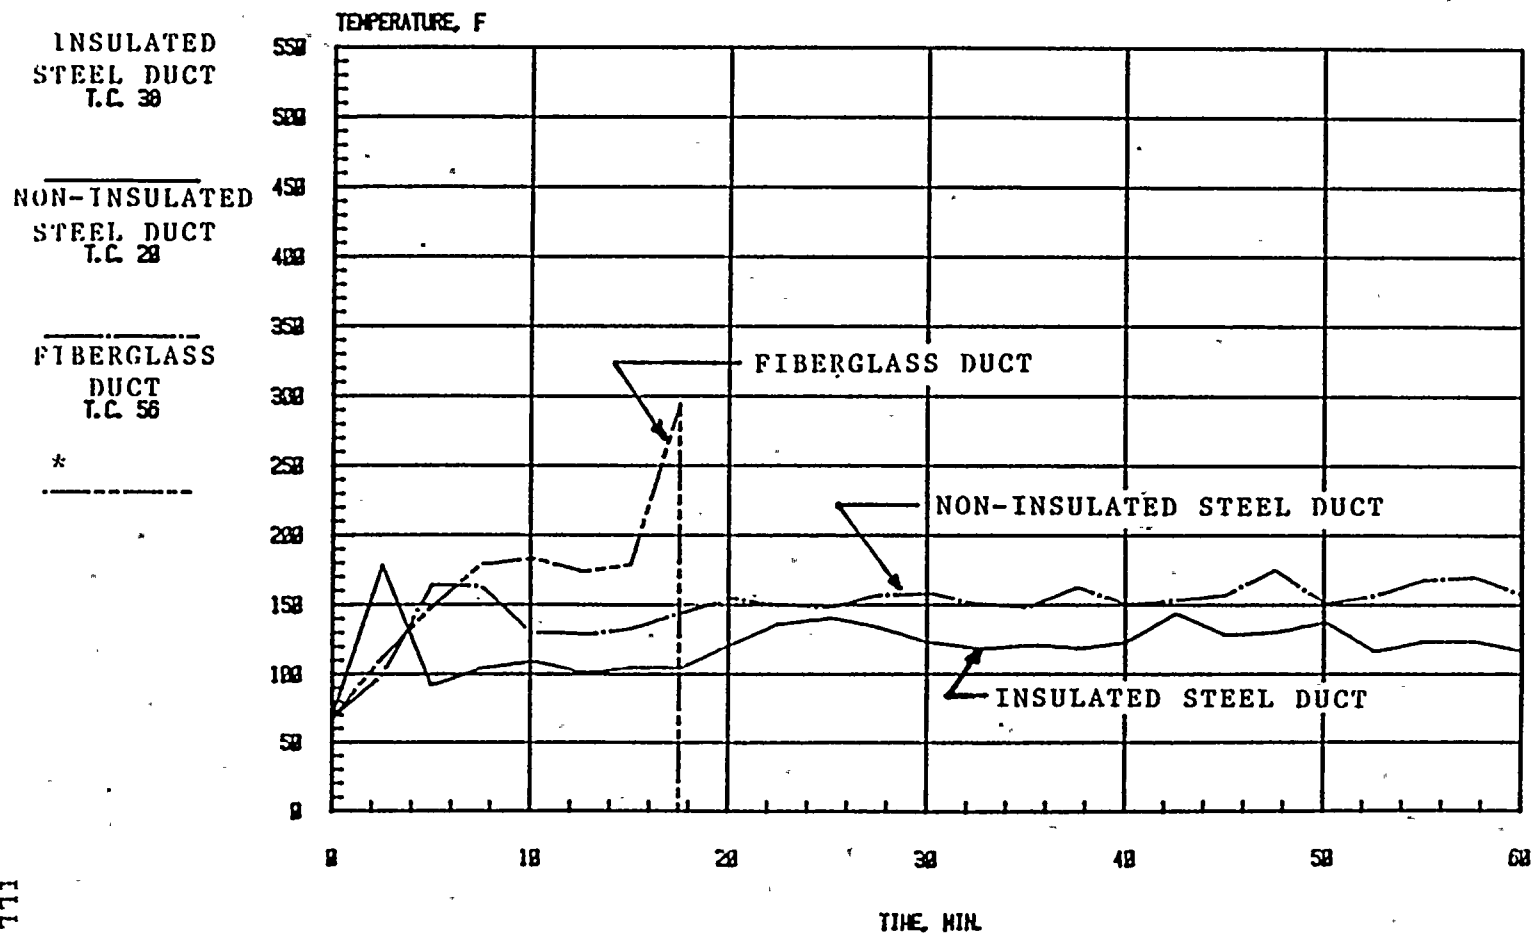
ELL. 13
NC 505-12

TEMPERATURES ON TOP SURFACE OF DUCT ASSEMBLIES
THERMOCOUPLES LOCATED 9 FT. 3 IN. FROM
UNEXPOSED SIDE OF WALL ASSEMBLY

*SECTION OF FIBERGLASS DUCT IN THE AREA OF T.C. 56 COLLAPSED
AT 19 MIN.
