SUBJECT: Forwards SEA-CW-037, "Root Cause Failure Analysis of B & C Diesels: 1989."

SUSQUEHANNA STEAM ELECTRIC STATION
DIESEL GENERATOR CRANKCASE EXPLOSIONS
ROOT CAUSE ANALYSIS REPORT
PLA- 3321 FILE S024, R41-2

ROOT CAUSE FAILURE ANALYSIS OF "B" AND "C" DIESELS: 1989**I. ABSTRACT**

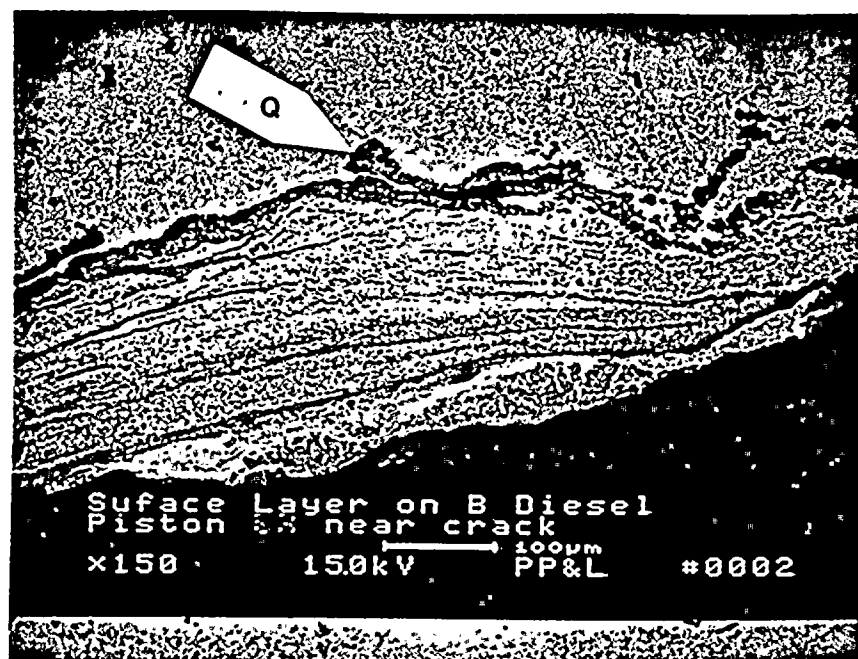
Figure B-6. Cross-section of a cracked area of the B diesel 7L piston skirt showing metal deposits on the surface.

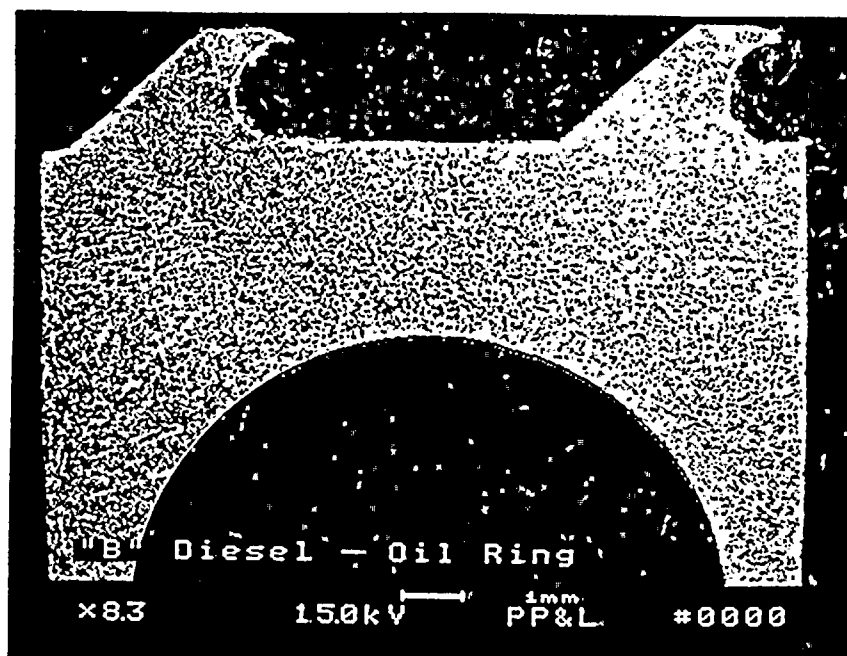
Figure B-12. Cross section of the lower oil ring from the B diesel 7L piston showing the wear and deformation on the two wiper surfaces.

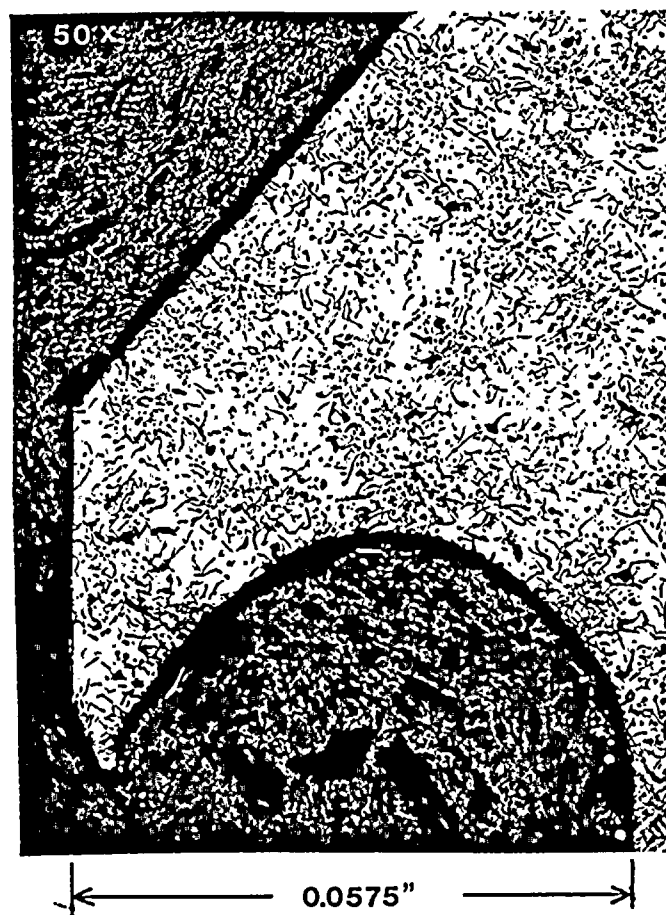
Figure B-13. Picture of oil ring profile at high magnification.
Magnified image of oil ring finger from B diesel,
7L piston lower oil ring showing structure deformation and size of
the finger.

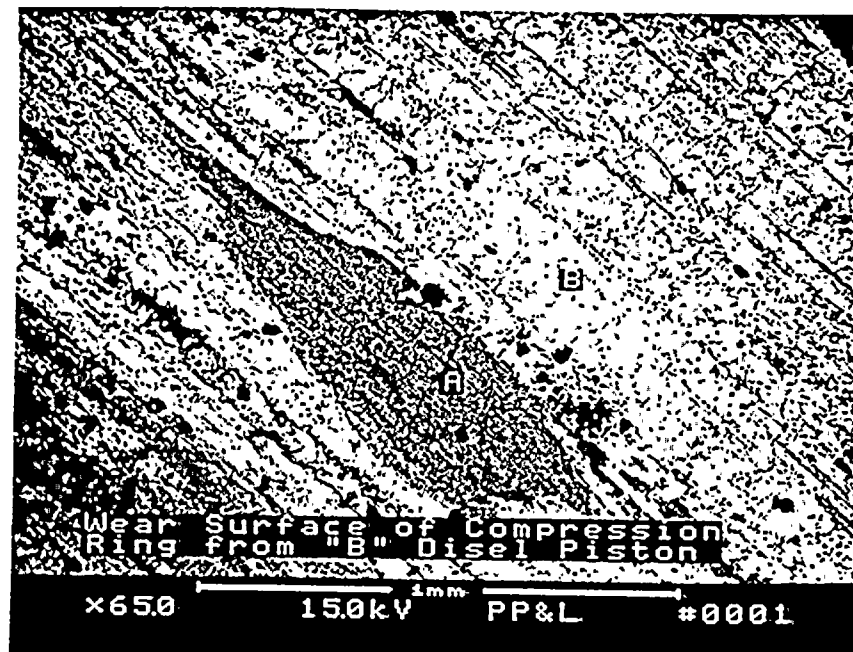
Figure B-15. Smeared metallic deposits found on the #4 compression ring of the B diesel, 7L piston are shown here as the dark gray area labeled 'A'. EDS analysis of area 'A' shows it to contain Cr, Fe, Si(trace) and Sn(trace). Area 'B' shows only Fe with a trace of Cr.

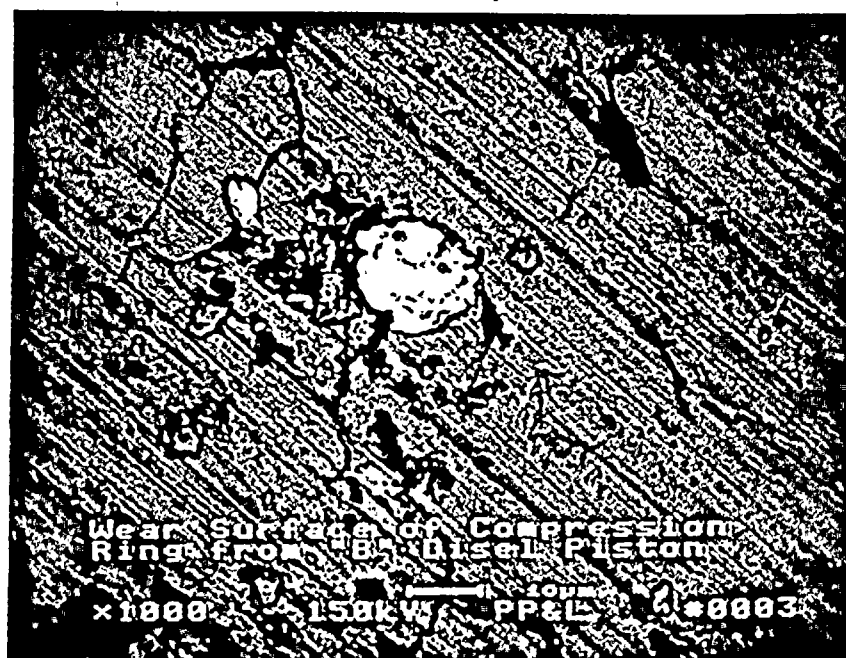
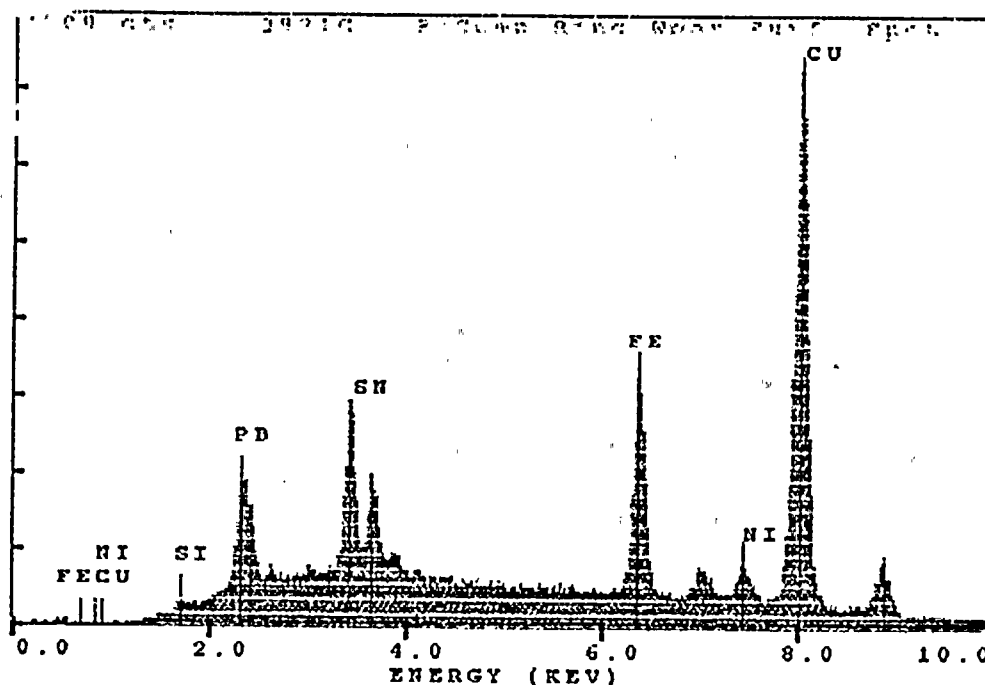
Figure B-17. An unusual spot of foreign material found embedded in the #4 compression ring from the B diesel 7L piston. EDS analysis shows it to contain Cu, Fe, Sn, Pb, and Ni.

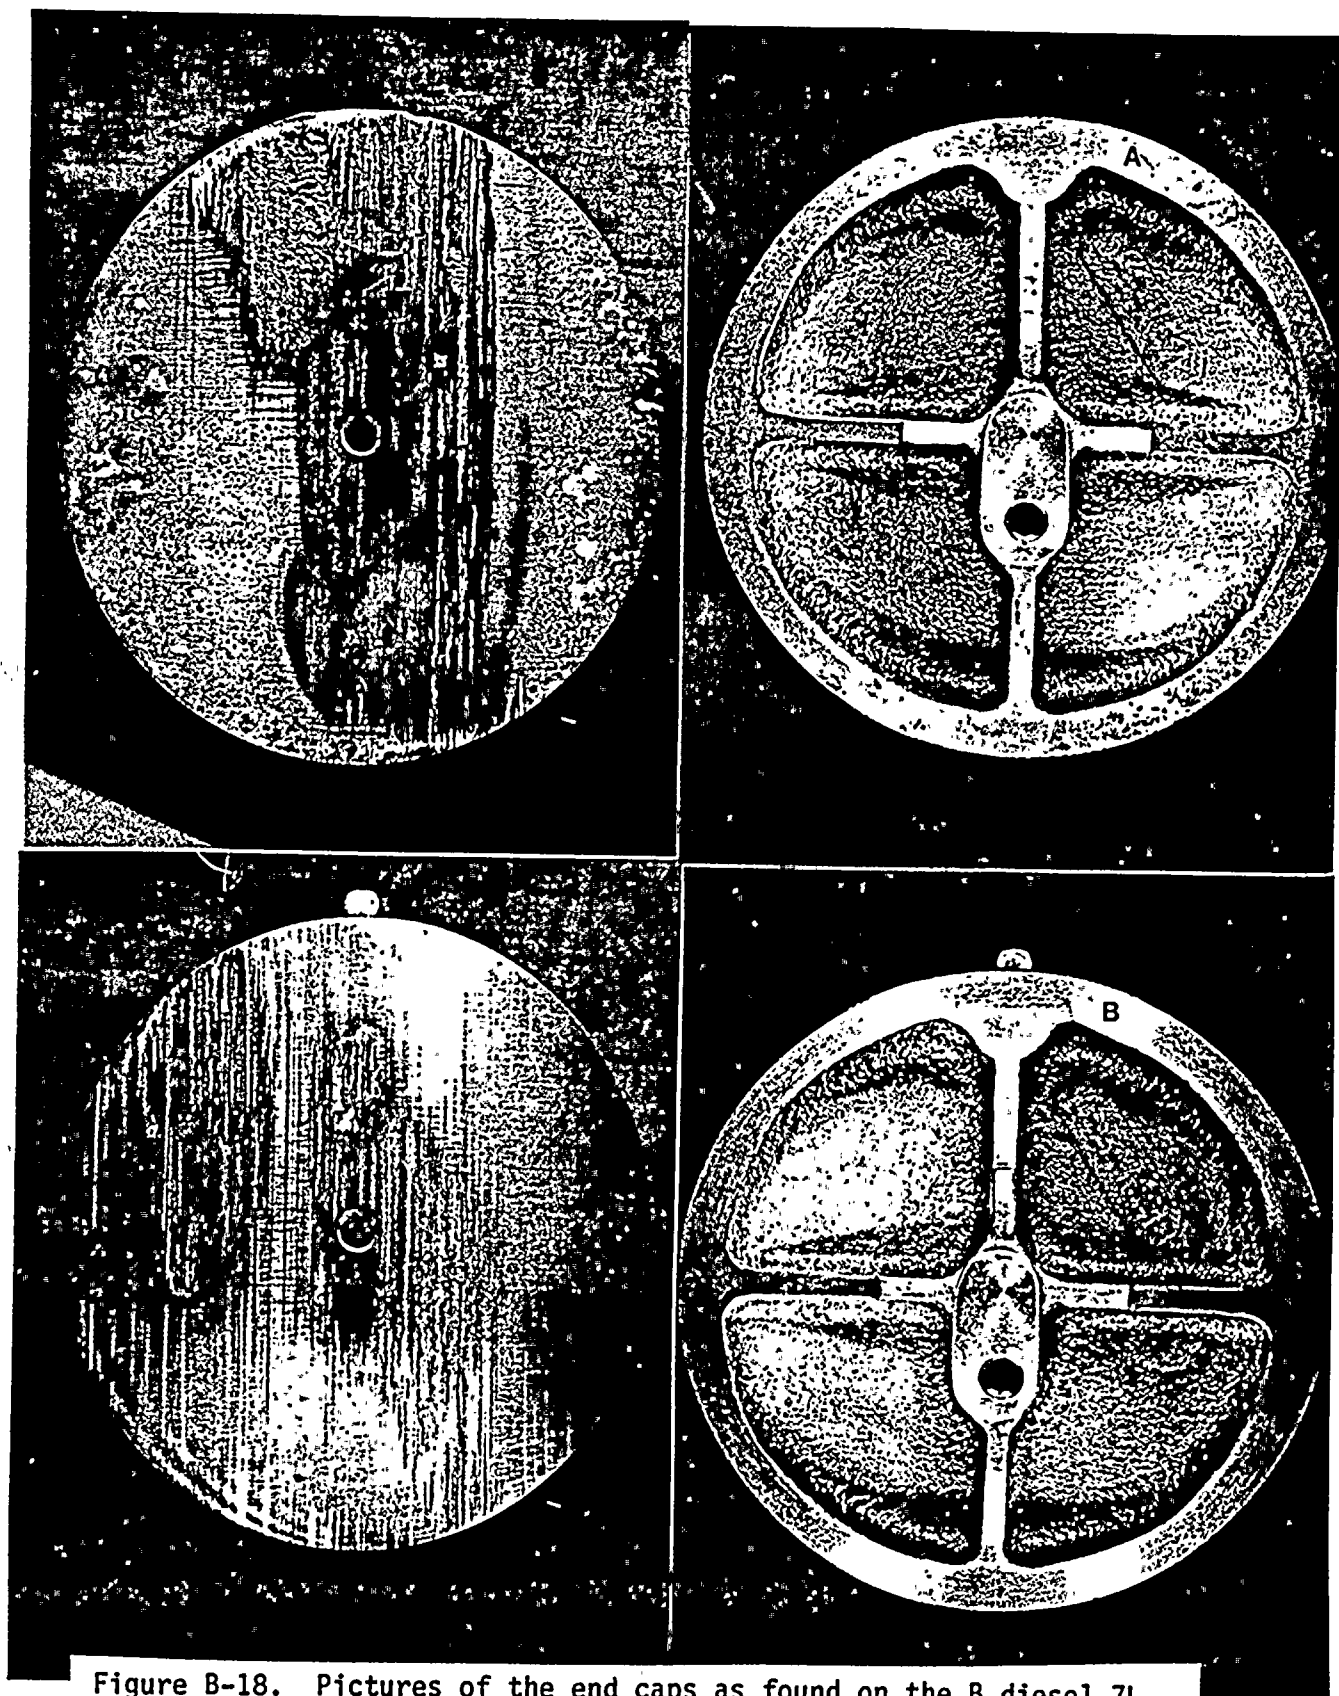
Figure B-18. Pictures of the end caps as found on the B diesel 7L piston showing the scraping and local heating experienced by these parts during the failure sequence.

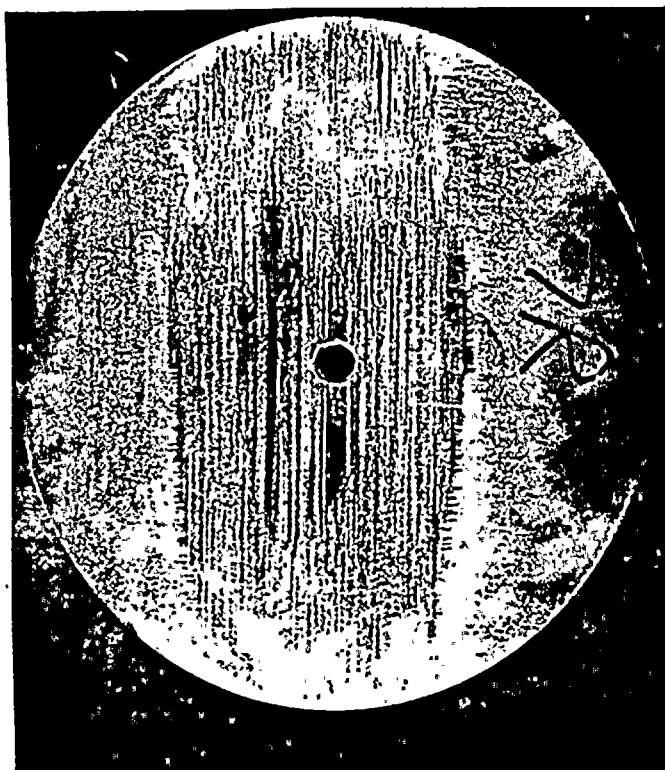
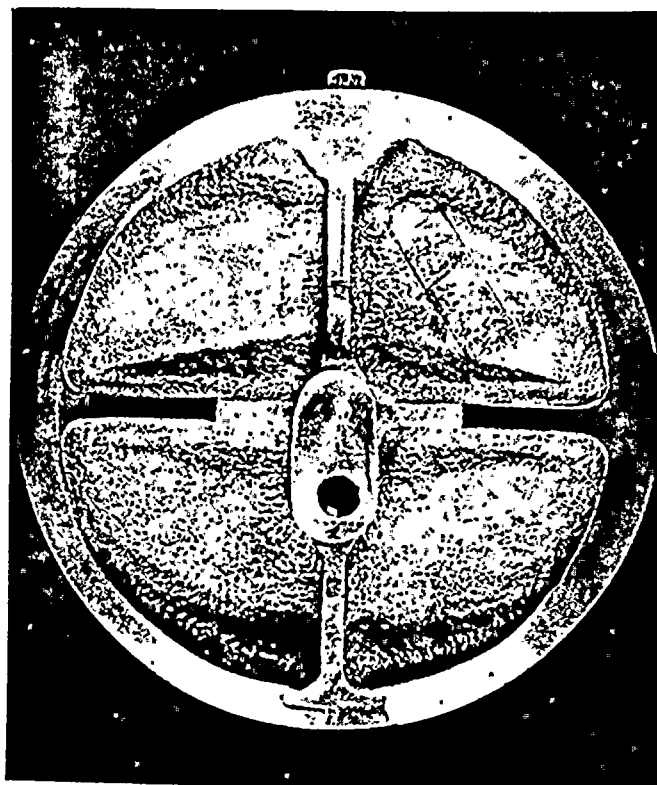
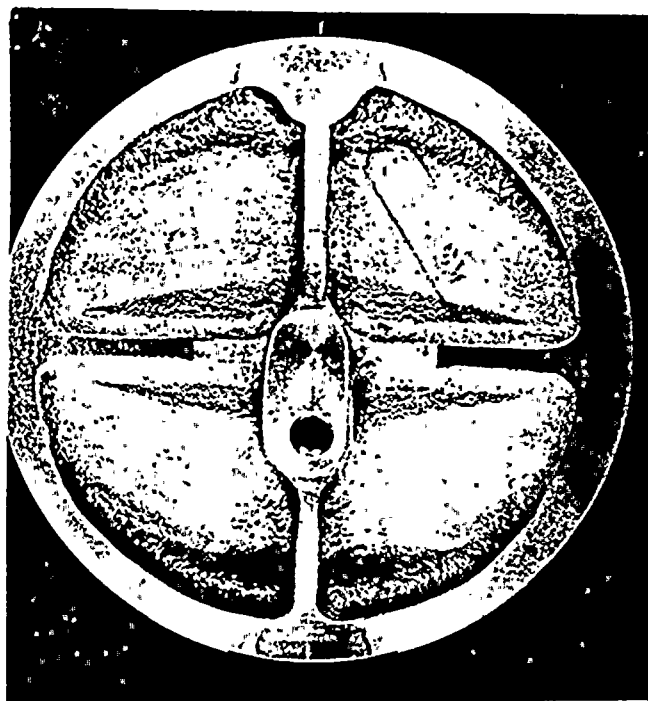
Figure B-21. Abrasion and wear found on the B diesel 7R piston pin end caps.

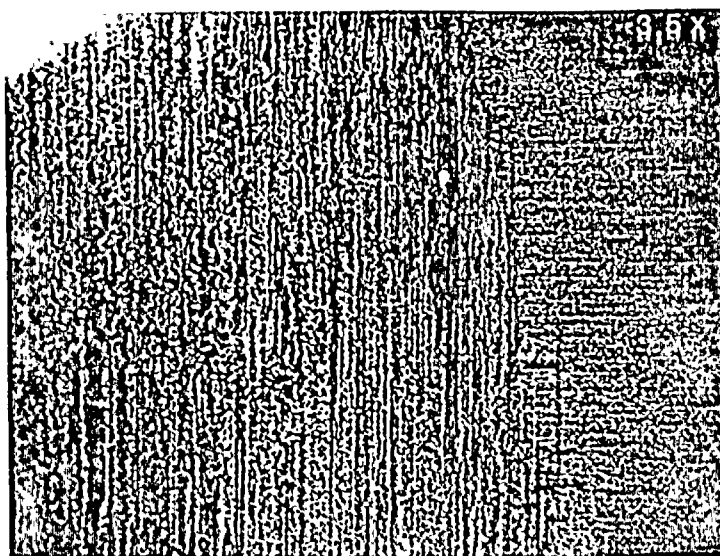
Figure B-22. Photograph of the B diesel 7R piston end cap which showed the worst amount of wear, heating and metal transfer.

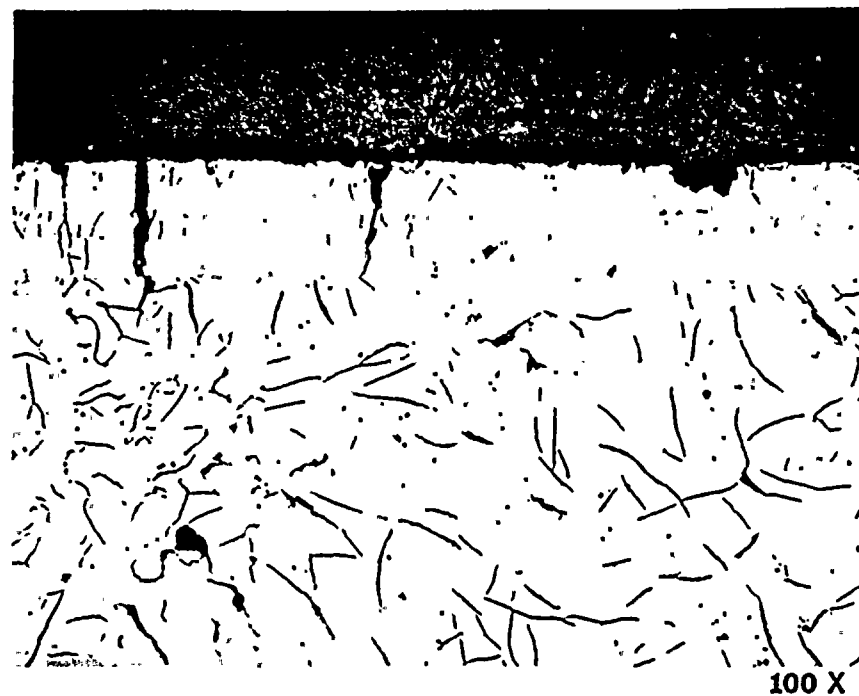
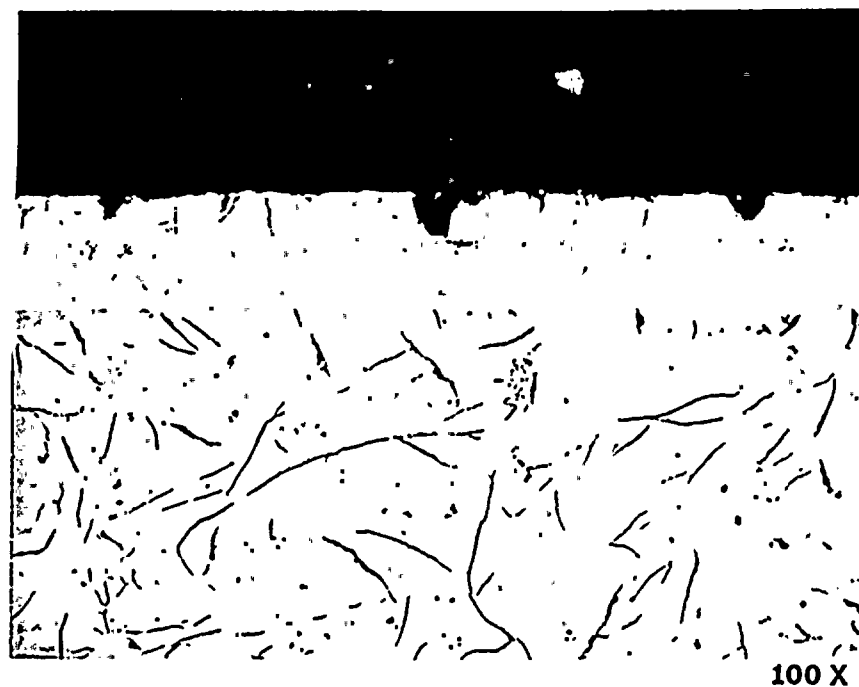
Figure B-27. Transverse cross-sectional views of the thrust side of the B diesel 7L liner 22 7/8 inches from the bottom(piece 'A'). The chromium plating is cracked and some of the pores are filled with metallic particles.

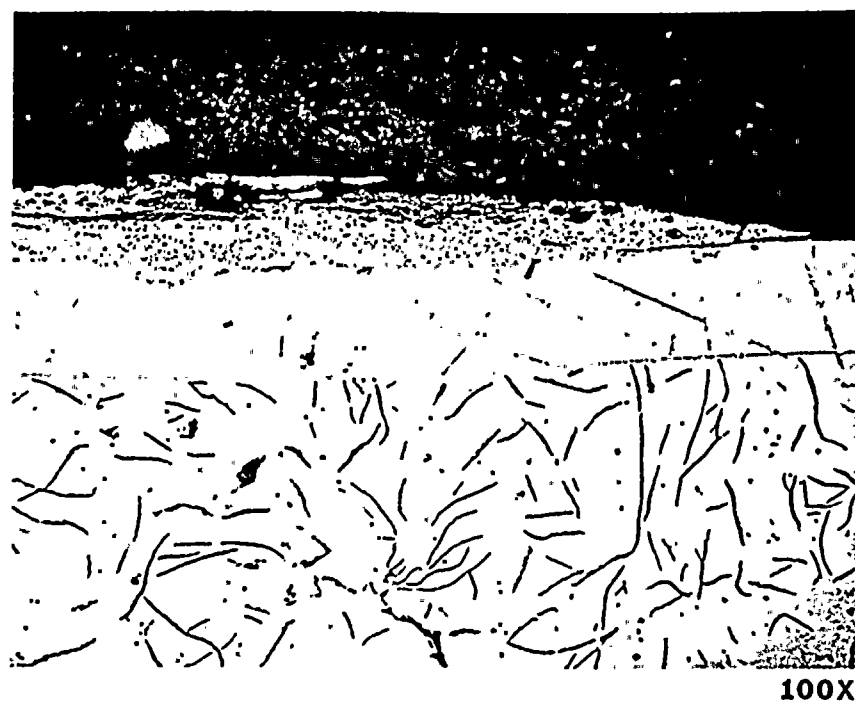
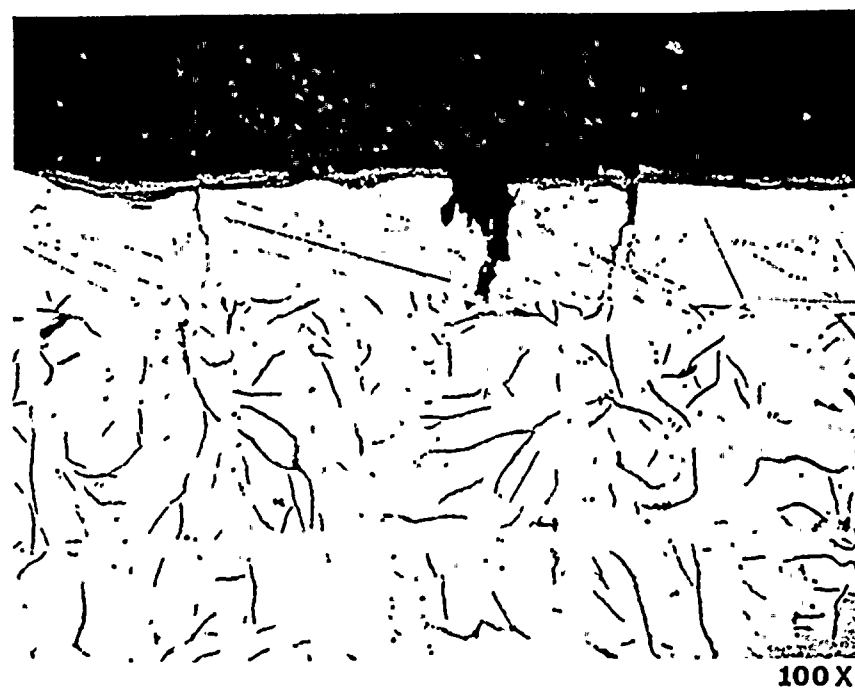
Figure B-28. Longitudinal view of the B diesel 7L liner on the thrust side 11 1/2 inches from the bottom showing metallic deposits, filled pores and cracking in the Cr plating(piece labeled 'B').

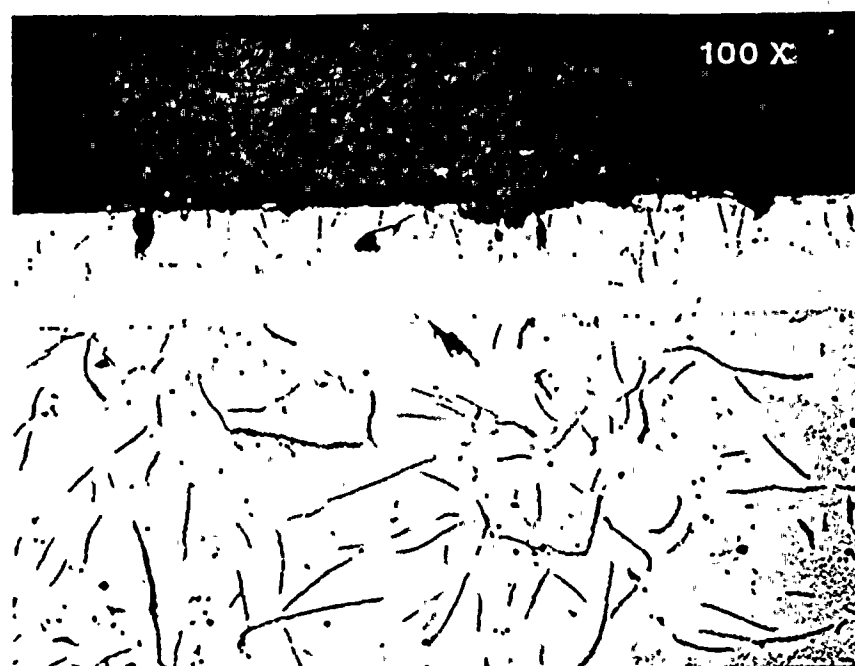
Figure B-29. Longitudinal cross-section (labeled 'C') taken 12 inches from the bottom of the B diesel 7L cylinder liner showing a rough fractured surface with pieces missing and some debris in the pores of the chromium plating layer.

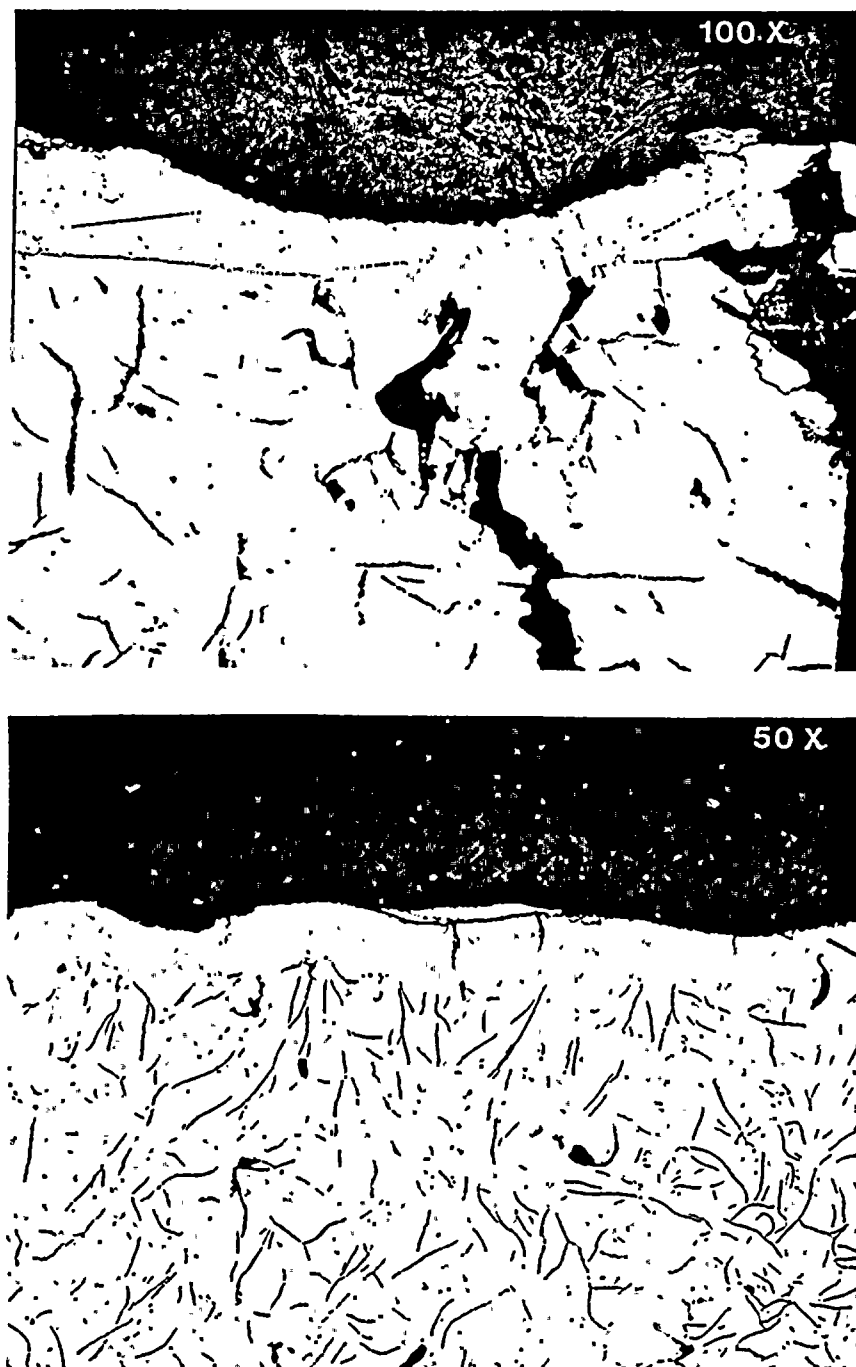
Figure B-30. Transverse cross-section(labeled area 'D') taken 7 1/2 inches from the bottom of the B diesel 7L liner showing depressions in the Cr plating surface, cracking of the base metal casting and deposited metal.

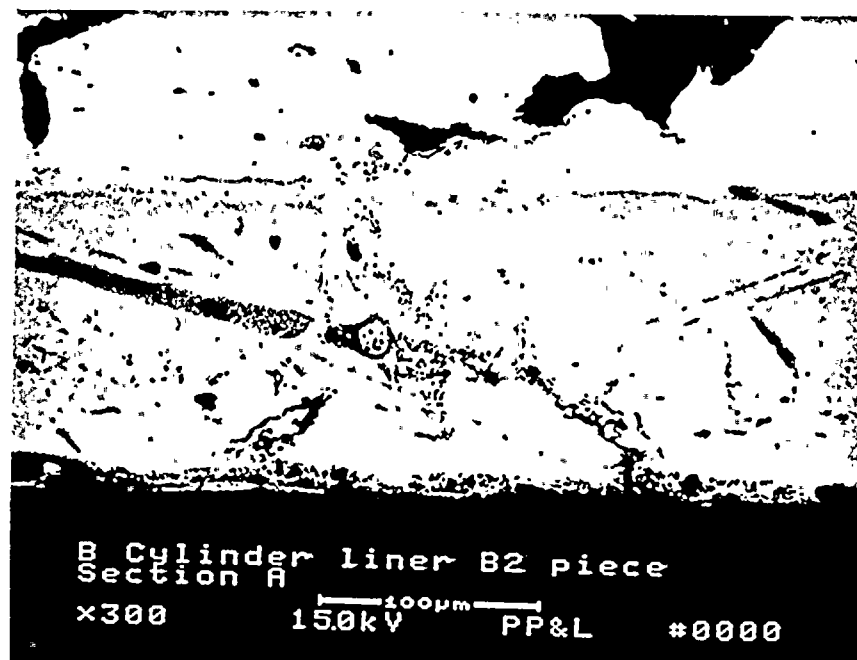
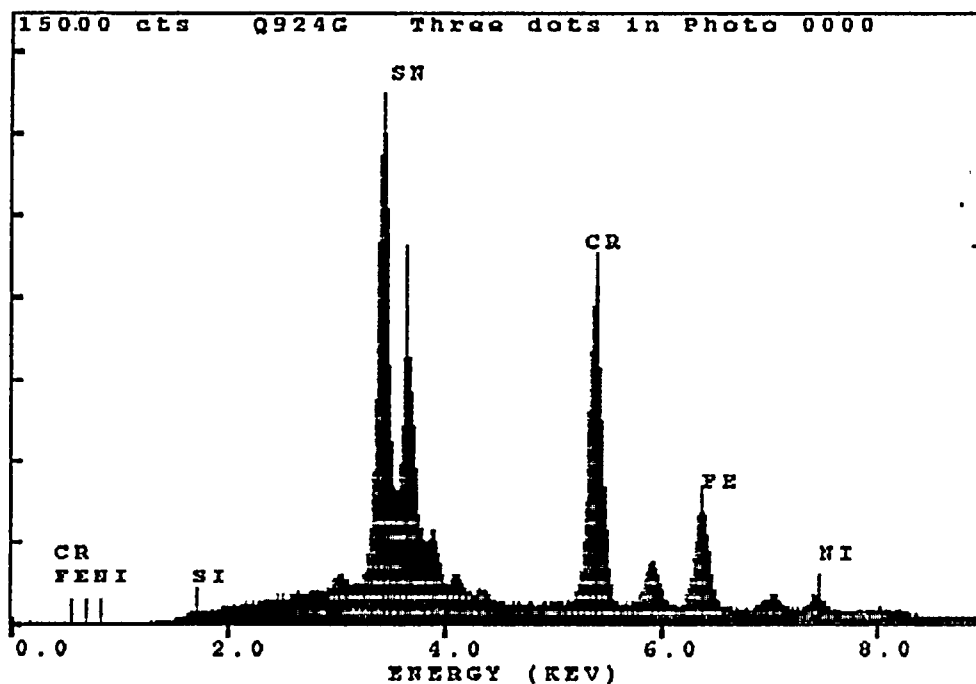
Figure B-34. Longitudinal section of B diesel 7L liner (labeled 'A' of part B-2) showing cracking in the Cr plating surface and the presence of Sn at the Cr-Fe base metal interface.

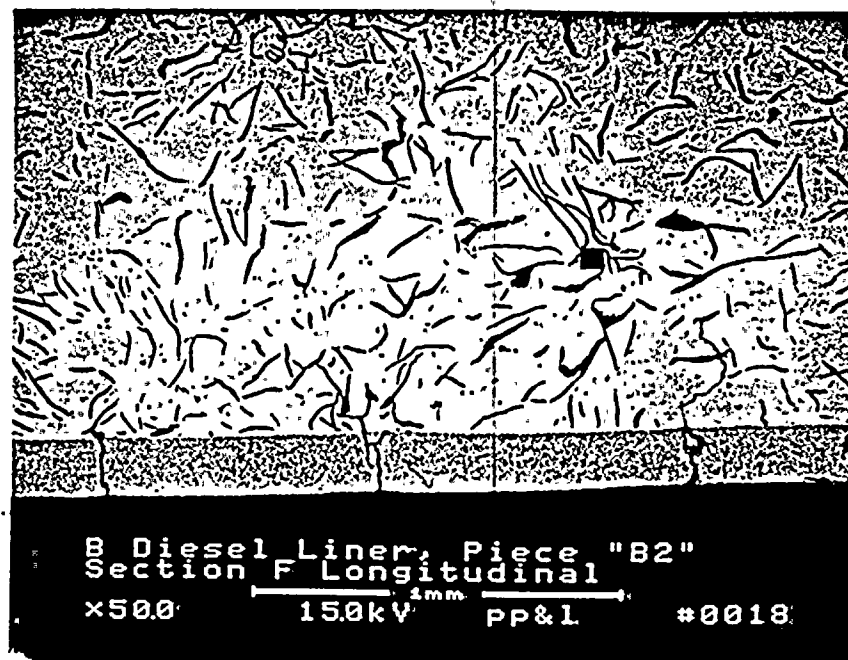
Figure B-38. Longitudinal section 'F' from B diesel liner 7L piece B-2 taken 24 5/8 inches above the bottom. This section does not show any pores filled or otherwise, but does show several cracks through the thickness of the Cr plate.

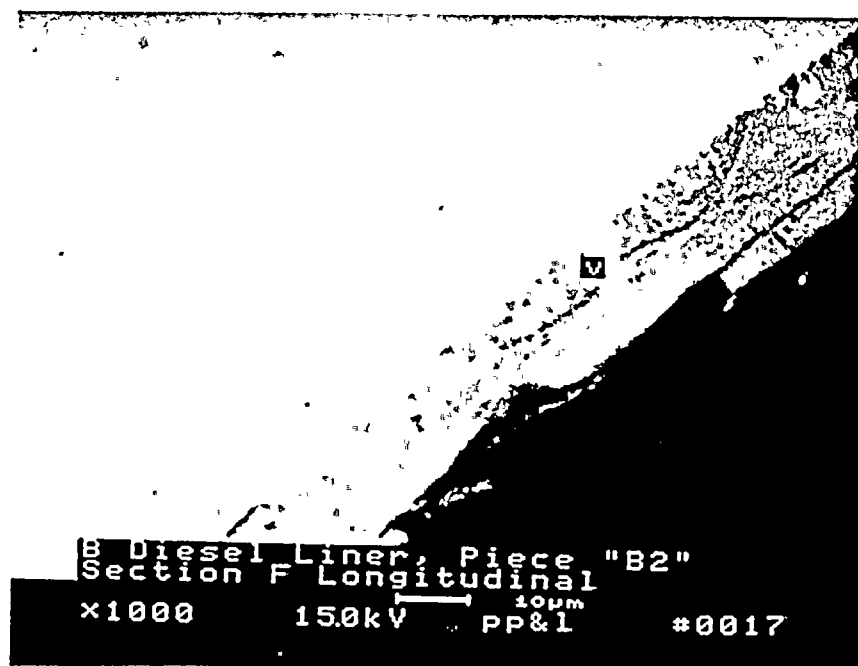
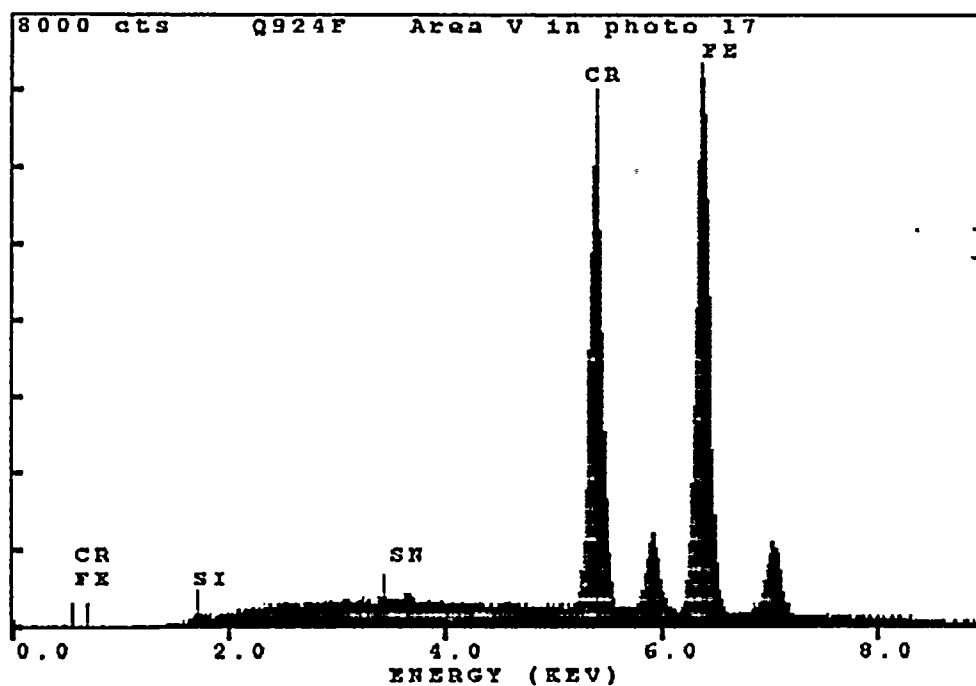
Figure B-39. Longitudinal section of B diesel 7L liner taken from the end cap side 24.625 inches from the bottom showing the layer of deposited metal and the EDS analysis of the lighter grey area.

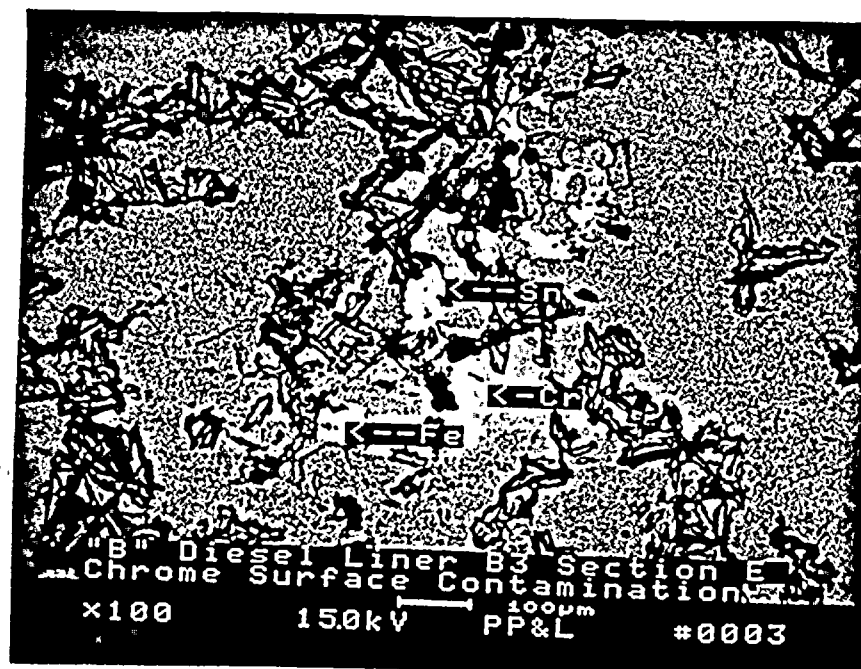
i Figure B-44. Magnified image of the surface condition of the non-thrust side of the B diesel 7L liner near the upper position of the top compression ring. Both iron and tin are seen embedded in the chromium liner pores.

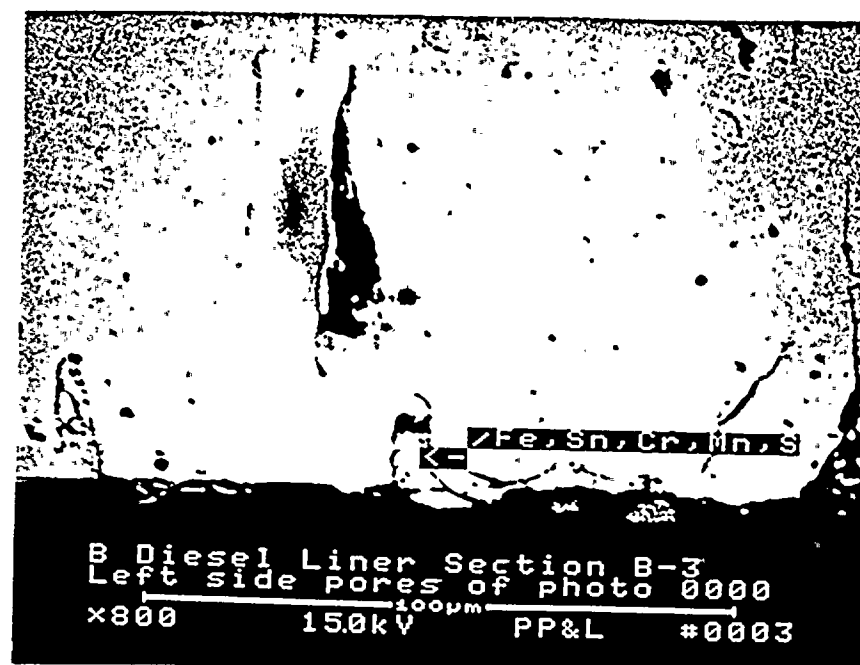
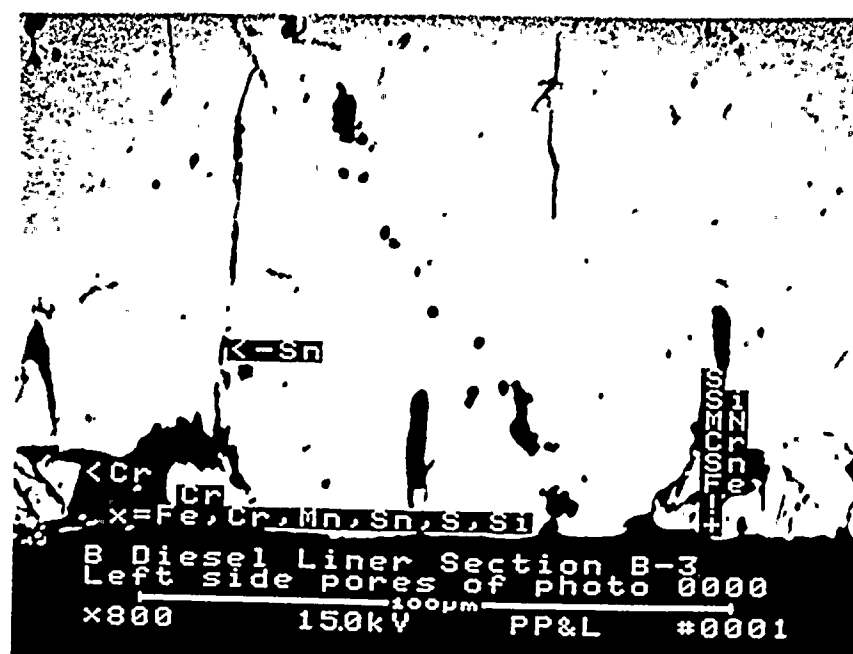
Figure B-55. Another area of pore deposits and elements found present in longitudinal cross-section 'C' part B-3 of the B diesel liner 16.5 inches from the bottom.

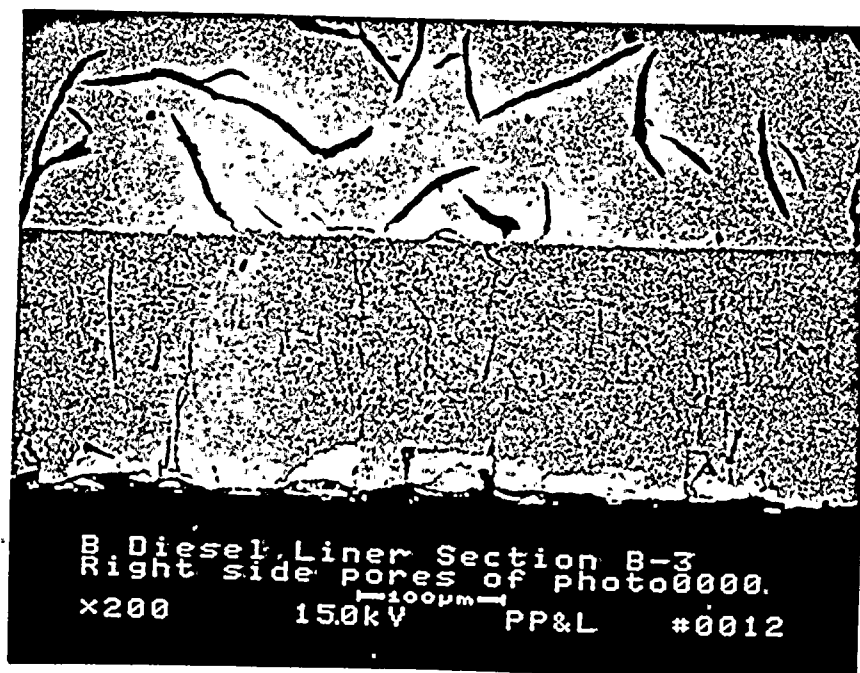
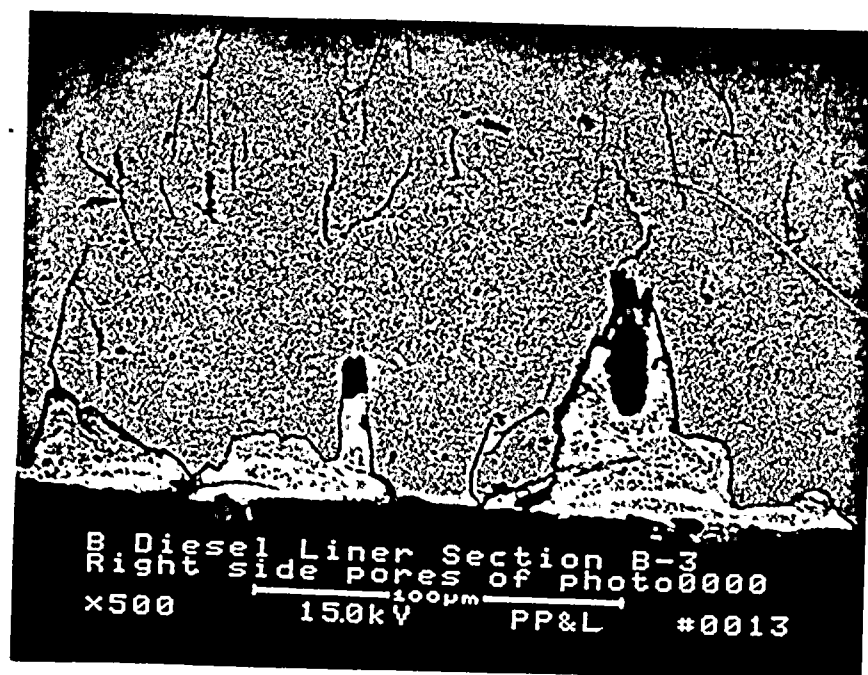
Figure B-58. Additional areas of filled pores found in area 'C' of part B-3 of the B diesel 7L cylinder.

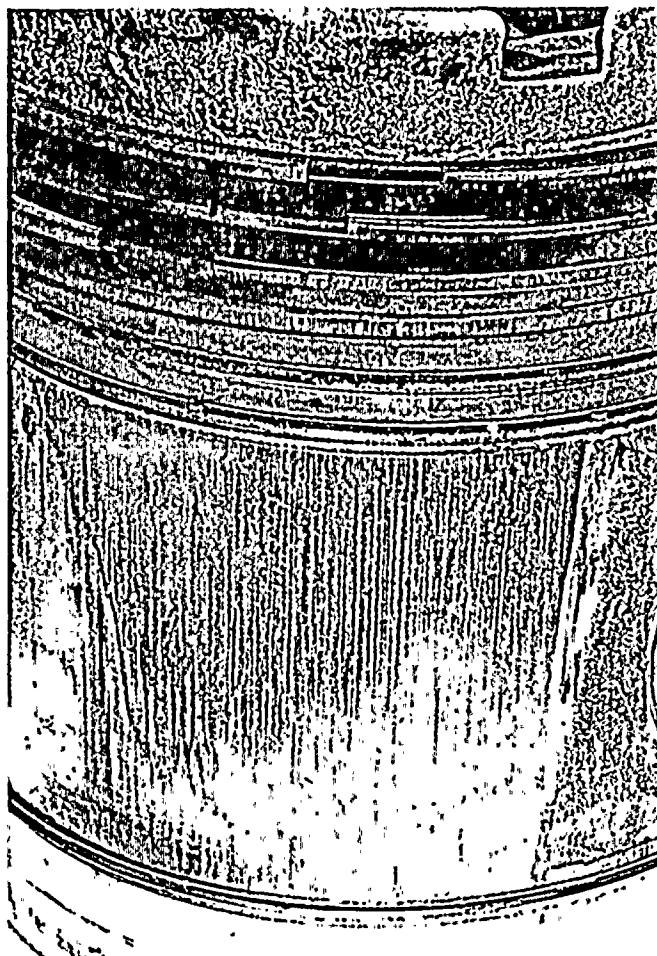
Figure C-1. Photograph of the 6L piston from the C diesel showing the area of detining and the alignment of the compression rings.

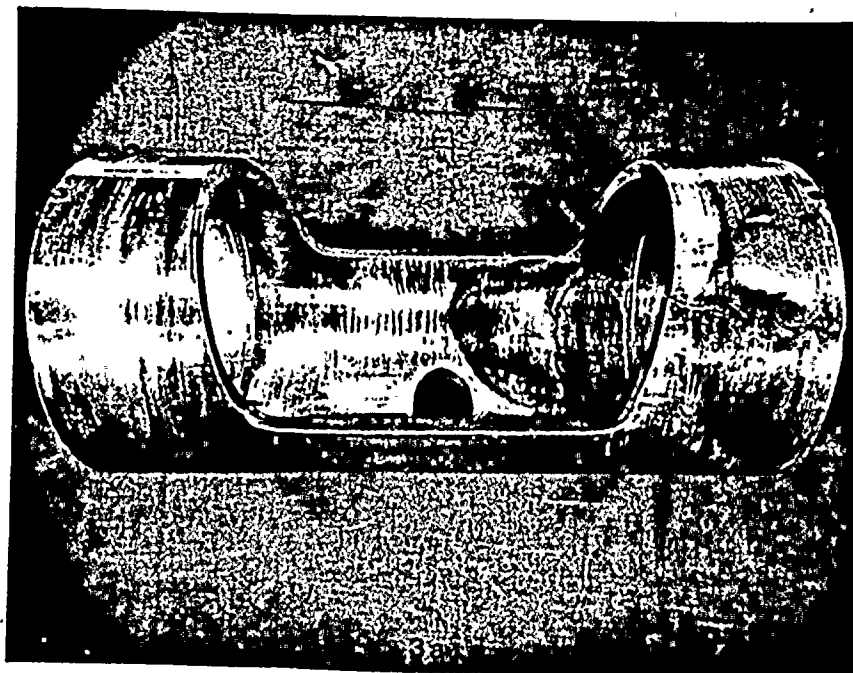
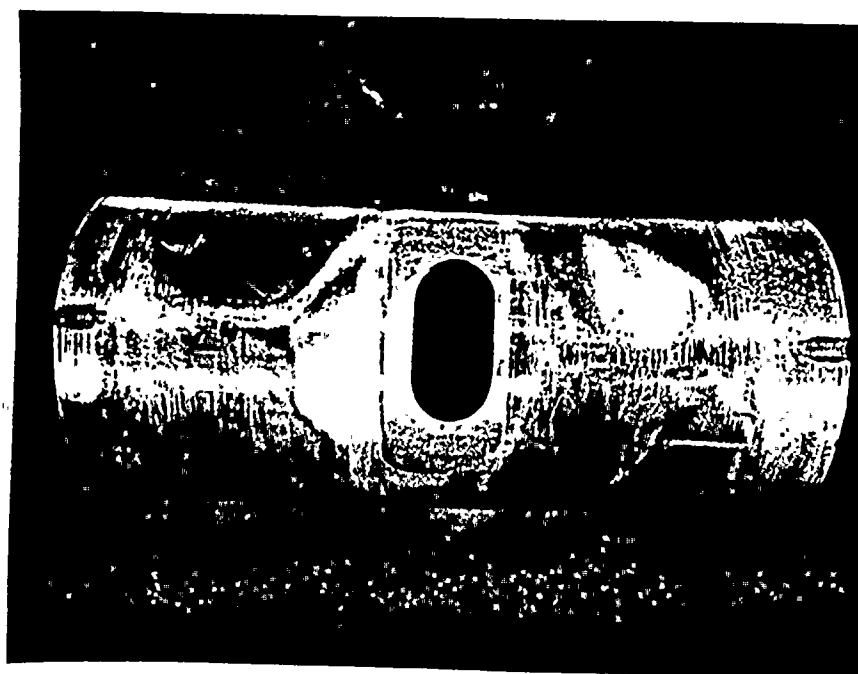
Figure C-3. a) Photograph of the 5R piston, C diesel, pin bushing through wall crack; b) OD damage caused by the bushing rotating.

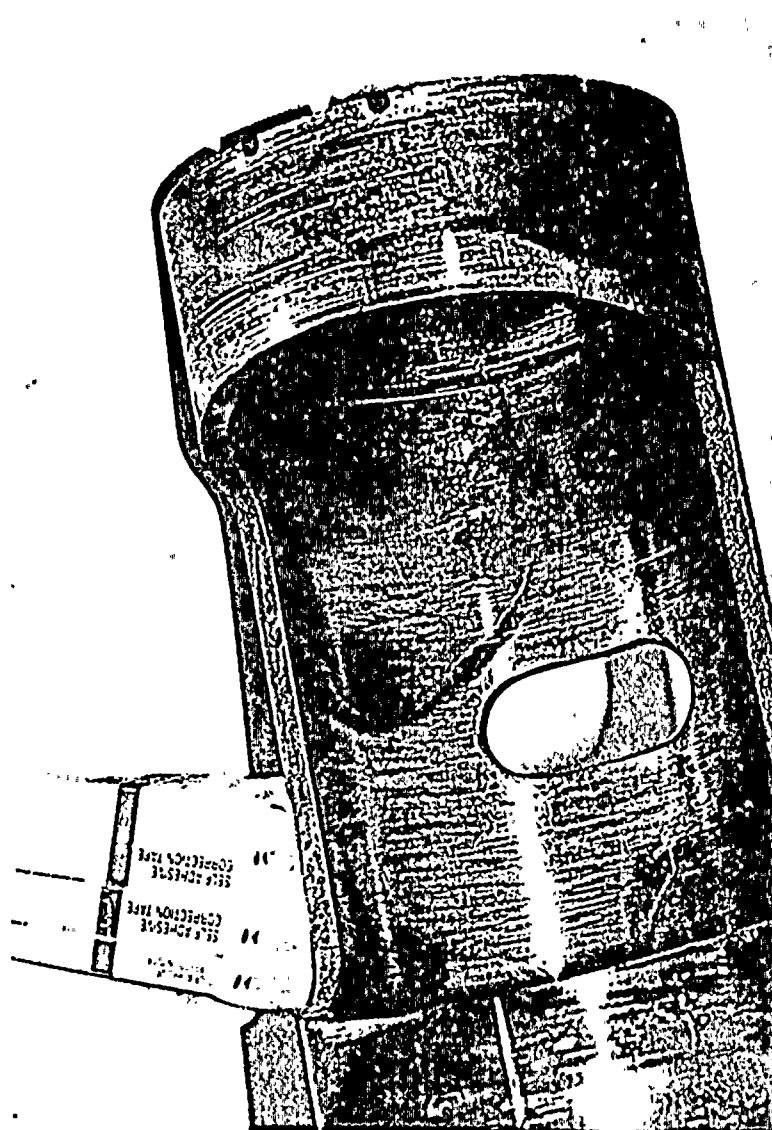
Figure C-4. Photograph discoloration (bluing) of the 5R, C diesel, pin bushing.

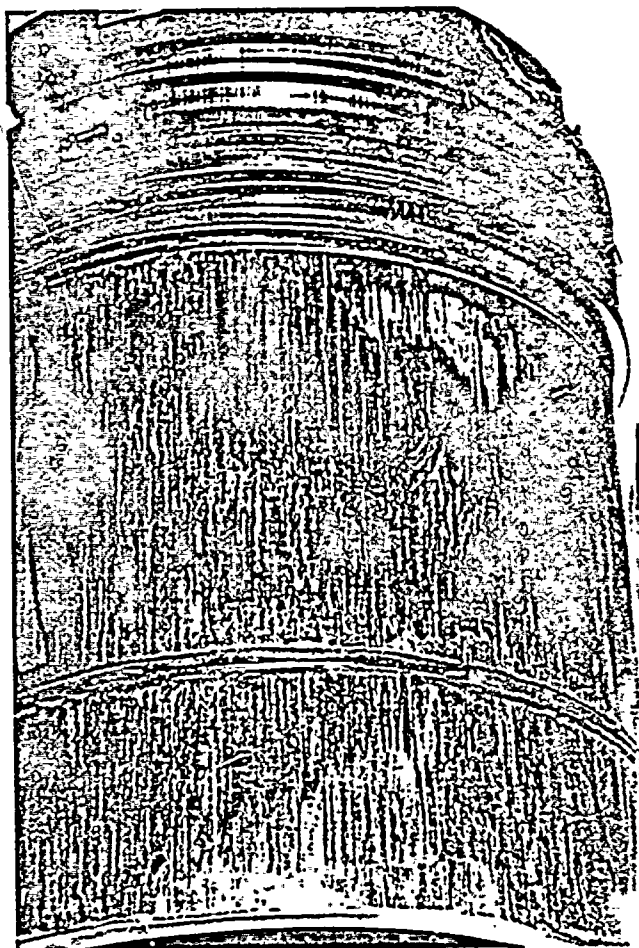
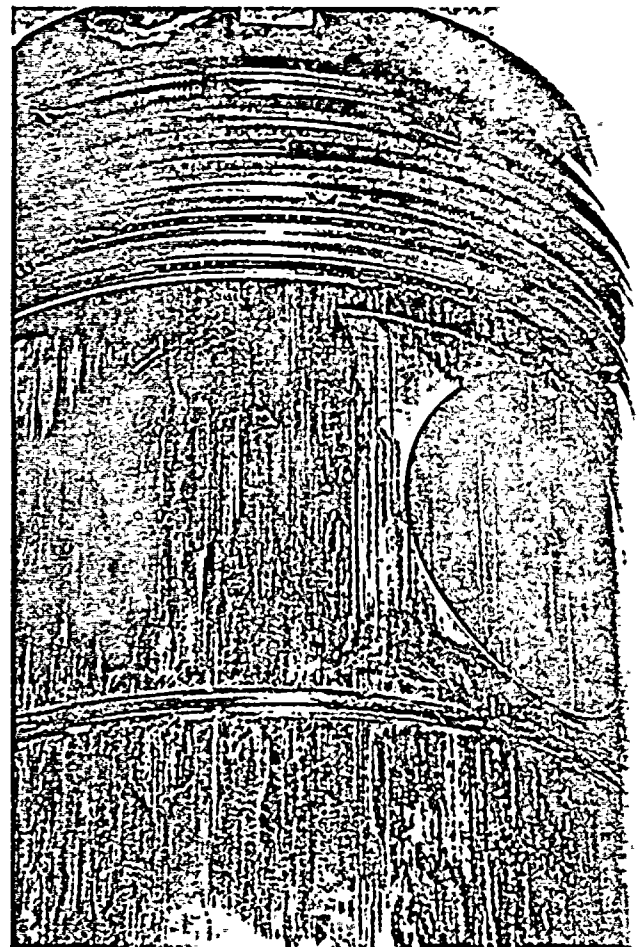
Figure C-6. Photographs of the damage on the thrust side (center of engine) of the 5R piston, C diesel.

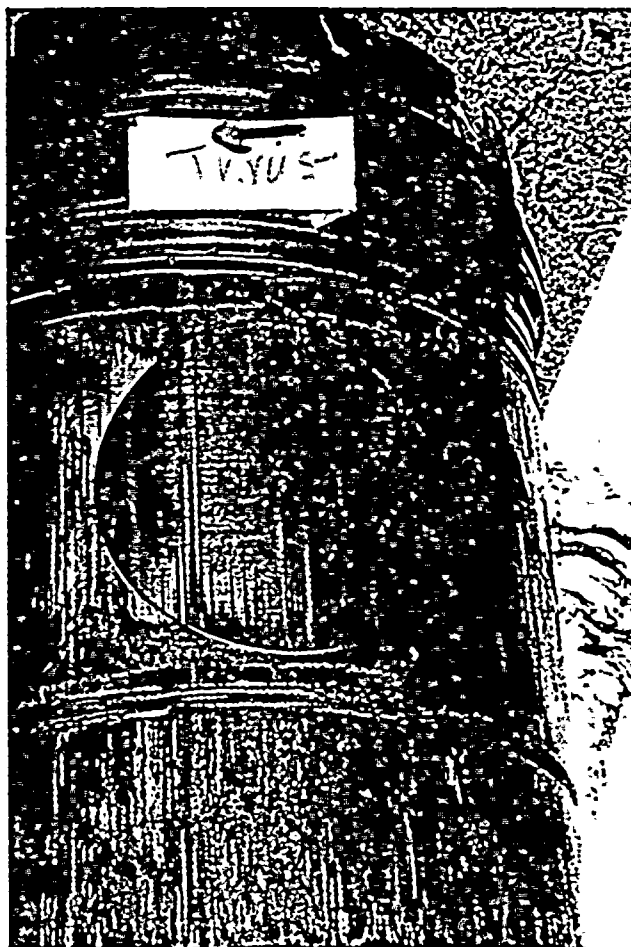
Figure C-7. a) Photographs of the 5R piston end cap facing the generator end of the C diesel; b) The opposite end cap facing the aux. skid end of diesel.
