SUBJECT: Forwards SEA-CW-037, "Root Cause Failure Analysis of B & C Diesels: 1989."

SUSQUEHANNA STEAM ELECTRIC STATION
DIESEL GENERATOR CRANKCASE EXPLOSIONS
ROOT CAUSE ANALYSIS REPORT
PLA- 3321 FILE S024, R41-2

ROOT CAUSE FAILURE ANALYSIS OF "B" AND "C" DIESELS: 1989**I. ABSTRACT**

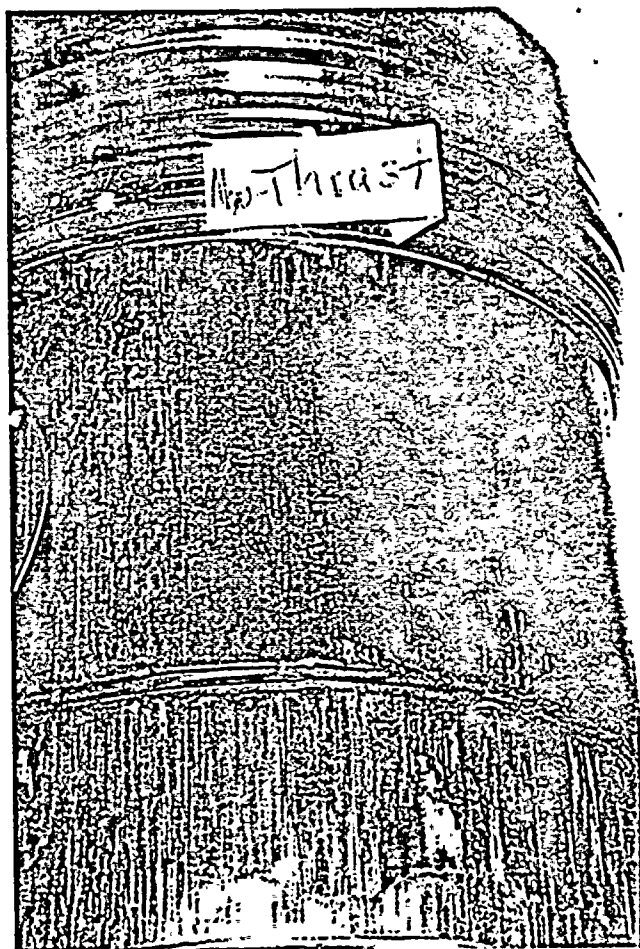
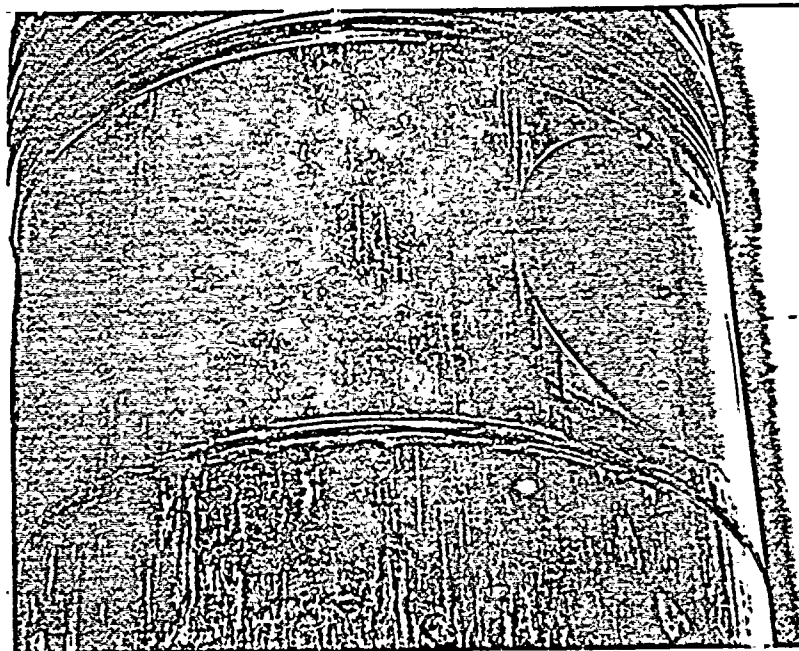
Figure C-8. Photographs of the damage on the non-thrust side of the 5R piston, C diesel; Note the two holes in the skirt at the bottom center of the photo on the right.

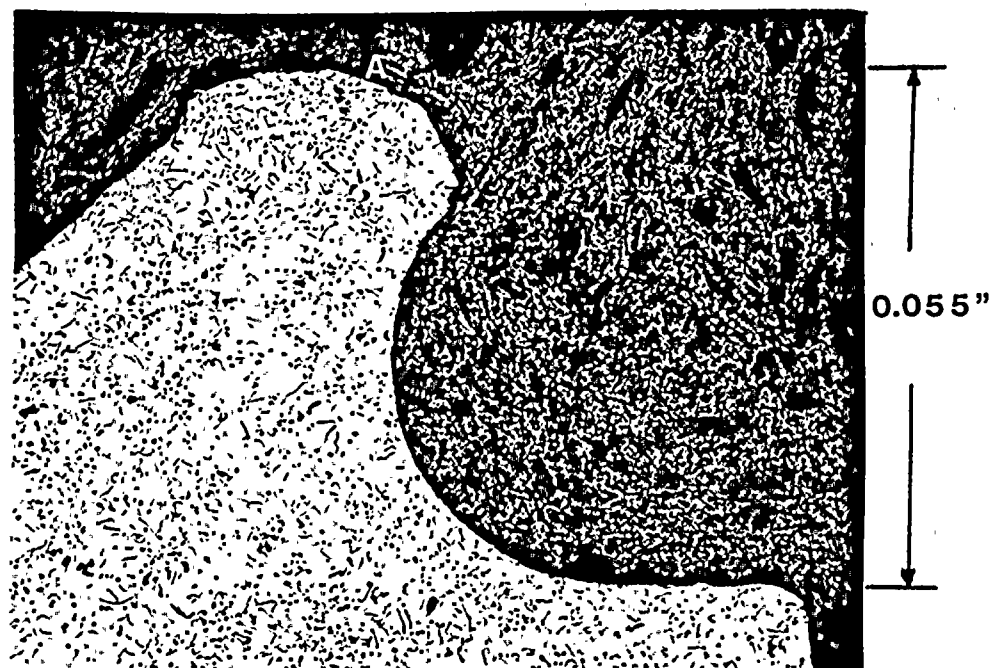
Figure C-21. Microphotograph at 50X of cross section of the lower oil ring from the 5R piston, C diesel. The deformed structure where the oil ring was worn can be seen at area 'A'.

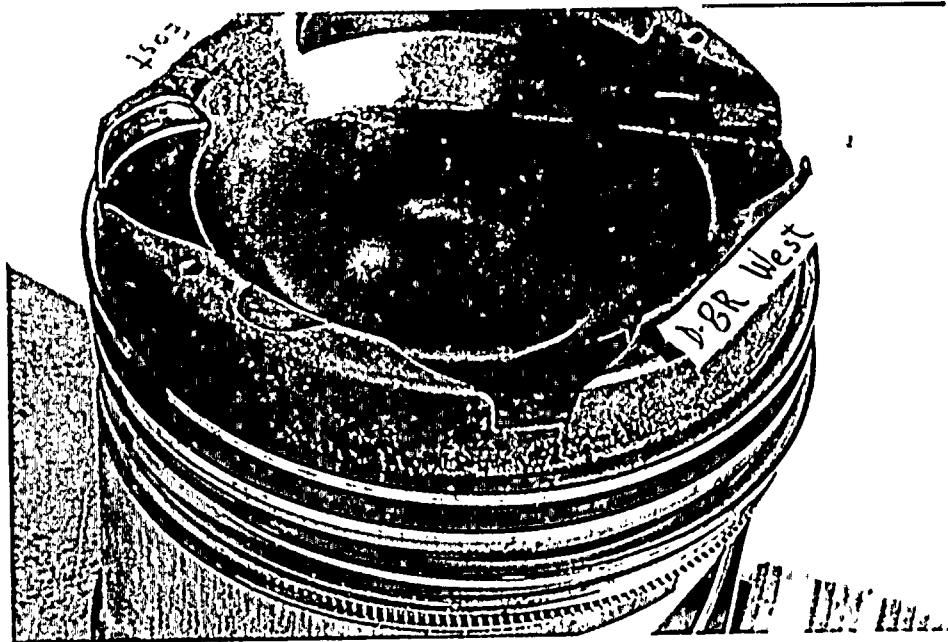
Figure D-1. (a) Non-thrust side of 8R piston showing wear between No. 1 and No. 2 compression rings. (b) Head view of 8R piston.

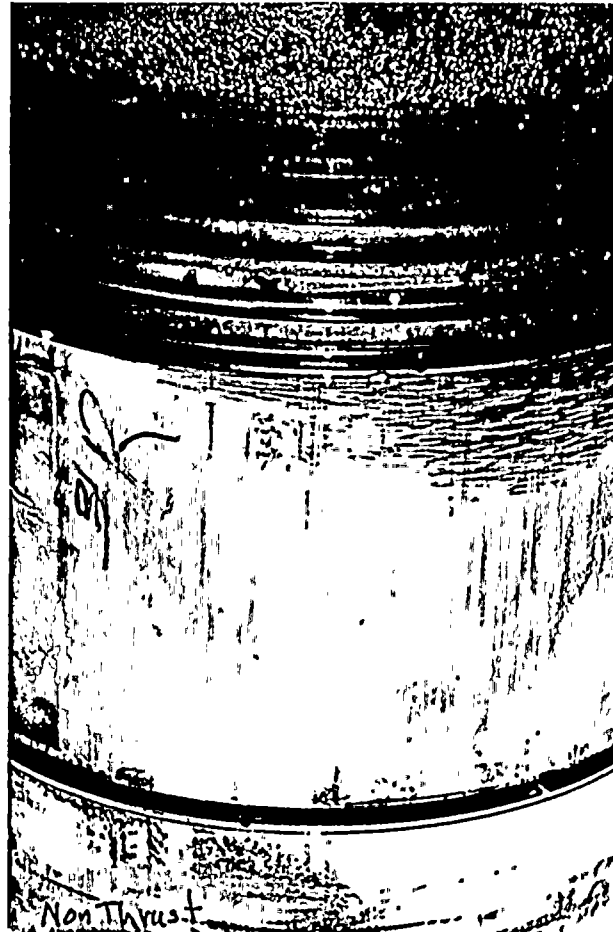
Figure A-2. Photo of the longitudinal scratches on the non-thrust side of the 3R piston - probably caused by the piece broken off the middle oil ring.

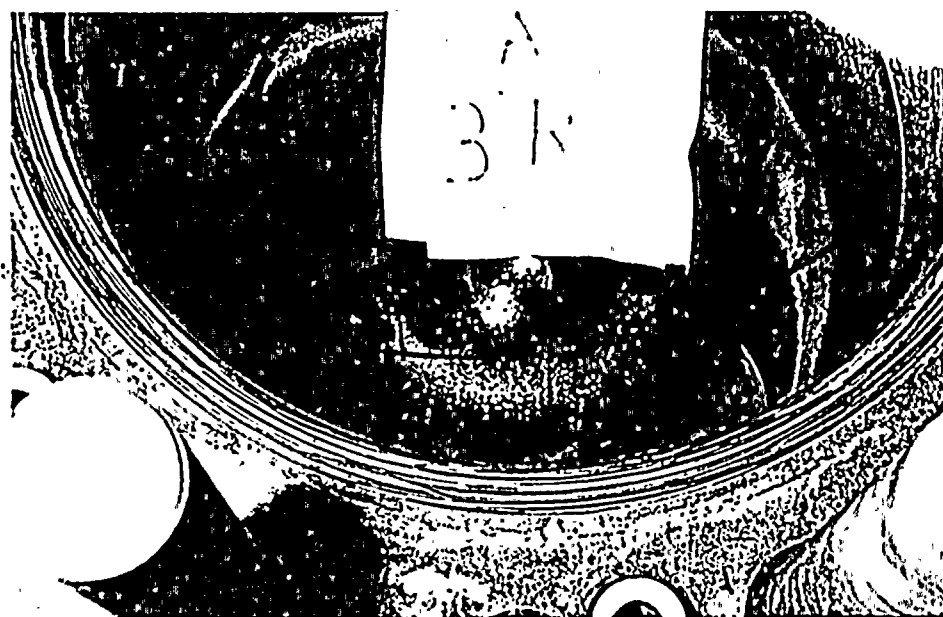
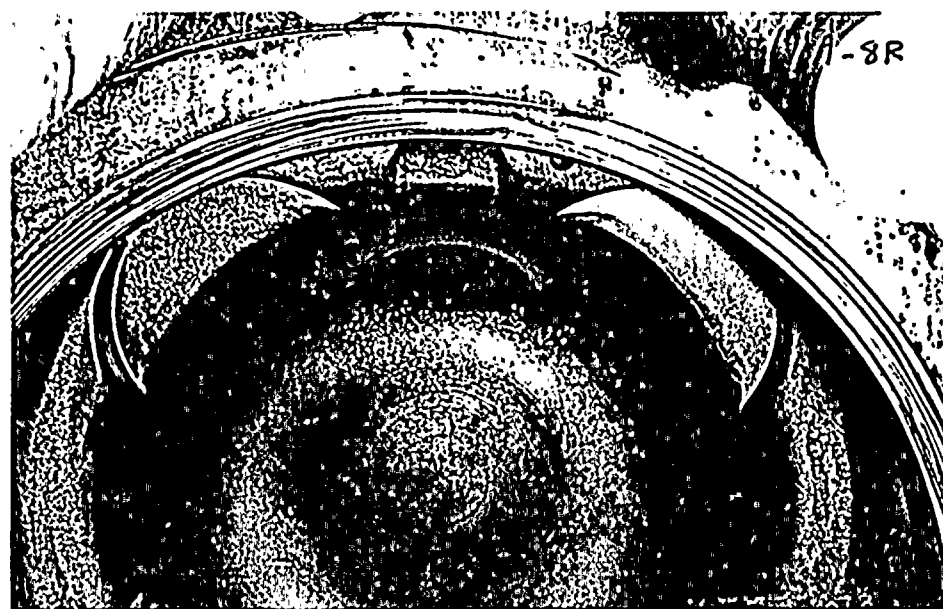
When Maintenance removed the heads from the 8R and 3R cylinders, they discovered damaged gaskets. The gaskets, shown in photos on Figures 5a and b, had disintegrated to a point where just the metal portion of the gasket remained; no binder was left. Cooper has substituted new gaskets that no longer deteriorate.

Figure A-5. Photos of deteriorated head gaskets found after removing head on cylinder 3R. All the binder in the gasket had disintegrated leaving the metal windings.
