LICENSEE EVENT REPORT

Attachment to LER 79-042/01-T-0
Consumers Power Company
Palisades Nuclear Plant
Docket 50-255

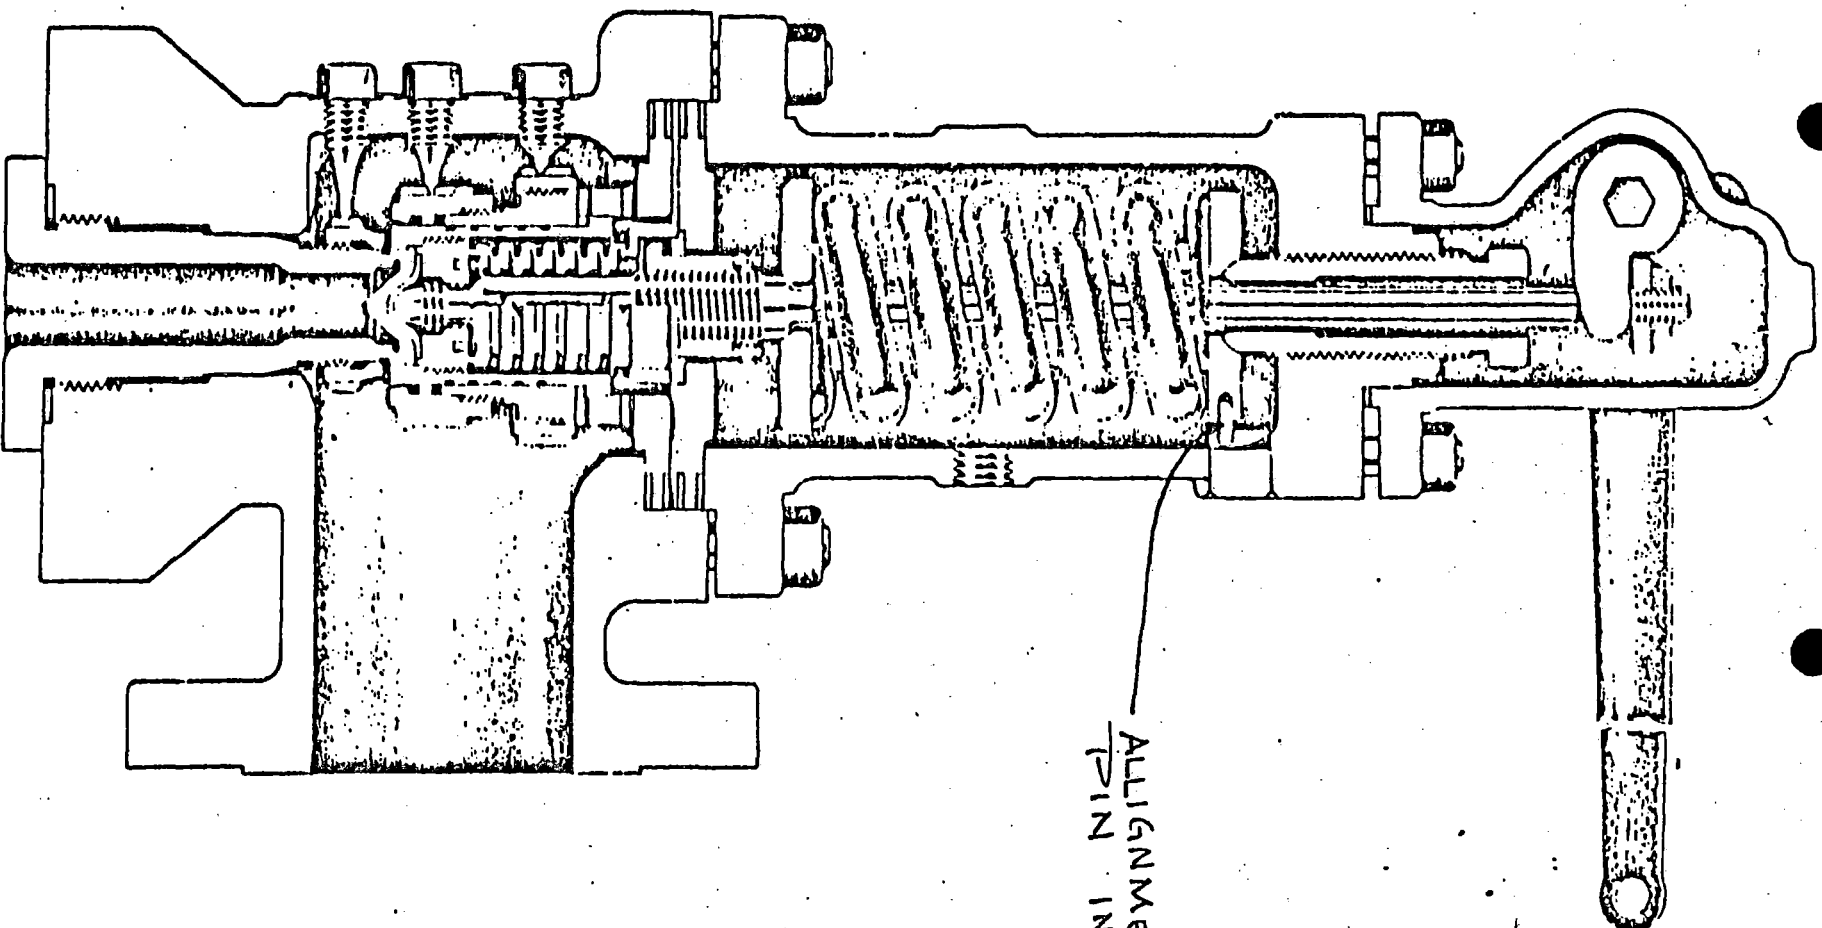
ALIGNMENT
PIN IN SLOT

CAUSE DESCRIPTION AND CORRECTIVE ACTIONS (27)																																																																																							
10		Disassembly of RV 1039 revealed that an alignment pin was mispositioned.																																																																																					
11		This may have caused the out of spec condition of that valve. In																																																																																					
12		addition, info from the vendor reveals that testing with cold nitrogen																																																																																					
13		can result in up to 10% errors when compared to the lift settings with																																																																																					
14		steam as the test medium. Future testing will be done with steam.

The valves were disassembled, inspected, refurbished and retested satisfactorily with steam. Inspection of RV 1039 revealed that the alignment pin on the upper spring washer was out of its slot, and was bound on the land under the slot (see attached figure). It is probable that the mispositioning of the alignment pin occurred during the previous rebuilding of the valve in March, 1976. It is noted; however, that subsequent to the rebuilding of the valve in March, 1976, it was tested satisfactorily by checking the lift setting four times with cold nitrogen. Inspection of RV 1040 revealed no apparent deficiencies.

To avoid future errors in the lift settings of the Palisades pressurizer code safety valves, these valves will continue to be tested with steam as long as there exists no other practical means of testing which will provide acceptable results.
