January 31, 2018

File No.: HMC2017

**SUBJECT: REPORT OF 2017 ANNUAL INSPECTION OF TAILING IMPOUNDMENTS
AND PONDS, HOMESTAKE GRANTS PROJECT, GRANTS, NEW MEXICO**

Homestake Grants Project, Grants, New Mexico

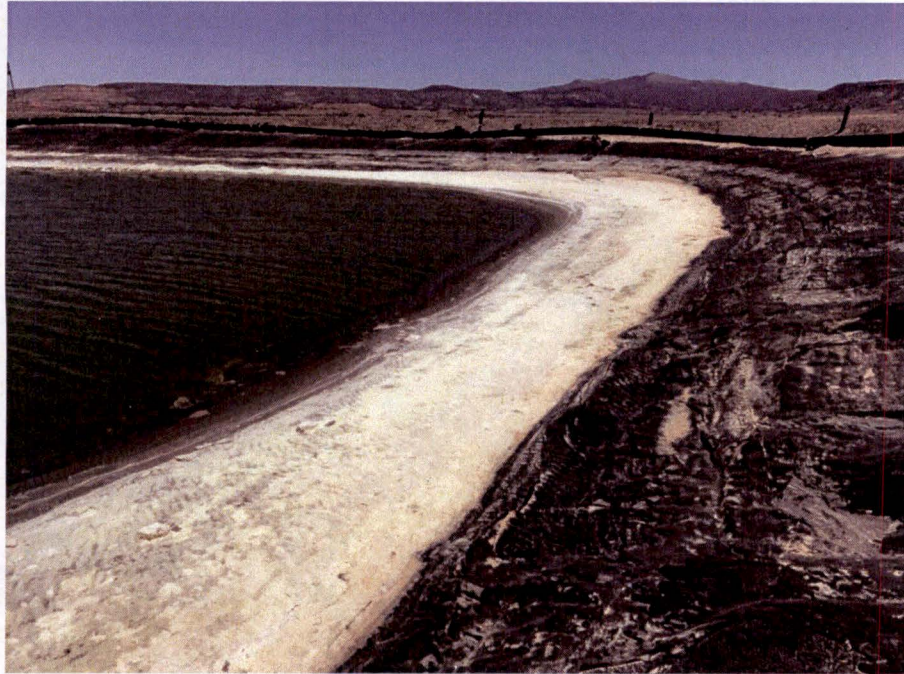
The small impoundment (location of evaporation pond #1, or EP1) remains in generally good condition. The slumps in the subgrade fill of the south inslope of EP1, under the pond liner along approximately 200 feet of the pond westward from the southeast corner (Photo 1), have not visibly changed in 2017, and the liner remains intact. Similar but more limited slumps are now visible along the east inside slope of EP1 (Photo 2). During 2017, the water level was lowered for part of the year, making it possible to examine the precipitated sludge that has accumulated since 1990 (Photo 3). Weathering cracks have developed at several locations in the pond liner. The liner remains functional despite these conditions, but Homestake initiated an engineering feasibility assessment of options to address the issues related to aging of EP1, including the slumps in the liner (letter Wohlford to Meyer, 4/24/17).

Photo 1 – EP1 liner near the southeast corner. Slumps along right side.

Until the EP1 options are evaluated and a course of action taken, the slumps along the inside slopes of EP1 should be protected against further displacement to protect the liner. Site staff should note any changes in the slumps and in the condition of the liner.

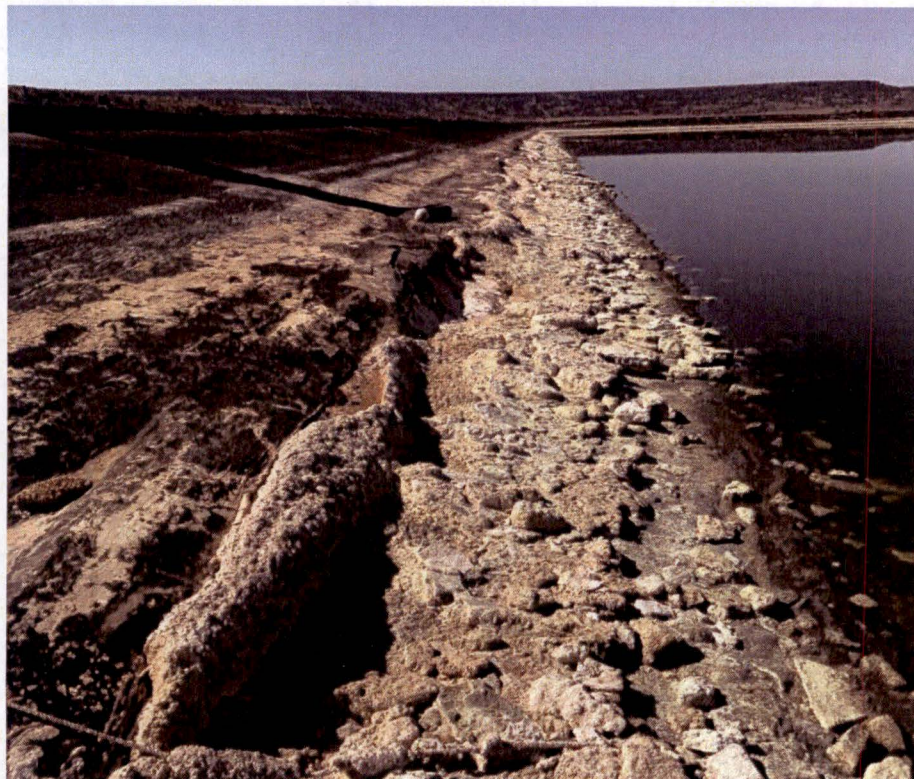
Photo 2 – EP1 east slope. Slumps below normal pool level.

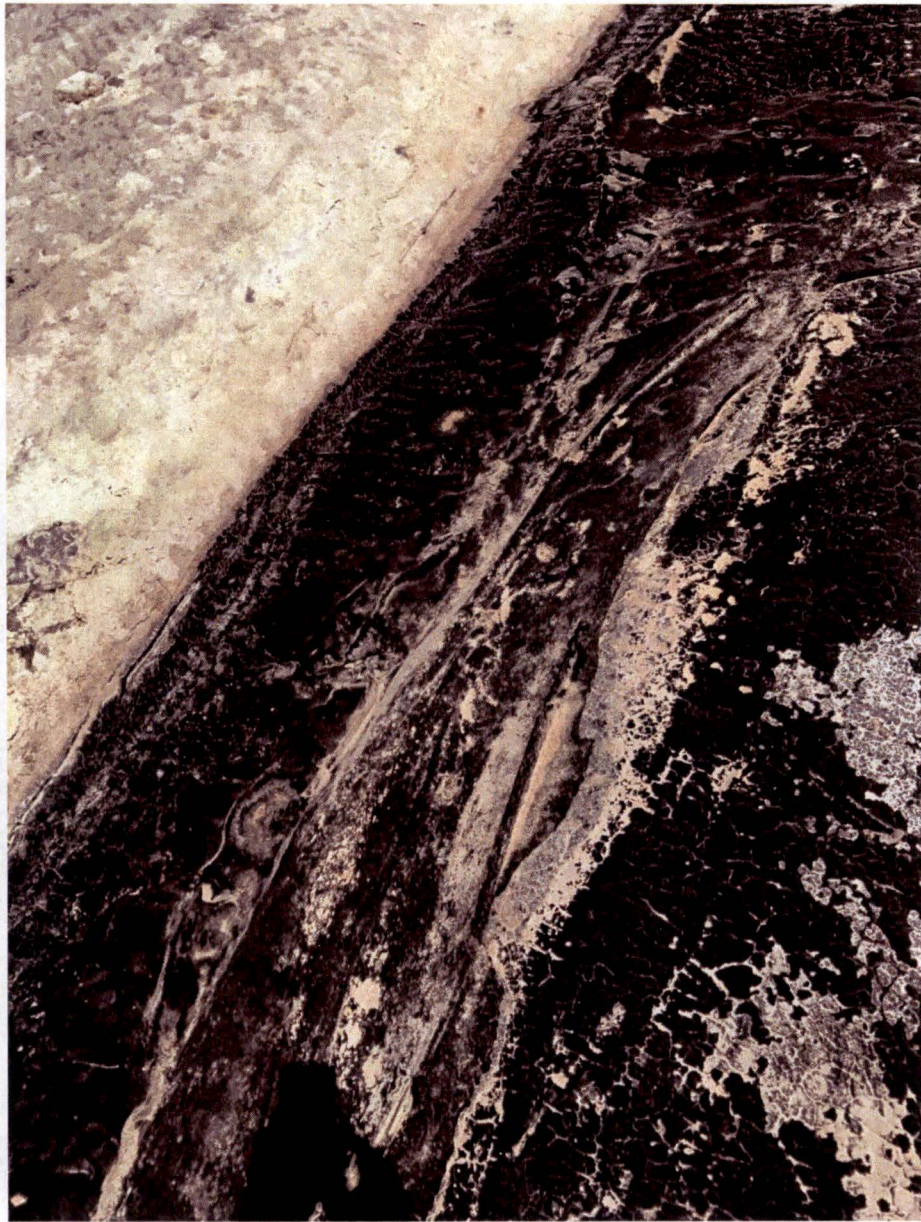
Photo 3 – Close-up of precipitated sludge of the EP1 liner.

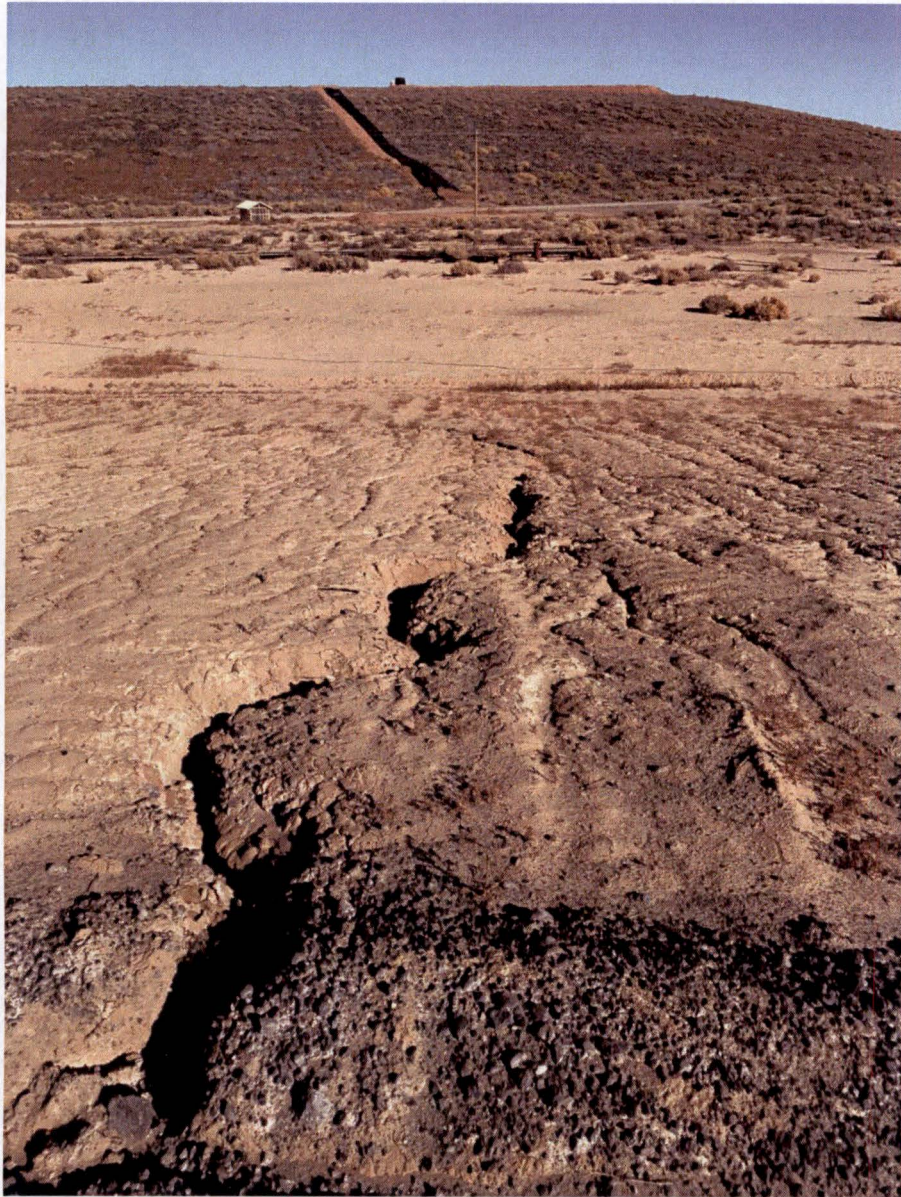
Homestake repaired rills during the 2016-2017 winter, but rills have developed again on all of the small tailing pile outslopes during 2017. On the east outslope, rills were up to 6 inches deep. On the southeast and north slopes, rills were generally 4-8 inches deep but up to two feet deep in a few places downslope from low spots in the EP1 perimeter berm where runoff was concentrated (Photo 4). The west and southwest slopes had minor rilling up to 4 inches deep. HMC has prepared an erosion mitigation plan that includes earthwork to fill rills and deployment of erosion control blanket. Implementation of this plan is expected in early 2017.

Photo 4 – Major rill in EP1 north outslope.

The undersigned advised HMC that rill management and grade control are needed annually to maintain erosional stability of the small tailing impoundment, the evaporation ponds, and the interim cover of the LTP. Perimeter berms on the covers of the STP and LTP should be maintained to minimize the potential for surface runoff to create concentrated sideslope flows and sideslope rilling. In response, HMC has developed a plan for erosion control on EP1, with applications for EP3, as well.
