RE: LQD 2016-2017 Annual Inspection Report, Uranium One, Willow Creek ISR Project, Permit No. 478

IN SITU MINE INSPECTION REPORT

Permit Number:	PT0478	Permittee:	URANIUM ONE USA INC
Inspection Date:	11/29/2017	Inspector(s):	Luke McMahan
Report Date:	1/9/2018	Participant(s):	Scott Schierman, Kevin Filbert
Last Inspection:	10/18/2016	Current Bond:	\$21,707,323
Inspection Reason(s):	Annual	Field Conditions:	Clear, windy, dry, all areas accessible, ~55° F
		Approval Date:	4/18/1978

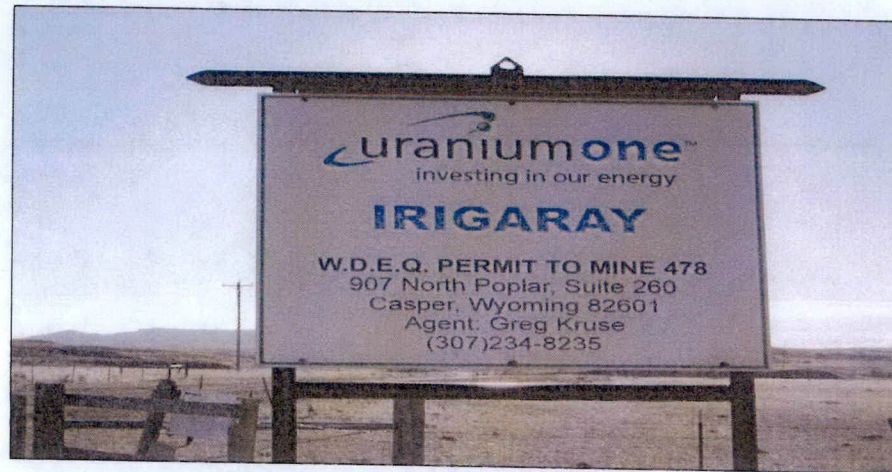
• Signs	Yes
<p>The permit signs for the Irigaray site and the Christensen Ranch site were found to be up to date and posted with the appropriate information (Photos #1 and #5).</p>

Photo #1: Irigaray Site Permit Sign.

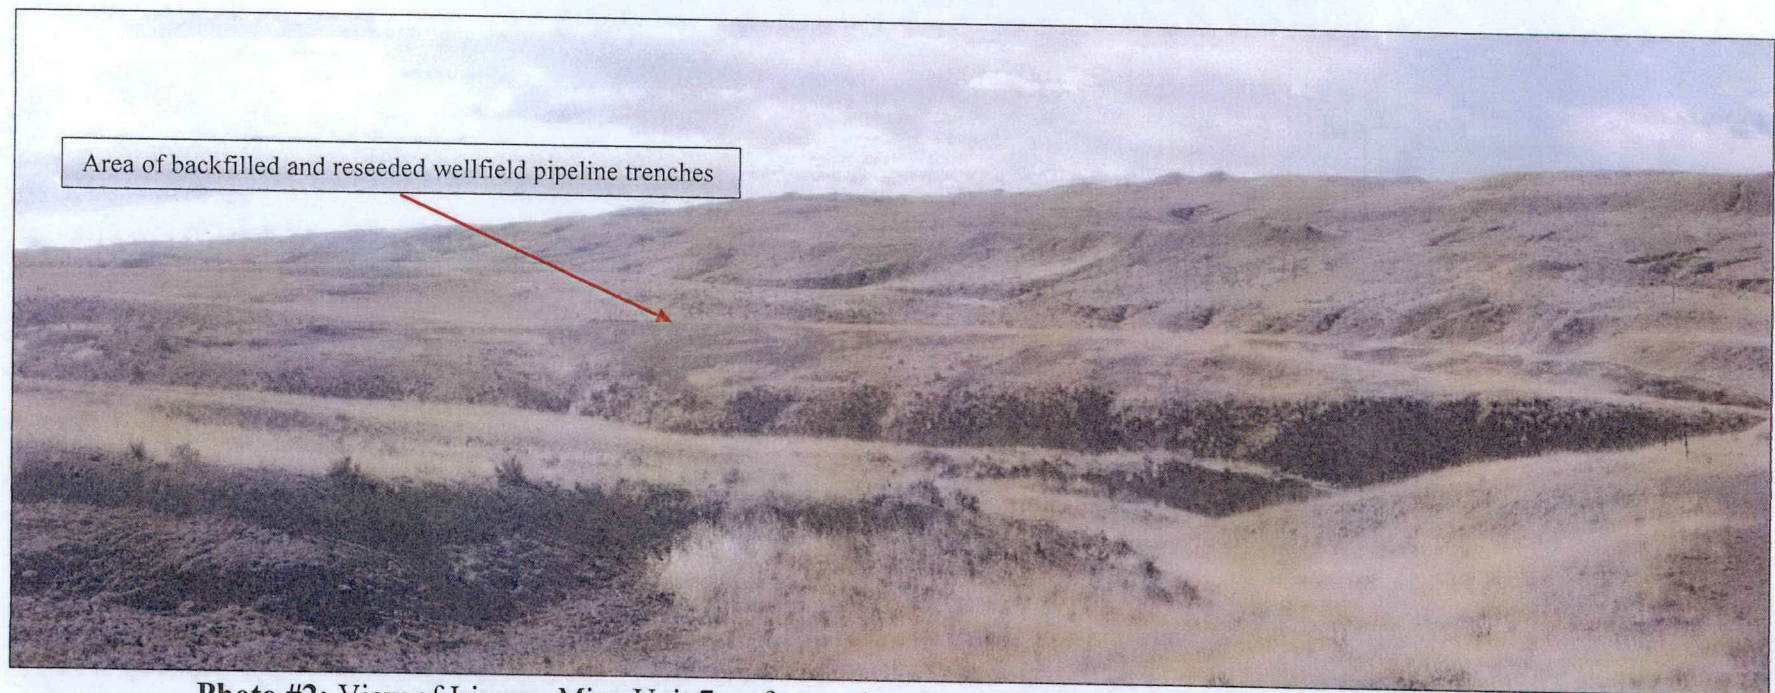
Photo #2: View of Irigaray Mine Unit 7 surface reclamation following removal of wellfield infrastructure.

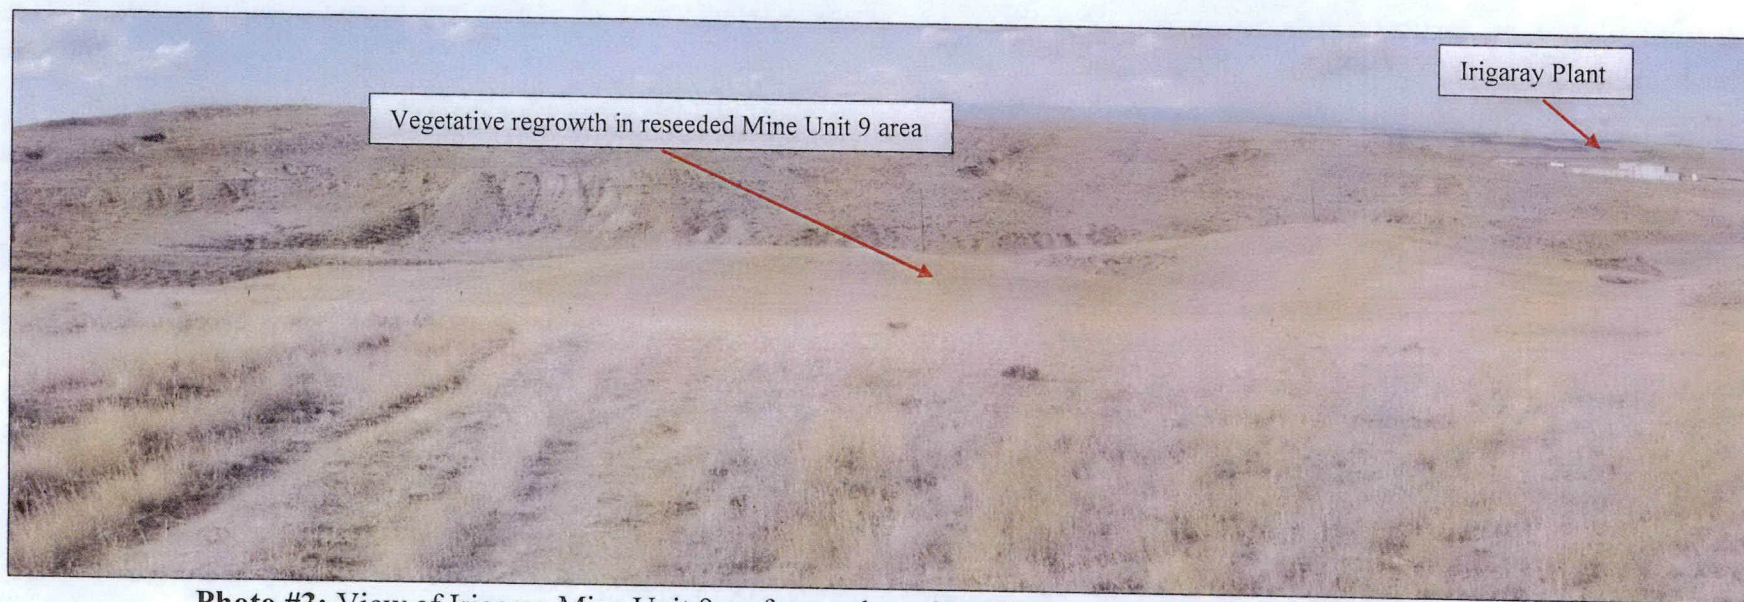
Photo #3: View of Irigaray Mine Unit 9 surface reclamation following removal of wellfield infrastructure.

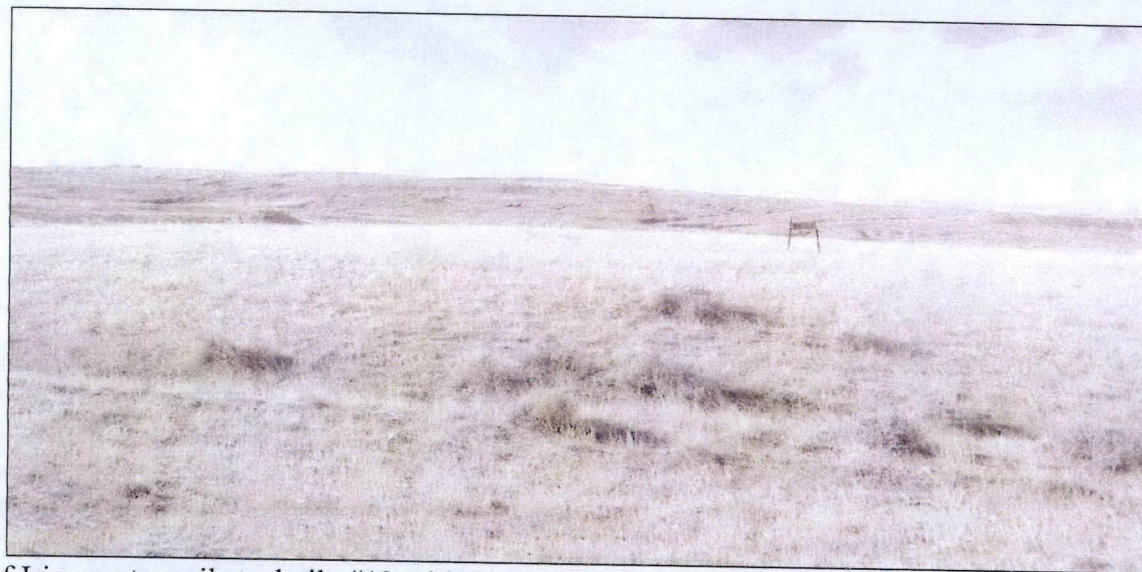
• Topsoil Stockpiles	Yes
<p>Based on the Annual Report and the Annual Inspection, a total of 49 topsoil stockpiles (Photos #4 & #11) and two (2) subsoil stockpiles (Photo #21) are present at Willow Creek Mine. All of these stockpiles were viewed during the annual inspection and were found to be in stable condition with no erosional issues. Two (2) of the topsoil stockpiles, #23 & #30 were found to be missing topsoil identification signs. Following the inspection, Uranium One posted topsoil signs at stockpiles #23 and #30 and emailed photographs of the identification signs posted at stockpiles #23 and #30 to the inspector on November 30, 2017 (Photos #12, #13, #14, #15). Topsoil stockpiles #35 & #36, not listed in the Annual Report topsoil stockpile table but shown on the Annual Report map for the Christensen area, could not be located during the inspection. Although #35 & #36 could not be located, it was noted during the inspection that these stockpiles were quite small and relatively difficult to see from a distance. Following the inspection, Uranium One found and verified the mapped locations for stockpiles #35 & #36, and emailed photographs to the inspector on November 30, 2017 (Photos #16, #17).</p> <p>Of the Forty-nine topsoil stockpiles viewed during the inspection, three (3) of the topsoil stockpiles were not listed in the Annual Report stockpile table or on the Annual Report maps. The three unnamed topsoil stockpiles were found located next to the maintenance area burn pit (43.802264, -106.031164), located next to the Mine Unit 3 access road (43.807297, -106.034825), and located next to the access road between Mine Unit 4 and Mine Unit 5 (43.785218, -106.028453). These stockpiles were found to be stable and posted with a topsoil identification sign (Photos #18, #19, #20). As requested in LQD's annual report review memorandum, these stockpiles will need to be added to the applicable annual report table and map.</p>

Photo #4: View of Irigaray topsoil stockpile #12 with ID sign, vegetative growth and signage typical of IR stockpiles viewed.

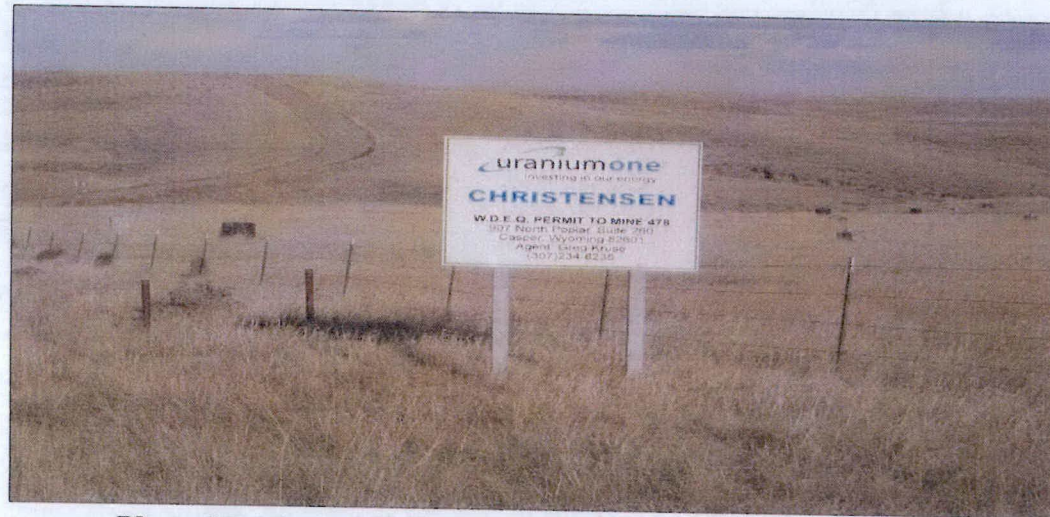
Photo #5: View of Christensen Ranch Site Permit Sign.

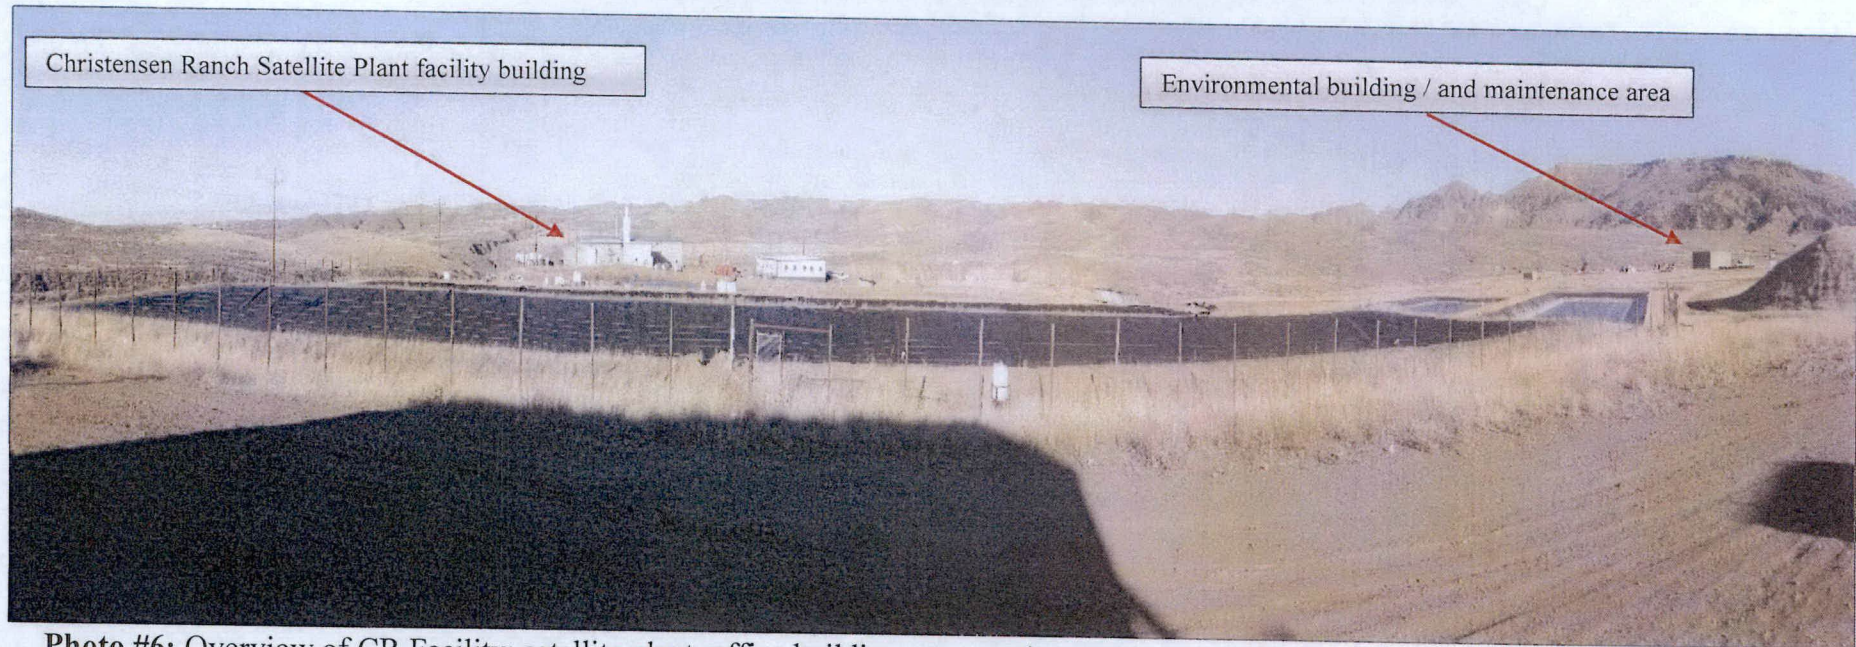
Inspection Topic	In Compliance
• Ponds	Yes
<p>The evaporation ponds (active and inactive) located at the Irigaray and Christensen sites were viewed in passing. The Irigaray facility has seven (7) ponds, three of which have had their liners removed and are no longer in use. The remaining four, IR-B, IR-D, IR-RA, and IR-RB were in use at the time of the inspection and no issues were identified with the Irigaray ponds. The Christensen facility has five (5) ponds, all of which were in use at the time of the inspection (Photo #6). No issues with the Christensen facility ponds were identified during the inspection.</p>

Photo #6: Overview of CR Facility; satellite plant, office building, evaporation ponds and maintenance area, looking NE from DDW site.

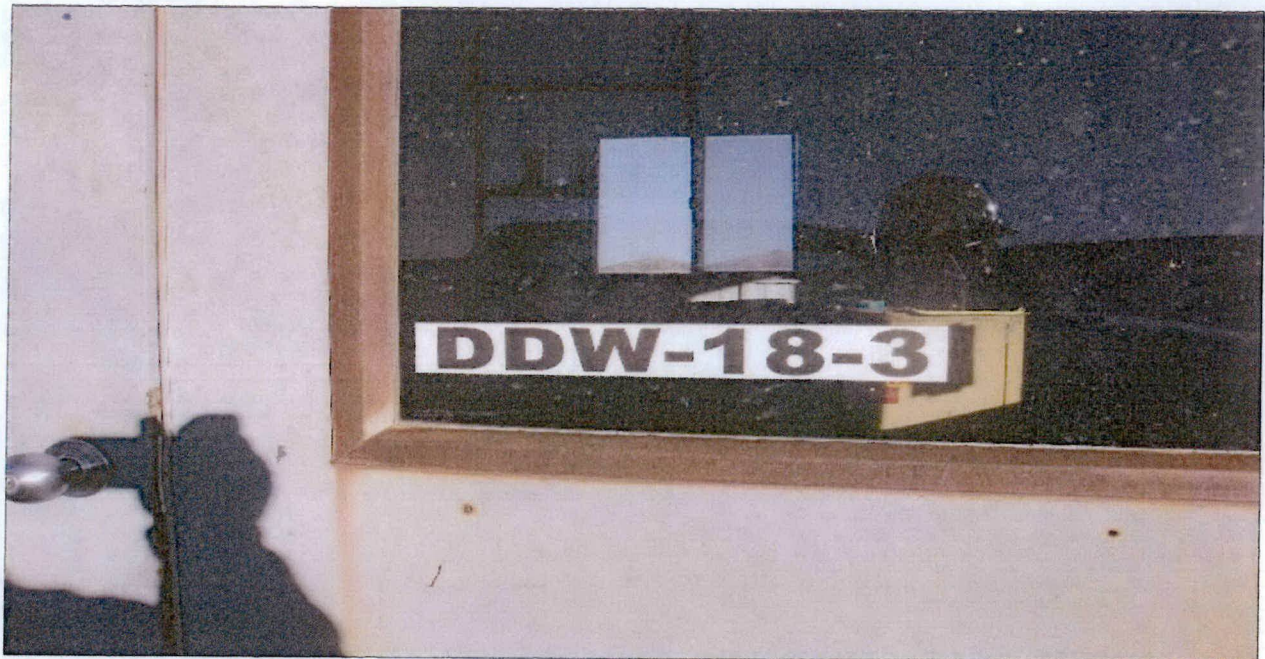
• Deep Disposal Wells	Yes
The Willow Creek Mine has two (2) Class I Deep Disposal Wells, Christensen Ranch DW-1 and Christensen Ranch 18-3. Both wells are located at the Christensen Ranch Facilities area. The wells are permitted for injection of industrial wastes under the WDEQ Water Quality Division (WQD) Permit UIC 10-219. Construction, operation, mechanical integrity testing standards and the cost of reclamation are under the purview of the WQD UIC permit. However, the bond amount posted by Uranium One for reclamation of the wells is held by LQD in accordance with the LQD permit to mine for Willow Creek. Both wells were operational at the time of the inspection. No evidence of significant leakage or spills around the wellheads or around the well facilities was observed (Photos #7 & #8).

Photo #7: View of Christensen Ranch Facility DDW-18-3.

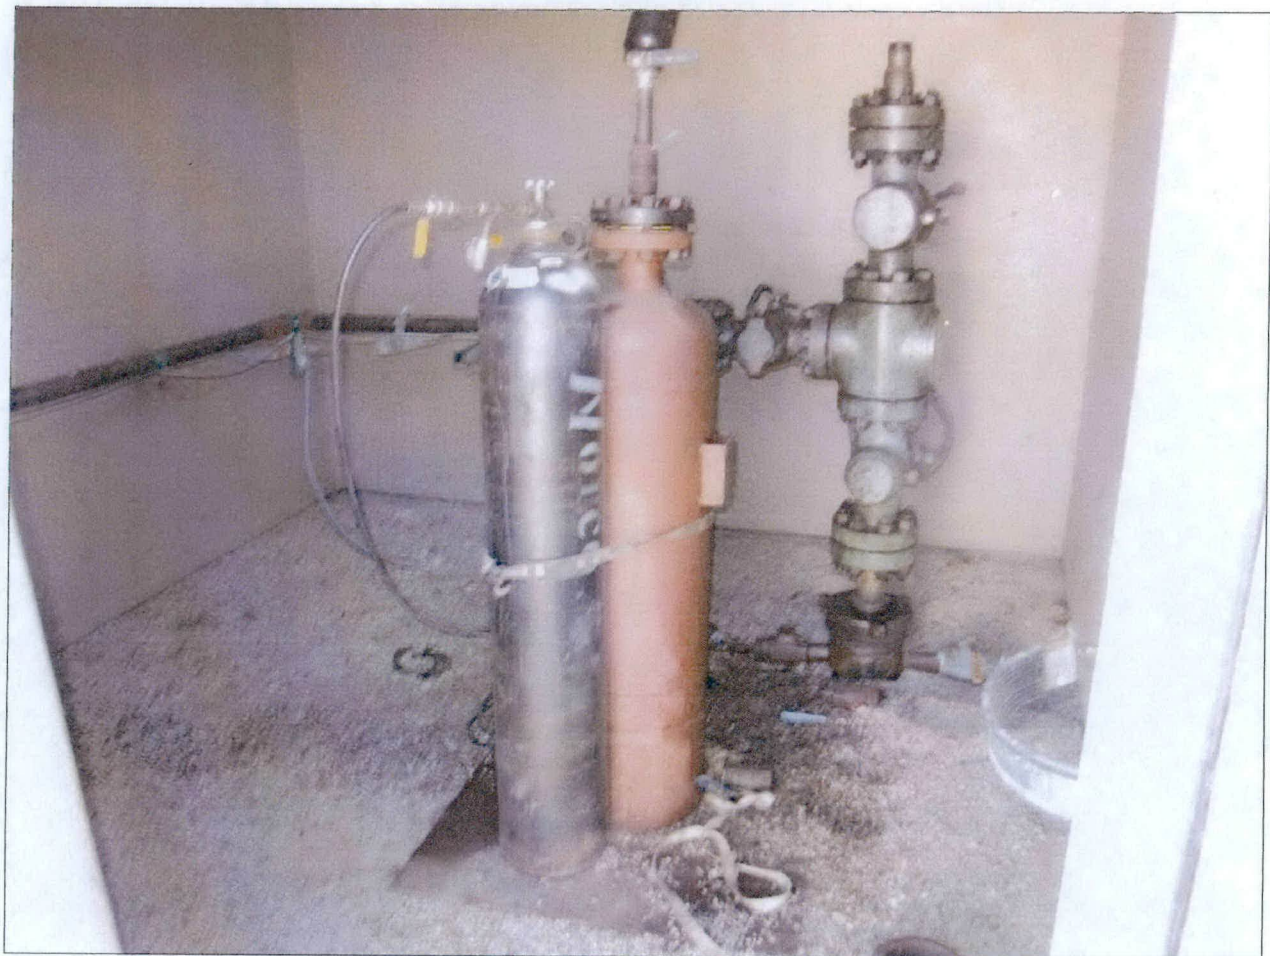
Photo #8: View of Christensen Ranch Facility DDW-18-3.

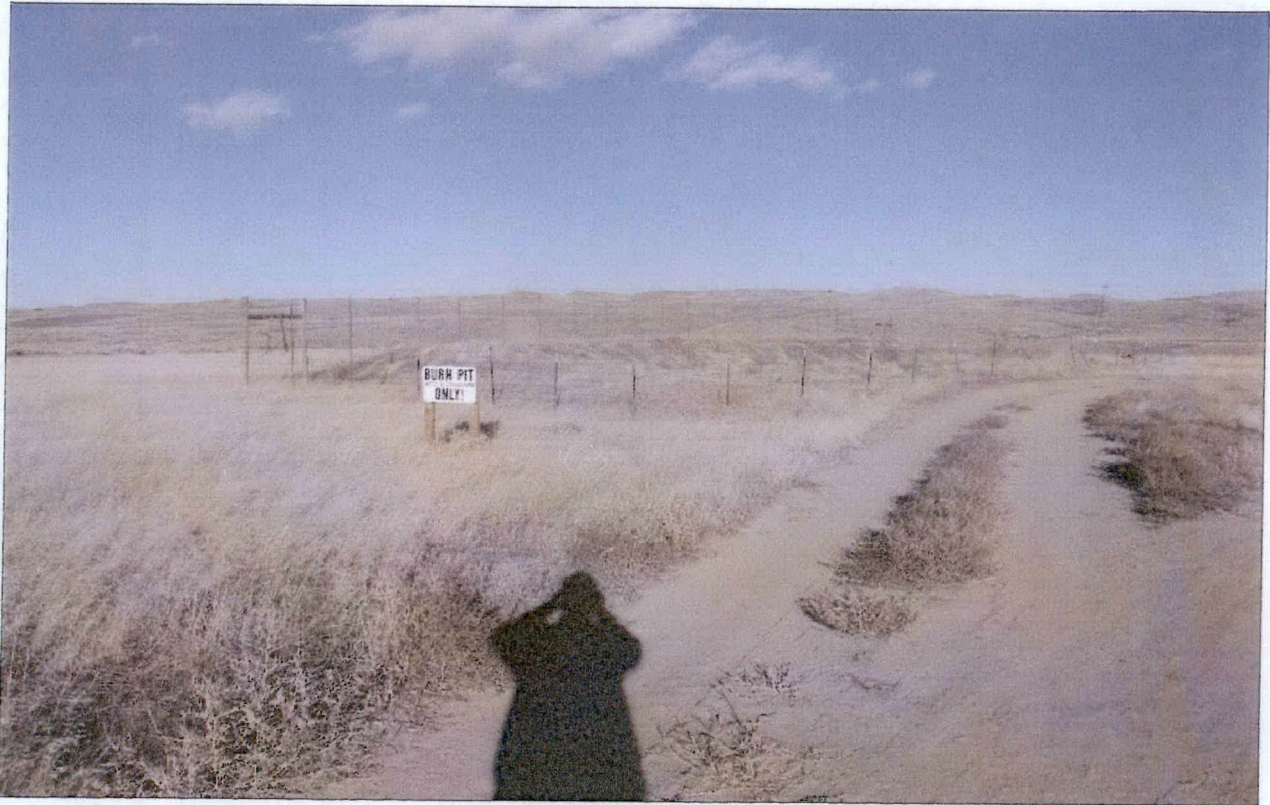
• Facilities	Yes
Both the Irigaray Plant and Christensen Ranch Plant facilities were viewed in passing, however, the inspector did not enter the plant facilities during this inspection. The solid waste disposal area for common trash at the Christensen Ranch site was viewed. Although a minor amount of wind-blown trash was observed in the area, the containment fencing above and around the trash bins appeared to be effectively preventing wind-blown trash from migrating away from the trash bin location (Photo #10). The burn pit located adjacent to the maintenance area at the Christensen Ranch site was also viewed and found to have appropriate signage and fencing. There was no wind-blown debris observed to be around or migrating away from the pit location (Photo #9).

Photo #9: View of Christensen Ranch Facility burn pit.

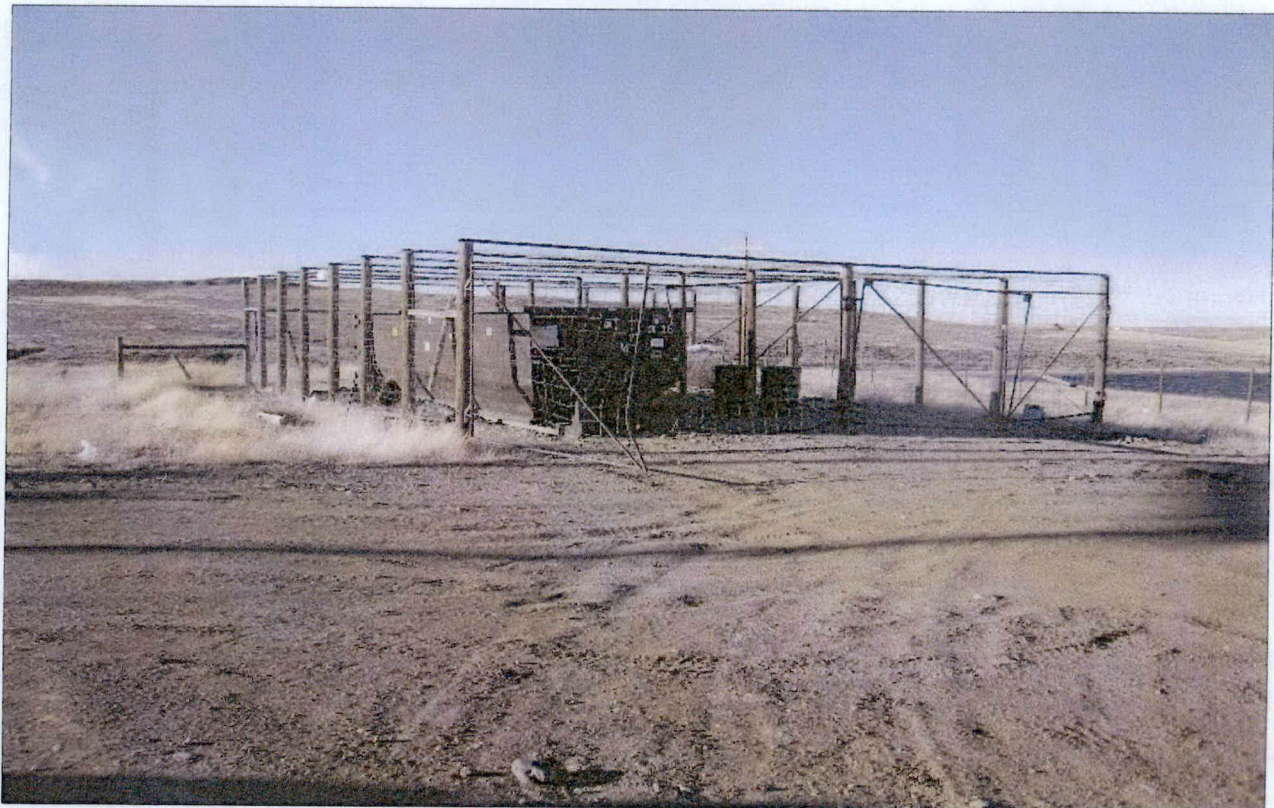
Photo #10: View of Christensen Ranch Facility solid waste disposal (common trash).

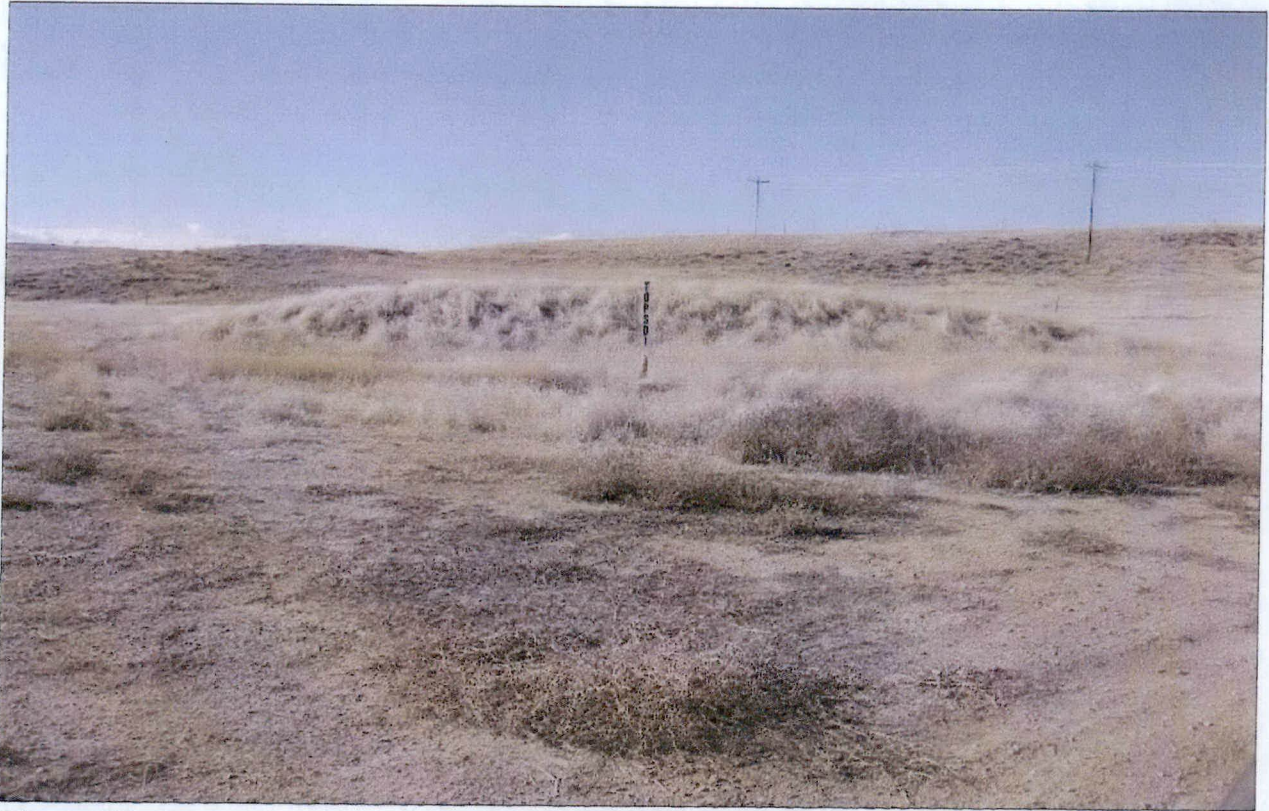
Photo #11: View of Christensen Ranch Topsoil Stockpile #28, typical of CR stockpiles viewed.

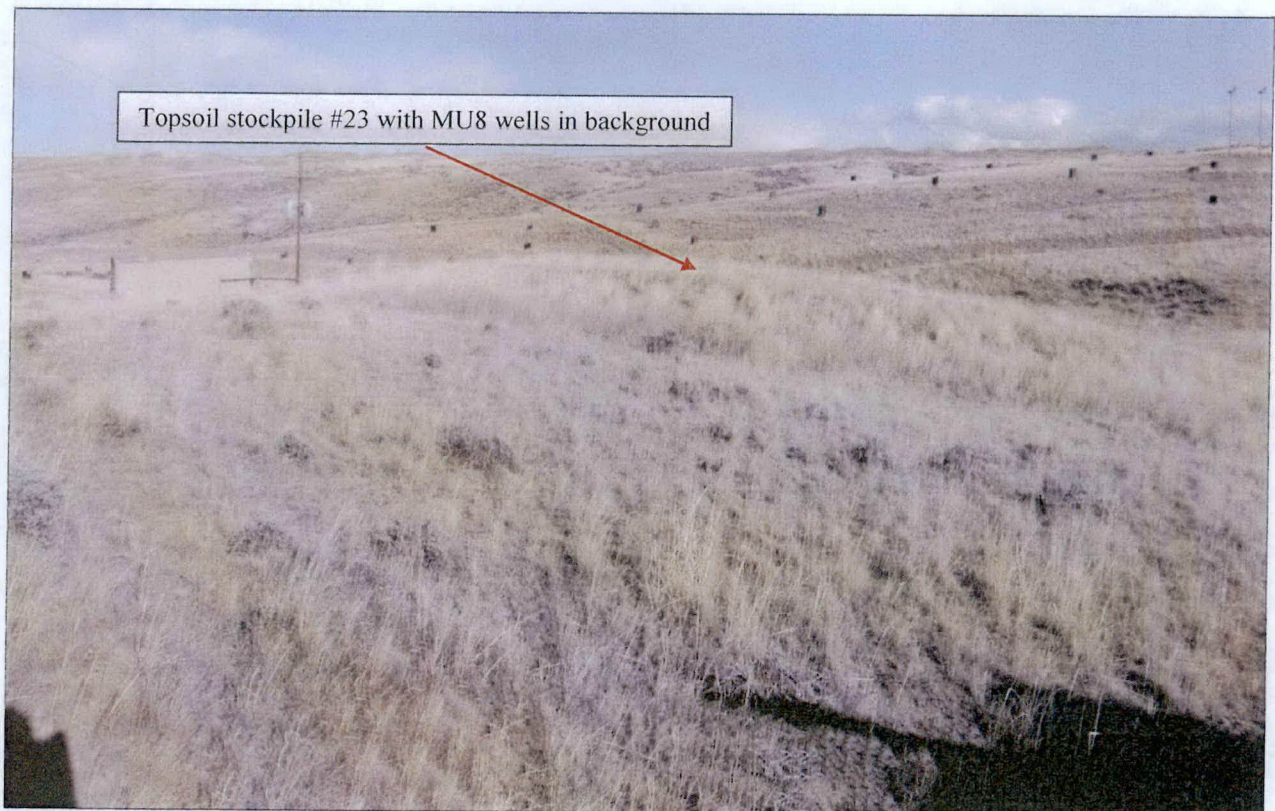
Photo #12: View of CR Topsoil Stockpile #23, no topsoil identification sign present.

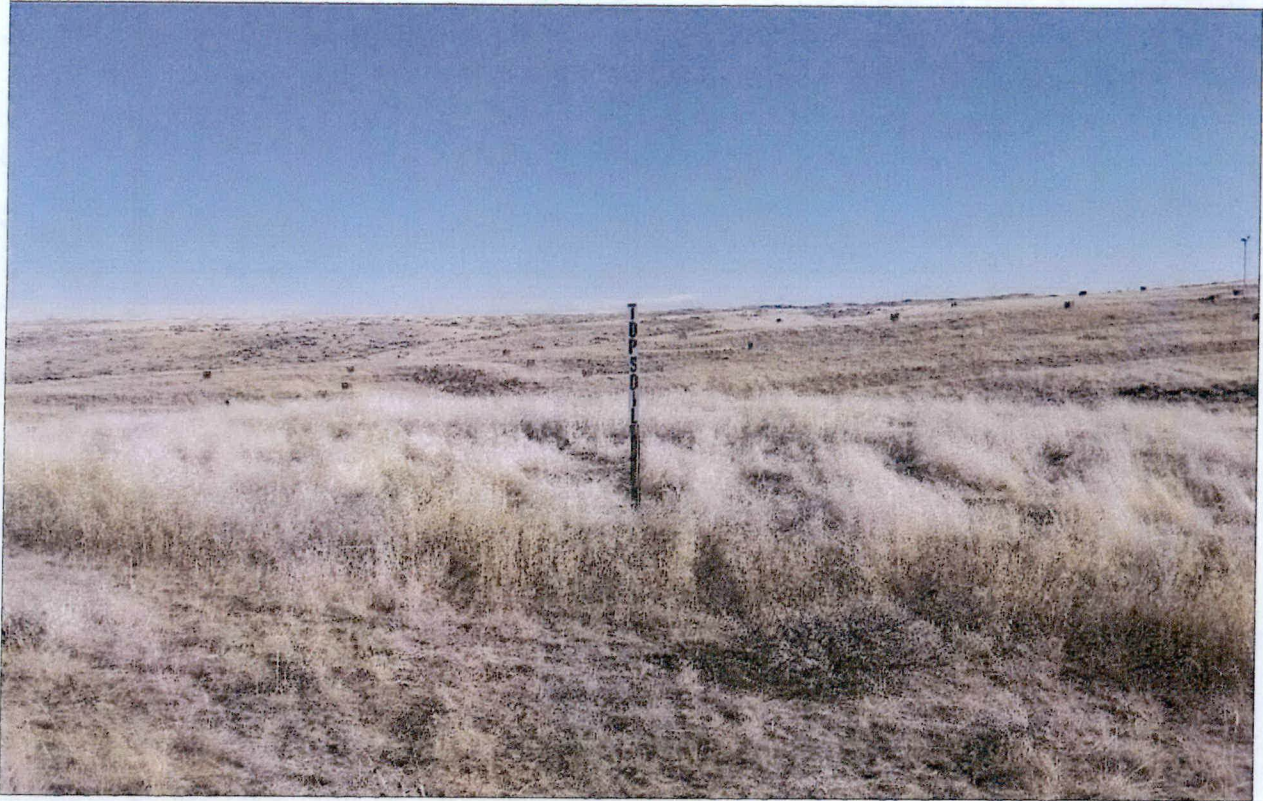
Photo #13: View of CR Topsoil Stockpile #23 with topsoil identification sign posted.

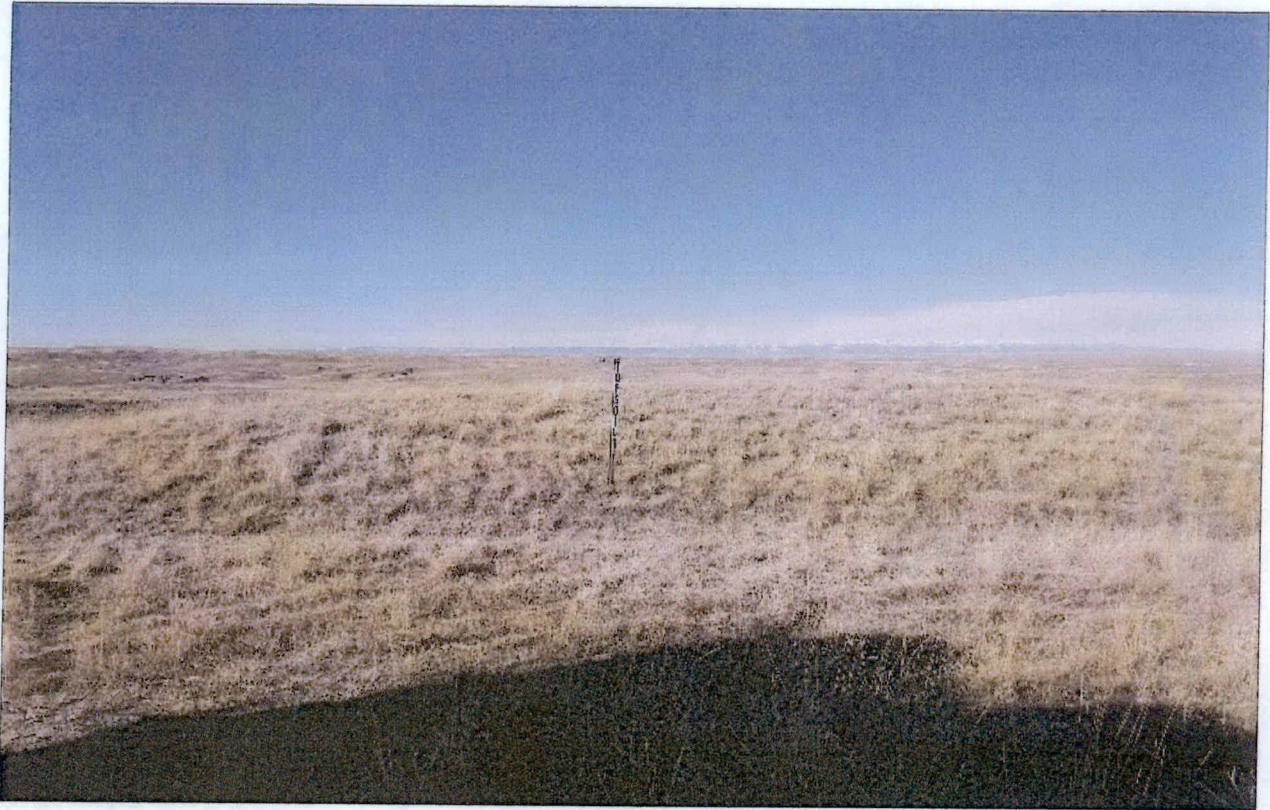
Photo #15: View of CR Topsoil Stockpile #30 with topsoil identification sign posted.

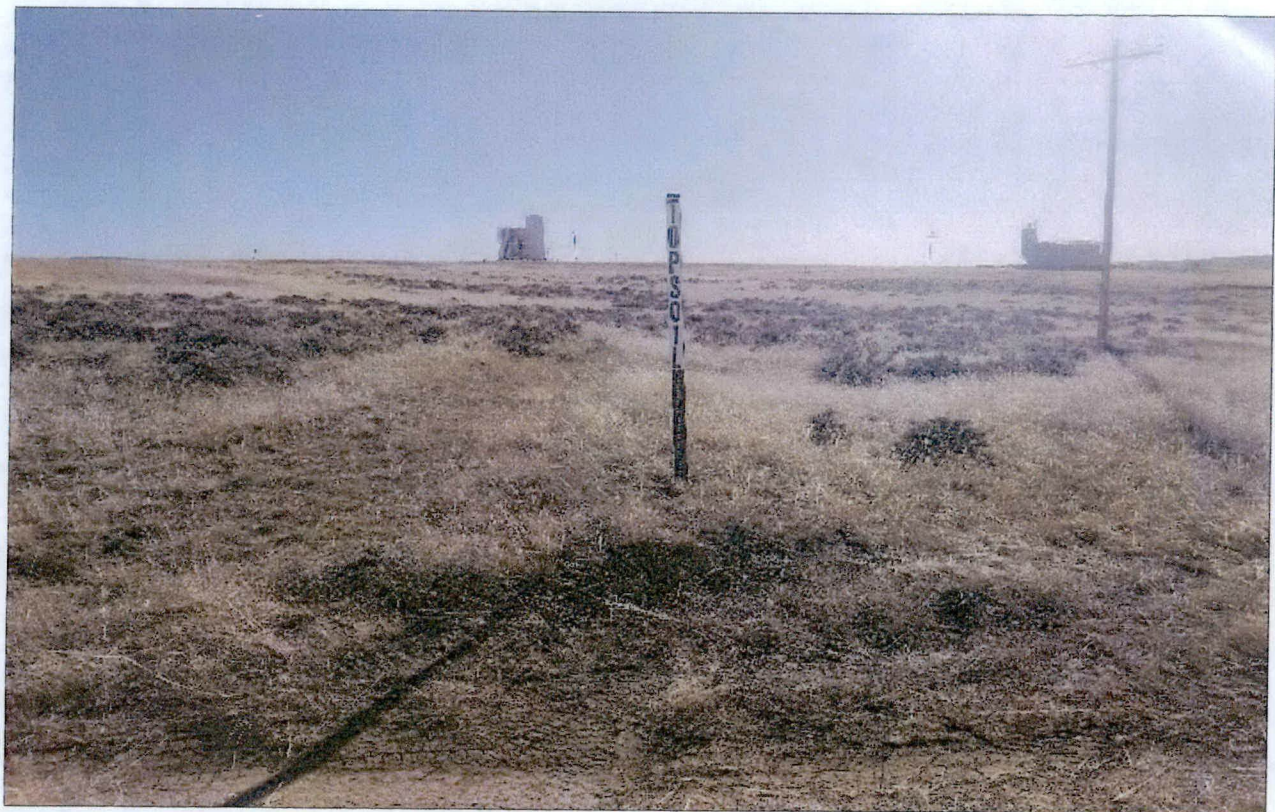
Photo #16: View of Christensen Ranch Topsoil Stockpile #35.

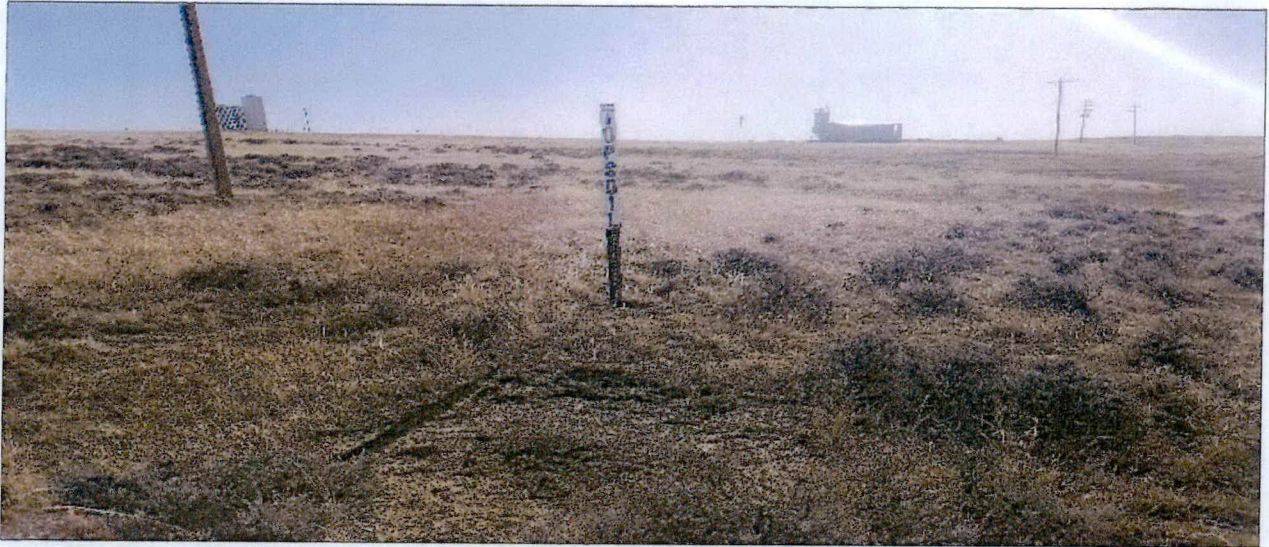
Photo #17: View of Christensen Ranch Topsoil Stockpile #36.

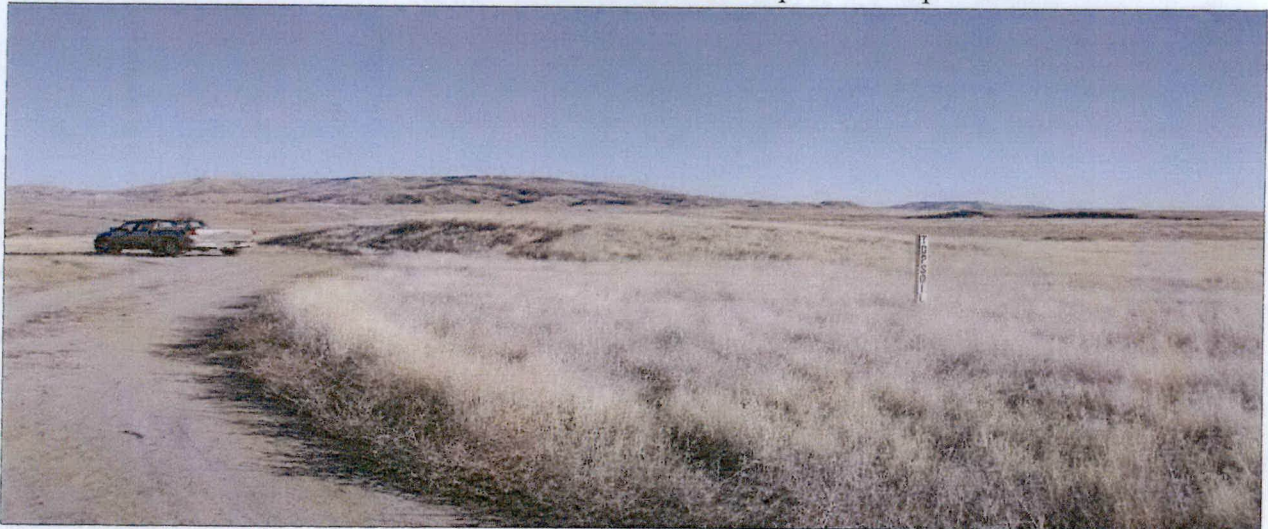
Photo #18: unnamed CR topsoil stockpile next to burn pit (43.802264, -106.031164).

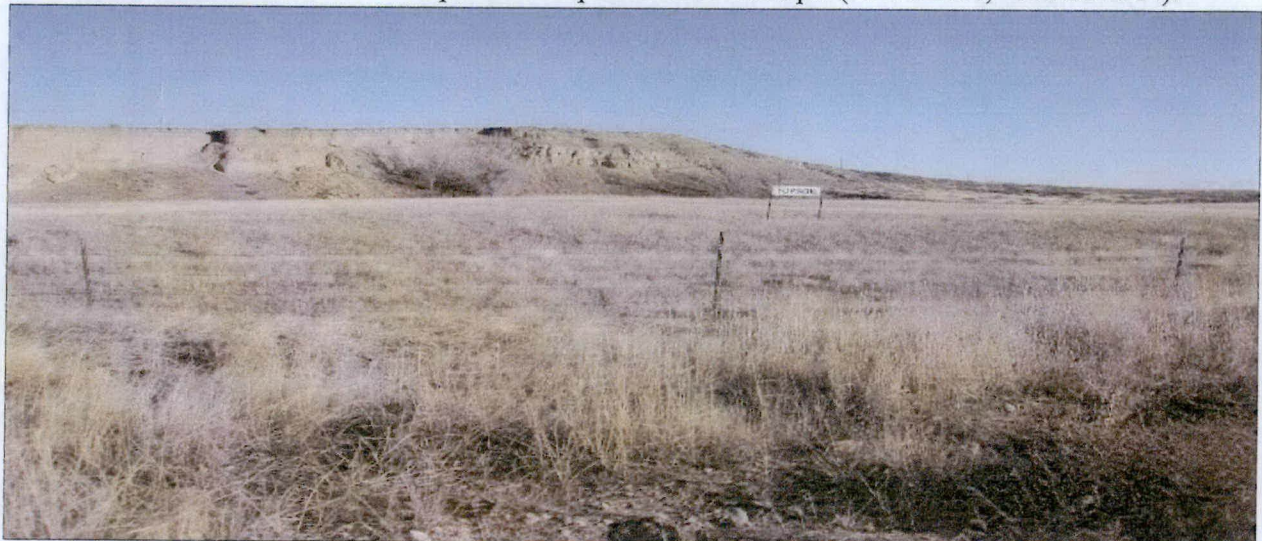
Photo #19: unnamed CR topsoil stockpile next to MU3 access road (43.807297, -106.034825).

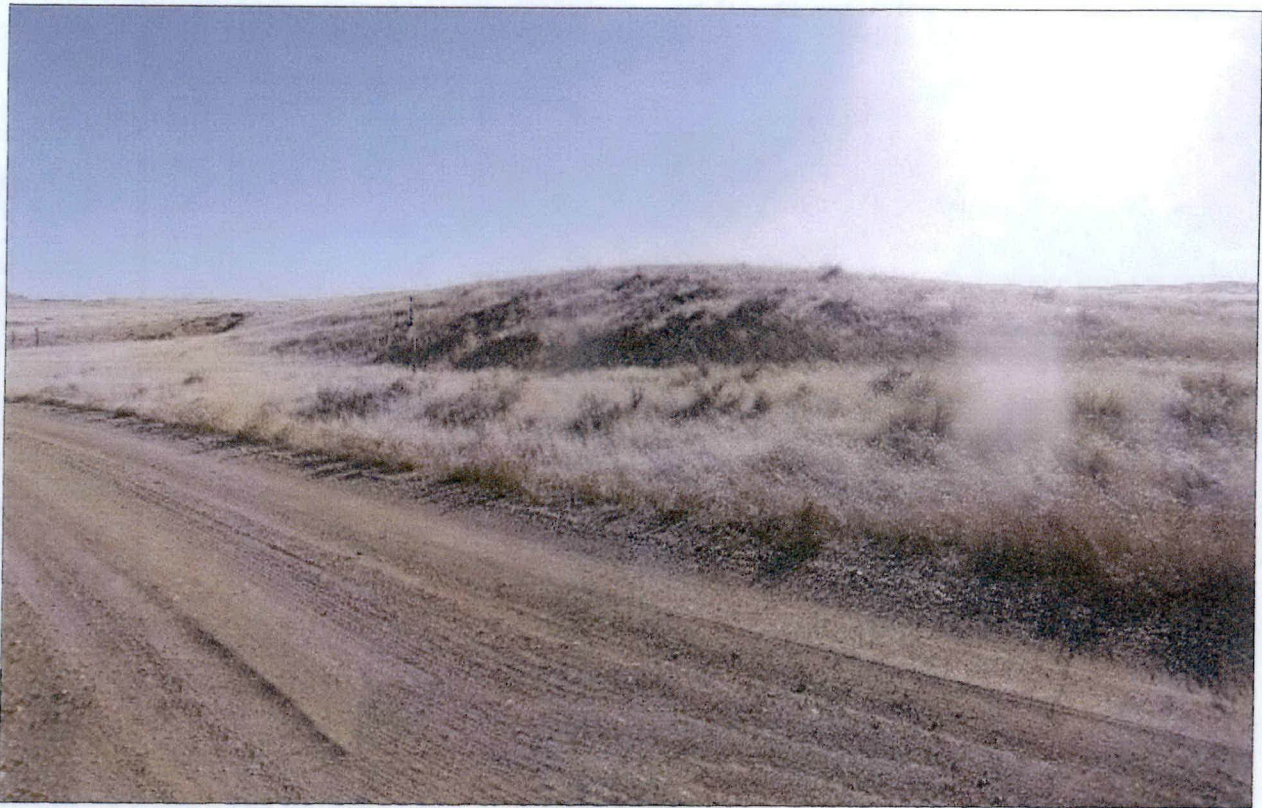
Photo #20: unnamed CR topsoil stockpile by MU4/MU5 access road (43.785218, -106.028453)

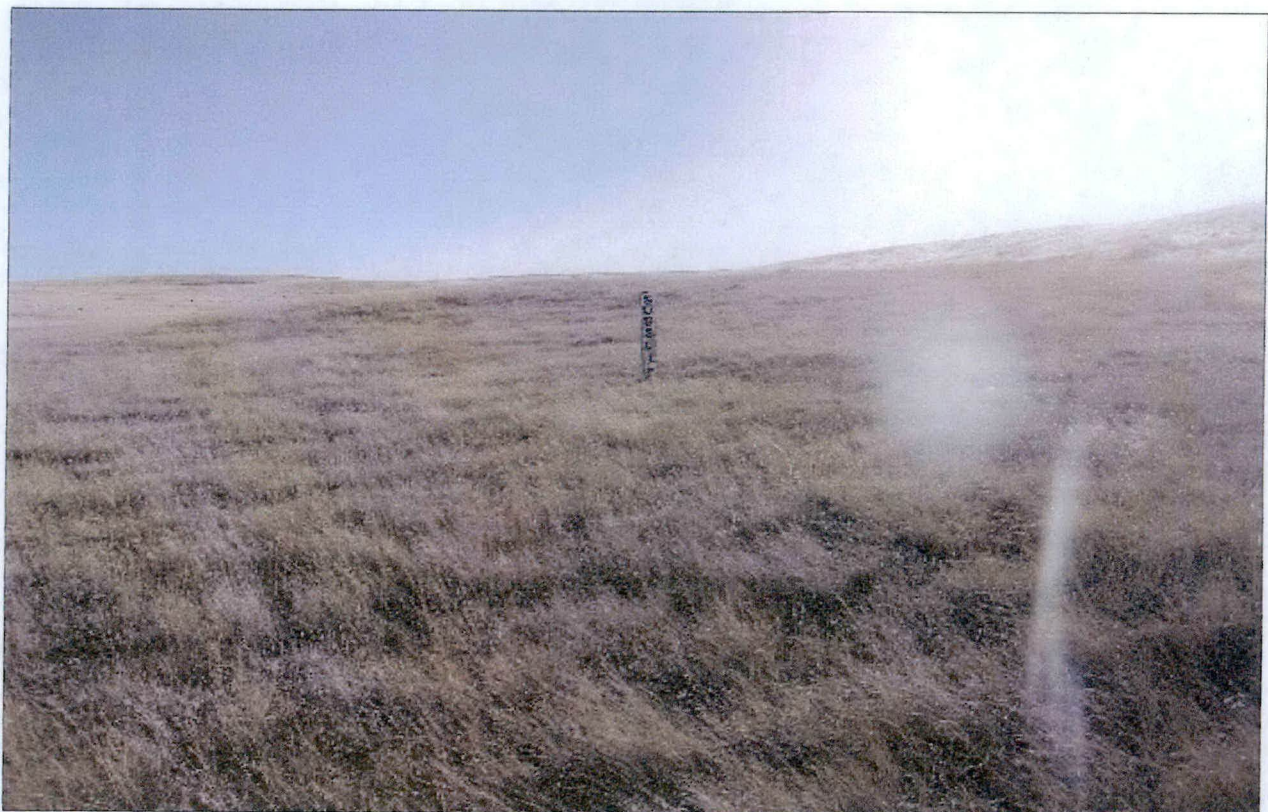
Photo #21: View of CR Subsoil Stockpile #8, typical of subsoil stockpiles viewed.

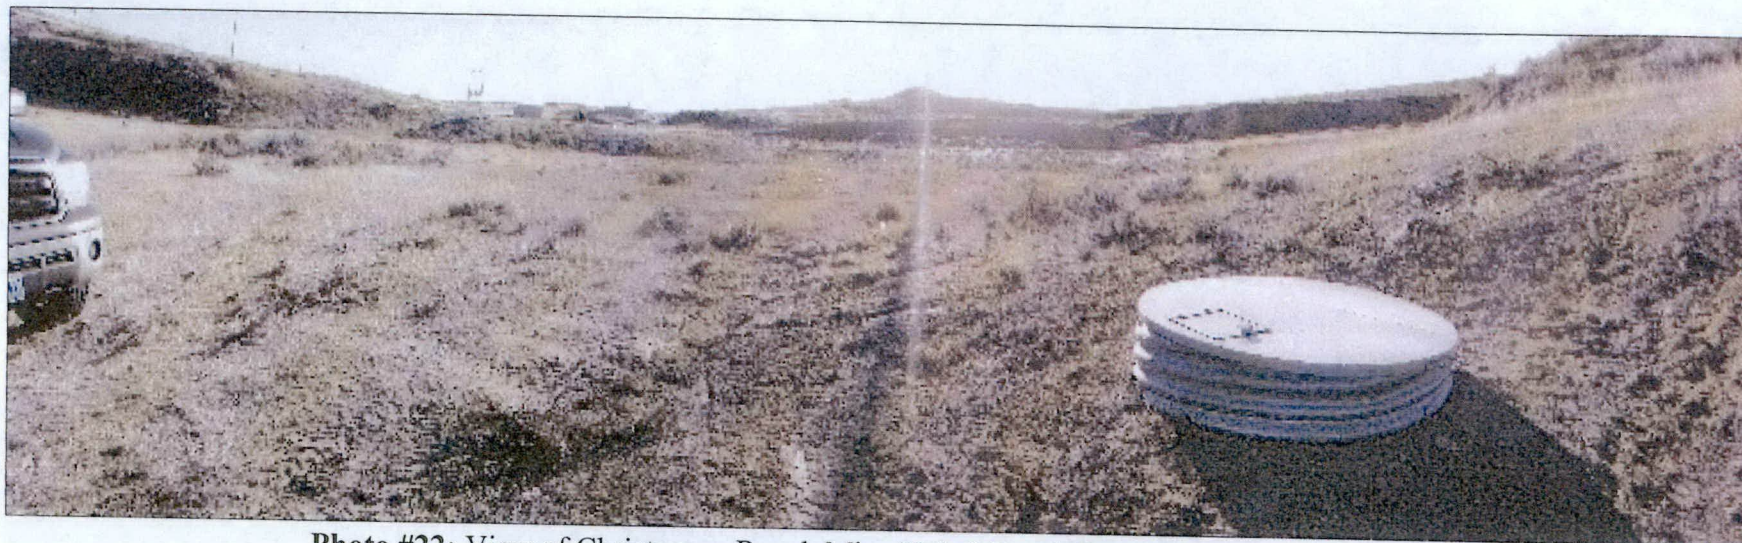
Inspection Topic	In Compliance
• Spills	Yes
<p>In August of 2017 Willow Creek Mine reported a spill from the Mine Unit 2 trunk line where a 10" x 6" poly transition which ties-in Module 2-2 to the Mine Unit 2 trunk line had failed. Groundwater is pumped from this wellfield and conveyed through the trunk line in order to maintain an inward gradient in the wellfield. Assessment of spill impacts and repair of the trunk line had been completed prior to the inspection. The site of the spill and repair was viewed during the inspection and all repair work was observed to be complete (Photo #22). Mine Unit 2 has undergone groundwater restoration efforts and therefore is no longer being mined. Groundwater restoration has not yet been approved by LQD for Mine Unit 2.</p>

Photo #22: View of Christensen Ranch Mine Unit 2 Trunk line spill location and repair.

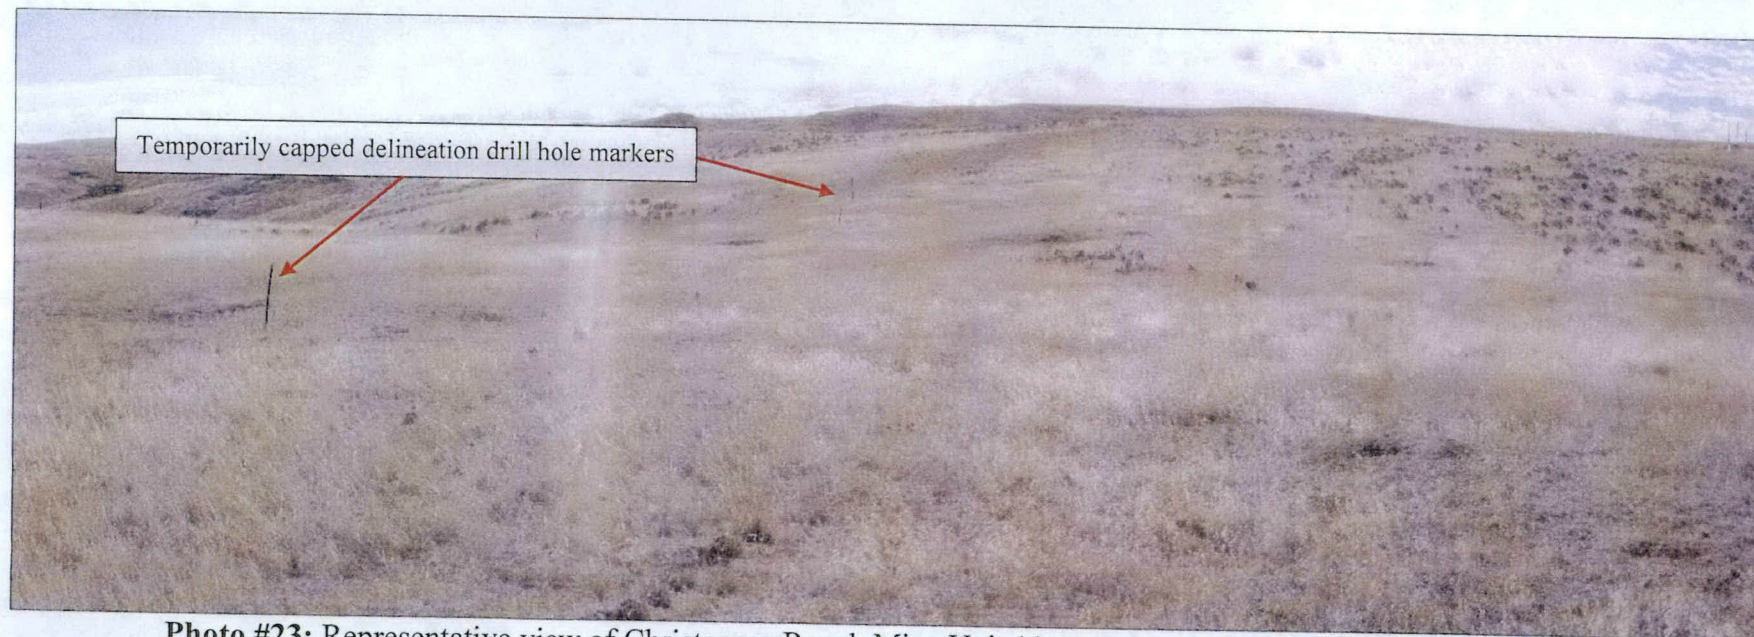
Inspection Topic	In Compliance
Drill Holes	N/A
• Delineation Drilling	Yes
Temporarily capped pilot holes in undeveloped portions of Mine Unit 10 and temporarily capped delineation drilling holes in undeveloped Mine Units 11 & 12 were viewed during the inspection (Photo #23). No issues were identified at the surface with these temporarily capped holes. The reclamation status for the temporarily capped pilot holes in Mine Unit 10 is discussed in Section IV of the Annual Report. However, the reclamation status of temporarily capped delineation holes located in Mine Units 11 & 12 needs to be clarified as was discussed during the inspection. This issue is being addressed under Comment #3 of LQD's Review Memorandum for the 2016-2017 Annual Report (dated 12/15/17), and therefore this issue is not listed under the <i>Actions Required</i> section of this inspection report.	
General	N/A

Photo #23: Representative view of Christensen Ranch Mine Unit 11 temporarily capped delineation drill holes.
