SUBJECT: TRANSMITTAL OF FINAL TURKEY POINT NUCLEAR GENERATING
UNIT NO. 3 ACCIDENT SEQUENCE PRECURSOR REPORT
(LICENSEE EVENT REPORT 250-2017-001)

Final Accident Sequence Precursor Analysis - Turkey Point
Nuclear Generating Station (Unit 3), Loss of 3A 4kV Vital Bus
Results in Reactor Trip, Safety System Actuations, and Loss of
Safety Injection Function (LER 250-2017-001) - Precursor

Accident Sequence Precursor Program – Office of Nuclear Regulatory Research			
Turkey Point Nuclear Generating Station, Unit 3		Loss of 3A 4kV Vital Bus Results in Reactor Trip, Safety System Actuations, and Loss of Safety Injection Function	
Event Date: 3/18/2017		LER: 250-2017-001 IRs: 05000250/2017008 and 05000250/2017002	CCDP = 3×10^{-6}
Plant Type: Westinghouse 3-Loop Pressurized-Water Reactor (PWR) with Dry, Ambient Pressure Containment			
Plant Operating Mode (Reactor Power Level): Mode 1 (100% Reactor Power)			
Analyst: Chris Hunter	Reviewer: Ian Gifford	Contributors: N/A	Approval Date: 02/12/2018

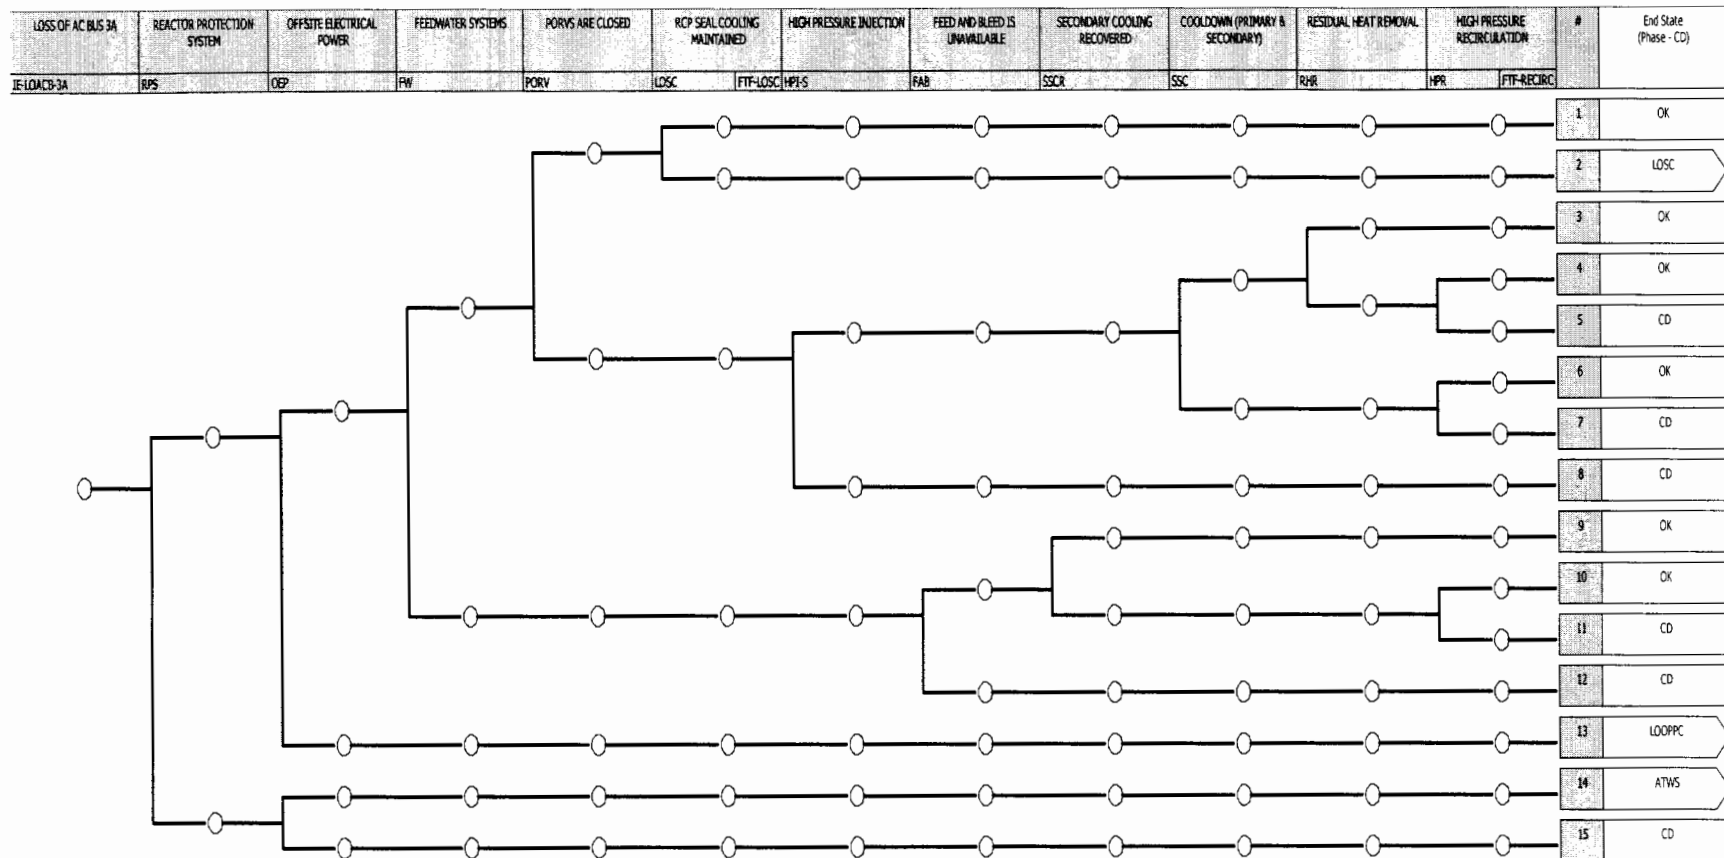
Figure A-1. Turkey Point Loss of 4.16kV Safety-Related Bus 3A Event Tree

Dominant Sequence. The dominant accident sequence is LAC3A sequence 13-16-22 (CCDP = 2.30×10^{-6}), which contributes approximately 71 percent of the total internal events CCDP. The dominant sequences that contribute at least 1.0 percent to the total internal events CCDP are provided in the following table. The dominant sequence is shown graphically in Figures A-1 through A-4 in Appendix A.

Sequence	CCDP	Percentage	Description
LAC3A 13-16-22	2.30E-6	71.4%	Loss of safety-related bus 3A initiating event; successful reactor trip; subsequent loss of bus 3B results in a loss of all safety-related AC power; AFW succeeds; a PORV fails to reclose resulting in a LOCA; all HHSI pumps are unavailable due to no electrical power (Unit 3) or maintenance (Unit 4), which results in core damage
LAC3A 13-16-20	2.68E-7	8.3%	Loss of safety-related bus 3A initiating event; successful reactor trip; subsequent loss of bus 3B results in a loss of all safety-related AC power; AFW succeeds; RCP seal injection/cooling is lost and a subsequent RCP seal LOCA occurs; all HHSI pumps are unavailable due to no electrical power (Unit 3) or maintenance (Unit 4), which results in core damage
LAC3A 02-9-05	1.21E-7	3.8%	Loss of safety-related bus 3A initiating event; successful reactor trip; AFW succeeds; RCP seal injection/cooling is lost and a subsequent RCP seal LOCA occurs due operators failing to trip the RCPs; high-pressure injection succeeds; accumulators successfully inject in the reactor coolant system; secondary-side cooldown fails, and high-pressure recirculation fails resulting in core damage

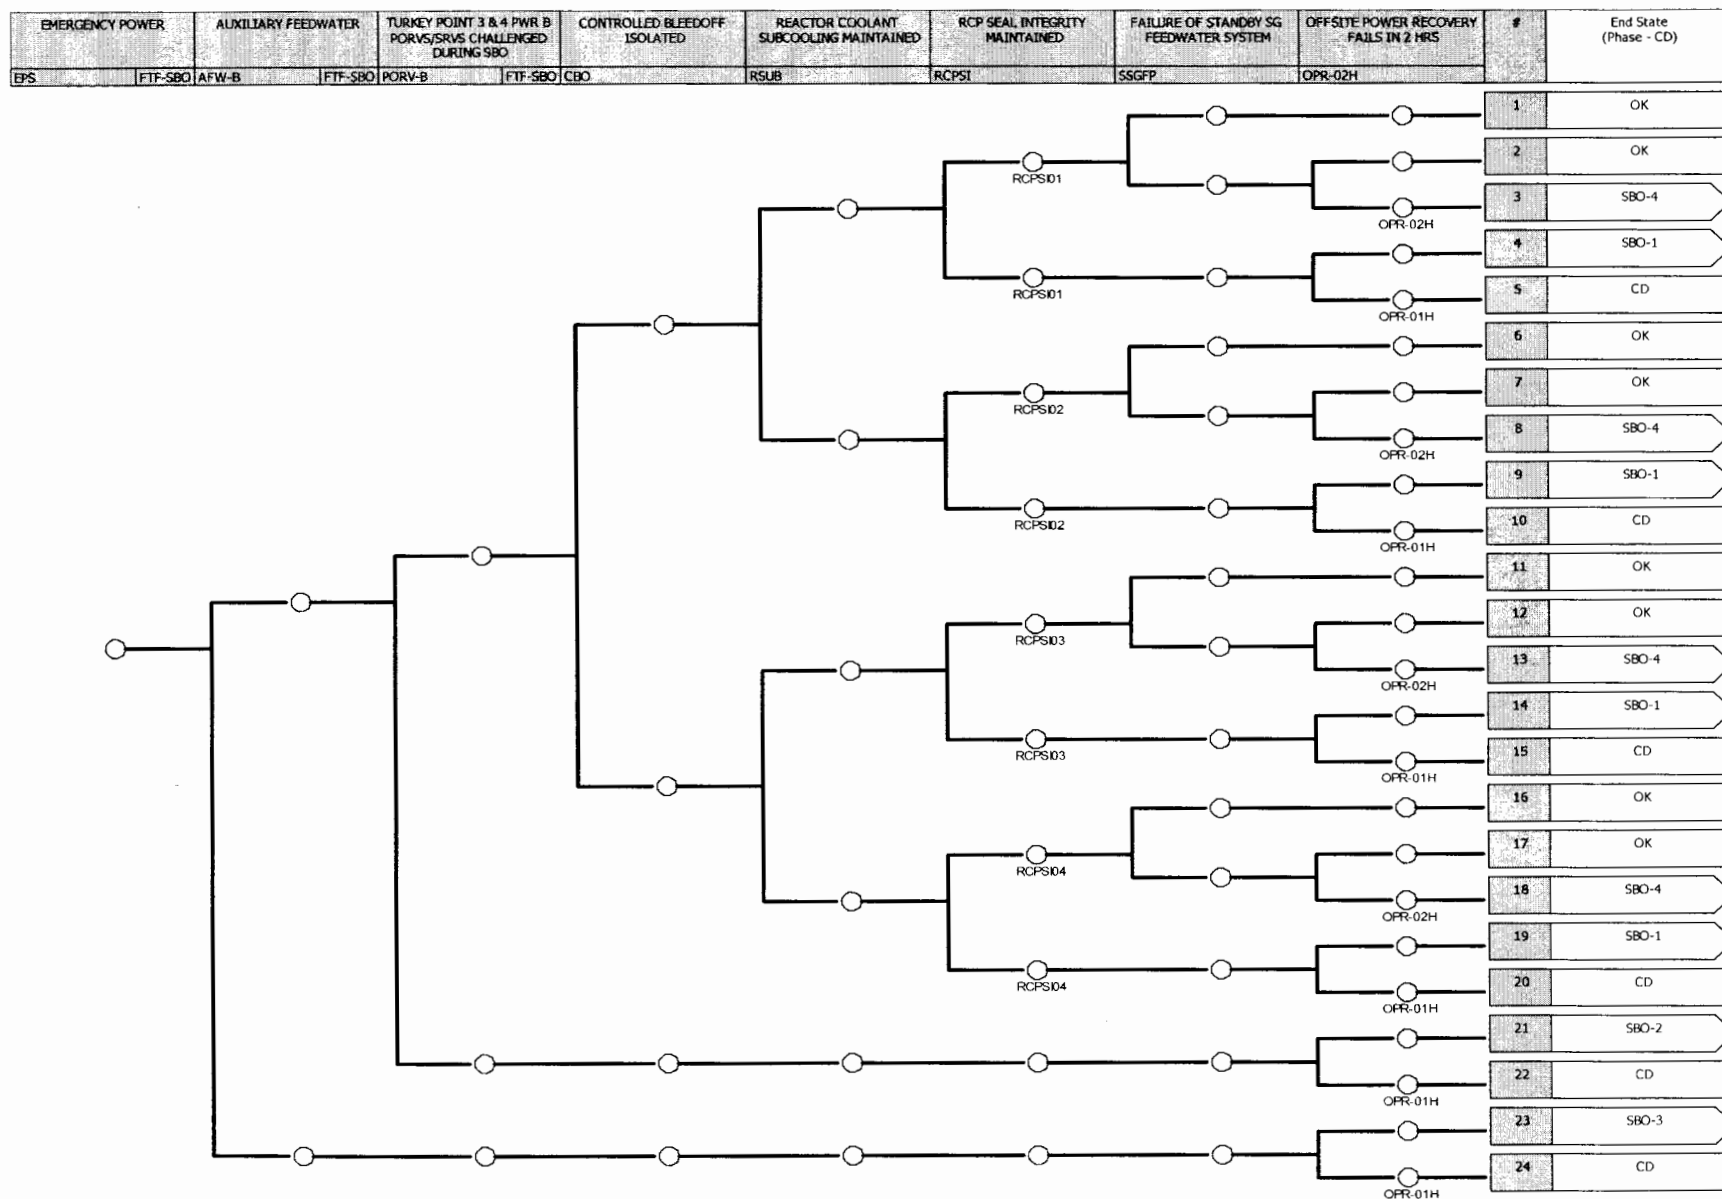
Figure A-3. Modified Turkey Point SBO Event Tree

- In ASP analyses, recovery credit for EDG failures is limited to cases where event information supports credit for EDG recovery. Therefore, the DGR-02H (*diesel generator recovery in 2 hours*) top event (including applicable event tree branching) was eliminated from the station blackout (SBO) event tree. The modified SBO event tree is shown in [Figure A-3](#).

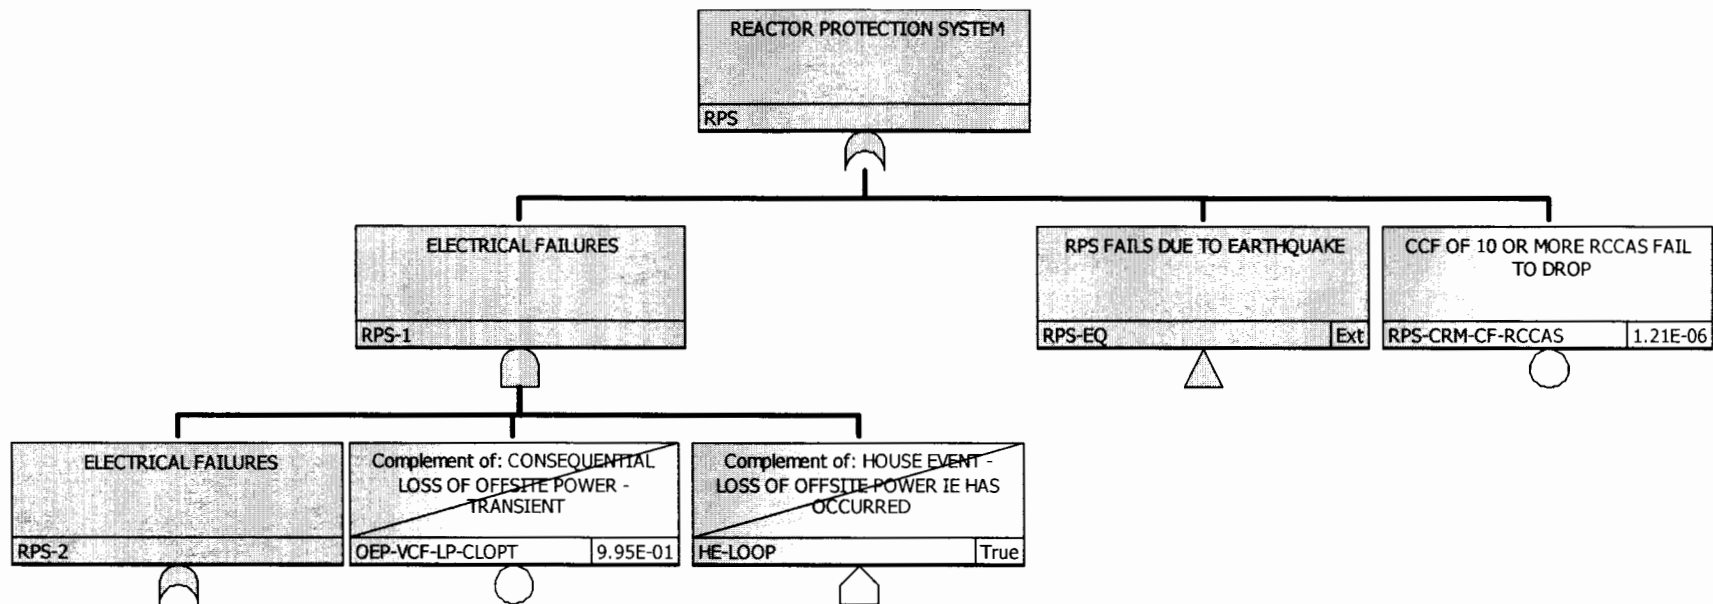
Figure B-1. Modified Turkey Point RPS Fault Tree

- To prevent risk contributions from certain anticipated transient without scram (ATWS) cut sets that do not apply to this assessment, the complement basic event OEP-VCF-LP-CLOPT (*consequential loss of offsite power—transient*) was inserted under gate RPS-1 (*electrical failures*) in the RPS (*reactor protection system fault tree*). An ATWS is only possible during a consequential loss of offsite power (LOOP) if the rods fail to insert into the reactor (i.e., they are mechanically stuck). The modified RPS fault tree is shown in [Figure B-1](#).

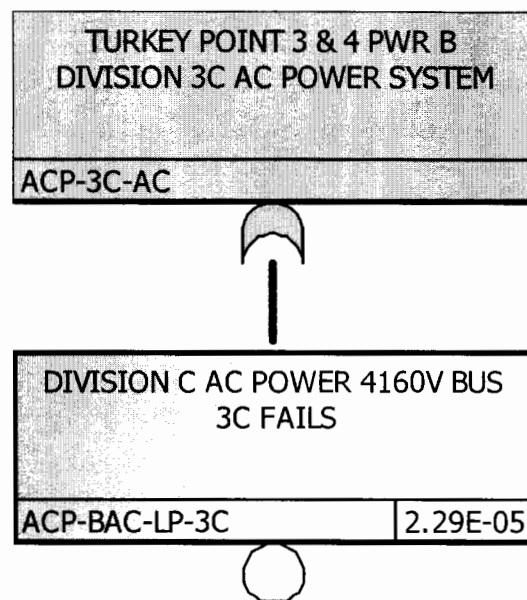
Figure B-2. Modified Turkey Point ACP-3C-AC Fault Tree

- During the event, nonsafety-related AC bus 3C remained energized and, therefore, the motor-driven standby SG feedwater pump was available to provide inventory makeup to the SGs. This pump would also be available for the dominant (postulated) scenarios in this analysis (i.e., loss of all safety-related 4.16 kV power). To ensure that credit for this pump is provided in this analysis, basic events HE-LOOP (*house event—loss of offsite power initiating event has occurred*) and HE-LOSP-3C (*loss of division 3C offsite power flag*) were deleted from the ACP-3C-AC (*Turkey Point 3 and 4 PWR B division 3C AC power system*) fault tree. The modified ACP-3C-AC fault tree is shown in [Figure B-2](#).
