# **Industry Response to Flowserve Part 21 on Anchor Darling Double Disk Gate Valves and NRC Staff Next Steps**

Public Meeting  
February 15, 2018

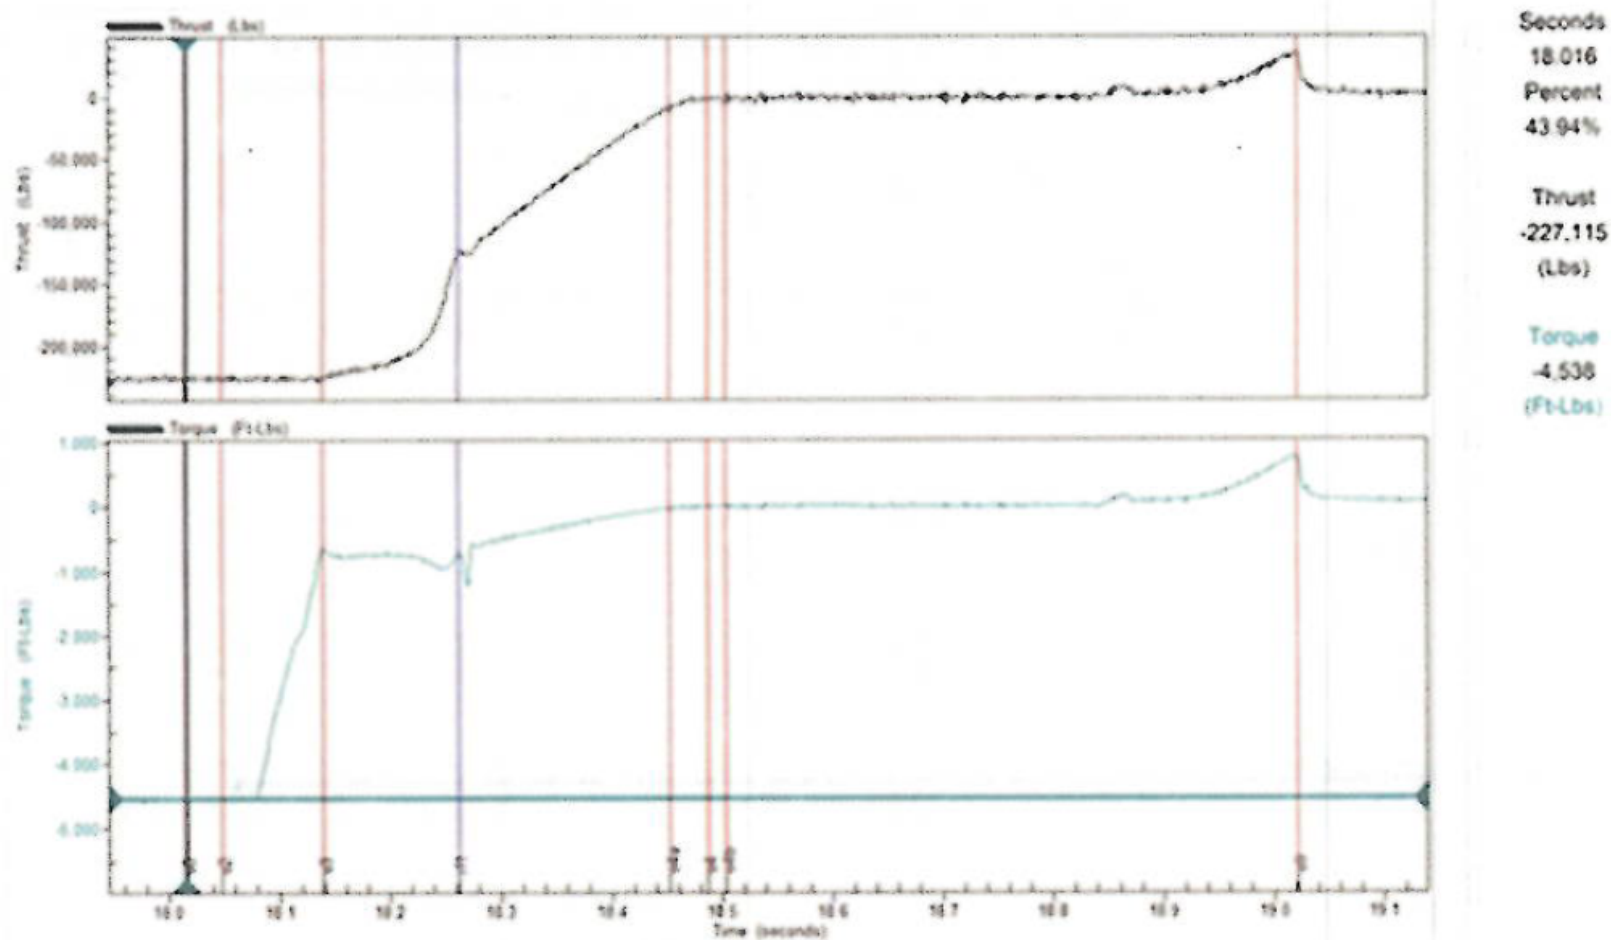
**2E22-F004 - As-Left**  
02/05/2015 05:40:14 File 150361004

# **Example of Diagnostic Test Inability to Conclusively Determine Degradation of Stem-to-Wedge Connection**

## LaSalle Unit 2 Anomaly 2015 - Example used in BWROG Guide as Active Stem-to- Wedge Connection Degradation

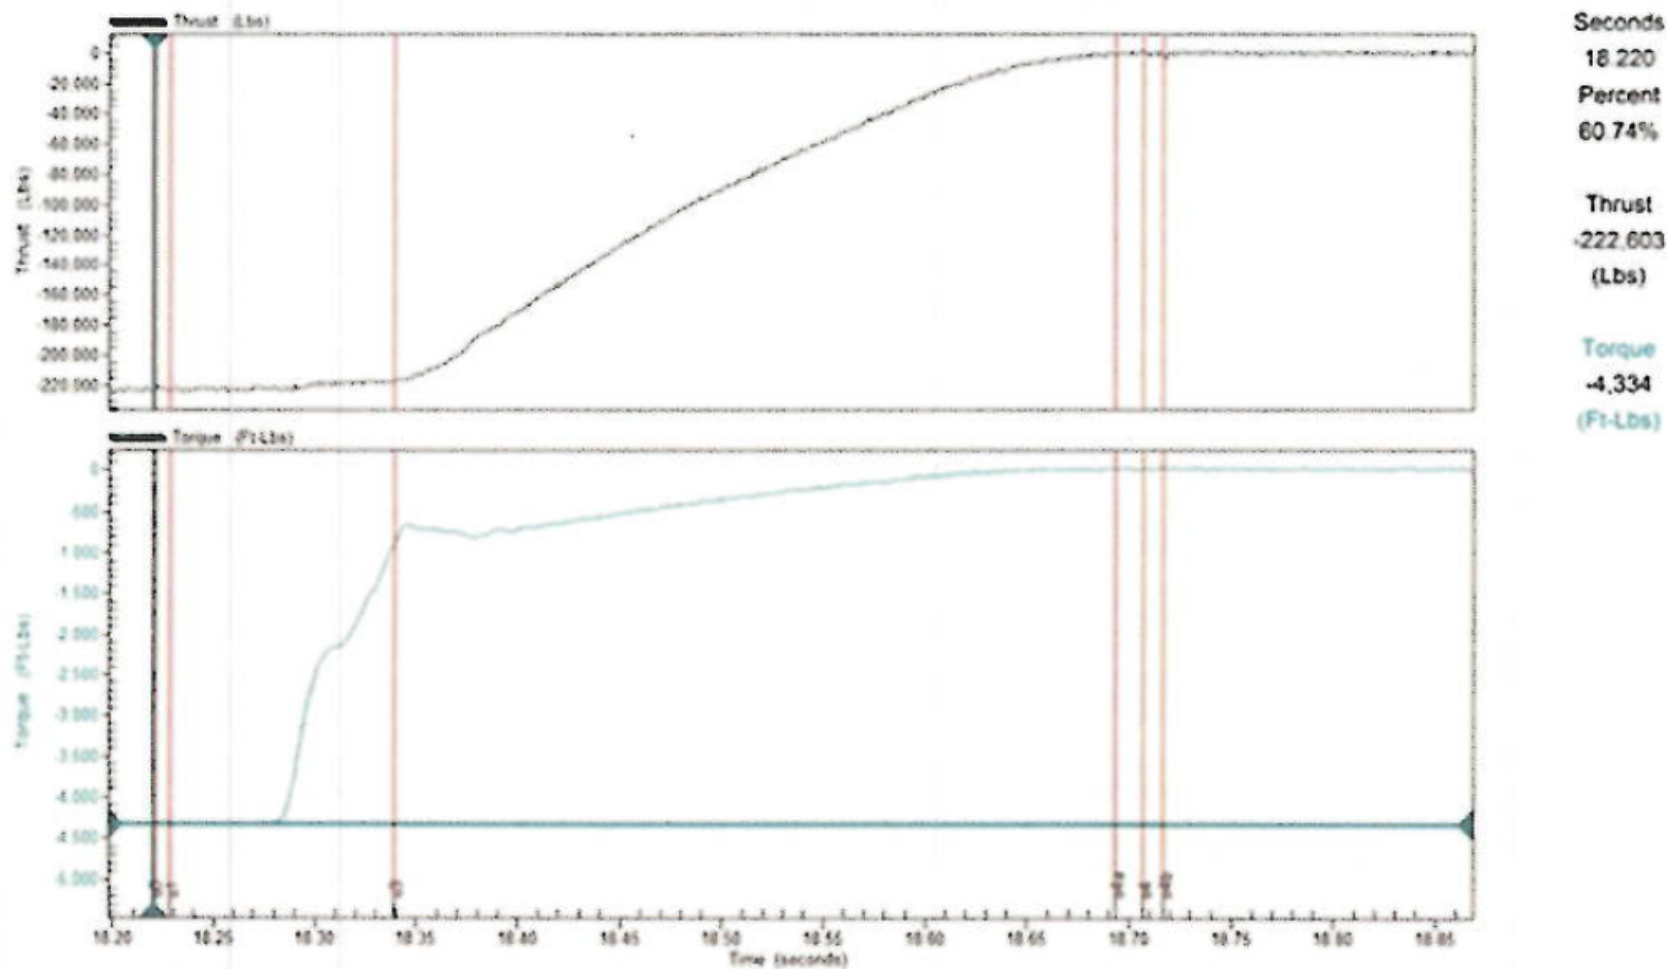
**2E22-F004 - As-Left**

# LaSalle Unit 2 As Left Thrust/Torque Trace After Rework

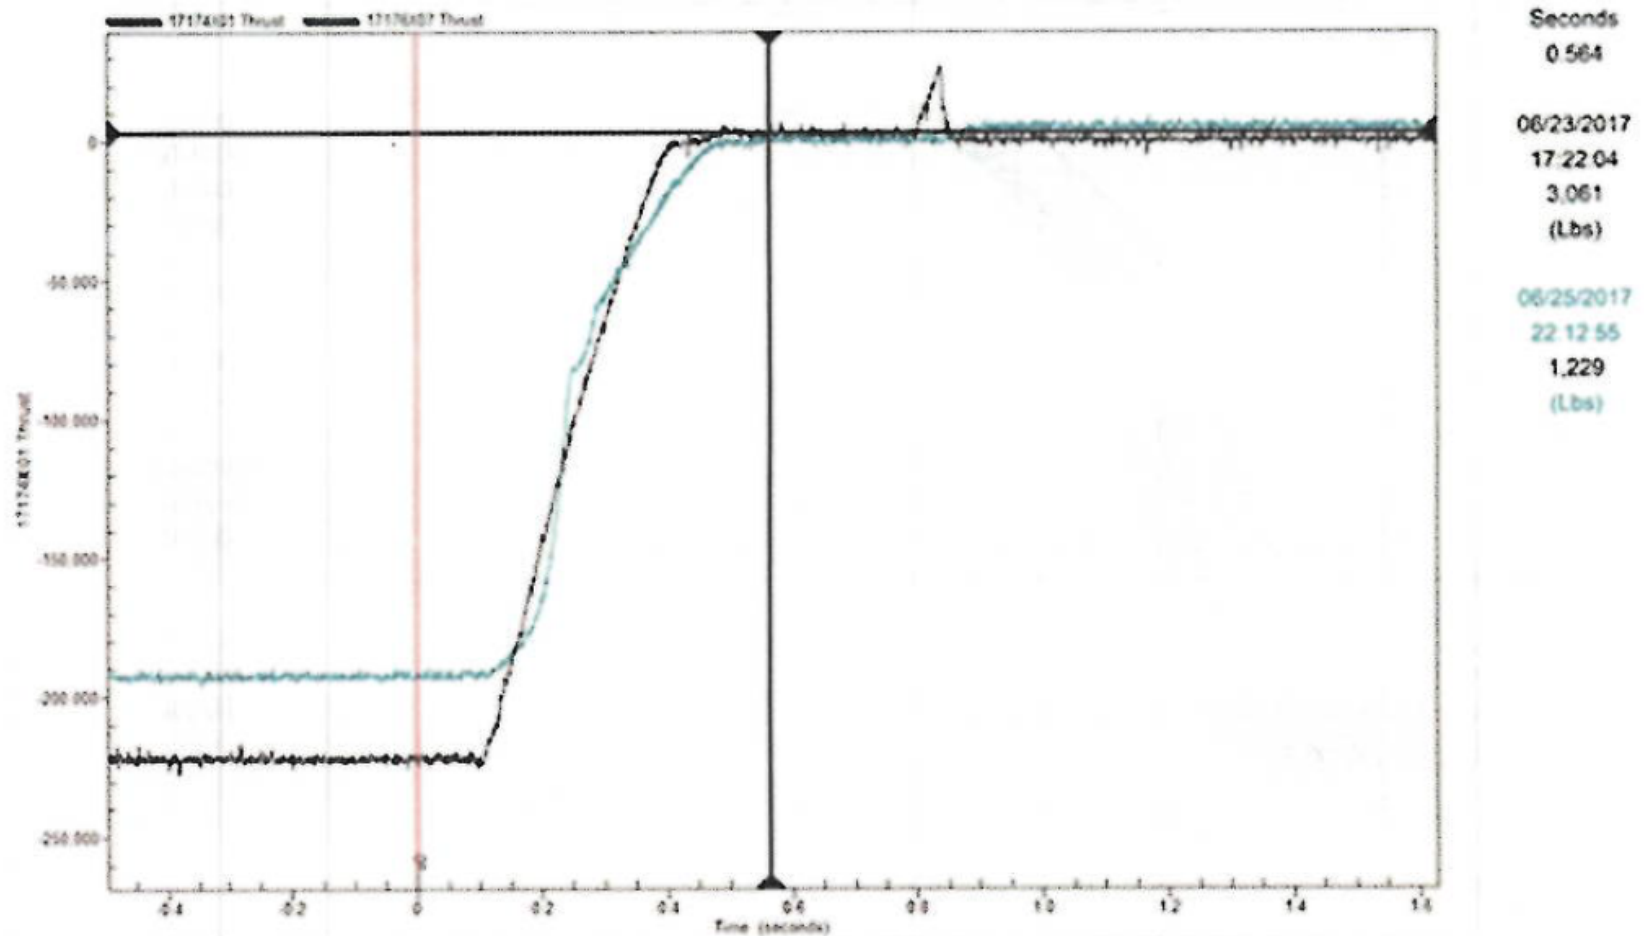
## Recent MOV Rework As-Found-Left Thrust Trace

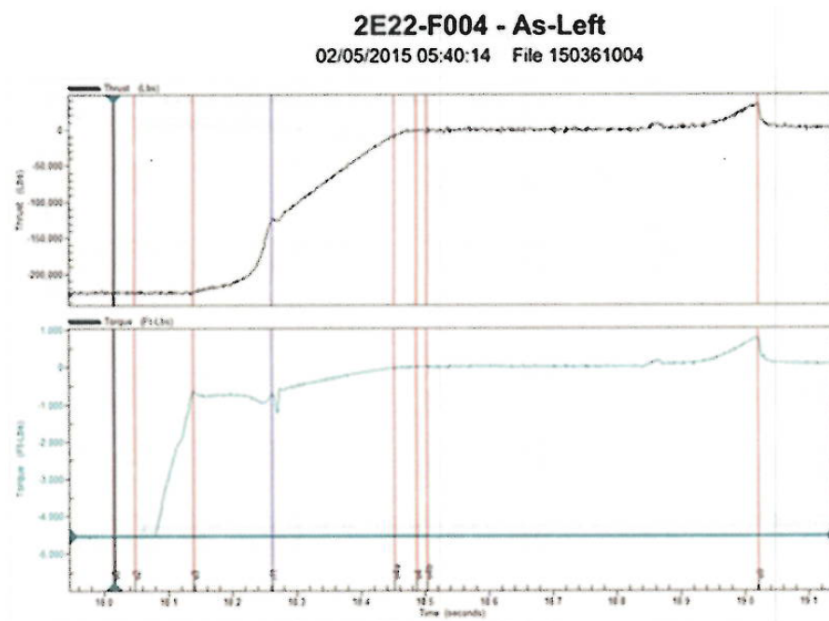
### Unit 2 Anomaly

## LaSalle Unit 2 Anomaly Compared to Recent MOV Post Rework Trace

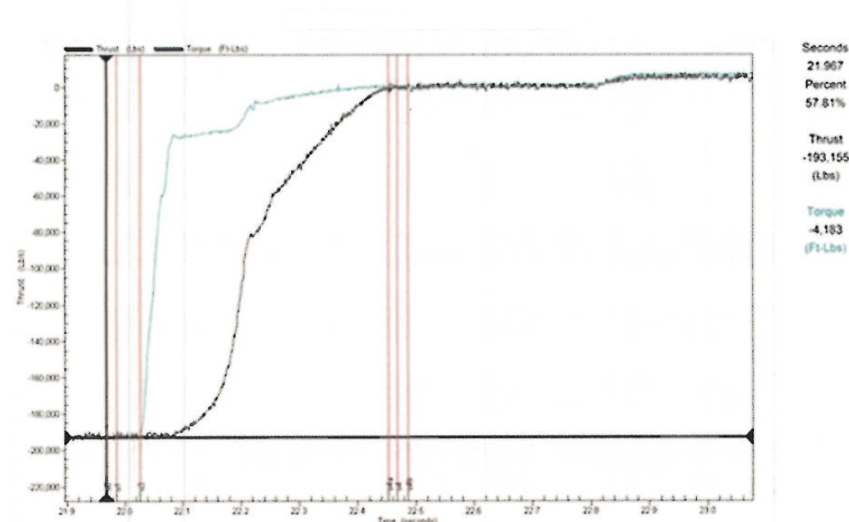
### Recent MOV Post Rework As Left Torque & Thrust Trace
