*DALISADES AUXILIARY FEEDWATER
NOZZLE GRINDOUTS*

SS-31
CALCULATION NO.

CONSUMERS POWER
CUSTOMER

STEAM GENERATOR
COMPONENT

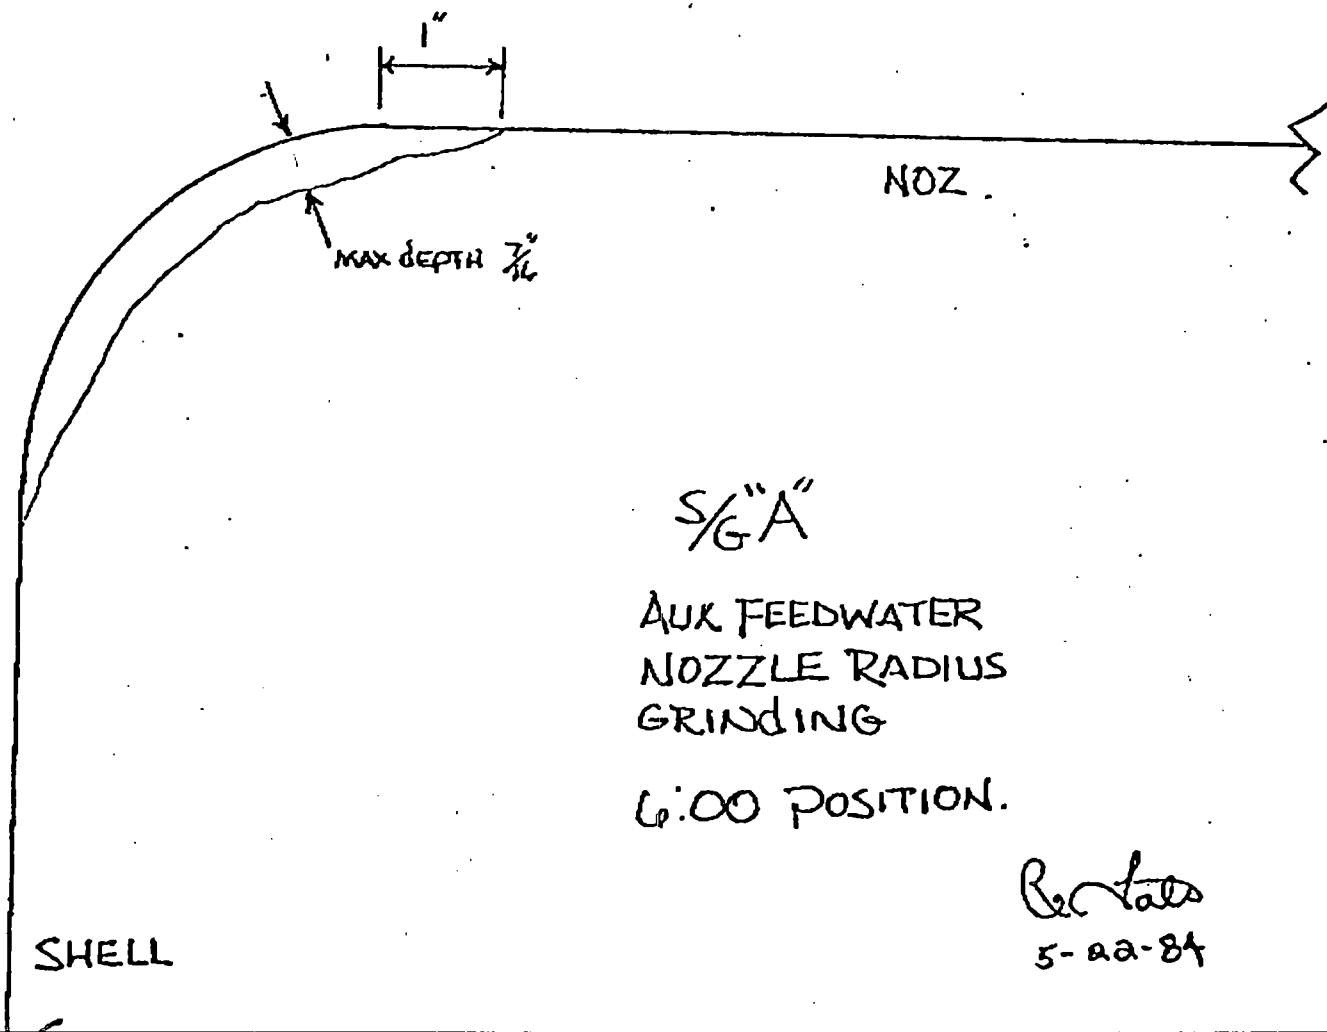
S/G "A"
AUX FEEDWATER
NOZZLE RADIUS
GRINDING
6:00 POSITION.

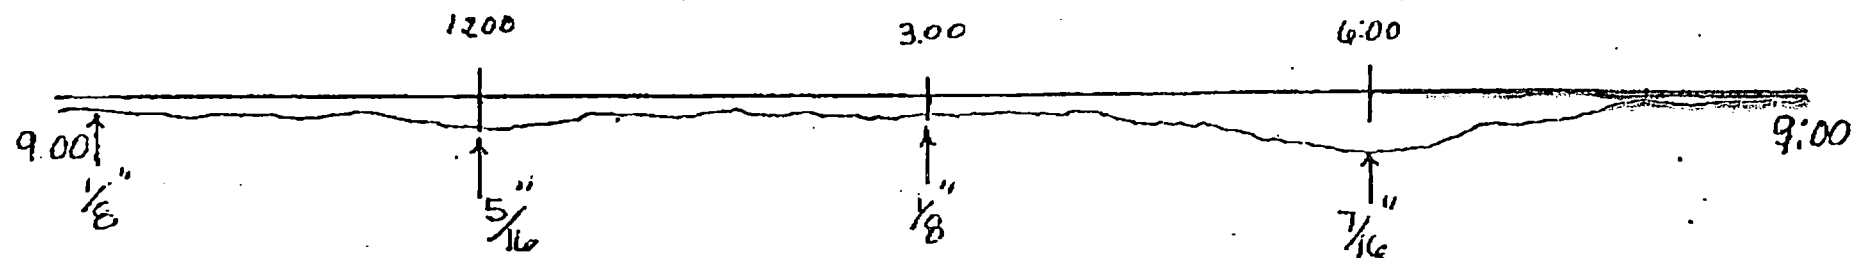
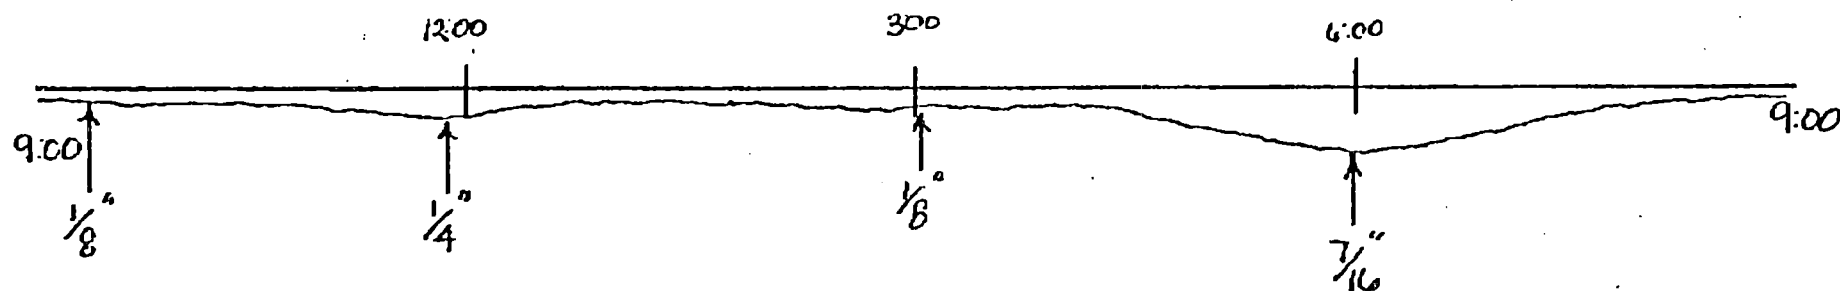
S/G "B"

GRINDING DEPTHS ARE MAX. DEPTH AT LOCATION INDICATED.
NO LOCAL GRINDOUTS EXIST AS THE TOTAL RADIUS SURFACE
WAS GROUND WITH TAPERED TRANSITION BETWEEN
HIGH AND LOW AREAS.

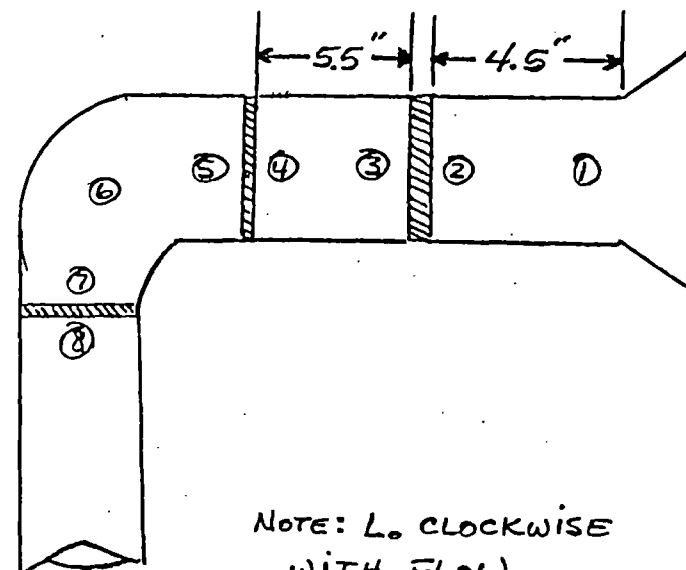
S/G 'B'

NOTE: L. CLOCKWISE
WITH FLOW

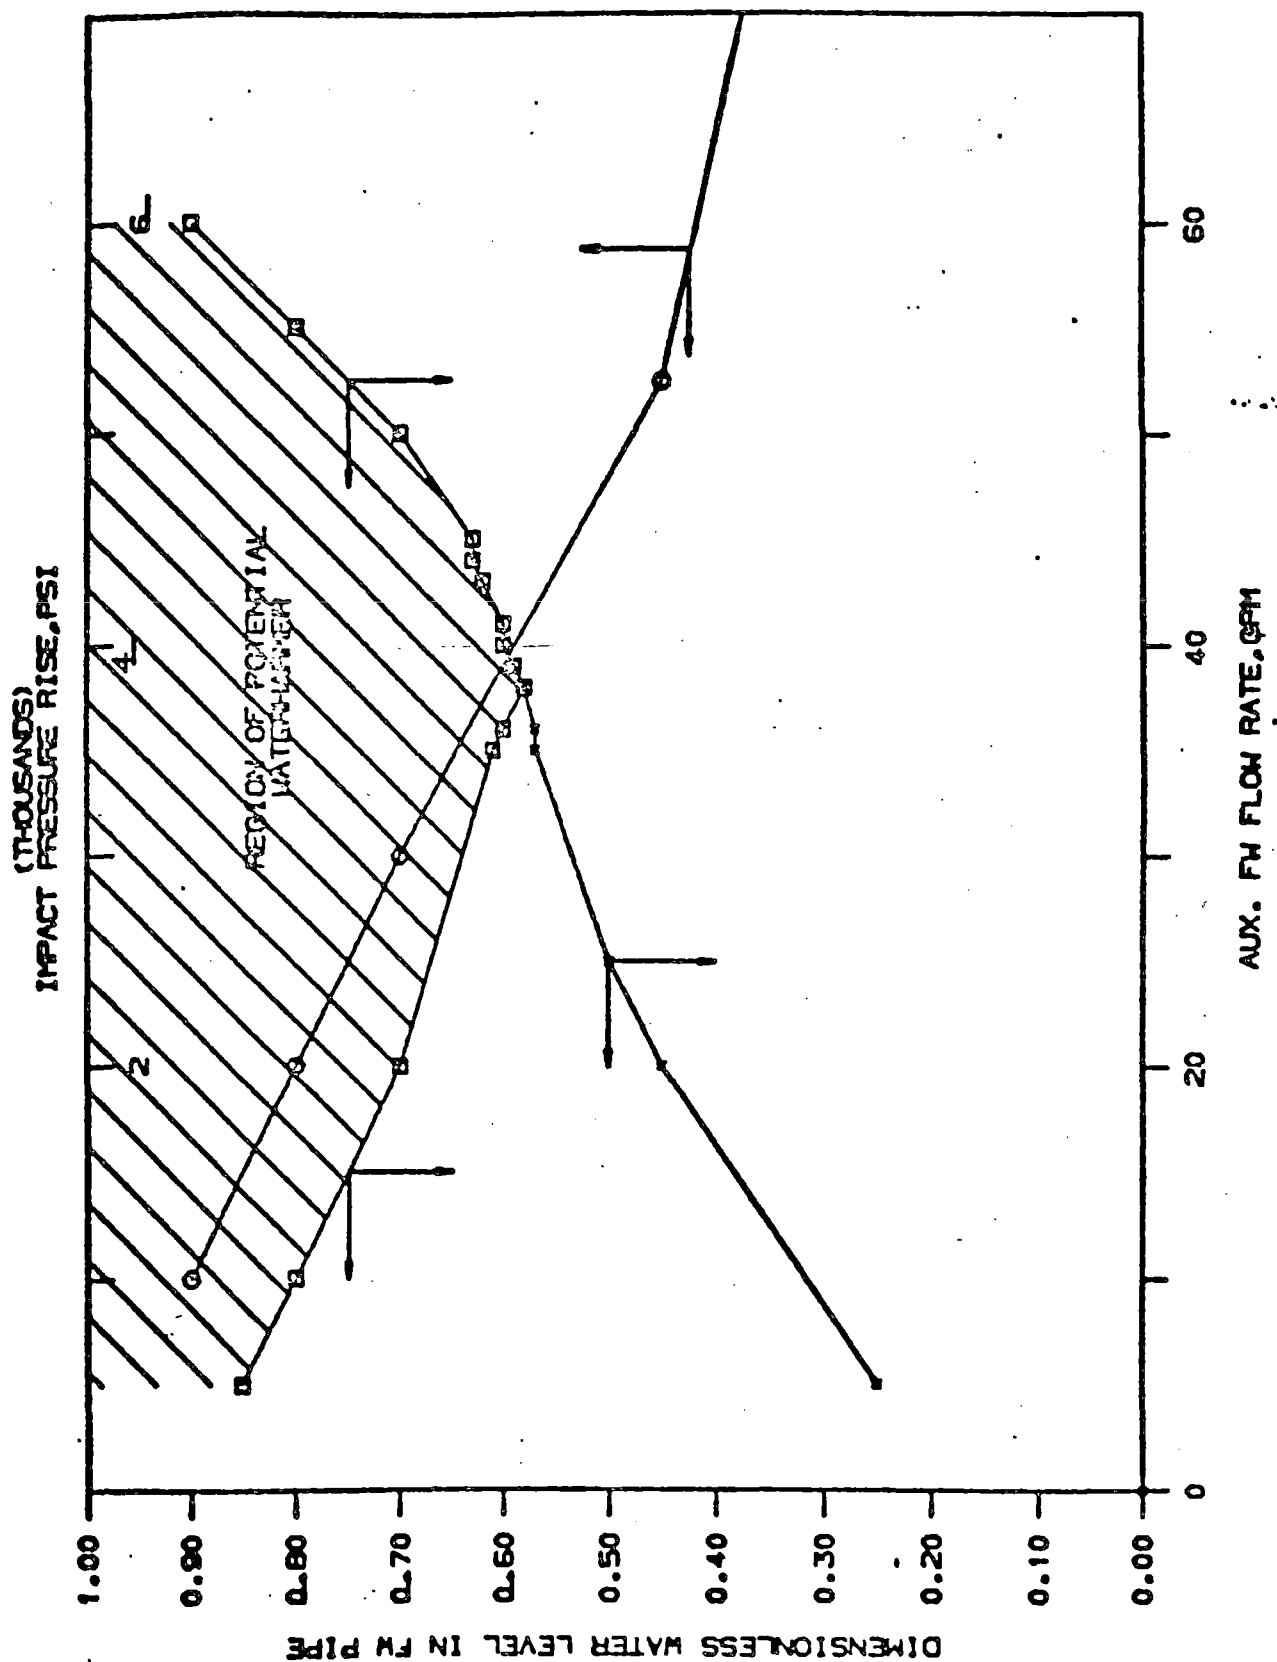
PALISADES REGION OF POTENTIAL WATERHAMMER AND IMPACT PRESSURE RISE RELATION

The most severe waterhammer is predicted to occur when the pipe is approximately 60% full. Under these conditions, a worst case waterhammer of approximately 4000 psi is predicted. If wave formation occurs at higher or lower water levels within the pipe, and/or flow rates are either smaller or greater, the predicted pressure pulse is reduced significantly. This has prompted C-E to recommend that an interim minimum auxiliary flow restriction of 70 gpm be placed on plant operations when the level in the steam generator is below the top of the auxiliary feedwater nozzle. Both tests and analytical calculations indicate that, for this flow, the sleeve will flow full, thus preventing the formation of a steam pocket which must be present before waterhammer can occur.

As shown on the attached figure there is a theoretical possibility of water hammer over a range of flows of 5 gpm (when the auxiliary feedwater nozzle is being recovered) to 60 gpm. The recommended operational restriction is 70 gpm.

Based on reported operators' recollections, waterhammer (when it was observed) occurred at flow rates of 30 to 40 gpm and ceased when the flow rate was increased to 50 gpm. This is in excellent agreement with our calculations as shown on the attached figure. Based on the operators' observations the actual upper limit for observable water hammer to occur may be approximately 50 gpm.

If a flow rate less than 70 gpm occurs at a steam generator level below 60% (NR) the flow rate should be promptly increased to greater than 70 gpm, or terminated.
