NRC FORM 464 Part I (03-2017)	U.S. NUCLEAR REGULATORY COMMISSION RESPONSE TO FREEDOM OF INFORMATION ACT (FOIA) REQUEST	FOIA 2018-000304	RESPONSE NUMBER 1

Operating Experience Note

End of Cycle Operating Experience Update, 2018

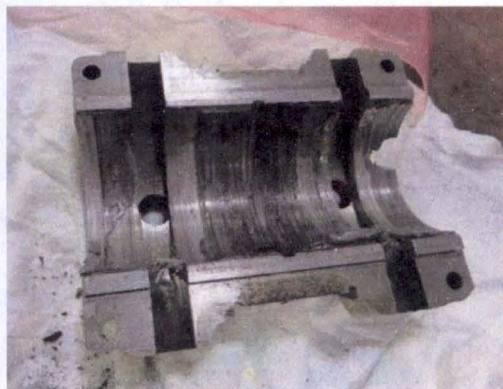
Figure 1: Davis Besse Failed Inboard Bearing

On September 13, 2017, during an auxiliary feedwater pump (AFW) quarterly surveillance run, the licensee at Davis Besse noted high temperatures on the AFW turbine inboard bearing. Operators tripped the pump, and investigation revealed bearing damage, which was attributed to a lack of lubrication caused by insufficient level in the oil reservoir. The staff issued an Operating Experience [OpE Communication](#) (COMM) describing the event at Davis Besse. The COMM includes discussions of other similar events where oil levels in various components were inaccurately indicated on sight glasses for a variety of different reasons.

The minimum level mark on the sight glass was lower than what was described in the vendor manual. Operators had recently drained 10-11 ounces from the oil reservoir for a sample. Since level was still above the low level mark on the sight glass, they did not replenish the oil. This caused oil level to remain below that required for the turbine's slinger rings to effectively lubricate the inboard bearing, and resulted in excessive bearing damage (see figure 1).

A review of the vendor guidance for the AFW pump and turbine revealed specific instructions for setting the oil sight glass minimum and maximum levels. The band described in the guidance required oil level to read higher on the sight glass, and required oil level to be maintained within a tighter band

- Evidence that the licensee's methods for assuring proper oil level using a sight glass is based on procedural guidance and vendor recommendations, and limits reliance on skill of the craft or other operator workarounds.
- Potential leaks from oil sight glasses.
- Sight glasses that may have been installed upside down, rendering the level markings inaccurate.
- Air flow in the vicinity of sight glass vents which can cause erroneous level readings.

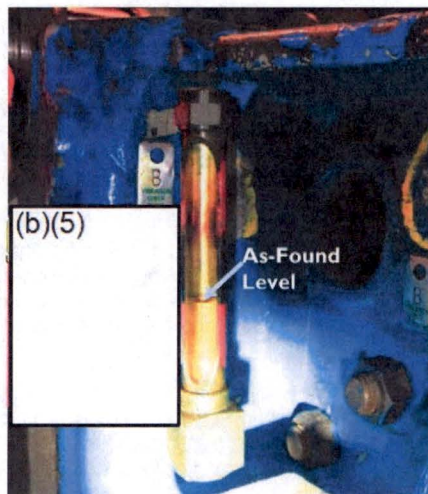
Figure 2: Davis Besse As-Found Oil Level

- ANO-2 (2016) - EDG inboard generator bearing failed from lack of lubrication. The sight glass was inverted by workers during post-surveillance reinstallation which led to low oil level.
- Hope Creek (2009) - HPCI booster pump outboard bearing oil level was below the minimum level mark with oil leaking from the sight glass housing threaded connection. Procedural guidance and other operator aids were insufficient to ensure proper oil level was maintained.
- Beaver Valley (2001) - AFW pump outboard bearing oil level sight glass did not have sufficient markings for high/low oil level.

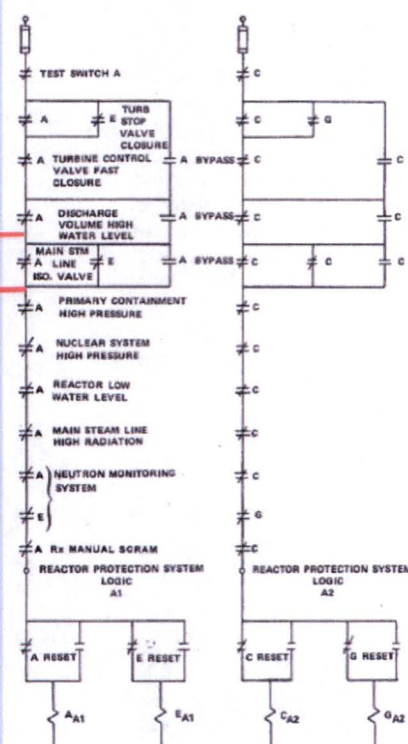
Figure 3: Fermi-2 RPS Trip System Logic Showing Location of RPT Test Box for MSIV Surveillance Testing

When used in MSIV and TSV RPS logic surveillances, the RPS Test Box is installed across contacts that are arranged in parallel (see Figure 3). Doing so removes multiple contacts from the circuit, and impacts the ability to meet the TS requirement for both trip systems to have each channel associated with the MSIVs in 3 main steam lines either operable or in trip, or for both trip systems associated with the TSVs to have 3 channels either operable or in trip. With the RPS Test Box installed across multiple contacts, 2 of 4 main steam lines become inoperable, rendering the MSIV closure function (and similarly for the TSV closure function) not maintained. This requires the licensee to enter a TS Condition requiring

action to restore trip capability within one hour. In the case of Fermi, the test box was installed for less than an hour, but the licensee did not enter the TS Condition. At Oyster Creek, the licensee had the RPS Test Box installed for greater than the one hour allowed by TS.

For most BWRs, use of the RPS Test Box is a change in testing that requires a formal 10 CFR 50.59 evaluation. Following its realization that use of the RPS Test Box would require entry into a TS action statement for trip functions involving parallel logic strings, Fermi-2 revised its procedures to discontinue use of the RPS Test Box. IOEB staff is drafting an information notice on this issue.

- Did the change require a 50.59 evaluation and was the evaluation performed?
- Whether use of the RPS Test Box involves bypassing any contacts that are arranged in parallel.
- Whether the plant should be entering any TS conditions when using the RPS Test Box
- (b)(4) licensee is aware of (b)(4) along with existing industry OpE related to use of the RPS Test Box.

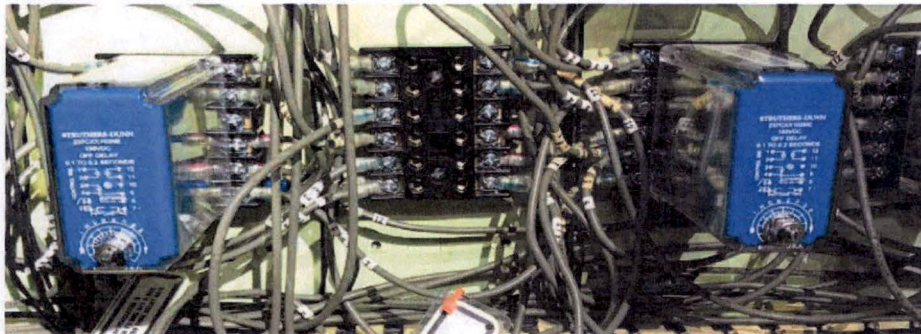
Figure 4: Image of Struthers-Dunn Relays Installed at Waterford 3

The root cause for the failure of the fast transfer of electrical loads from the UATs to the startup transformers was the failure of the installed Struthers-Dunn time-delay relays in the fast transfer circuitry. When the UATs lost power, the subsequent de-energization of the 152X relay produced a large change in voltage that, because surge suppression was not utilized, caused the Struthers-Dunn relays to instantaneously time out and open their contacts. The absence of any time-delay prevented the fast bus transfer to the startup transformers. The Struthers-Dunn relays were installed during the licensee's April 2017 refueling outage. Prior to their installation, Allen Bradley time-delay relays were used, which contained integrated surge suppression. The surge suppression allowed the Allen Bradley time-delay relays to mitigate the voltage transient produced by the 152X relay, which permitted the fast bus transfer to operate successfully.

The licensee considered the root cause of the fast bus transfer failure to be a deficient design change modification implemented on the fast bus transfer circuitry to replace the Allen Bradley time-delay relays with Struthers-Dunn time-delay relays. That design change did not consider surge suppression as a critical relay characteristic. Commercial grade dedication, including the importance of considering all of a component's critical design characteristics, is discussed in two recent NRC Information Notices:

- Inspectors can follow up on their licensee's disposition of industry operating experience and NRC generic communications pertaining to electrical connections.
- Inspectors can review their licensee's commercial grade dedication program. A good question to ask is how does the licensee ensure that they are including all critical characteristics when performing like for like piece-part replacements.

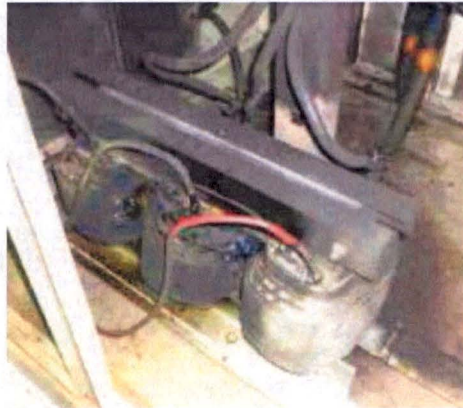
Figure 5: Failed PPT at Wolf Creek

In October 2014, during a 24-hour surveillance test, Wolf Creek's 'B' EDG tripped due to a fire in the electrical excitation control cabinet. The source of the fire was the power potential transformer (PPT). The PPT became overloaded because of two failed diodes in the EDG's current transformer (CT). When these diodes failed, the current boost to the EDG excitation field was reduced, and the voltage regulator compensated by increasing the output of the PPT. This exceeded the load capability of the PPT, and over time it eventually failed. The CT diodes had likely failed during a previous surveillance run in June 2014. Operators had noticed smoke coming from the PPT during interim monthly runs, but it wasn't until the 24-hour endurance run that conditions worsened to the point of PPT overheating and failure. The licensee had planned to replace the PPT in August 2014, but the replacement was delayed until February 2015.
