# 2017 Annual Site Inspection and Monitoring Report for Uranium Mill Tailings Radiation Control Act Title I Disposal Sites

March 2018

**2017 Annual Site Inspection and Monitoring Report  
for  
Uranium Mill Tailings Radiation Control Act  
Title I Disposal Sites**

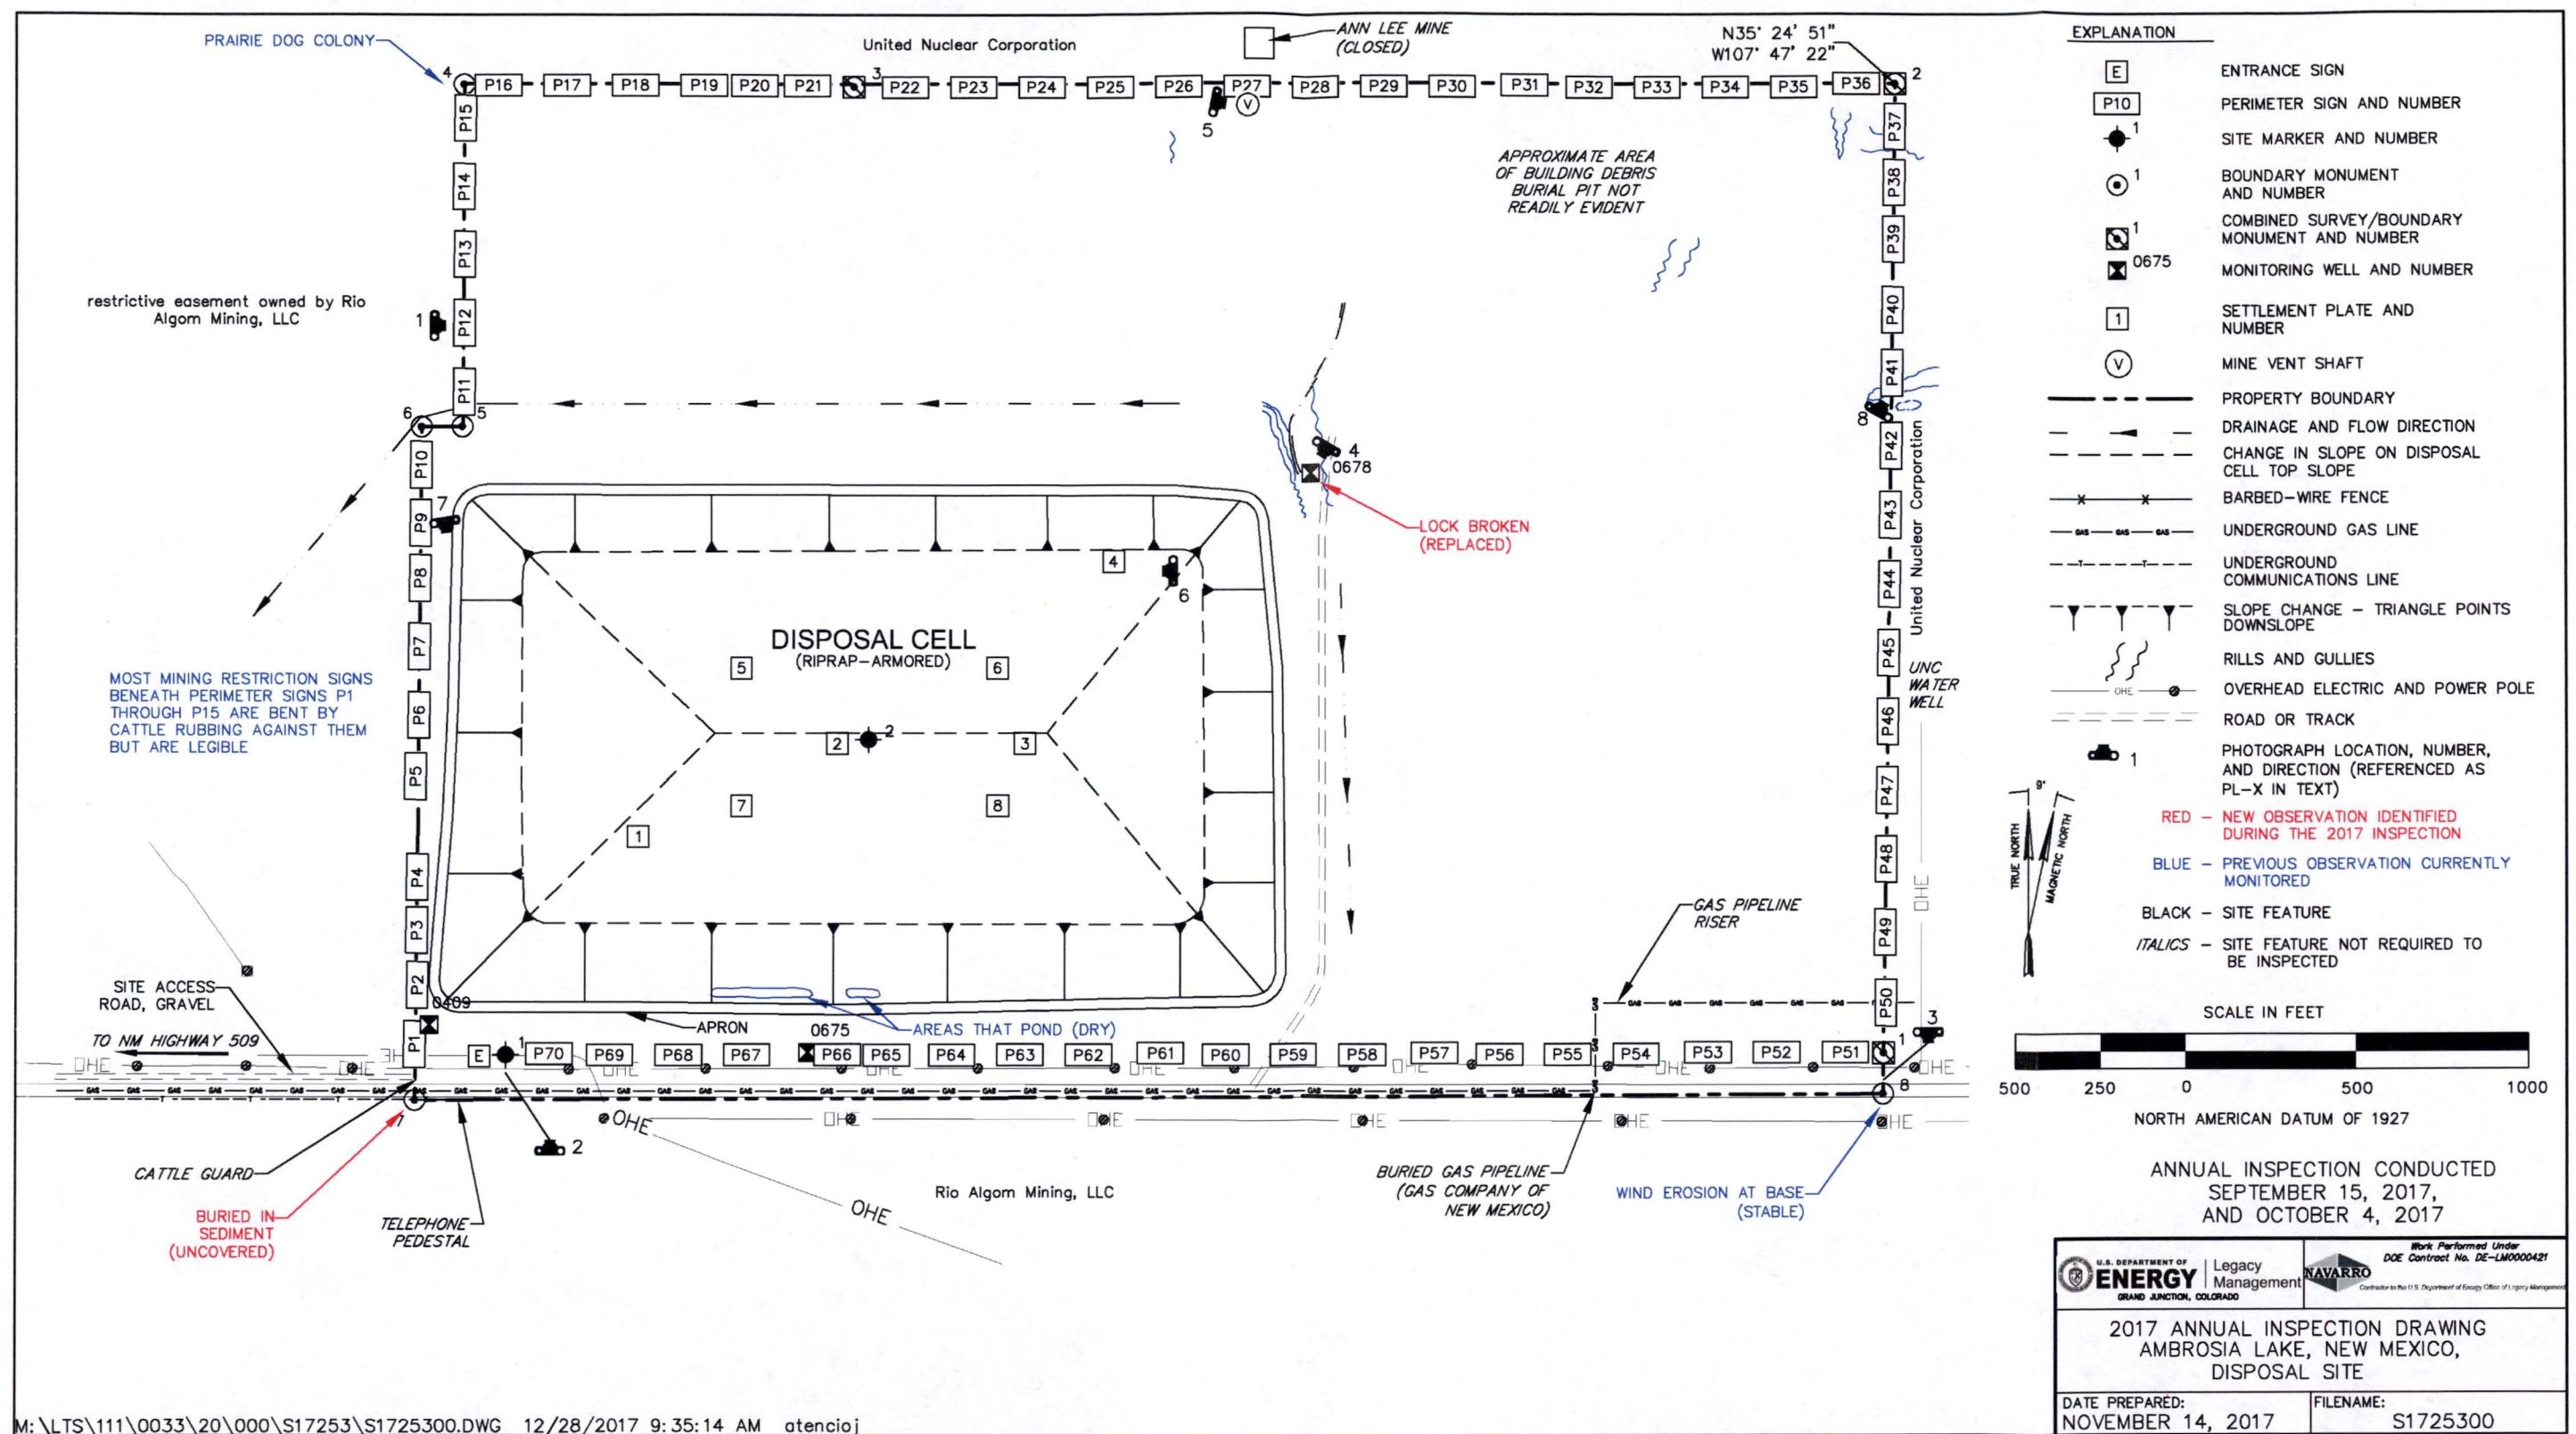
Figure 1-1. 2017 Annual Inspection Drawing for the Ambrosia Lake, New Mexico, Disposal Site

Three combined survey and boundary monuments and five additional boundary monuments delineate the property corners and boundary. Erosion has occurred around the base of boundary monument BM-8, but the monument is stable (PL-3). Boundary monument BM-7 was covered with sediment but was located. It is recommended that steel T-posts be installed next to boundary monuments to help inspectors locate them; this will be completed during the 2018 annual inspection. No other maintenance needs were identified.

The site has three monitoring wells. Gully formation adjacent to monitoring well 0678 appears to be stable, and the well is not affected by the erosion (PL-4). The lock on monitoring well 0678 was broken and was replaced during the inspection. All wellhead protectors observed during the inspection were undamaged and properly labeled. No other maintenance needs were identified.

The disposal cell, completed in 1994, occupies 91 acres. The disposal cell is armored with basalt riprap to control erosion. The top slope showed no evidence of cracking, slumping, or erosion, and there was no indication of riprap degradation. A shallow depression around settlement plate SP-4, near the northeast corner of the disposal cell cover, was first noted during the 1997 inspection and continued to grow in depth and area in subsequent years. The depression was repaired in August 2005. Visual observations during the 2017 inspection indicate that very minor settlement may have occurred since the depression was repaired (PL-6). Inspectors will continue to monitor this area.

The basalt riprap-covered side slopes and apron showed no evidence of erosion, settling, slumping, or cracking (PL-7). Standing water is occasionally observed in a portion of the south apron, but the area was dry during the inspection. This location is the topographic low spot along the base of the disposal cell, and rainfall runoff collects in this area. No maintenance needs were identified.

A broken lock was found on monitoring well 0678 and replaced during the inspection. Boundary monument BM-7 was covered with sediment, but the monument was uncovered during the inspection. It is recommended that steel T-posts be installed next to boundary monuments to help inspectors locate them; this will be completed during the 2018 annual inspection. No other maintenance needs were identified.

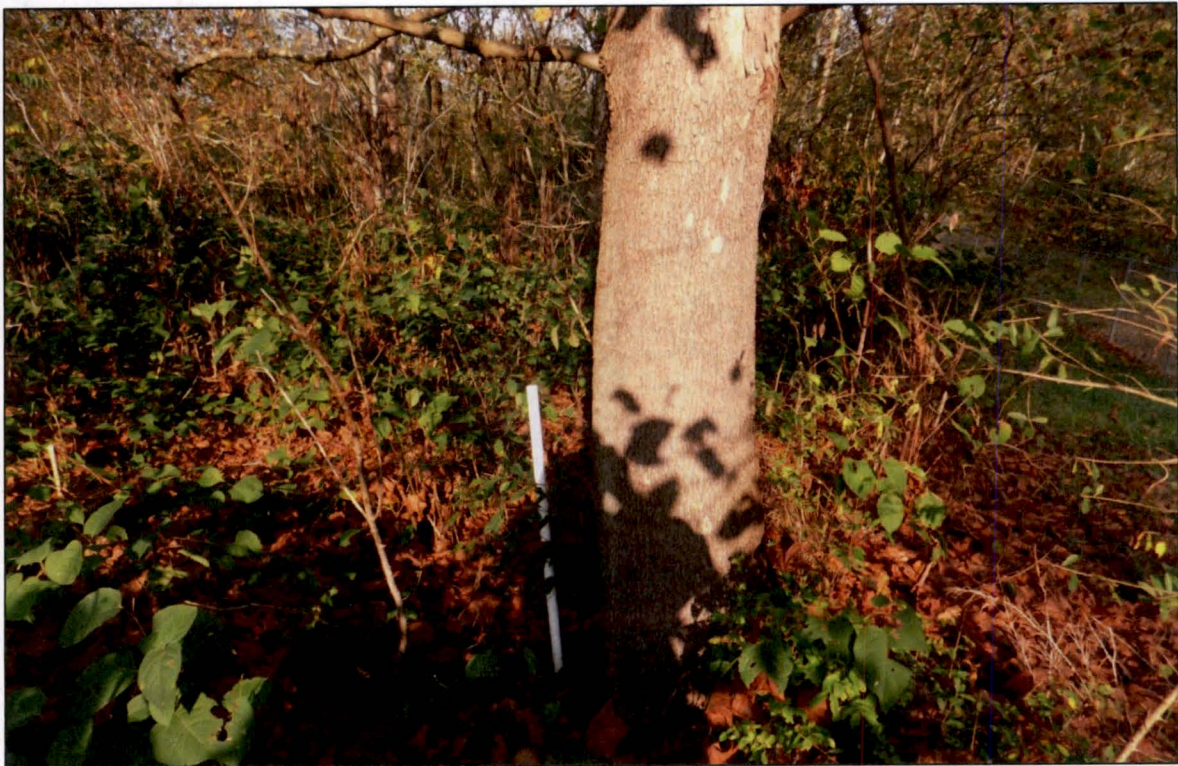
The site has three survey monuments and seven boundary monuments. White PVC pipe is installed at survey monuments SM-100 and SM-101 to aid in their location (PL-5). Even with the use of GPS coordinates and a metal detector, survey monument SM-102 could not be located during the inspection. Survey monument SM-102 will be replaced before the 2018 annual inspection; no other maintenance needs were identified.

*PL-5. PVC Pipe Marking Location of Survey Monument SM-100*

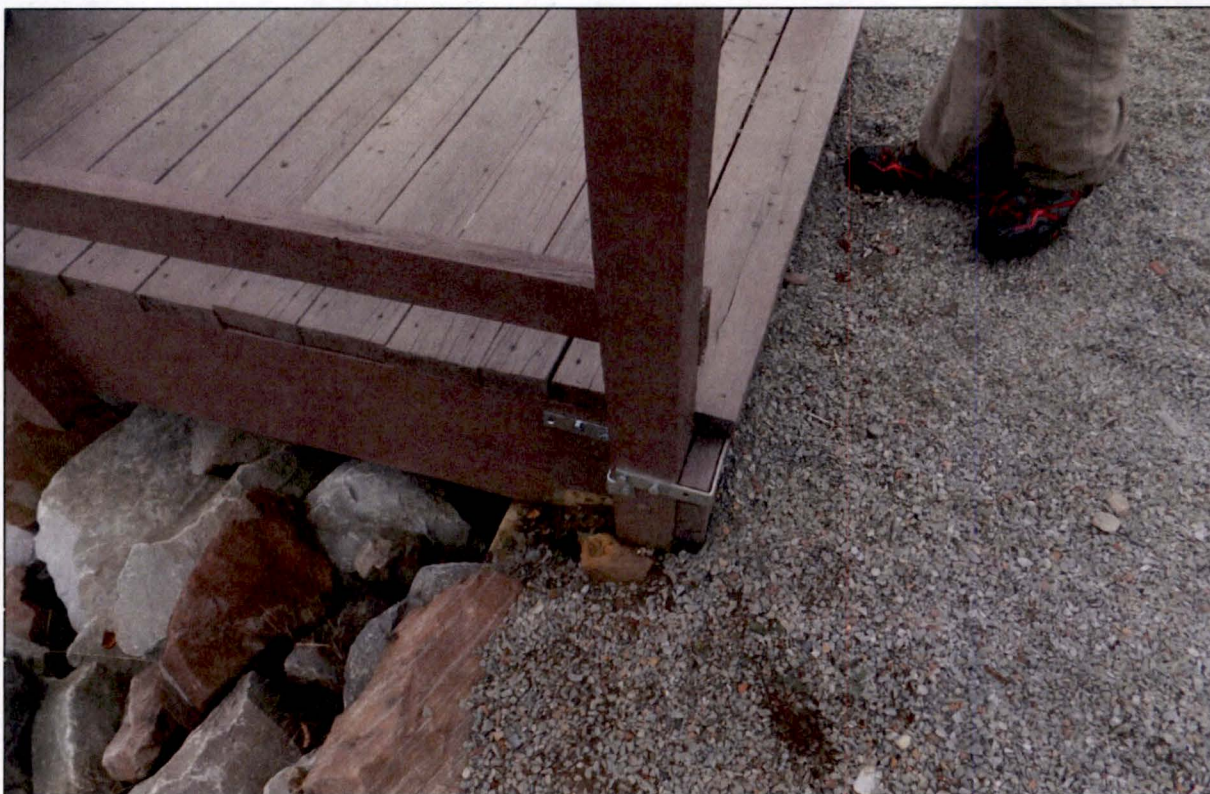
*PL-9. Temporary Footbridge Repair to Northwest Rail Support*

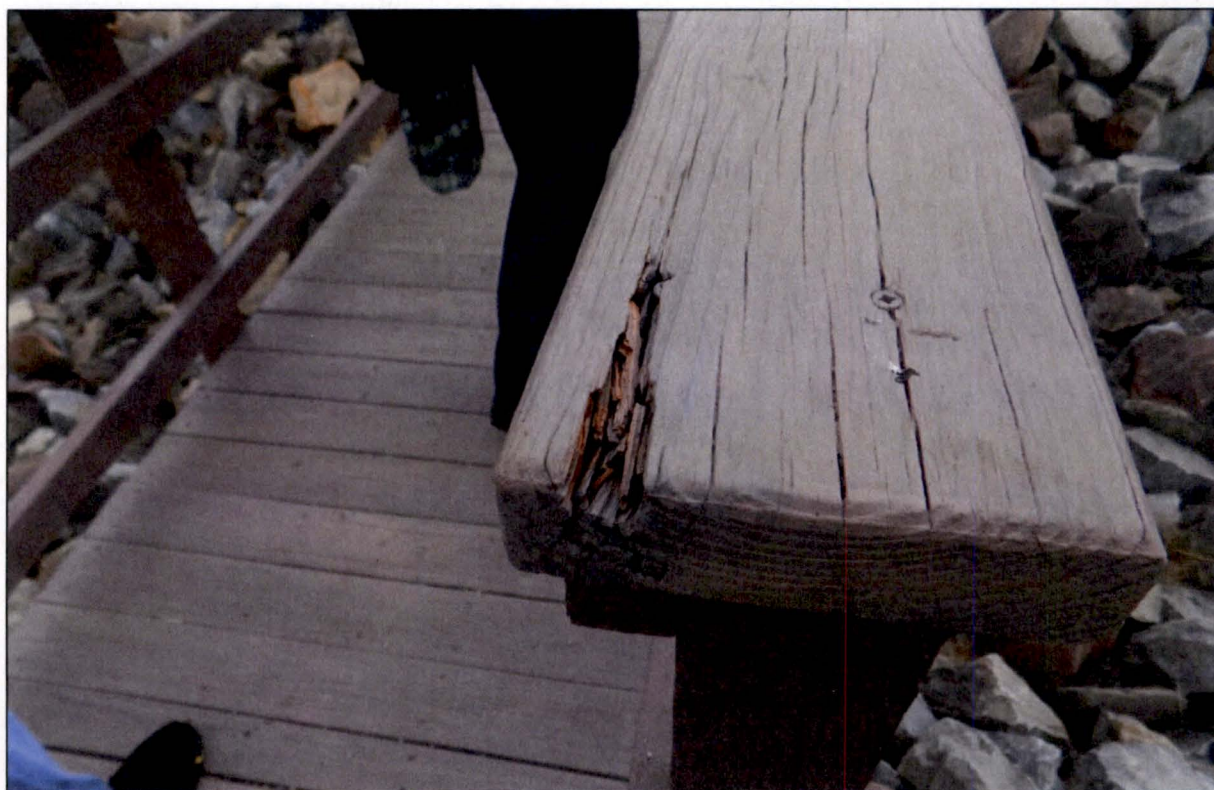
*PL-10. Rot Developing on Top Rail of Footbridge*

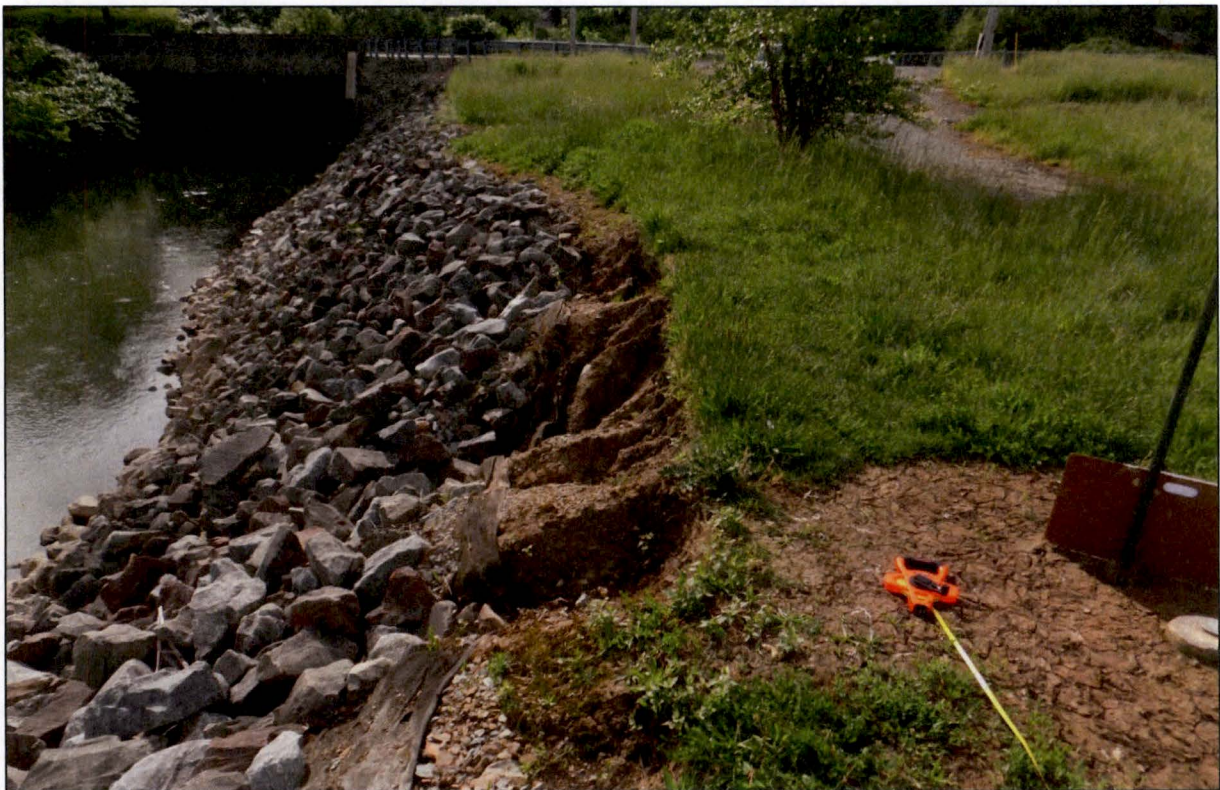
*PL-11. Area Needing Repair Along Chartiers Creek (May 2017)*

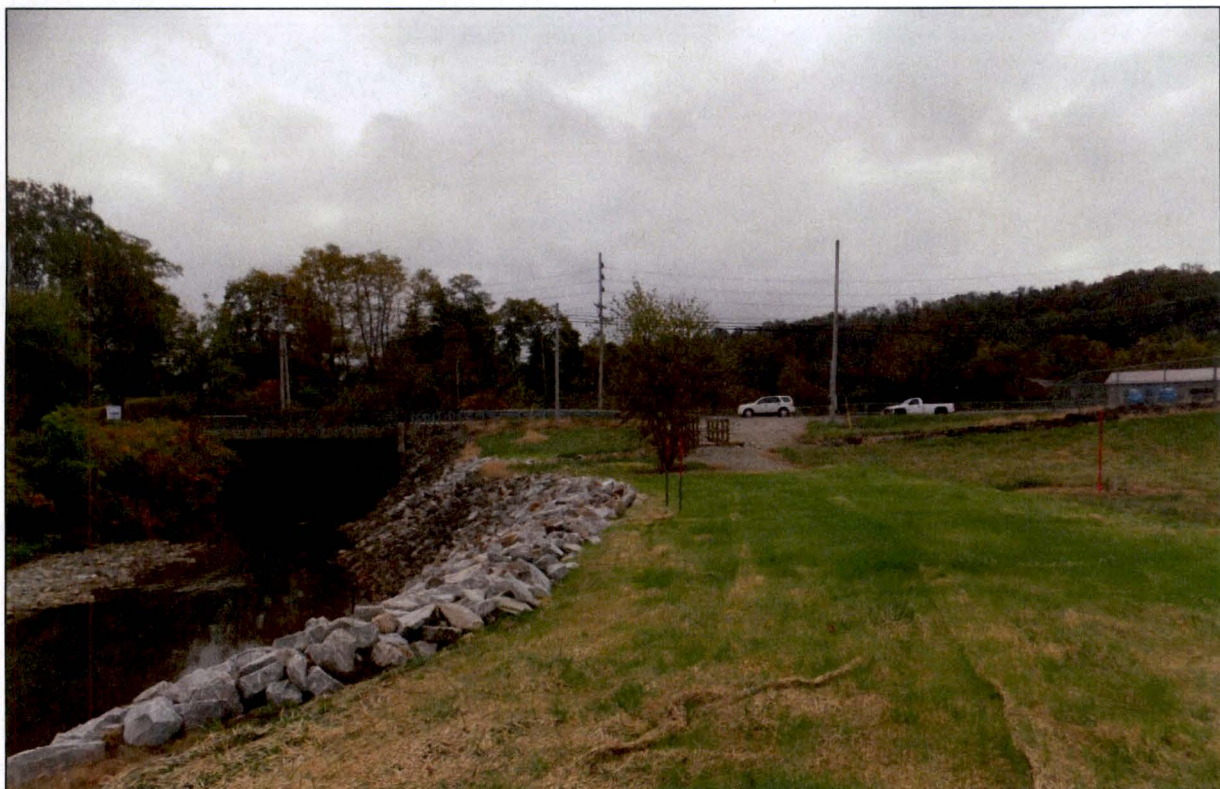
*PL-12. Repaired Area Along Chartiers Creek (October 2017)*

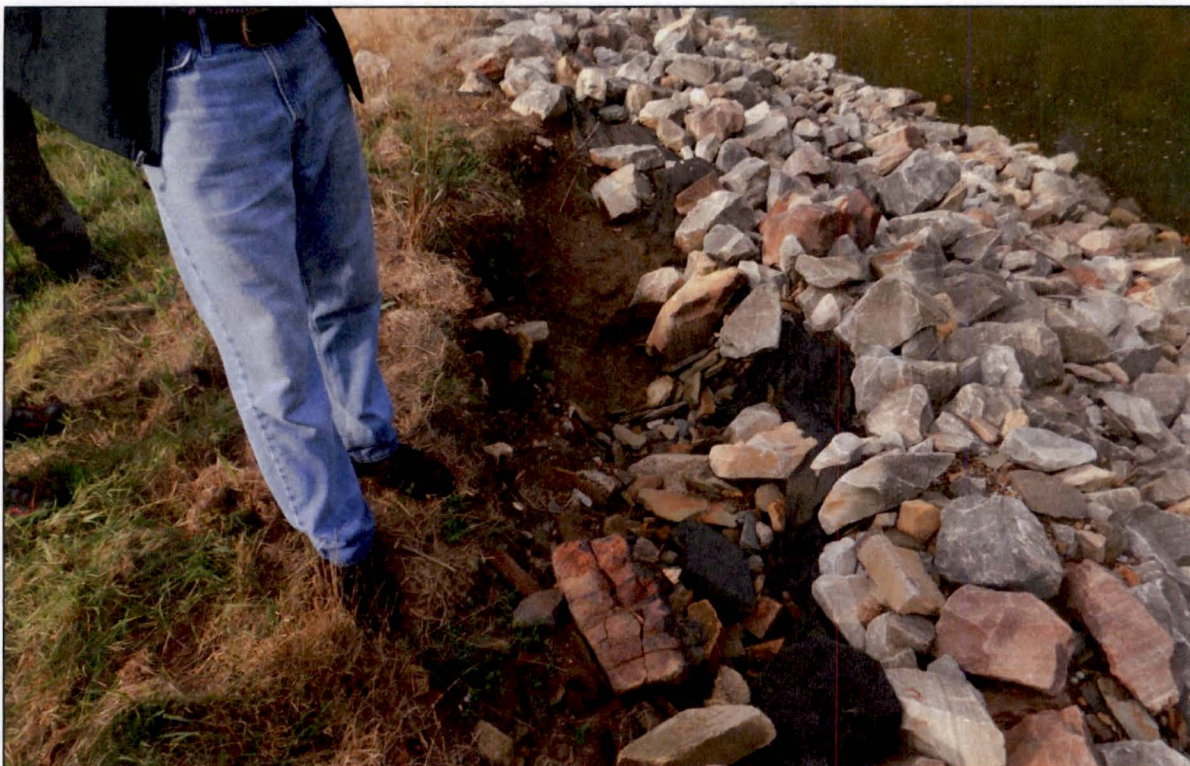
*PL-13. Top of Riprap Bank Along Chartiers Creek Shows Fabric Pulled Loose From Bank, Erosion Forming*

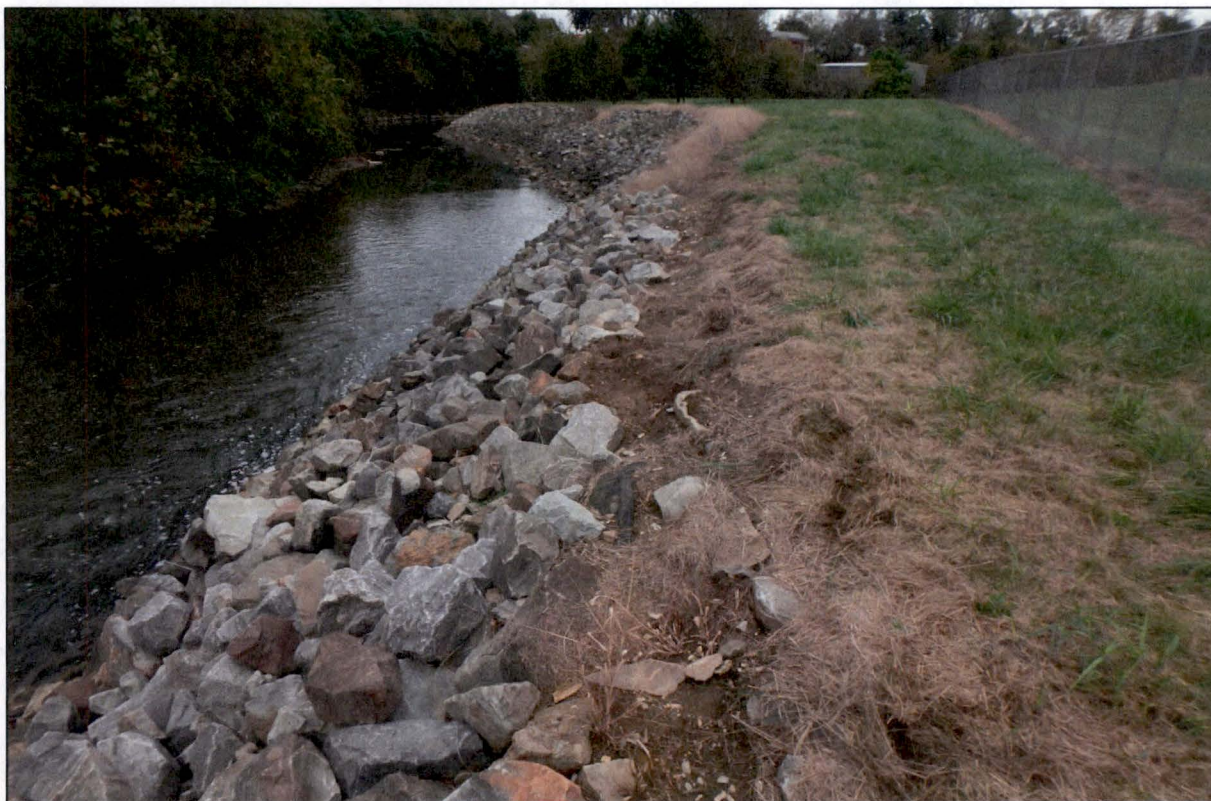
*PL-15. Stream Bank Needing Erosion Repair*

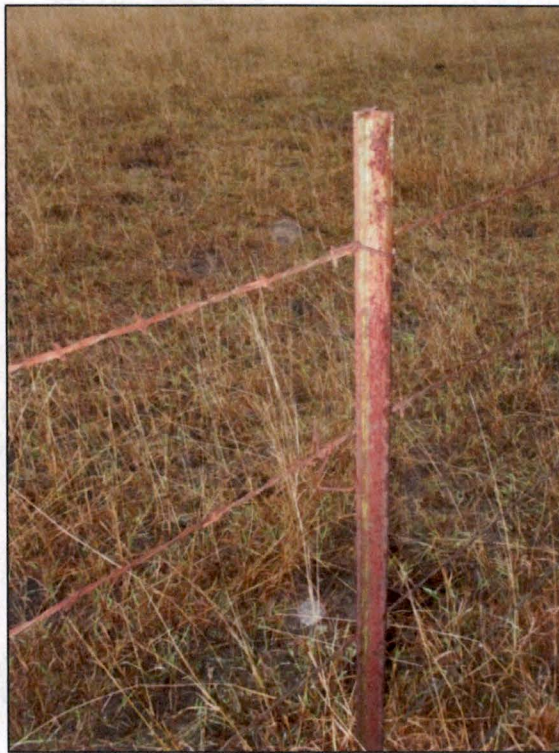
*PL-1. Southwest Perimeter Fence Showing Rusting Strands and Post*

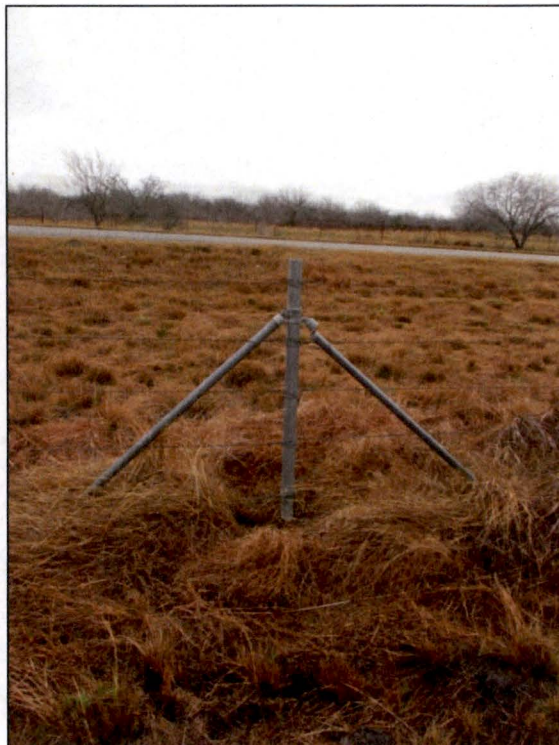
*PL-2. Line Brace With Missing End Cap, Northeast Perimeter Fence*

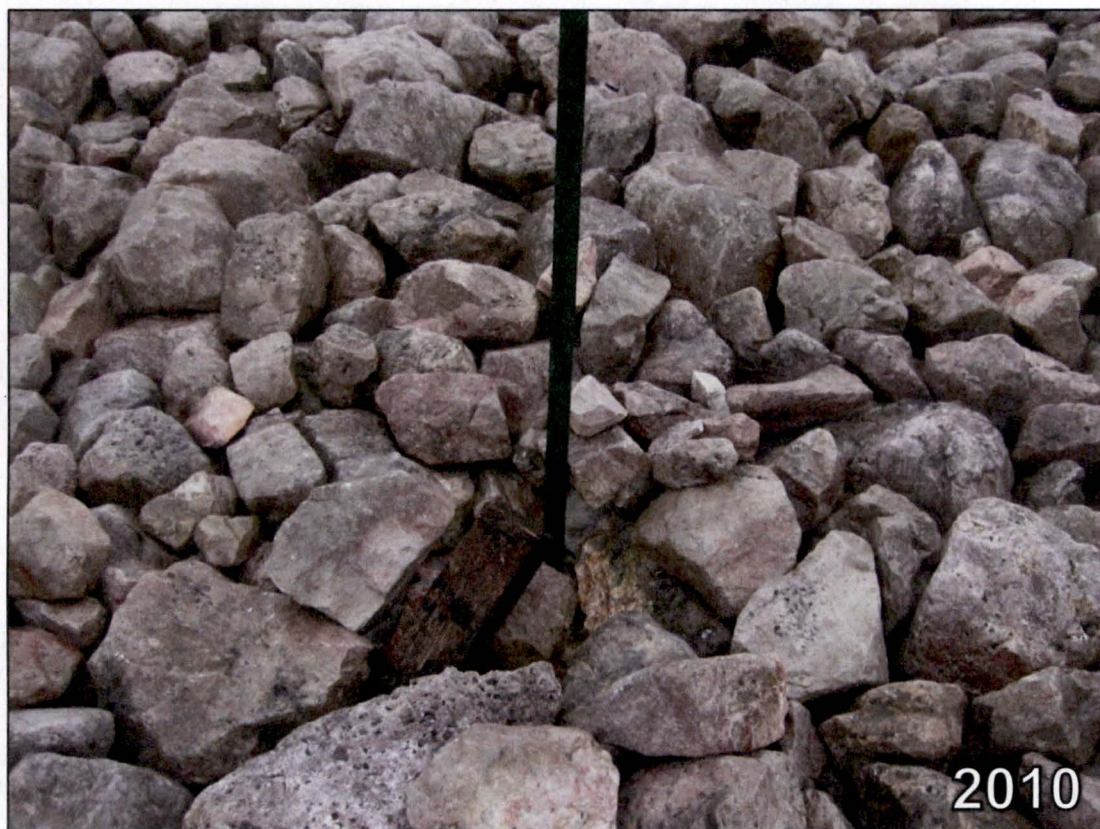
*PL-5. (b) Riprap at the Base of Post 4—2010 Photo for Comparison*

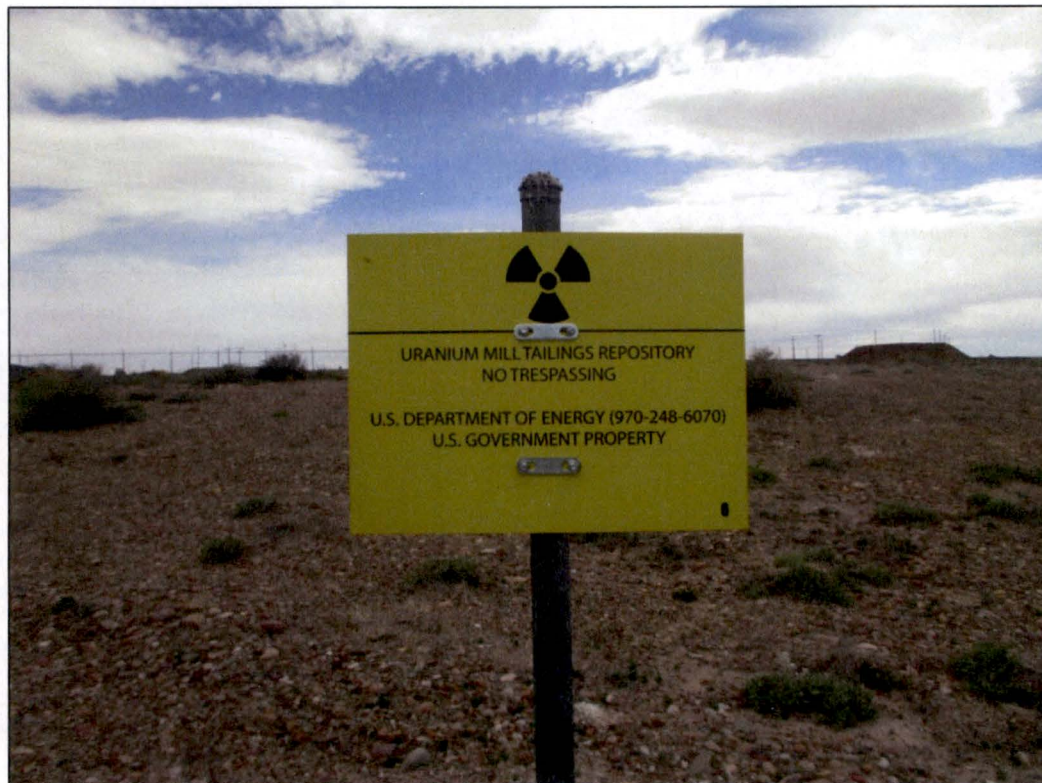
*PL-2. Replaced Perimeter Sign P6 (Sign Was Missing)*

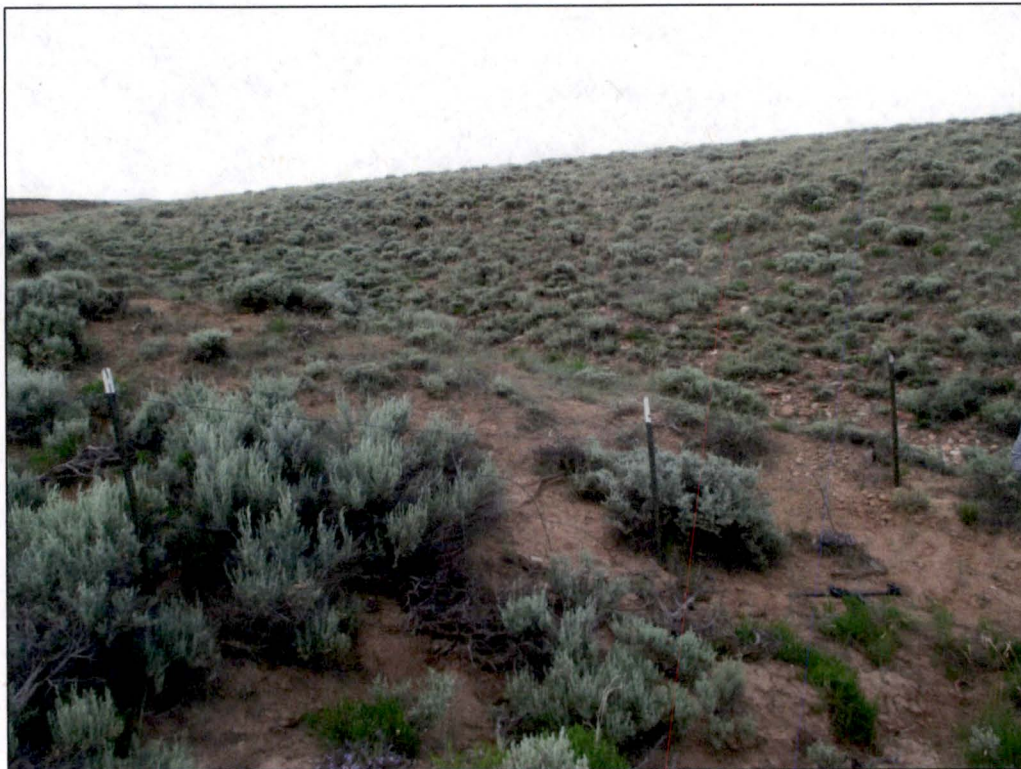
*PL-3. Broken Perimeter Fence Strands; Subsequently Repaired*
