Final ASP Program Analysis - Precursor

Accident Sequence Precursor Program – Office of Nuclear Regulatory Research			
Cooper Nuclear Station	Concurrent Unavailabilities—Residual Heat Removal Loop A, Reactor Core Isolation Cooling, and Emergency Station Service Transformer		
Event Date: 2/5/2017	LERs: 298-2017-001-01 , 298-2016-007 , 298-2016-008 , IRs: 05000298/2017001 , 05000298/2017009 , 05000298/2017010 , 05000298/2017011 , 05000298/2017012	ΔCDP= 6×10 ⁻⁶	
Plant Type: General Electric Type 4 Boiling-Water Reactor (BWR) with a Wet Mark I Containment			
Plant Operating Mode (Reactor Power Level): Mode 1 (100% Reactor Power)			
Analyst: Keith Tetter	Reviewer: Chris Hunter	Contributors:	BC Approved Date: 03/09/2018

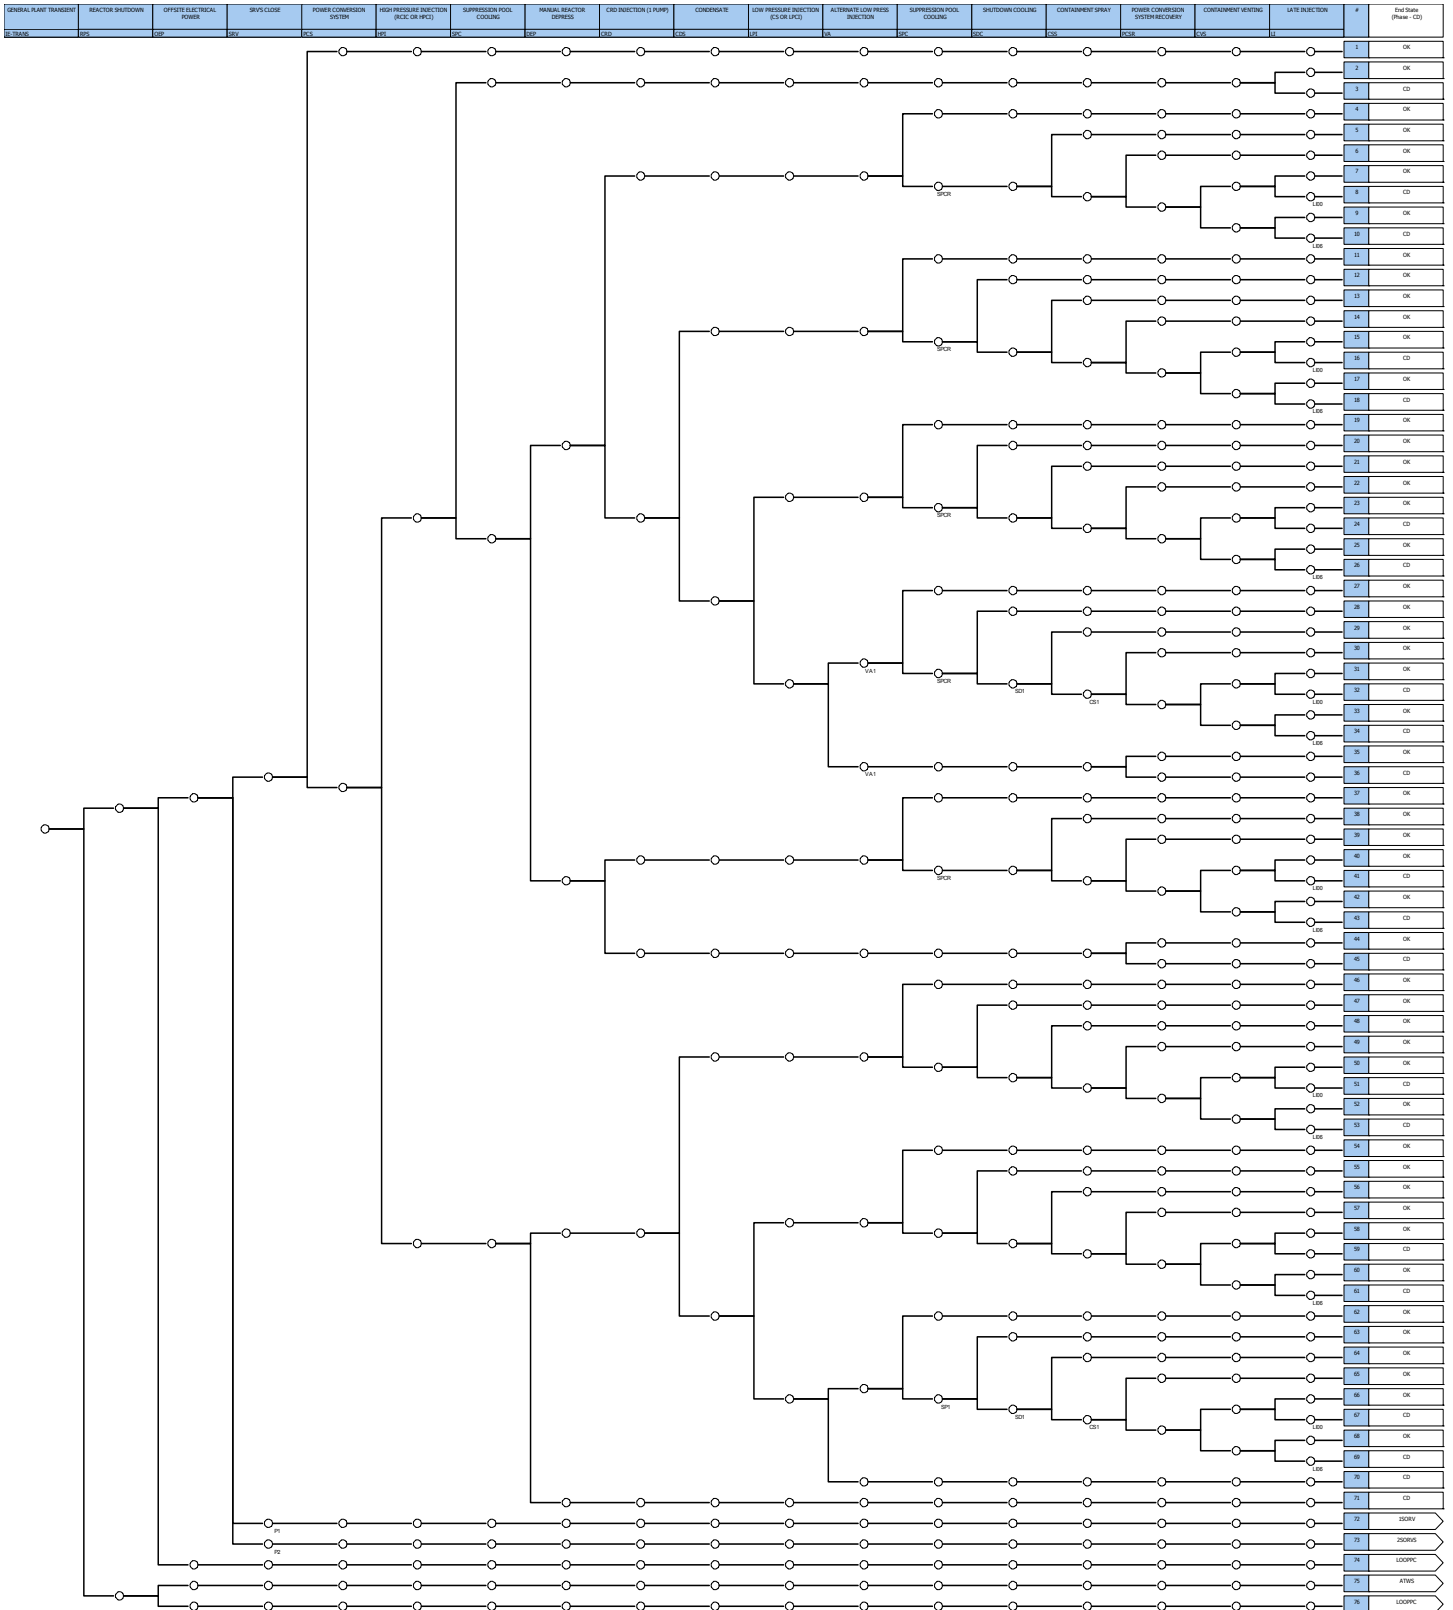
Figure A-1. Cooper Transient Event Tree

Dominant Sequence. The dominant accident sequence is TRANS Sequence 74-37-28 (ΔCDP = 5.6×10^{-7}) that contributes approximately 10 percent of the total internal events ΔCDP. Figures A-1 through A-3 in [Appendix A](#) illustrate this sequence. The dominant sequences that contribute at least 1 percent of the total internal events CDP are provided in the following table:

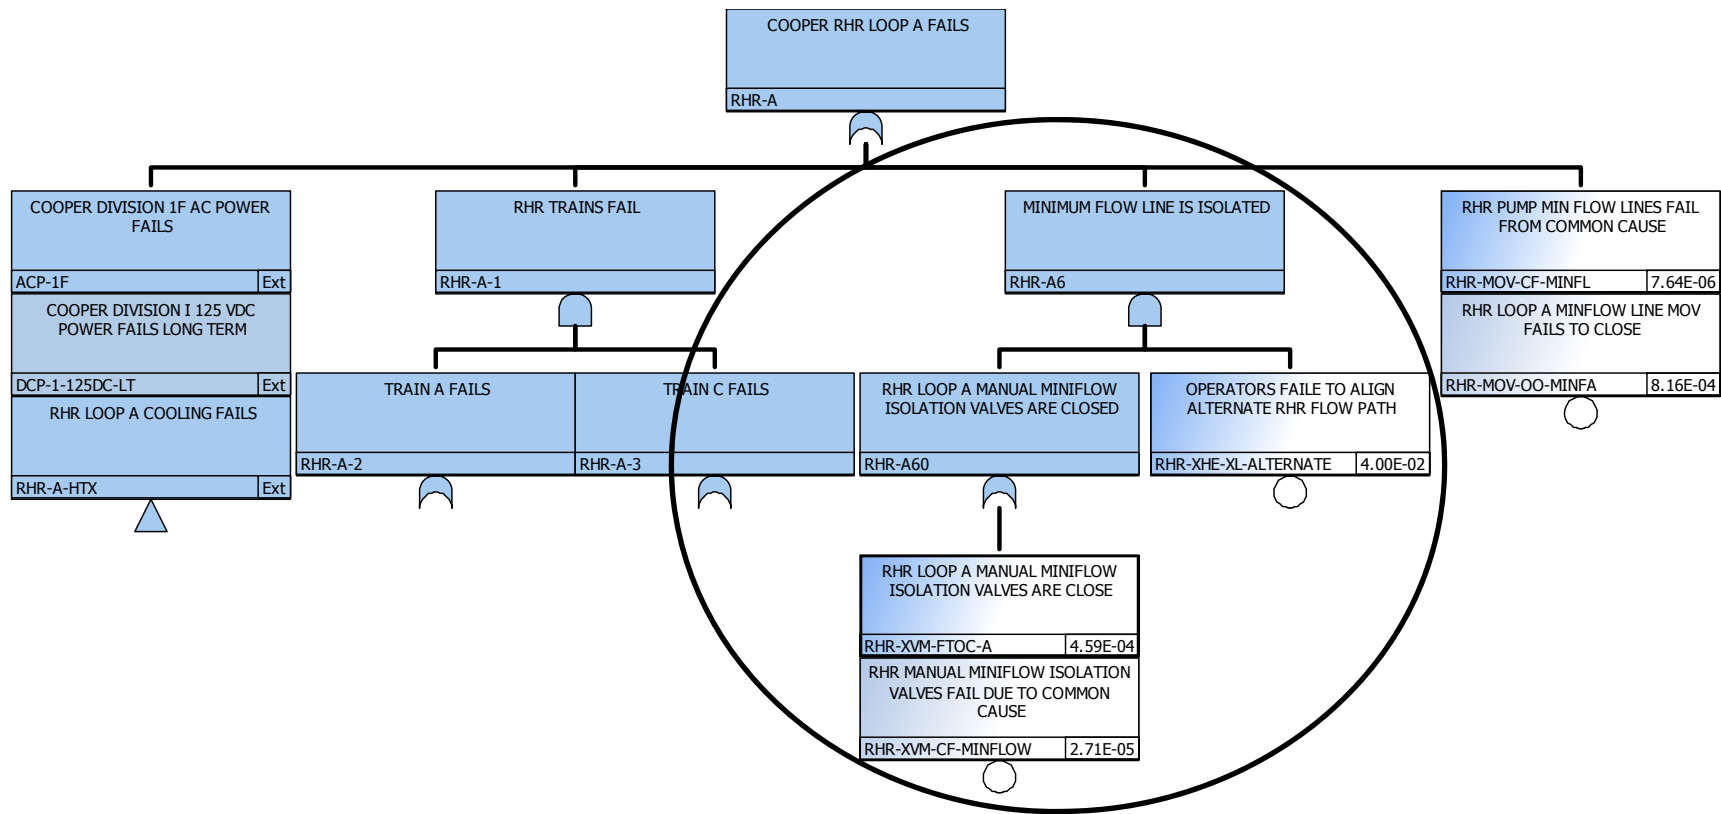
Figure B-1. Modified RHR-A Fault Tree

- Modifications were made to the applicable RHR fault trees. The RHR-A (*Cooper RHR loop A fails*) fault tree was modified to provide credit for operators aligning an alternate flow path (i.e., suppression pool cooling) and to account for potential common-cause failure (CCF) of the manual valves in the RHR minimum flow lines. A new 'AND' gate RHR-A6 (*minimum flow line is isolated*) was inserted under existing gate RHR-A (*Cooper RHR loop A fails*). Gate RHR-A60 (*RHR loop A miniflow isolation valves are closed*) was inserted under new 'AND' gate RHR-A6. Similar fault tree changes were made to the RHR-B (*Cooper RHR loop B fails*) fault tree. New basic events, RHR-XVM-FTOC-A (*RHR loop A miniflow isolation valves are closed*) and RHR-XVM-FTOC-B (*RHR loop B miniflow isolation valves are closed*), were inserted

under gates RHR-A60 and RHR-B60 (*RHR loop B miniflow isolation valves are closed*), respectively. The failure probabilities of these valves were set using template event ZT-AVM-FTOC (*manual valve fails to open*), which has a probability of 4.59×10^{-4} . A new basic event, RHR-XHE-XL-ALTERNATE (*operators fail to align alternate RHR flow path*), was inserted under gates RHR-A6 and RHR-B6. The failure probability of this basic event was set to 4.0×10^{-2} , per SPAR-H analysis described below, to provide for operator recovery credit to align an alternate RHR flow path. The RHR loop 'A' manual isolation valves for minimum flow that were incorrectly in the closed position were considered to be part of a common-cause component group (CCCG) with the similar valves in RHR loop 'B'.⁴ To create the CCF event, basic events RHR-XVM-FTOC-A and RHR-XVM-FTOC-B were used to create a new basic event, RHR-XVM-CF-MINFLW (*RHR manual miniflow isolation valves fail due to common-cause*), was inserted under gates RHR-A60 and RHR-B60 to account for potential CCF of the manual minimum flow isolation valves for loops 'A' and 'B'. The changes made in the RHR-A and RHR-B fault trees were made to the applicable SPC and low-pressure core injection (LPCI) fault trees. The revised RHR-A, RHR-B, SPC-A (*cooper RHR loop A fails*), SPC-B (*cooper RHR loop B fails*), LCI-A (*Cooper LPCI train A fails*), and LCI (*Cooper LPCI train B fails*) fault trees are provided in Figures B-1 through B-6 in [Appendix B](#).

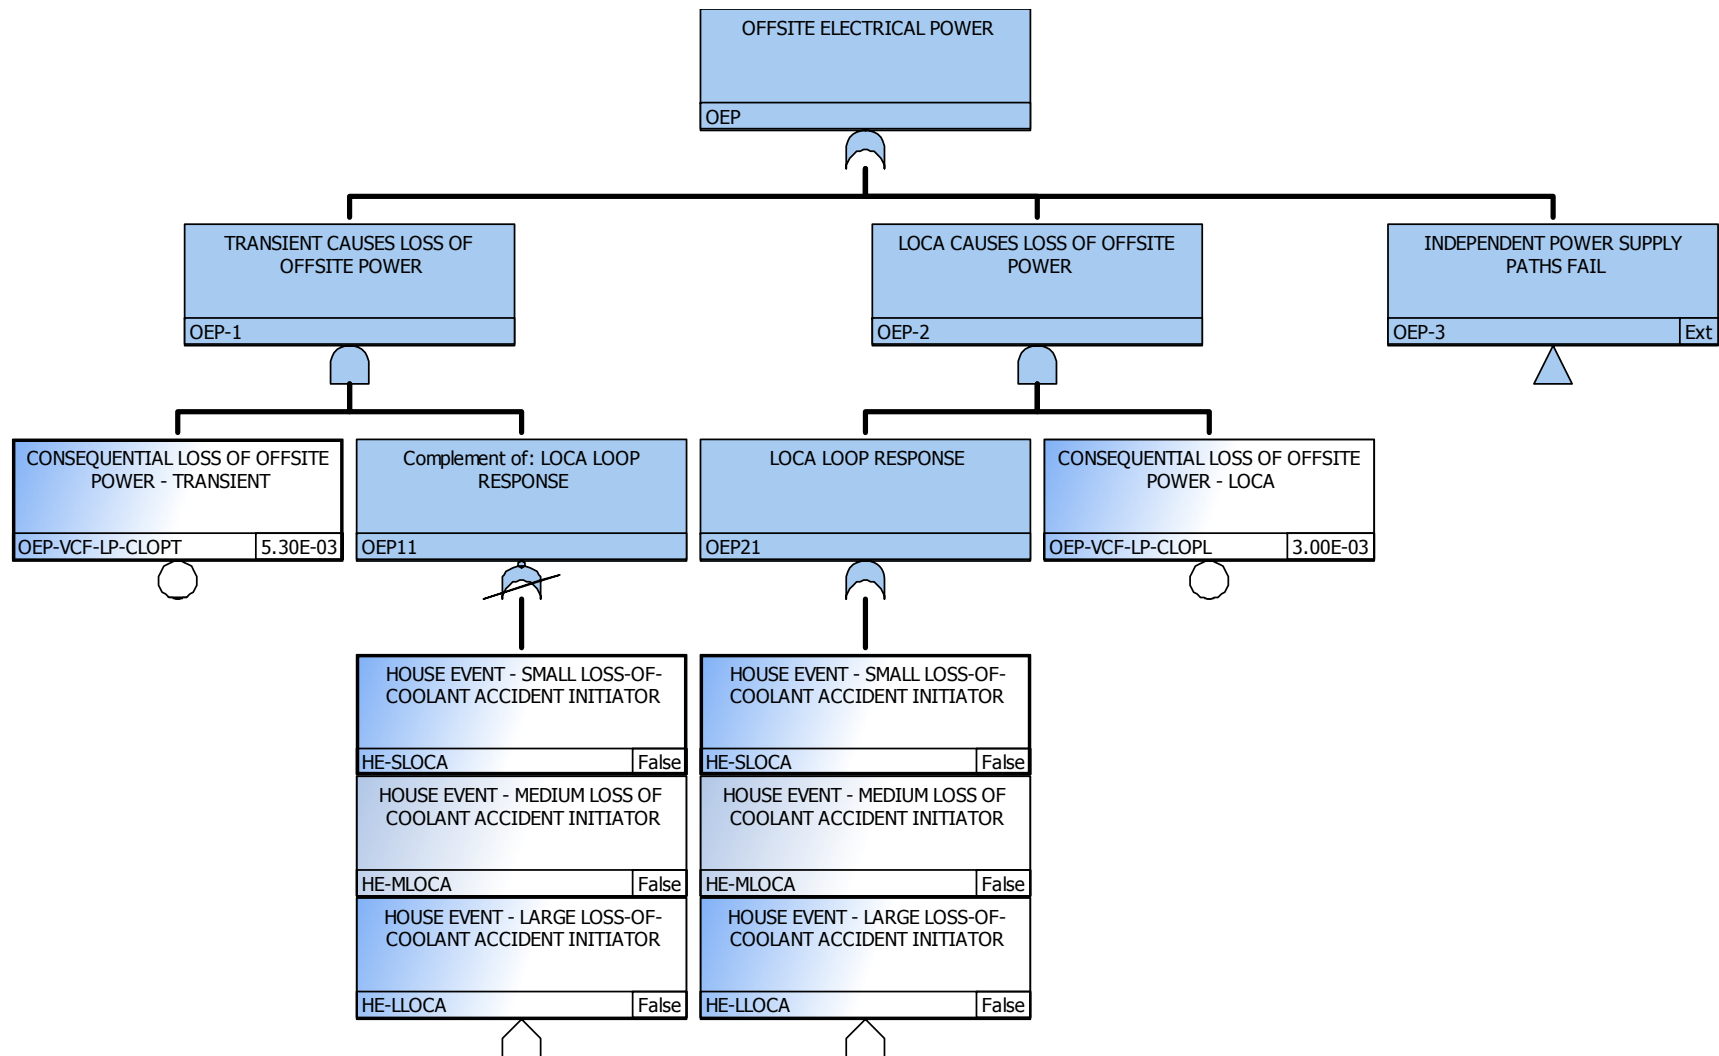
Figure B-7. Modified OEP Fault Tree

- Modifications were made to the ACP-1F-SWY (Cooper switchyard AC service to bus 1F), ACP-1G-SWY (Cooper switchyard AC service to bus 1G), OEP (offsite electrical power), OEP-3 (independent power supply paths fail), DGS (supplemental diesel generator faults), OPR (offsite power recovery), OPR-30M (offsite power recovery in 30 minutes), OPR-04H (offsite power recovery in 4 hours), OPR-08H (offsite power recovery in 8 hours), and OPR-12H (offsite power recovery in 12 hours) fault trees in a similar manner as in Attachment 2 in [IR 05000298/2017011](#). The revised ACP-1F-SWY,

ACP-1G-SWY, OEP, OEP-3, DGS and OPR fault trees are provided in Figures B-7 through B-12 in [Appendix B](#).

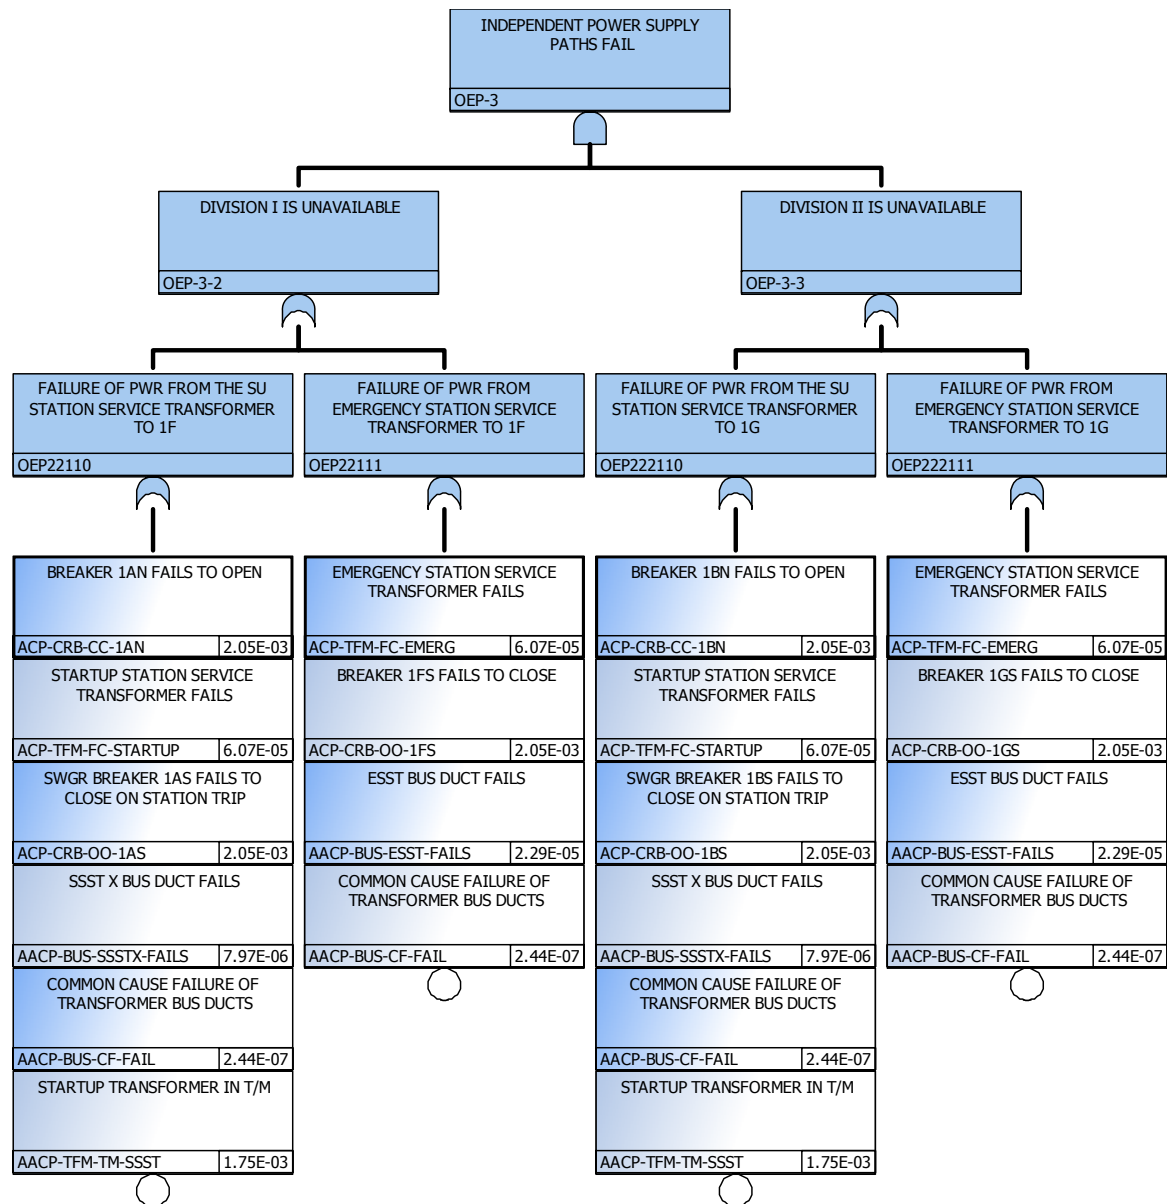
Figure B-10. Modified OEP-3 Fault Tree

- The OEP-3 fault tree was converted to transfer gate within the OEP fault tree.
- The nonsegregated bus work between the motor-operated disconnect associated with the ESST and electrical safety buses 1F and 1G is not included in the base SPAR model and is needed for this analysis. Therefore, new basic event AACP-BUS-ESST-FAILS (*ESST bus duct fails*) was created in the SPAR model using template ZT-BAC-LP (*AC bus fails to operate*). This basic event was added to the ACP-1F-SWY and ACP-1G-SWY fault trees under existing 'OR' gates ACP-1F-SWY-2 (*emergency station service failure*) and ACP-1G-SWY-2 (*emergency station service failure*). This basic event was also added to the OEP fault tree under existing 'OR' gates OEP22111 (*failure of power from ESST to 1F*) and OEP222111 (*failure of power from ESST to 1G*). Similarly, a new basic event, AACP-BUS-SSSTX-FAILS (*SSST-X bus duct fails*), representing the bus work from the X-winding of the SSST feeding the plant (which did not fail the SDG but was unavailable due to the failure of the ESST bus duct) was created using template ZT-BAC-LP and inserted under fault trees ACP-1F-SWY and ACP-1G-SWY as well under existing 'OR' gates OEP22110 (*failure of power from the startup station service transformer to 1F*) and OEP222110 (*failure of power from the startup station service transformer to 1G*) within the OEP-3 fault tree. In addition, basic event AACP-BUS-ESST-FAILS was inserted under the top gate of the DGS fault tree given the supplemental diesel generator would be unavailable given a bus duct failure.

- A new CCF basic event, AACP-BUS-CF-FAIL (*common-cause failure of transformer bus ducts*), representing the CCF of the ESST and SSST-X bus work was created. The common cause alpha factors, ZA-CCF-RATE-02A01 (*alpha factor 1 in group size 2 for component CCF with failure mode rate*) and ZA-CCF-RATE-02A02 (*alpha factor 2 in group size 2 for component CCF with failure mode rate*), were applied. These generic alpha factors for a CCG size of two are used because bus-work failure data is not explicitly collected and estimated for the SPAR models. This CCF basic event was inserted under existing 'OR' gates ACP-1F-SWY-1,

-
- ACP-1G-SWY-1, OEP22110, OEP222110, OEP22111, and OEP222111 within the OEP-3 fault tree.
- The OEP-3 transfer tree was inserted under the existing top gate for the OPR-30M, OPR-04H, OPR-08H, and OPR-12H fault trees.
 - In ASP analyses, recovery credit for EDG failures is limited to cases where event information supports credit for EDG recovery. Therefore, the DGR (diesel generator recovery) top event (including applicable event tree branching) was eliminated from the station blackout (SBO) event tree. The revised SBO event tree is shown in [Figure A-3](#).
 - The basic event SPC-XHE-XL-NOREC (*late recovery of suppression pool cooling fails*) was set to TRUE. The base model probability of 0.5 is only used for benchmarking purposes.
