Subject: TMI-1 Steam Generator Inspection Report for End of Cycle 21 Refueling Outage

THREE MILE ISLAND

UNIT 1

STEAM GENERATOR TUBE INSPECTION REPORT
END OF CYCLE 21 REFUELING OUTAGE

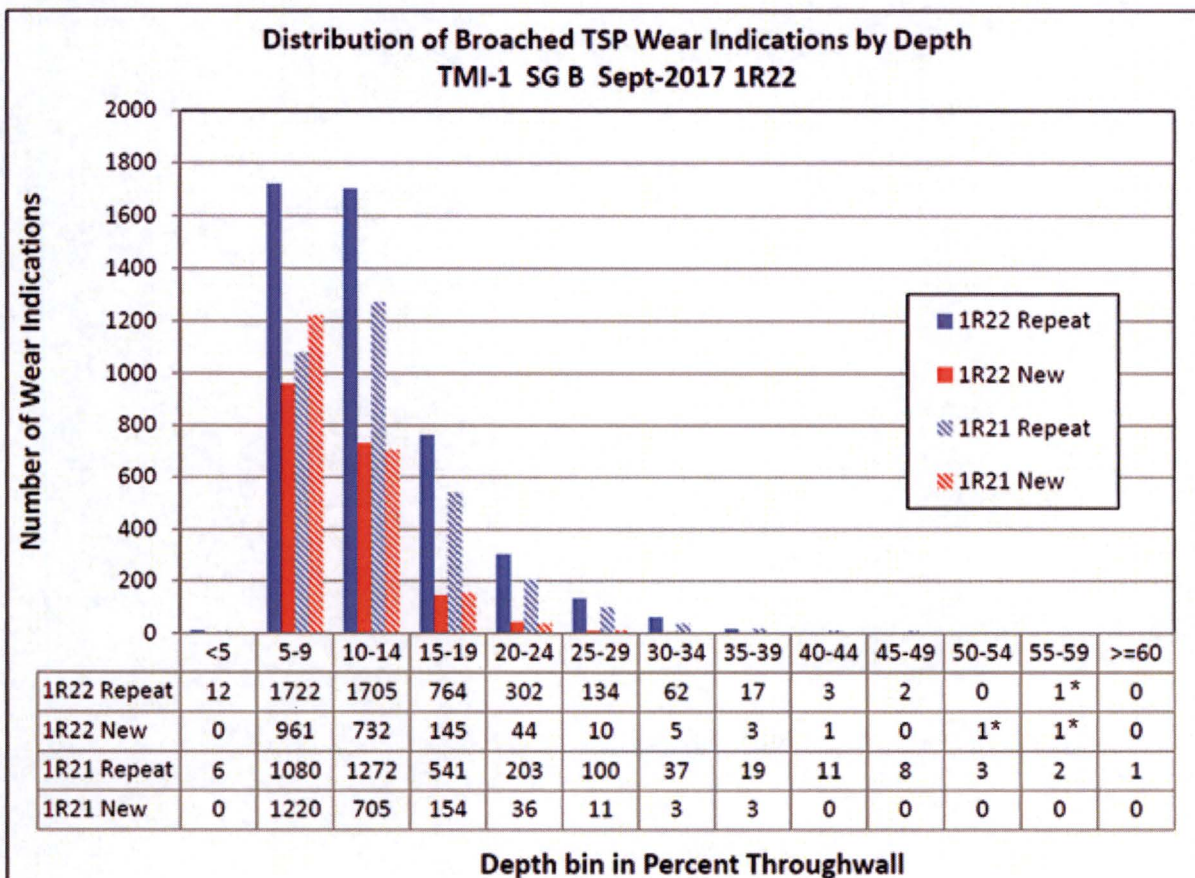
Figure 1: T1R22 - SG B - TSP Wear Support and Depth Distribution

In SG B, 6729 broached TSP wear indications were identified in the T1R22 inspection using the bobbin probe (see Exhibit 1). Most of these indications were located at or above the 8th TSP. The deepest indications were primarily located at the 10th through the 14th TSPs. The deepest bobbin indication (59%TWD in tube 105-3) consisted of 2 flaws at 2 lands at the same tube support; one had a maximum depth of 44%TWD and a structural depth of 40.4%TWD and the other a maximum depth of 25%TWD and structural depth of 24.3%TWD as measured with the array coil. The second deepest bobbin indication (58%TWD in tube 5-14) also consisted of 2 flaws at 2 lands at the same tube support; one had a maximum depth of 49%TWD and a structural depth of 40.9%TWD and the other a maximum depth of 18%TWD and structural depth of 15.8%TWD as measured with the array coil. Array sizing rather than bobbin was used because the qualification and calibration curve for the bobbin technique (ETSS 96043.1 Rev 2) is limited to

sizing wear at a single broached TSP land. Since there were indications at 2 different lands at that TSP elevation, bobbin sizing of the indications was not accurate and provided an overestimated indication depth. Therefore, the array coil was used for depth and length sizing these indications individually since the calibration curve for this technique is not affected by wear at multiple lands.

Figure 1 shows the distribution of broached TSP wear indications by depth.

(* Note table lists 3 indications above 50% TWD initially sized by bobbin which were actually due to wear at 2 lands at the same support and therefore, had their actual depth overestimated by bobbin sizing)

During the T1R22 outage 52 tubes were plugged in SG B. Nine tubes were plugged based on indications at or above the Tech Spec limit of 40% TWD. 42 tubes were plugged to support the operational assessment plugging limits. One tube was plugged based on engineering judgment due to flaw morphology and proximity to nearby tubes being plugged for similar but deeper indications. In the course of plugging tubes based on flaw depths that met the screening criteria, numerous smaller flaws in the same tubes were also removed from service.

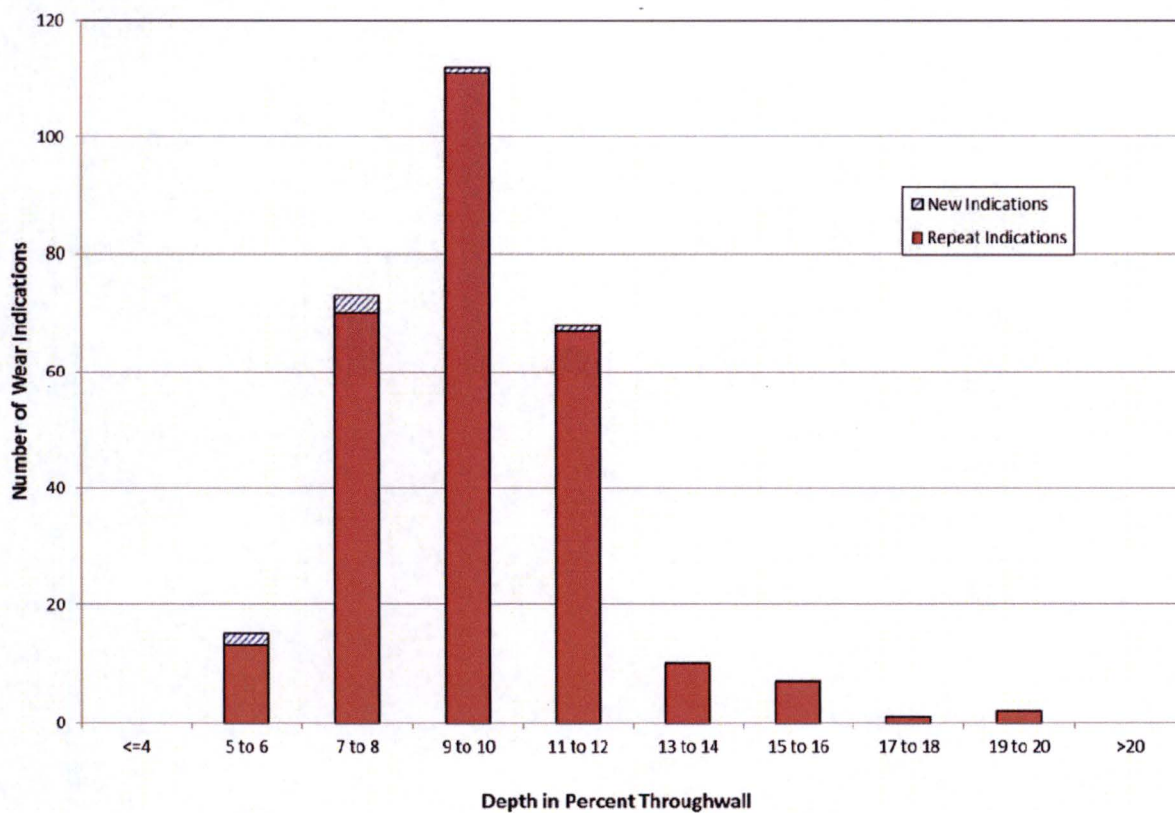
Figure 2: T1R22 - SG B - Tube-to-Tube (TTW) Wear Depth Distributions

During the T1R22 inspection, there were 288 indications of TTW reported in SG B. All of these indications were relatively shallow with the deepest measuring 19%TWD

The majority of TTW indications are located between the 8th and the 9th TSPs, fourteen indications were located between the 7th and 8th TSPs, six other indications were located between the 4th and 5th TSPs, and one indication was between the 3rd and 4th TSPs. Most of the tubes with TTW indications are located between 30"-45" from the center of the bundle. Generally speaking, there is a ring of tubes with indications.

The wear indications are essentially centered axially between the tube support plates and are typically in pairs with similar through wall depths. In some cases, there is a cluster of three or more affected tubes.

Figure 2 shows the distribution of the TTW indications by percent through-wall.

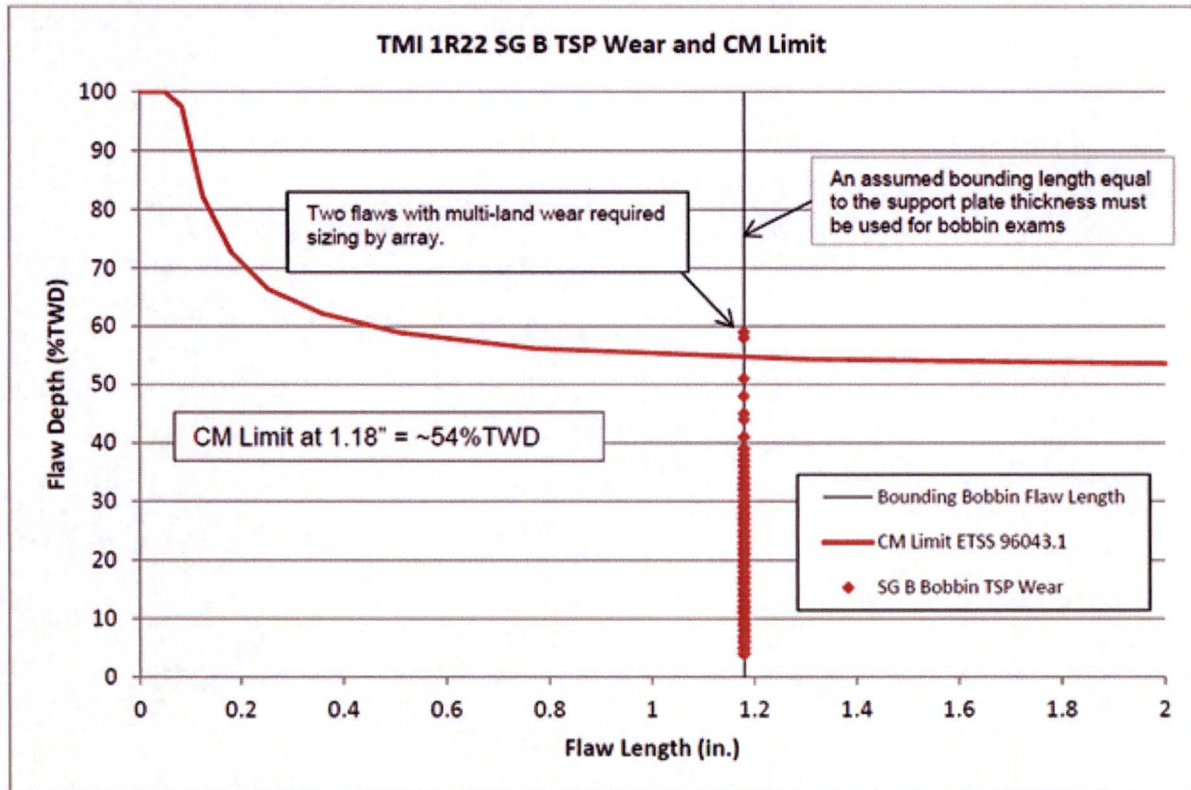
Figure 3: T1R22 - SG B - Condition Monitoring Limit Plot for Broached TSP Wear (Bobbin)

Figure 3 and Figure 4 show the CM limit as a function of length and depth for the bobbin coil (ETSS 96043.1) and array coil (ETSS 11956.3) techniques, respectively. As shown in Figure 3, the CM limit for an indication with a structural length of 1.18" is ~54%TWD when sized by the bobbin technique. Assuming a bounding flaw structural length equal to the entire thickness of the TSPs (1.18"), all indications except two met the structural integrity performance criteria by analysis based on bobbin sizing (ETSS 96043.1). The largest indications detected and sized by bobbin were 59%TWD in tube 105-3 at 14S and 58%TWD in tube 5-14 at 11S. Since the indications, as sized by bobbin, were not shown by analysis to meet the bobbin CM limit, the indications were line-by-line profiled using an array probe and ETSS 11956.3 to obtain a structurally equivalent length and depth, which was compared to the CM limit for the array technique. The tubes were each found to have two distinct wear indications on different lands of the same support plate, a condition for which the bobbin technique ETSS 96043.1 is not qualified to size. This is because the bobbin probe is incapable of distinguishing multiple indications at the same elevation and generally sums the depths of the indications, leading to an overestimation of the measured indication depth. ETSS 11956.3, using an array probe, is a qualified technique capable of resolving multiple indications at the same elevation and accurately sizing each indication at each land. As shown in Figure 4, using array probe data for the structural equivalent depth and length for the largest indication in each tube, tubes 105-3 and 5-14 also met structural integrity performance criteria by analysis. For reference, these values were 40.4%TWD structural equivalent depth and 1.10 in. structural equivalent length for tube 105-3 and 40.9%TWD structural equivalent depth and 0.37 in. structural equivalent length for tube 5-14.

Other than tubes 105-3 and 5-14, the next deepest indication reported by bobbin was 51%TWD (105-4 at 15S). Therefore, as a conservative measure this indication and numerous others in the upper range of the bobbin depth distribution were sized with array and evaluated for CM compliance. The array evaluation of the 51%TWD indication initially sized by bobbin also

showed wear at 2 lands at the same TSP, measuring maximum depths of 34% and 32%TWD. The 34% and 32%TWD values were obtained from the "line-by-line" sizing data. Therefore, this indication and all remaining TSP wear indications passed condition monitoring analytically with no need for in situ pressure testing.

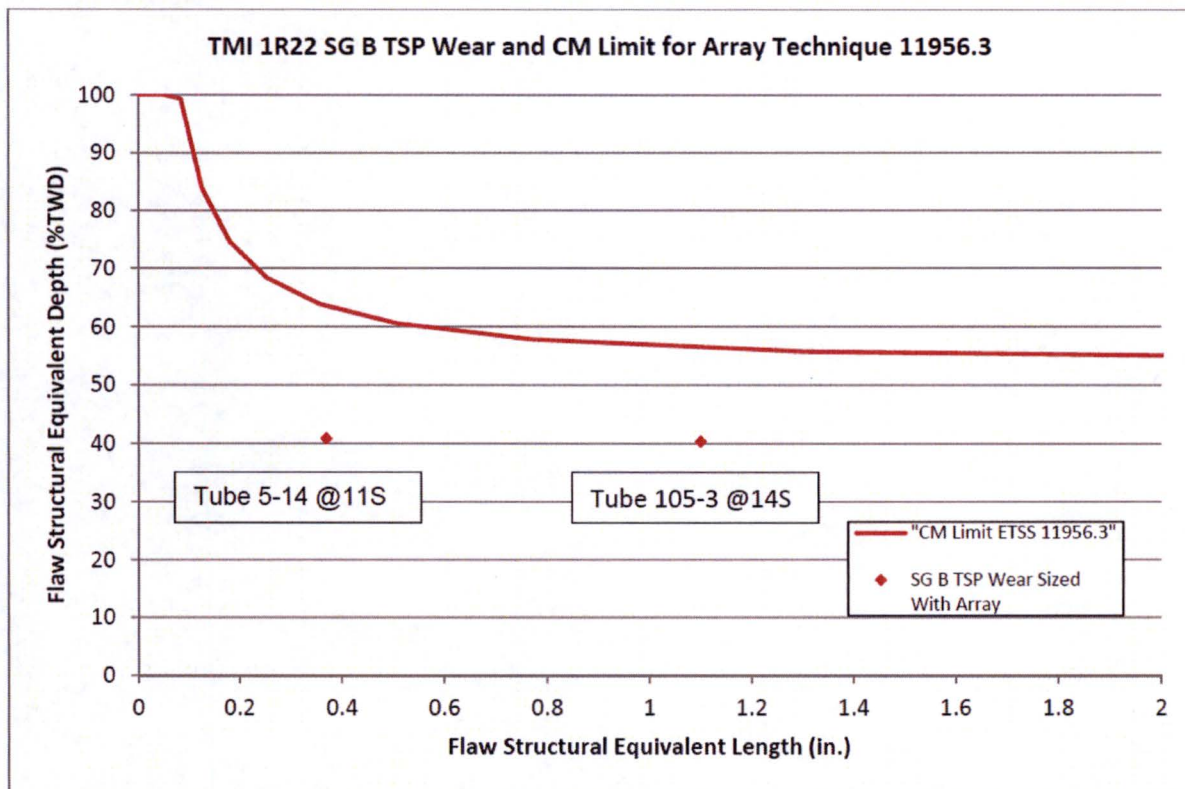
Figure 4: T1R22 - SG B - Condition Monitoring Limit Plot for Broached TSP Wear (Array)

It should also be noted that axial loading acting on the circumferential extent of the wear scar was also considered and is not limiting. Large Break Loss of Coolant Accident (LBLOCA) conditions were also considered during the CM evaluation. For LBLOCA events, the limiting load is the axial load created by the large tube-to-shell temperature differential that develops as the tubes cool faster than the shell. Structural integrity is satisfied with 100%TW wear indications with a total circumferential extent of 107 degrees. Converting this to a PDA gives a PDA of 29.7%. Since none of the detected indications approached 100%TWD, structural integrity under postulated LBLOCA conditions is satisfied.

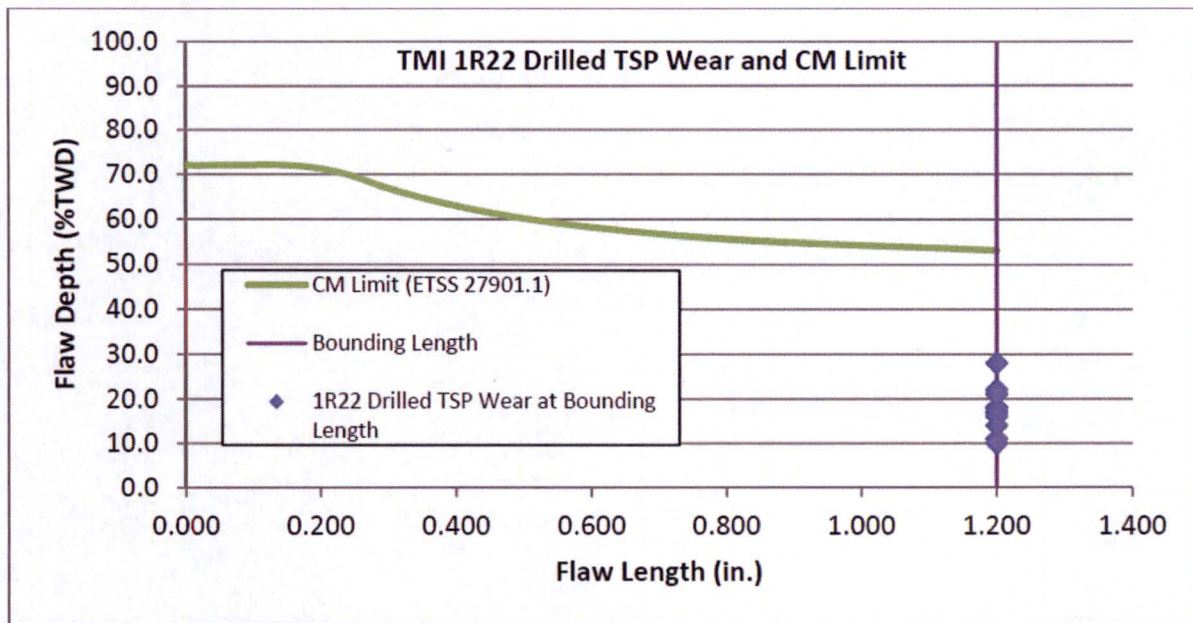
Figure 5: T1R22 - SG B - Condition Monitoring Limit Plot for Drilled TSP Wear (+PointTM ETSS 27901.1)

Thirteen tubes in SG B confirmed wear at the 15S drilled tube support plate locations. The deepest indication detected (tube 46-118) had a measured depth of 28%TWD. As shown in Figure 5 this is well below the CM limit of 53%TWD for a 360 degree, uniform thinning indication with a length of 1.2", which are extremely conservative bounds. A structural profile was performed and a structural equivalent length of 0.3" and a structural equivalent depth of 18%TWD. This CM limit was determined using methodology defined by the EPRI Flaw Handbook Calculator.

The indications at the drilled TSP locations were also evaluated for structural integrity at LBLOCA conditions. Measured circumferential extents varied from 0.23 to 0.89 inches. The max Percent Degraded Area PDA of any drilled TSP indication was 10%, satisfying the 29.7 PDA criterion discussed above. Since none of the indications approached this depth, the LBLOCA criterion is also met for this mechanism.

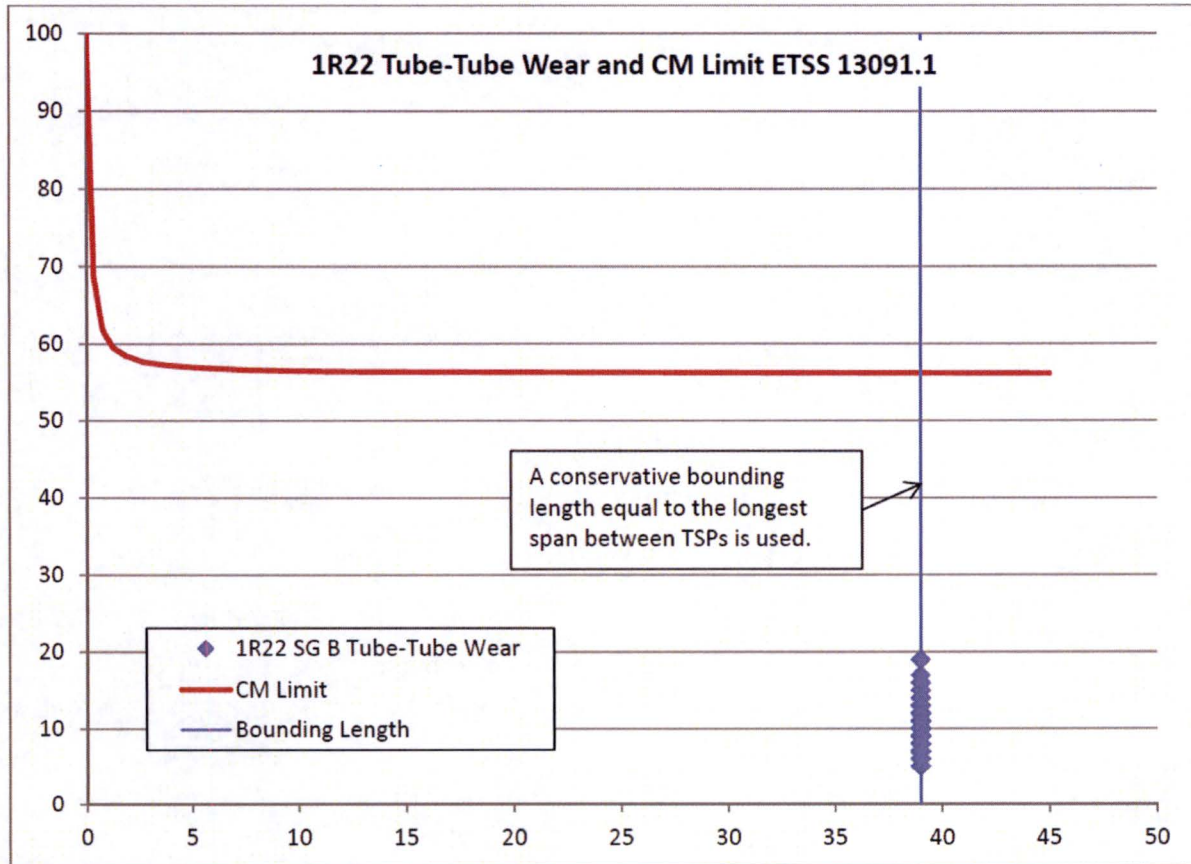
Figure 6: T1R22 - SG B - Condition Monitoring Limit for T1R22 Tube-to-Tube Wear

Figure 6 shows the CM limits as a function of length and depth for the bobbin coil TTW technique. As shown in the figures, the CM limit for an indication with a bounding structural

length of 39" is approximately 56%TWD. Since the deepest NDE depths were 19%TWD in SG B tubes 22-63 and 46-84 (which were also 19%TWD in T1R21), all tube-to-tube wear indications passed condition monitoring analytically with no need for in situ pressure testing. Screening for in situ pressure test candidates was performed in accordance with the EPRI In Situ Pressure Test Guidelines.

The indications of tube to tube wear were also evaluated for structural integrity at LBLOCA conditions. During the T1R19 inspection (2011), all the tube-to-tube wear indications were measured for circumferential extent. The T1R19 indications generally had circumferential extents of 50 to 70 degrees. During T1R20, there was one tube with four tube-to-tube wear indications in the same span. These indications had a combined circumferential extent of 147 degrees. Based on the allowable PDA of 29.7%, an allowable depth of 59.4%TWD is obtained for a postulated bounding 180-degree circumferential extent ($29.7\% \times 360 / 180$). Since none of the measured depths in T1R22 approached this value, structural integrity under postulated LBLOCA conditions is satisfied.
