FLORIDA POWER & LIGHT COMPANY  
ST. LUCIE PLANT - UNIT #1  
FINAL REPORT  
TOWER CRANE COUNTERWEIGHT DROP  
TO  
REACTOR AUXILIARY BUILDING ROOF DECK

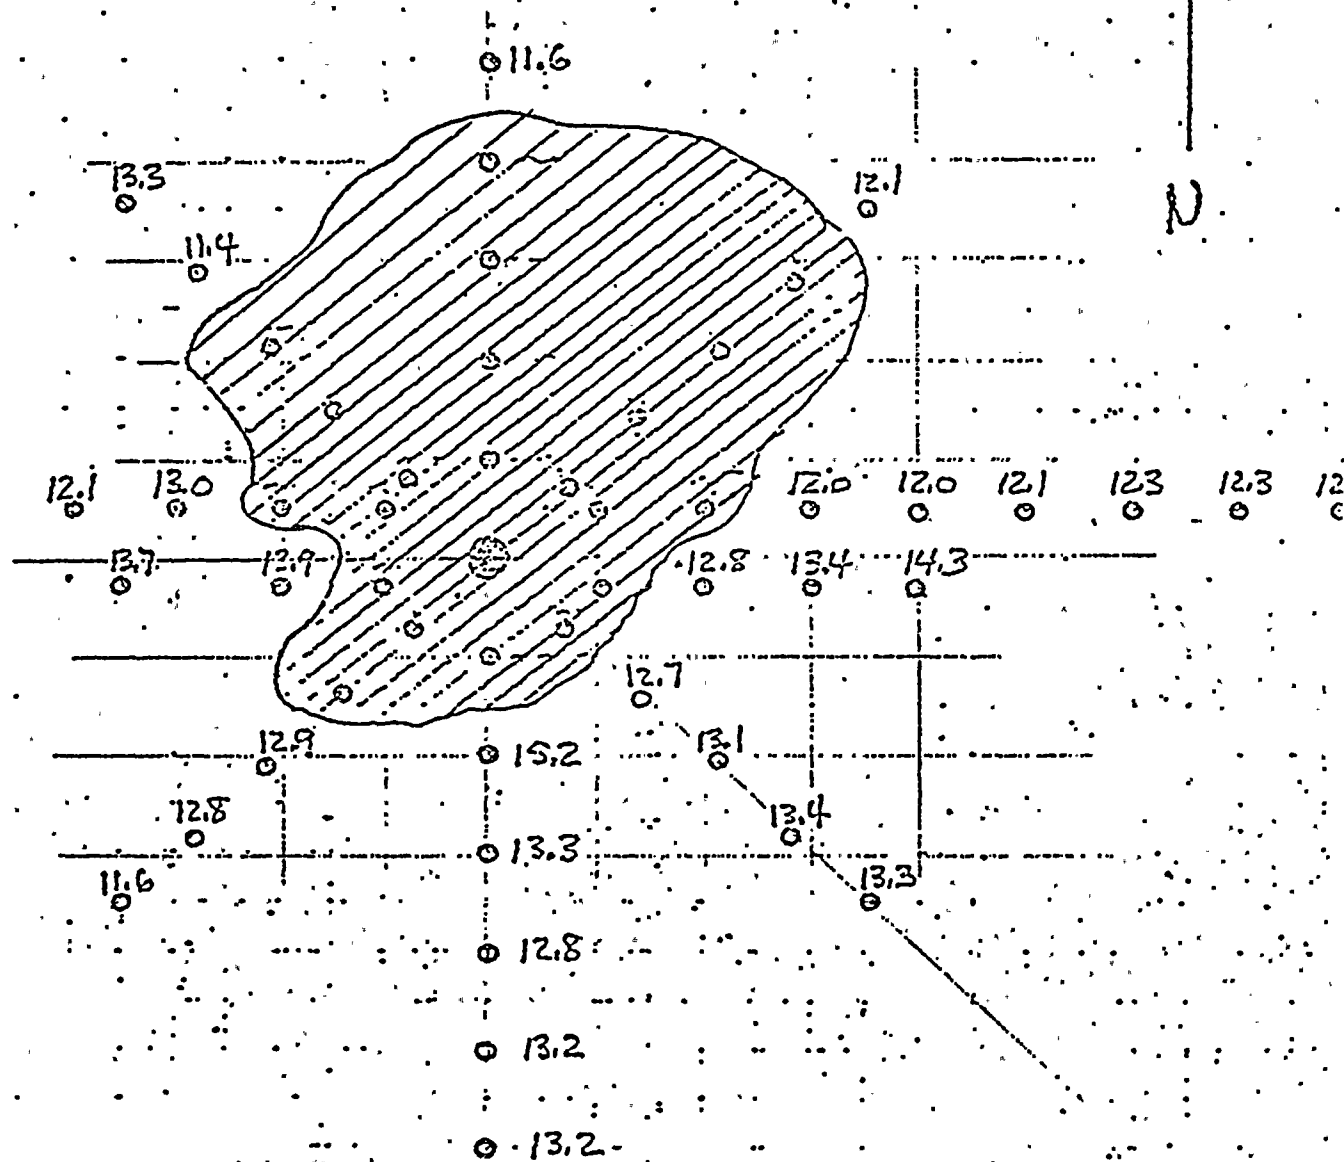
The vertical measurements indicated that cracks interfered with the compressional pulse. The area of most extensive damage was for a distance of about 9 feet to the north and northeast of the impact area, and for a distance of about 3 to 4 feet east, west, and south of the impact area. A sketch of the area affected is shown in Figure 3.

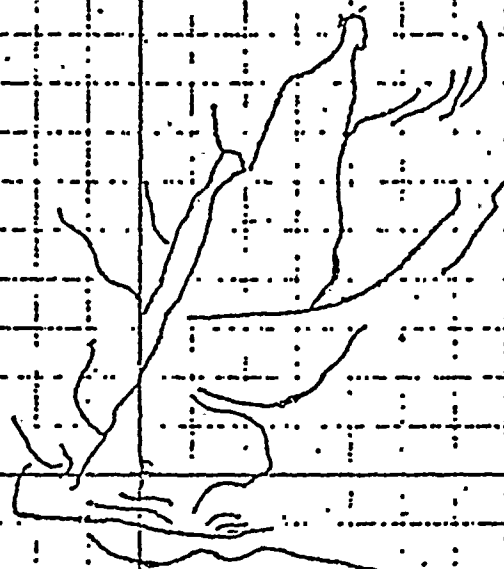
FIGURE 4. Sketch of cracks on the top slab surface in the vicinity of the impact

Cracks were tight, randomly oriented on the top slab surface, and confined to the area within and immediately adjacent to the impact. Those cracks are directly due to the impact.

The cracking pattern on the topside of the slab (Figure 4) directly reflects the impact of the counter weight. The cracking pattern on the underside of the slab, to the south of the impact area, has a directional pattern influenced by the reinforcing steel and is interpreted to reflect an initial drying shrinkage, possibly enhanced by the impact load.

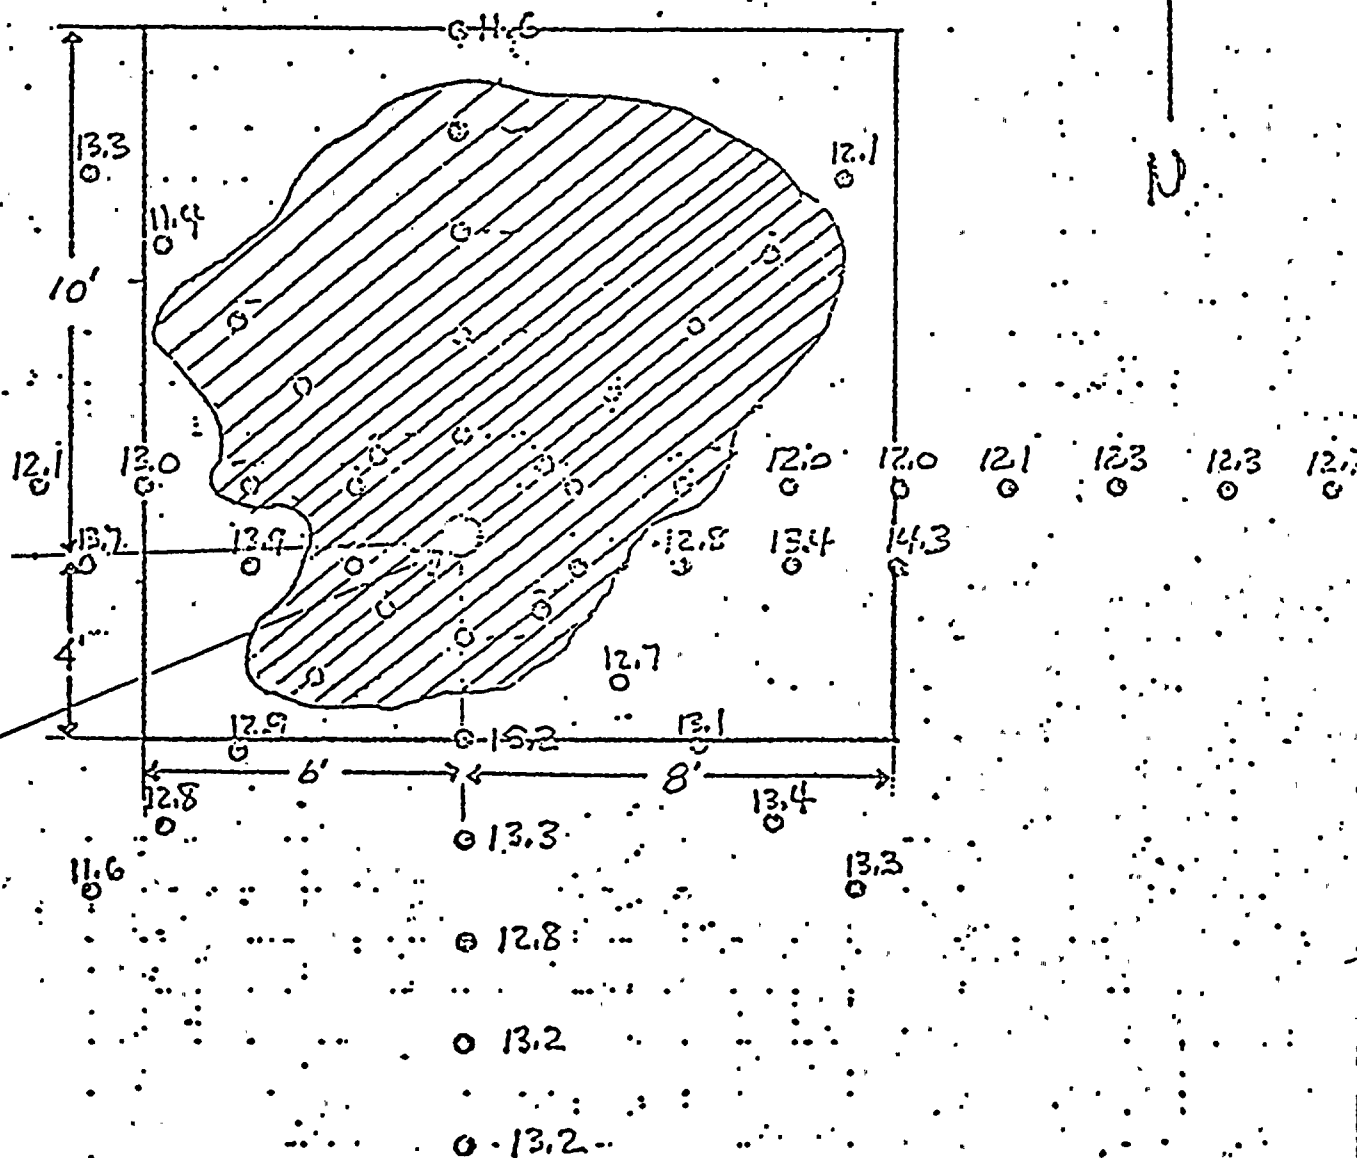
The cross-sectioned area is the affected area.

POINT  
OF  
IMPACT

RECOMMENDATIONS: The recommended repair is to reinforce the slab in the affected area by re-establishing the original integrity by epoxy intrusion grouting. This technique of intrusion of high penetration epoxy grout has been successfully utilized and is an established method (Reference ACI-503 "Guide for use of Epoxy Compounds with Concrete").

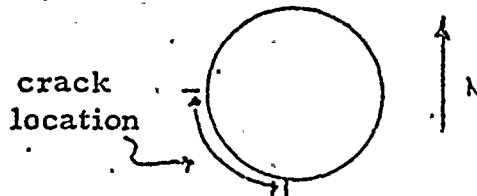
O - Origin

1. Circumferential crack at twelve inches (12") from top. No epoxy penetration evident.
2. Crack at three inches (3") from top, fragmented crack from south to west quadrant. No epoxy evident.

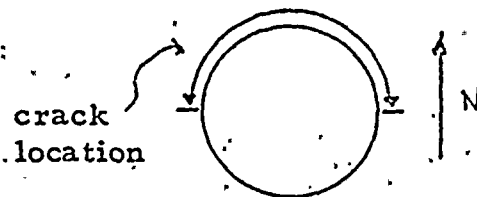
3. Crack at six inches (6") from top, located in northern sector. Fine hair line crack, no width. No epoxy evident.

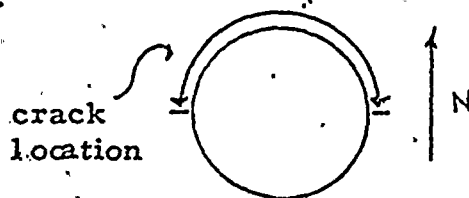
H - 2

1. Crack at seventeen inches (17") deep, no penetration of epoxy evident, located in northern sector.

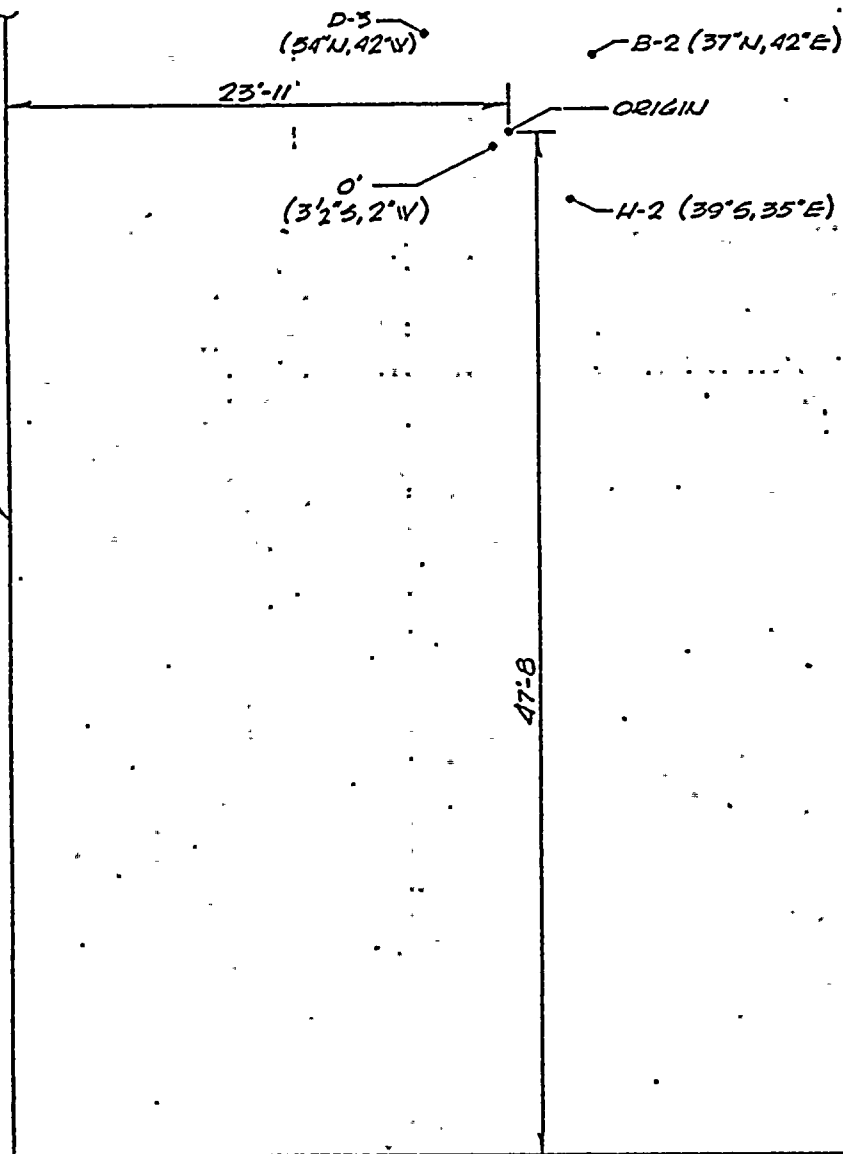
# REBAR DAMAGE

#1. O' → E-W REBAR, 20" BELOW TOP - FULL CUT -  
C OF BAR 3 1/2" S, 2" W

No additional reinforcing should be cut for any reason.
