VIRGINIA ELECTRIC AND POWER COMPANY
RICHMOND, VIRGINIA 23261

Subject: Steam Generator Inspection
Surry Power Station Unit No. 1

Steam Generator Tube Inspection
Program and Plugging Criteria
Surry Power Station - Unit No. 1
December, 1978

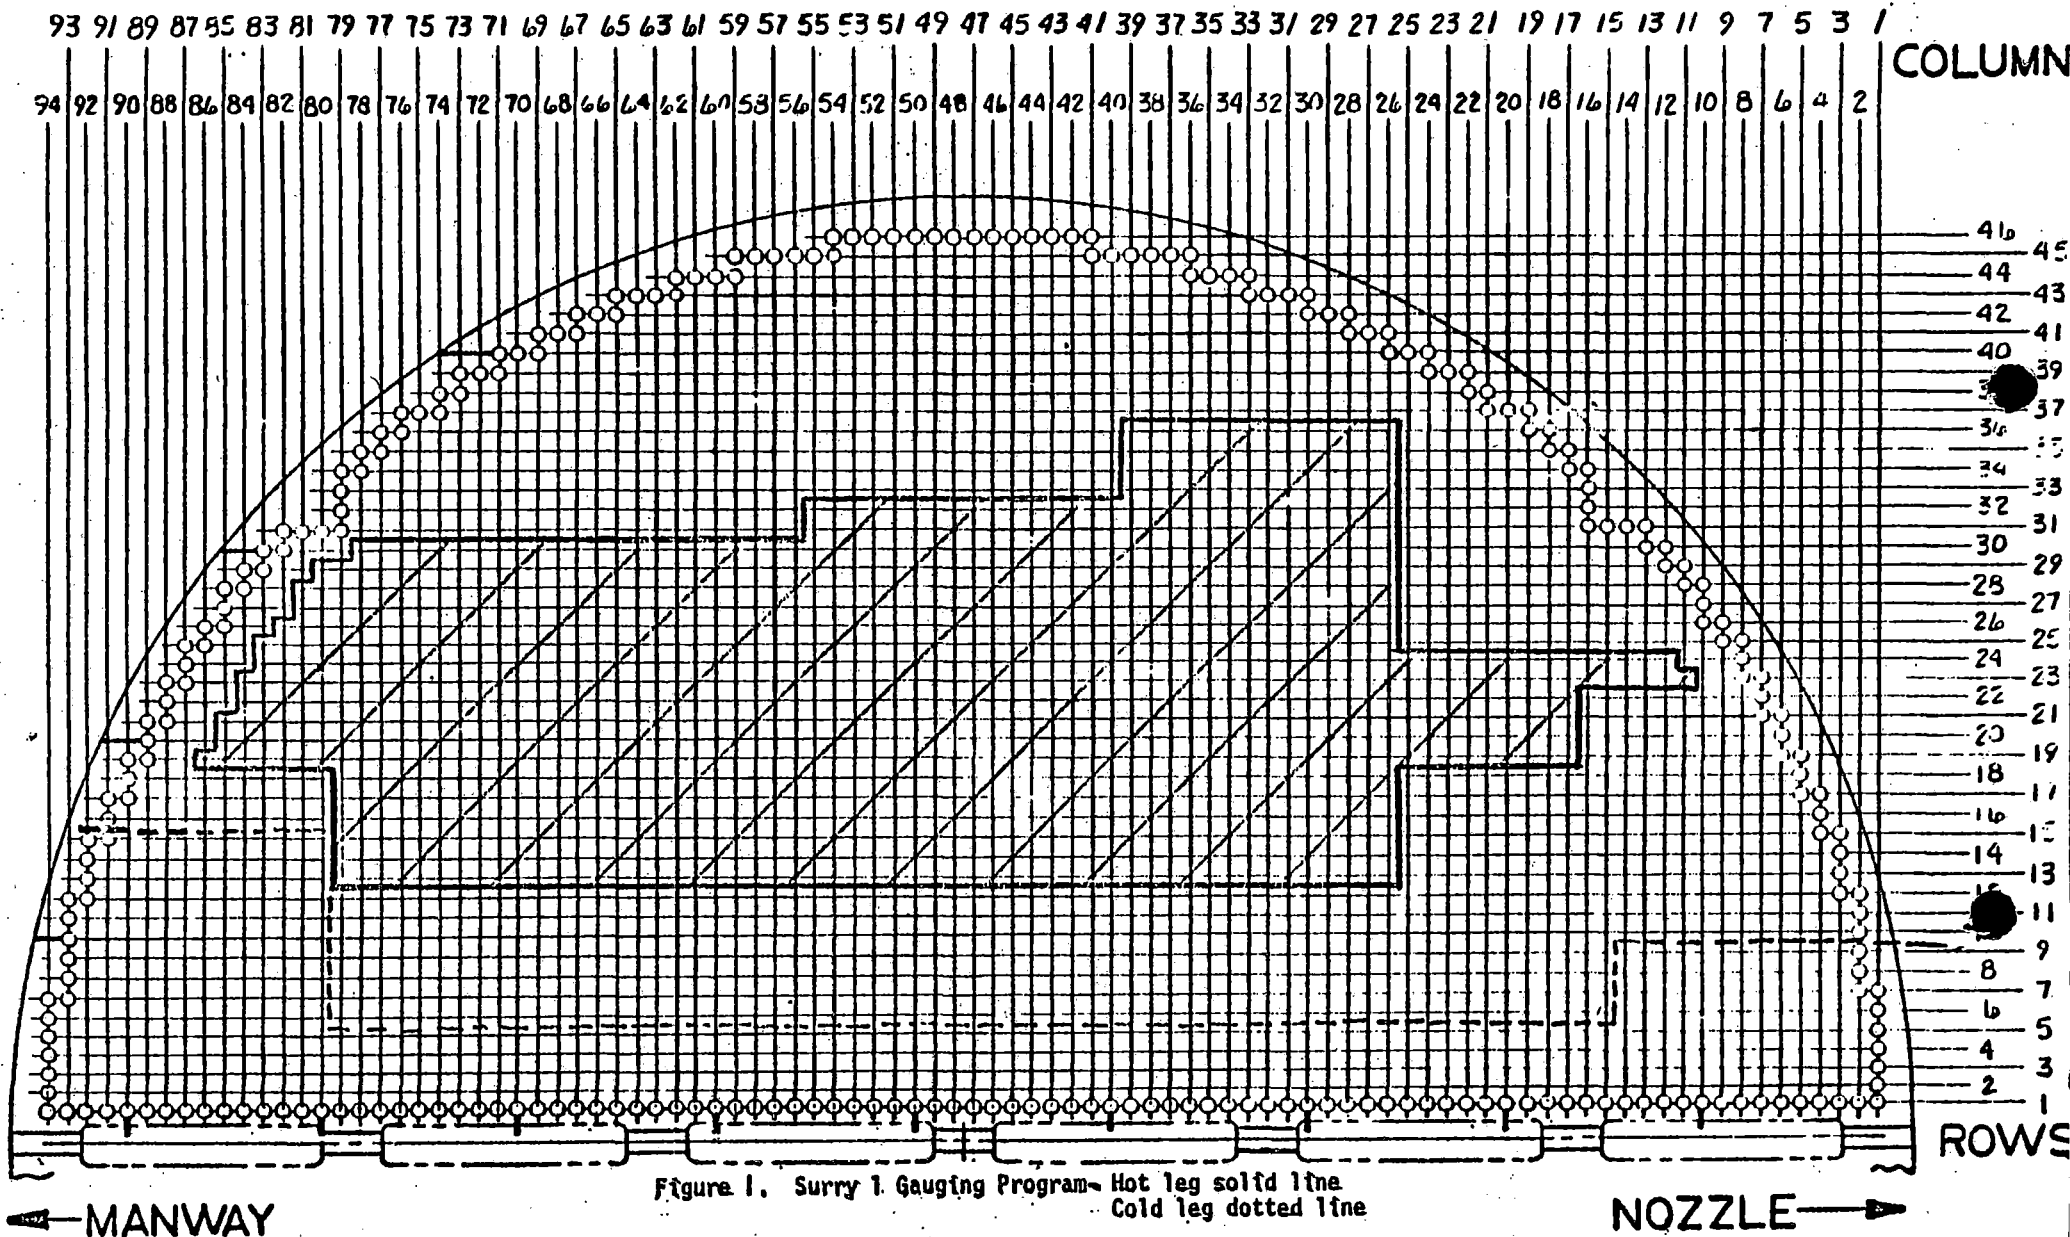
The tube gauging program is intended to encompass those regions where significant degrees of tube deformation may have occurred. The regions are determined by the finite element analysis which, when combined with tube strain tests, yields tube hoop strains versus tube location and extent of plate deformation. Additional inspections are defined for certain areas, particularly the wedge and patch plate regions. The inspection programs in the wedge and patch plate regions are based on previous leaker history at the Turkey Point and Surry sites, as well as previous gauging results at the Surry and Turkey Point sites. The basic inspection program was submitted in our letters of December 11 and 20, 1978 (Serial Nos. 703 and 703A). Additional inspections have been made on the basis of the visual inspection performed at the beginning of the inspection program. A summary of all inspections is included in Figure 1, Table 1 and Figures 3, 4, and 5.

- 1) The hot leg inspection boundary encompasses the 15% strain boundary as determined by finite element analysis. Since full closure was observed in Surry Unit 1 during the April 1977 inspection, Surry 1 is regarded as being beyond full closure by approximately 15 EFPM's. The tube hoop strain contours calculated for 15 EFPM's were utilized to determine the 15% boundary for this inspection. Figure 2, "Tube Hoop Strain at 18 EFPM's", conservatively represents the approximate current condition of Surry Unit No. 1 steam generators.

- 2) The cold leg inspection boundary was based on the 17.5% strain boundary and on past experience. The use of the 17.5% strain boundary is based on the minimal number of denting indications found in previous inspections. As explained in our letter of December 20, 1978, the results of this inspection confirm the validity of this approach.

- 3) When a restricted tube was found close to the inspection boundary, the inspection was expanded in that area.
- 4) During the visual inspection of steam generators at the beginning of the outage, two (2) tubes in the center area of the tube bundle on steam generator C were found dripping. An expanded inspection was performed in the area of these two tubes in steam generator C. Since leakage in these tubes was attributed to O.D. wastage additional inspections were made in all steam generators of all tubes that showed wastage of 20% or greater during the May, 1978 inspection and all tubes 1 and 2 tubes beyond the previous inspection boundary. These additional inspections were performed in order to determine if a) tubes exhibiting moderate wastage in May had deteriorated rapidly during the subsequent 6 months operation, or if b) the area of significant tube wastage had expanded beyond previous inspection boundaries.

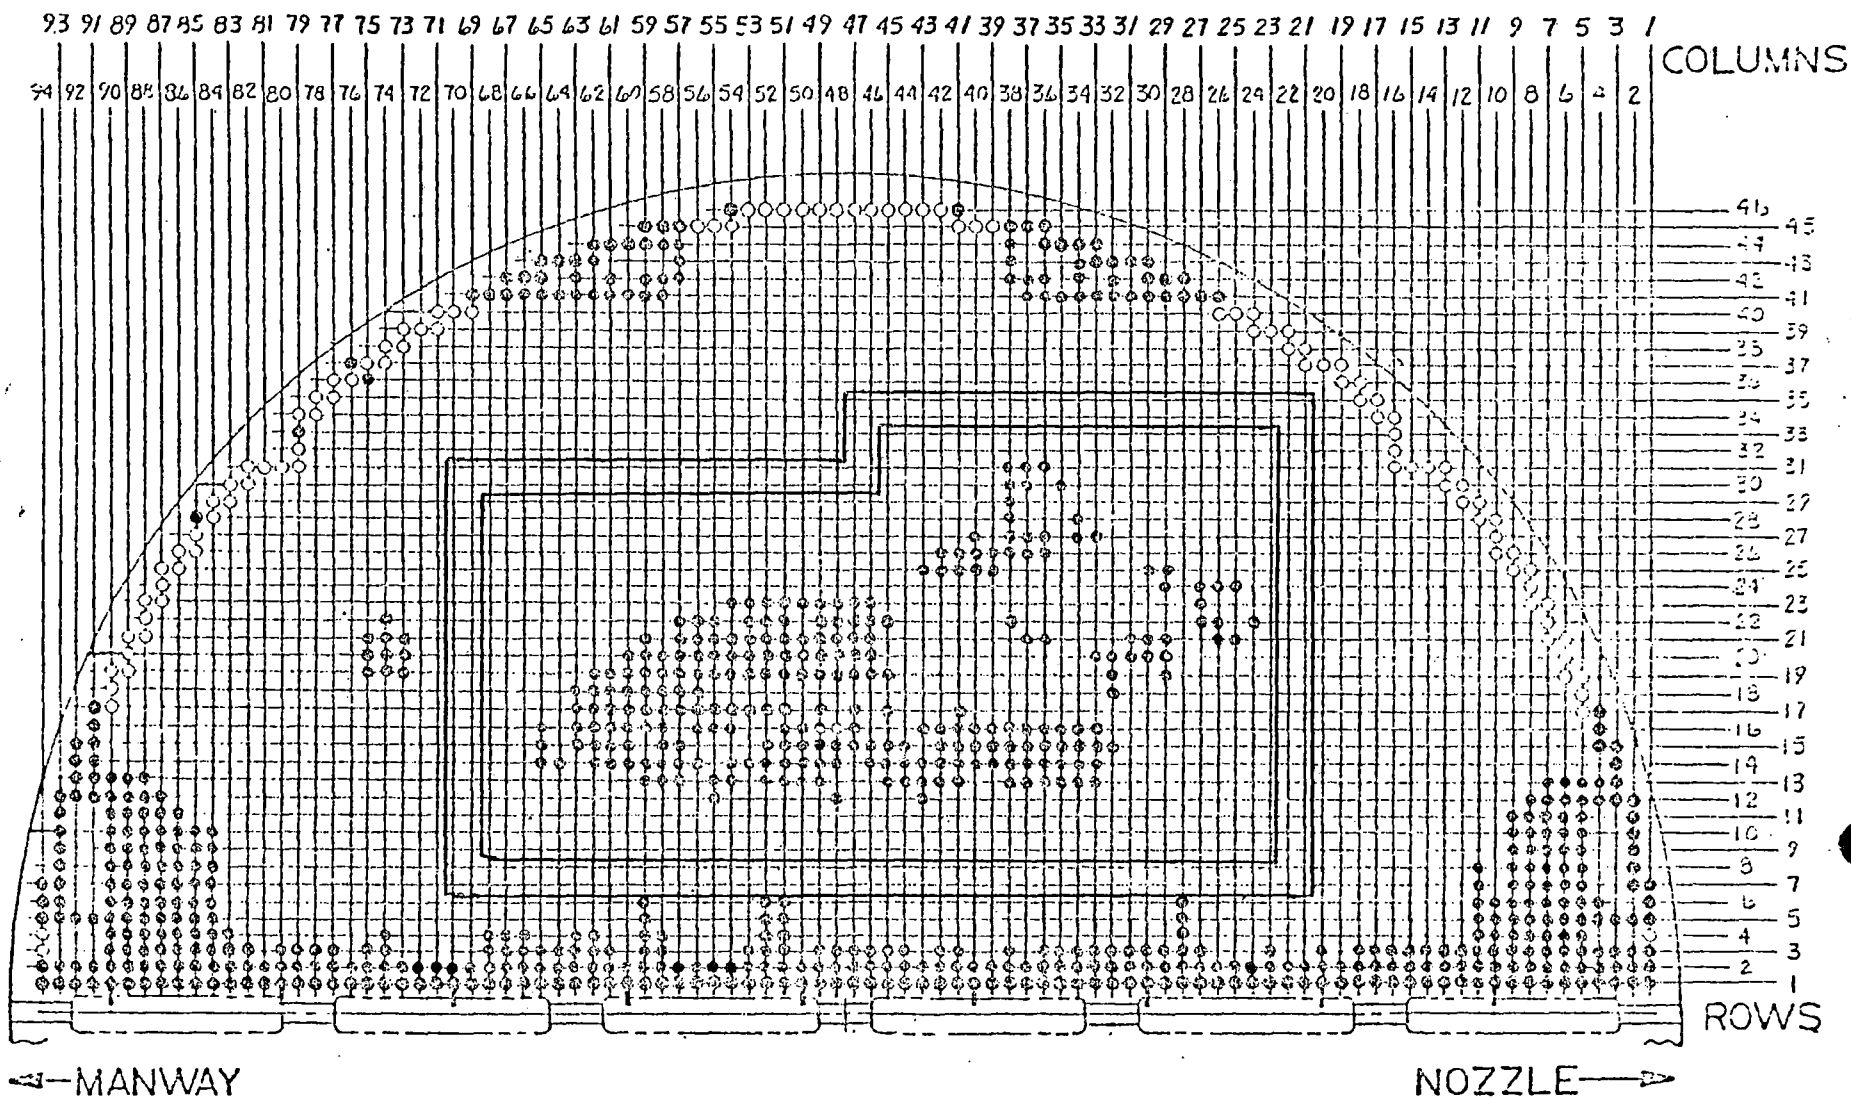
Recognizing that the above conclusions bring into question previous inspection results, extensive additional inspections were made in the wastage prone areas. Specifically, all tubes in all steam generators which indicated moderate (> 20%) wastage at the previous inspection were reinspected. Additionally 2 tubes in all directions beyond the boundary of the previous Regulatory Guide 1.83 inspection were inspected. This

was to detect any expansion in the area of significant wastage. The inspection areas are shown in Figures 3, 4, and 5. Note that on Figure 3 for steam generator "A", the inner enclosed area represents the boundary of the previous inspection. All tubes in the inner area which showed wastage of 20% or greater in the previous inspection were reinspected. This area is surrounded by a two tube boundary in which all tubes were inspected. The same applies to Figures 4 and 5 for steam generators "B" and "C". Additionally, in steam generator "C" a ten by ten area designated by the small square was completely inspected. This was the localized inspection in the area of the two suspected leaking tubes. The supplementary inspections for tube OD wastage included a total of 918 tubes. All tubes with either significant wastage or some wastage in proximity to a dent of sufficient size to mask the defect were plugged. This resulted in the plugging of a total of 63 tubes including all steam generators. While this is a large number of tubes, this indicates the application of an extremely conservative plugging approach more so than any increase in wastage activity. Almost all tubes plugged had indications of only minor wastage and were plugged due to masking. Only 16 tubes were judged as near or exceeding the 40% plugging limit, and in each case these were tubes which were close to the limit, i.e. 35-39% wastage, at the previous inspection. This indicates that there has been no rapid growth in wastage activity. The recognition of the masking effects of minor dents and the corrective action as implemented should ensure the integrity of the central bundle region during the next operating period.

STEAM GENERATOR 1A
SUPPLEMENTARY INSPECTION AREAS

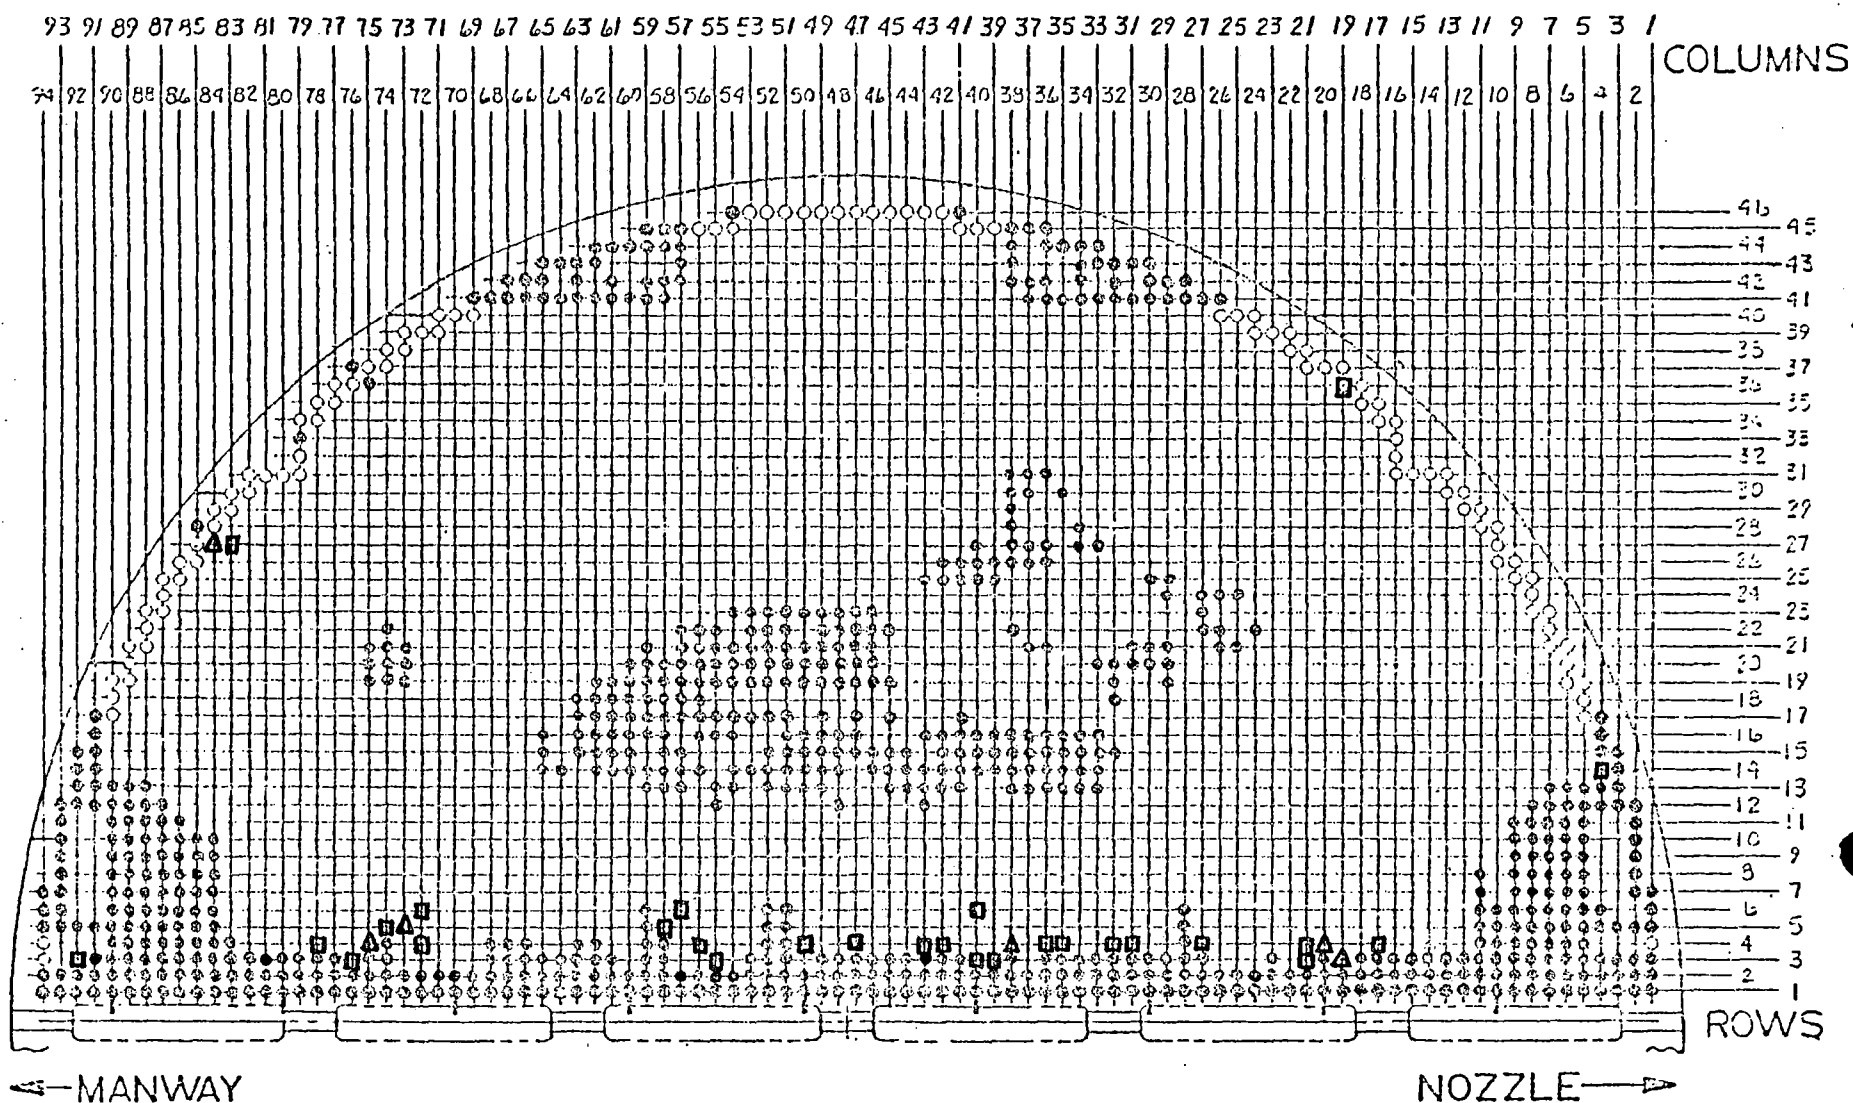
Figure 6.

The results of the inspection program are presented in Figures 6, 7, and 8. These results support the adequacy of the inspection program and the plugging criteria.

A. Tubes in the tubelance region that restrict the .650" probe lie within the 15% strain boundary. All tubes that restrict either the .610" or the .650" probe are adjacent to areas of previous activity.

B. There were no tubes in steam generators A, B, or C that restricted the .540" probe.

C. All activity appears to be moving in a stable manner, adjacent to previous activity.

D. Activity in the wedge areas appears consistent with previous experience at Surry and other sites. Based on the behavior of these areas at Surry and other sites, application of the plugging criteria should stabilize these regions.

GAUGING RESULTS

SURRY 1, S.G. "A"

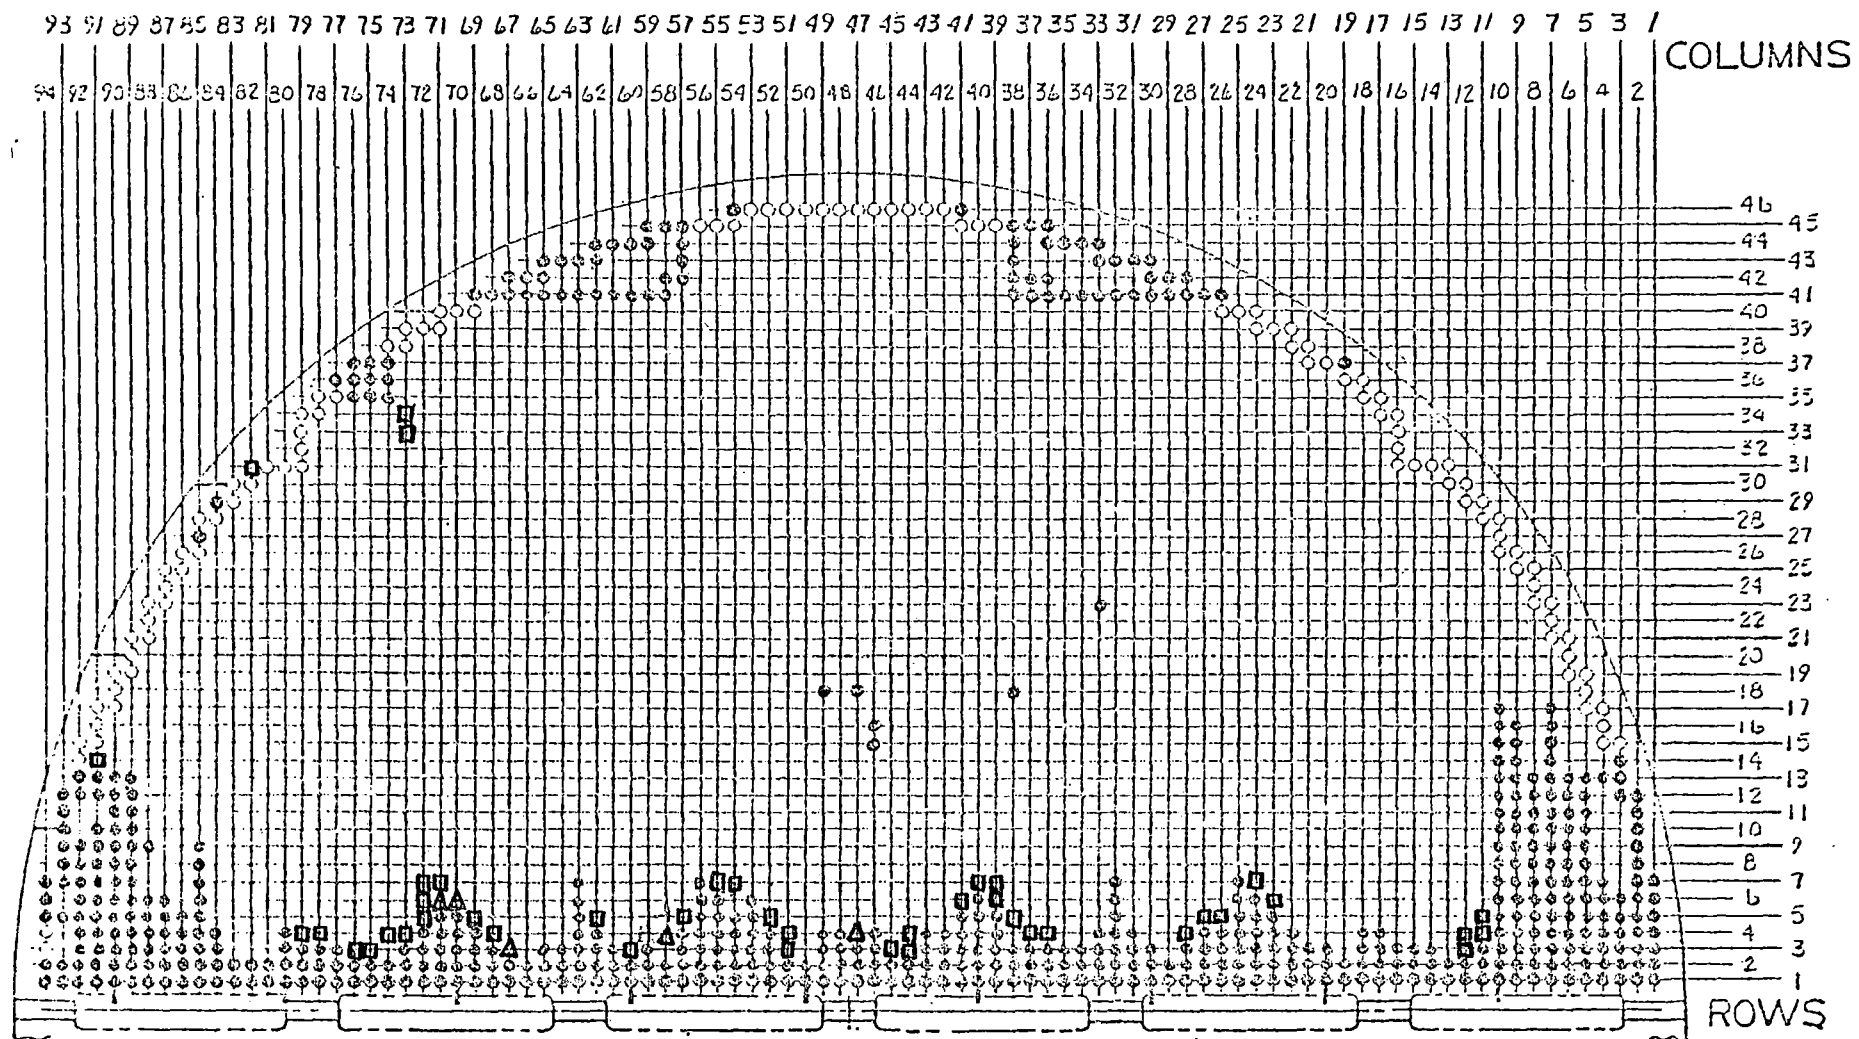
GAUGING RESULTS
SURRY 1, S.G. "B"

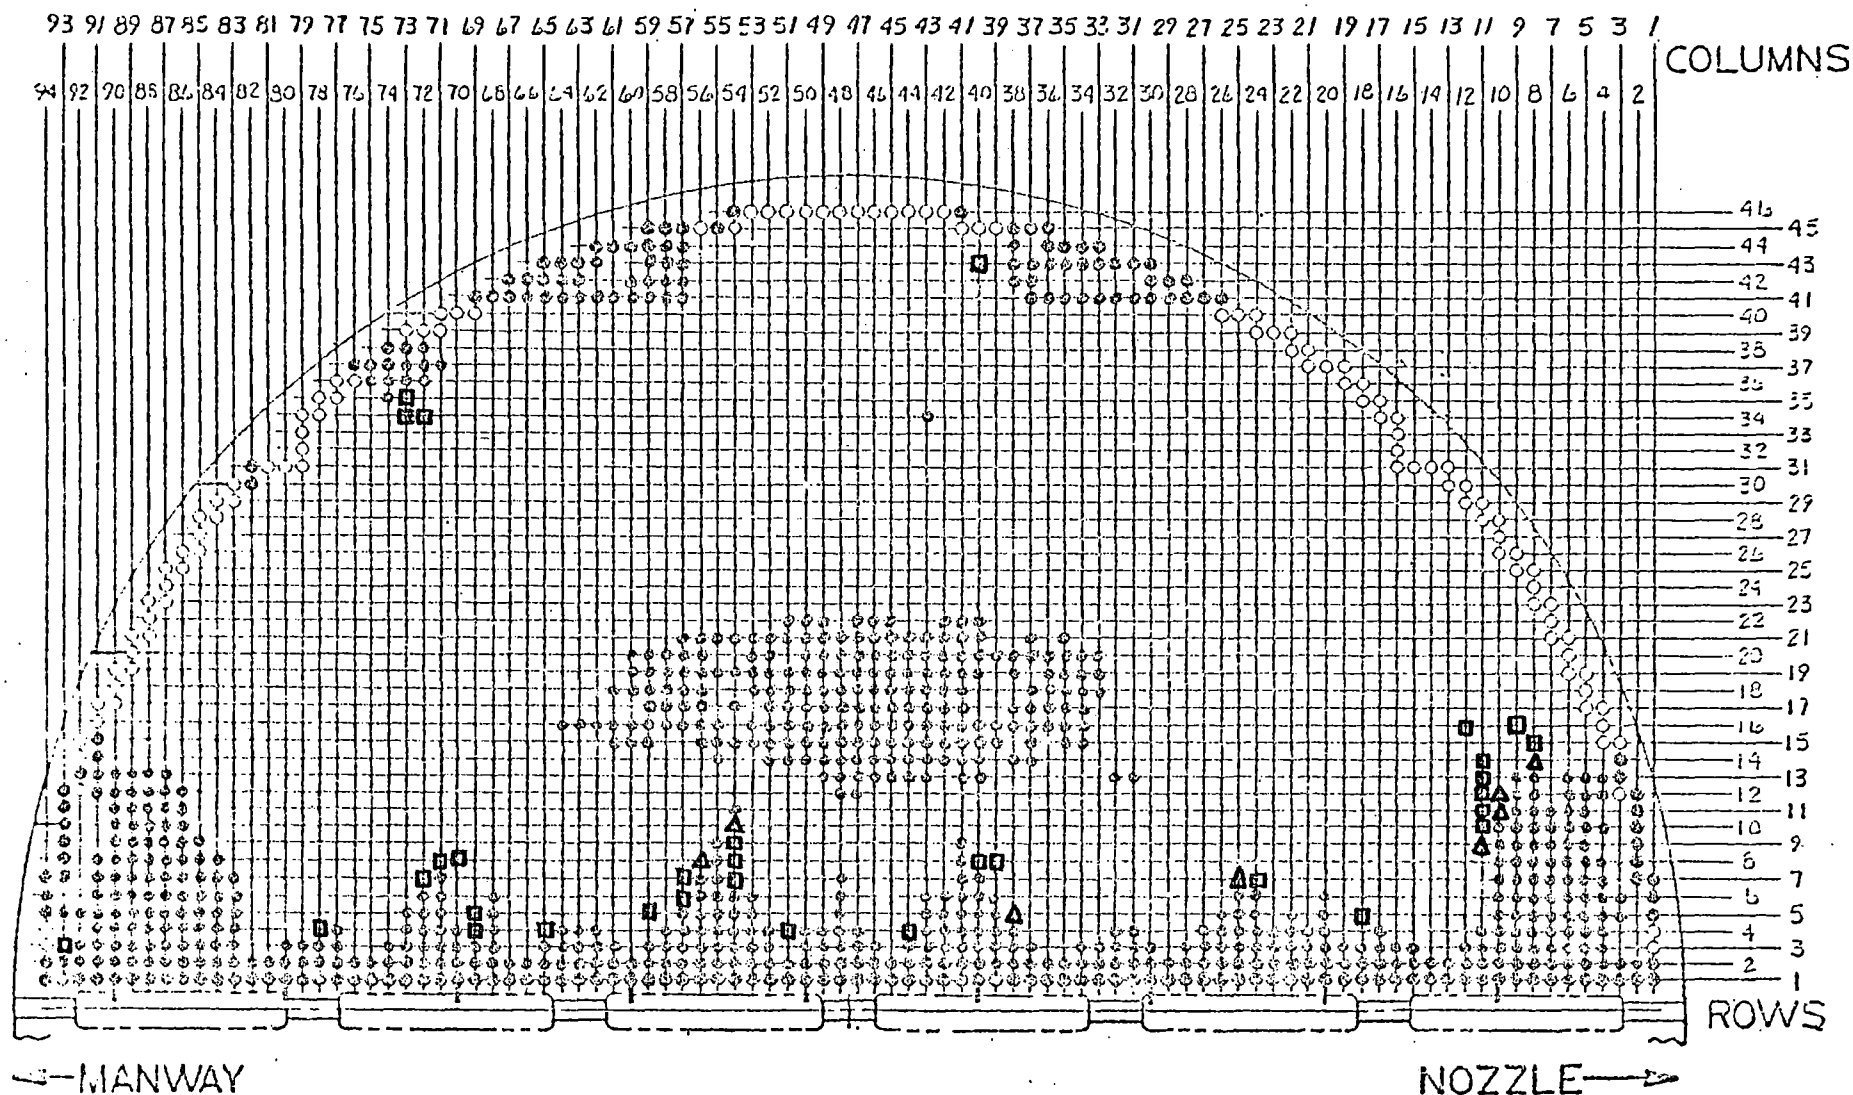
GAUGING RESULTS
SURRY 1, S.G. "C"

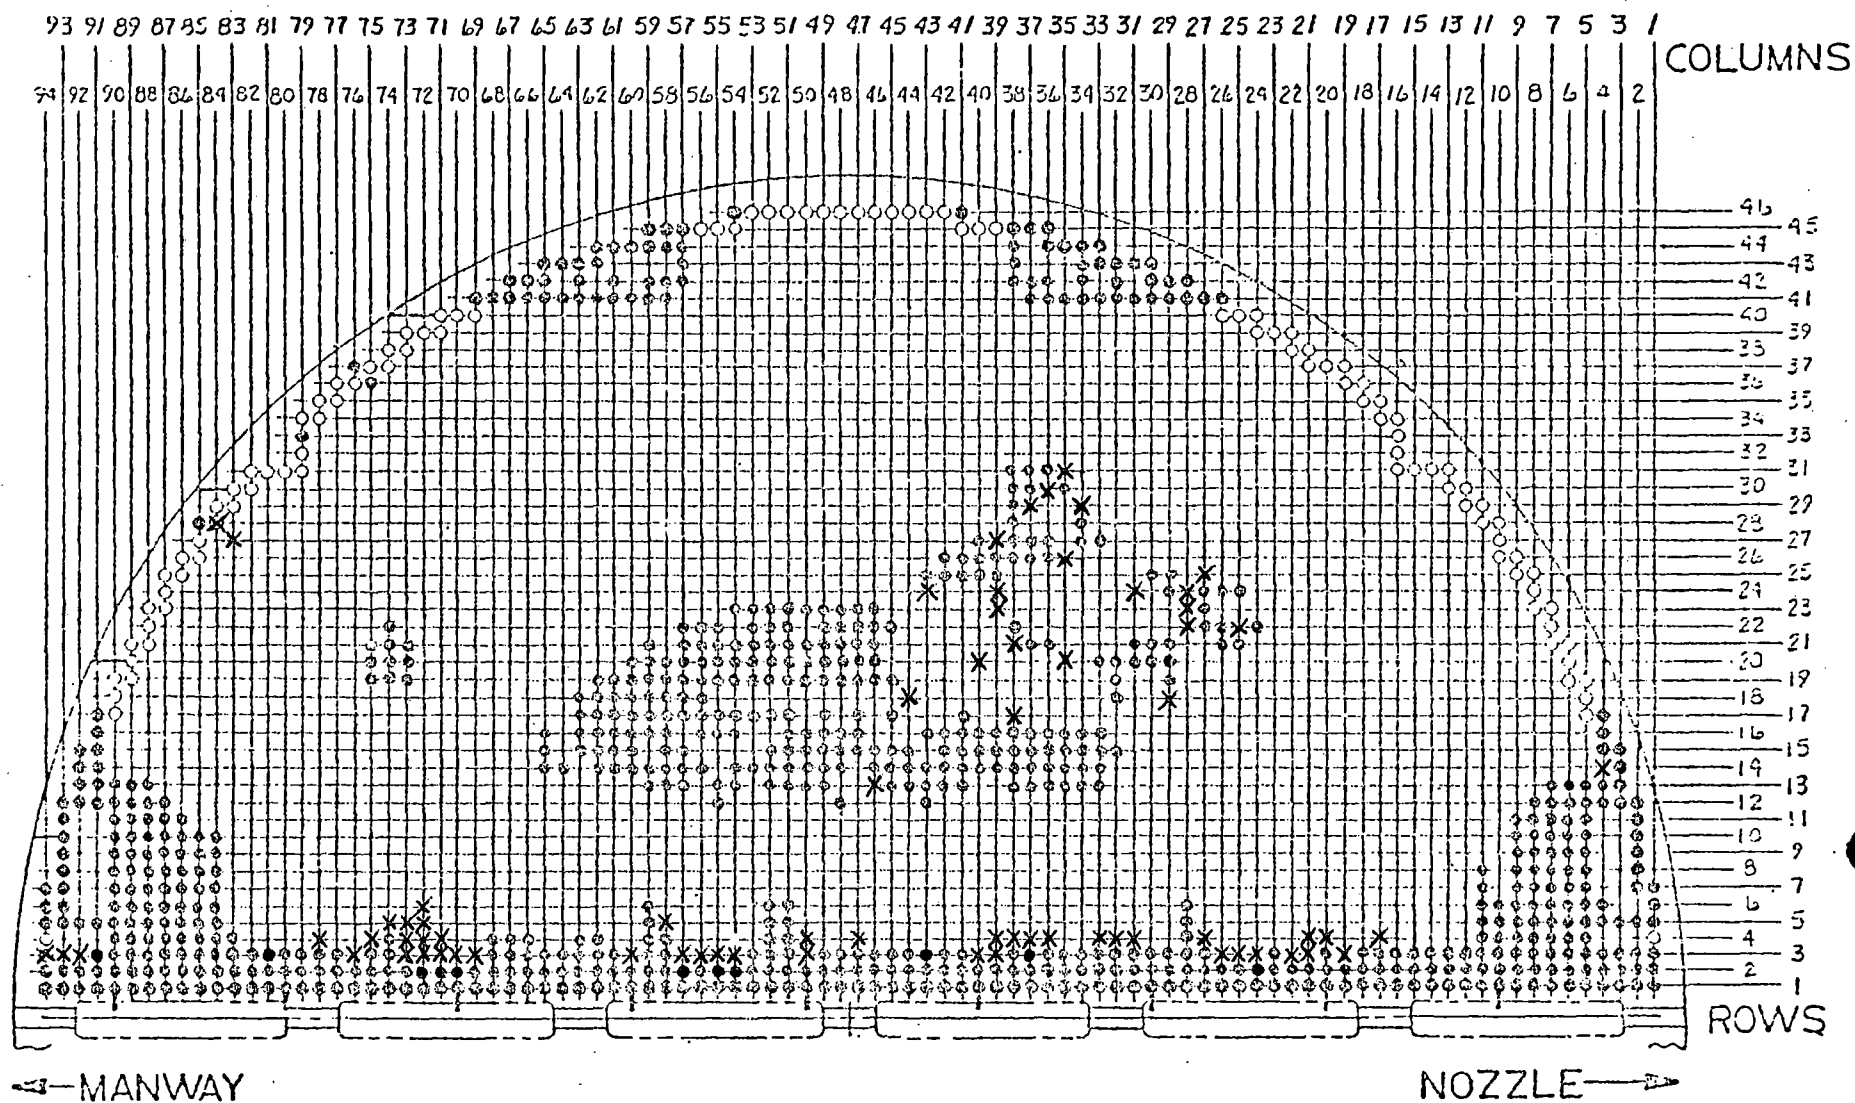
SURRY 1 STEAM GENERATOR A
 PREVENTIVE PLUGGING PATTERN

Figures 9, 10, and 11 indicate the plugging patterns for Surry 1 steam generators based on the plugging criteria described above.

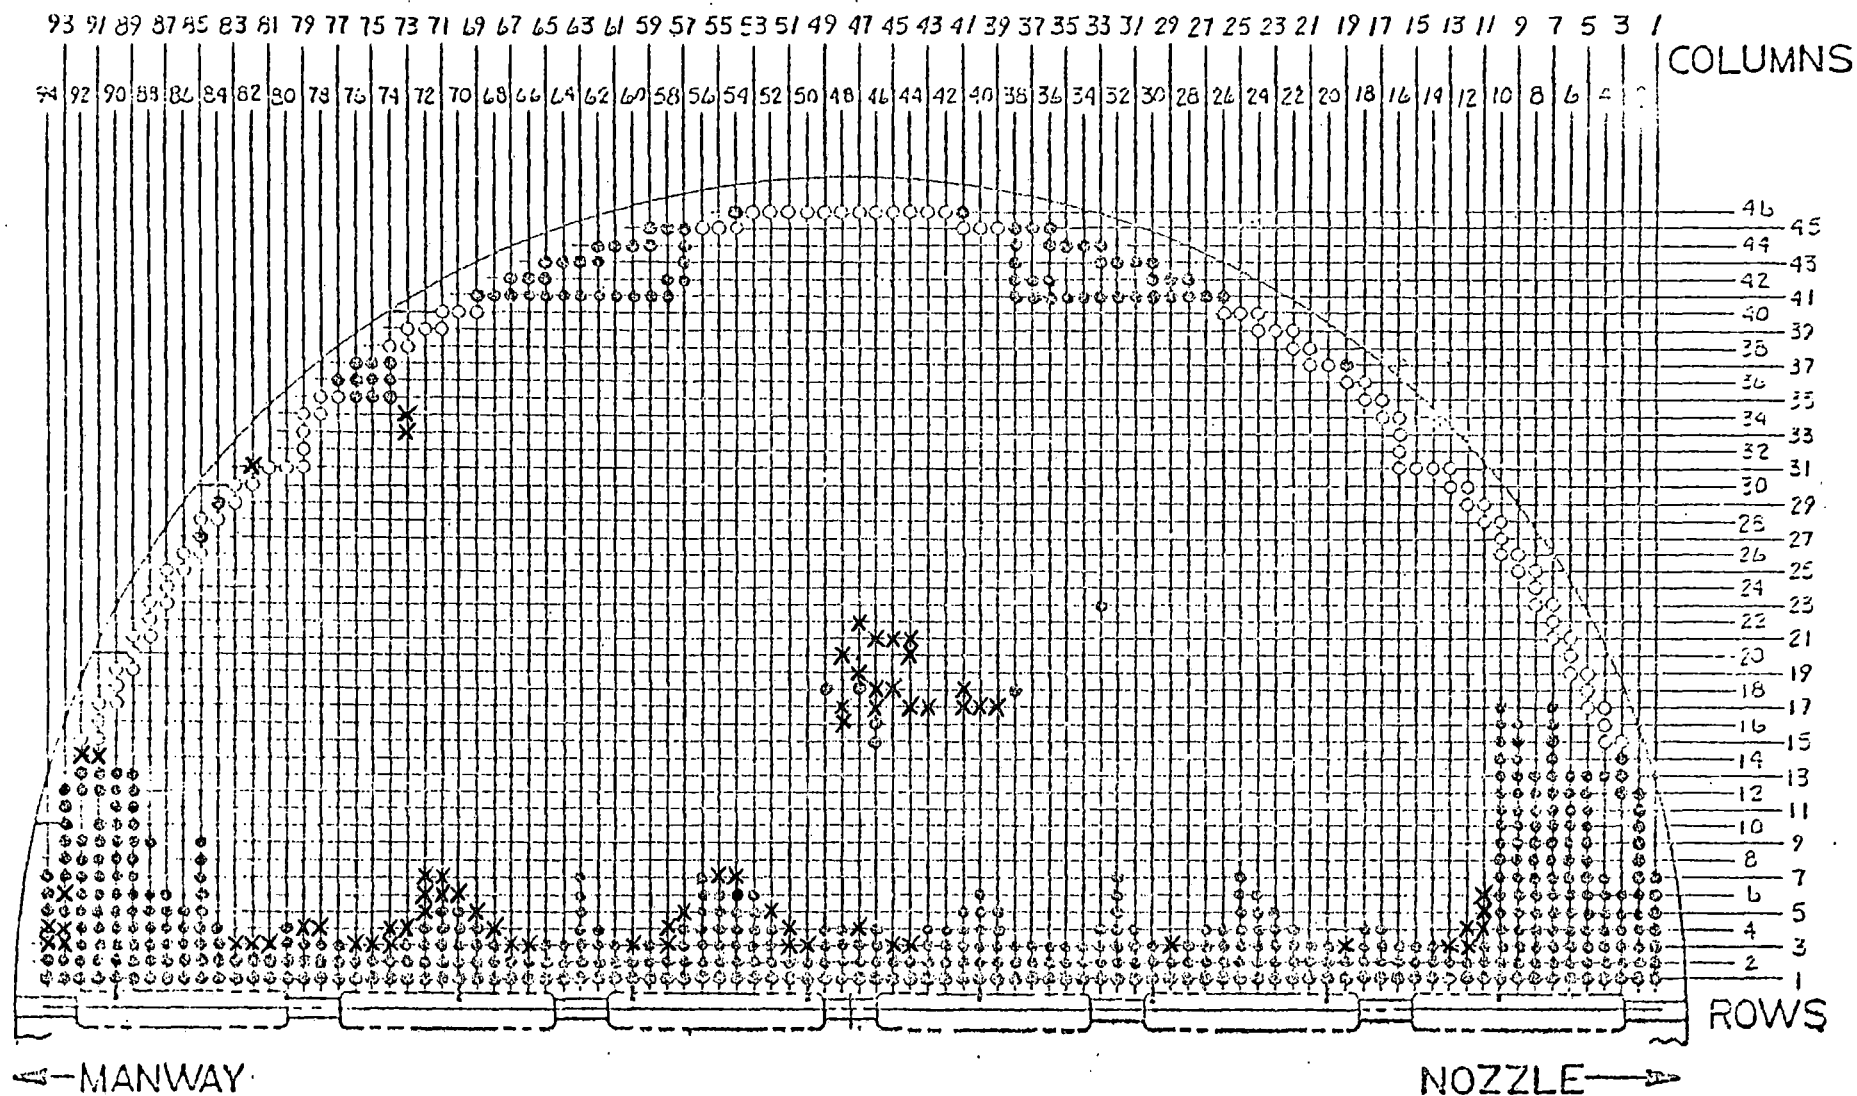
Figure 10

SURRY 1 STEAM GENERATOR B
PREVENTIVE PLUGGING PATTERN

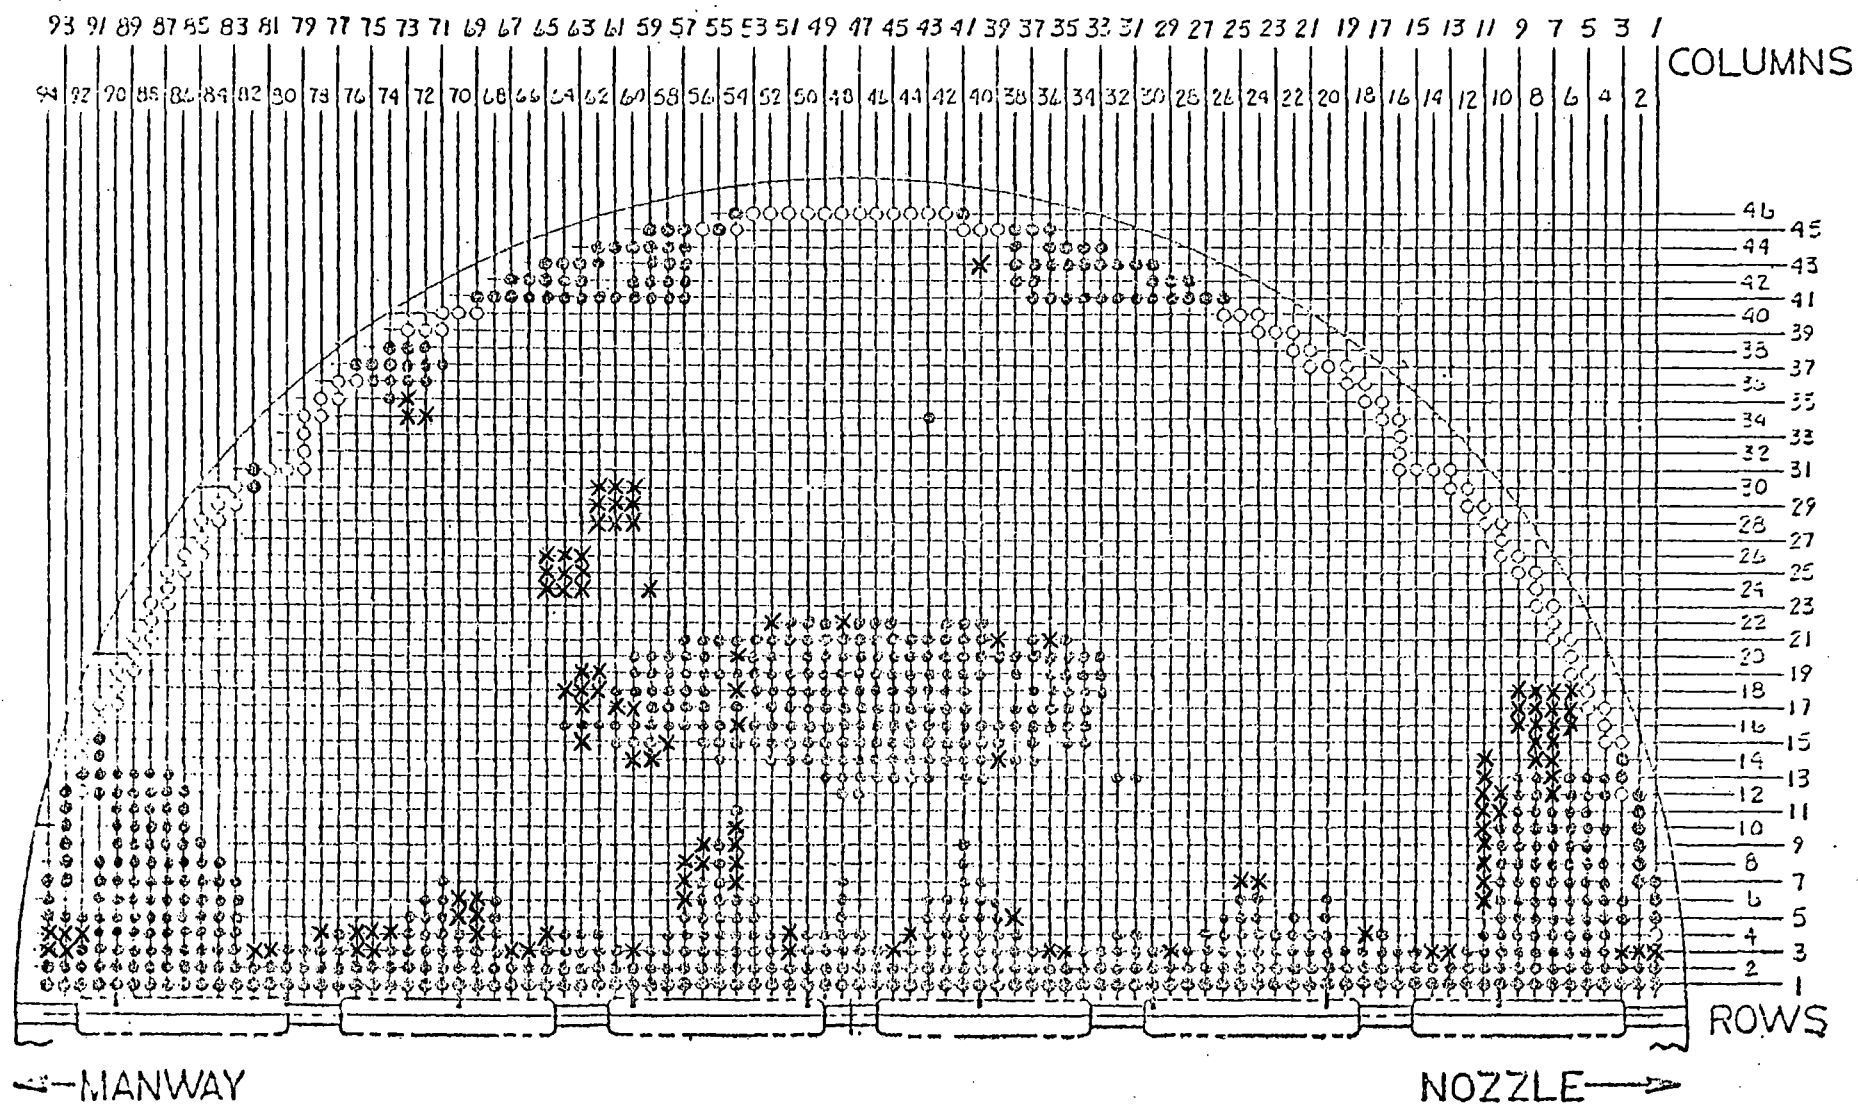
Figure 11

SURRY 1 STEAM GENERATOR C

PREVENTIVE PLUGGING PATTERN
