VIRGINIA ELECTRIC AND POWER COMPANY
RICHMOND, VIRGINIA 23261

This is in response to your letter of November 21, 1980 which forwarded IE Bulletin No. 80-24, "Prevention of Damage Due to Water Leakage Inside Containment (October 17, 1980 Indian Point 2 Event)". The information required by the Bulletin for North Anna Power Station Unit Nos. 1 and 2 and Surry Power Station Unit Nos. 1 and 2 is attached.

RESPONSE TO I.E. BULLETIN 80-24
NORTH ANNA UNITS 1 AND 2

RESPONSE TO IEB-80-24
PREVENTION OF DAMAGE DUE TO WATER LEAKAGE
INSIDE CONTAINMENT (OCT. 17, 1980 INDIAN POINT 2 EVENT)

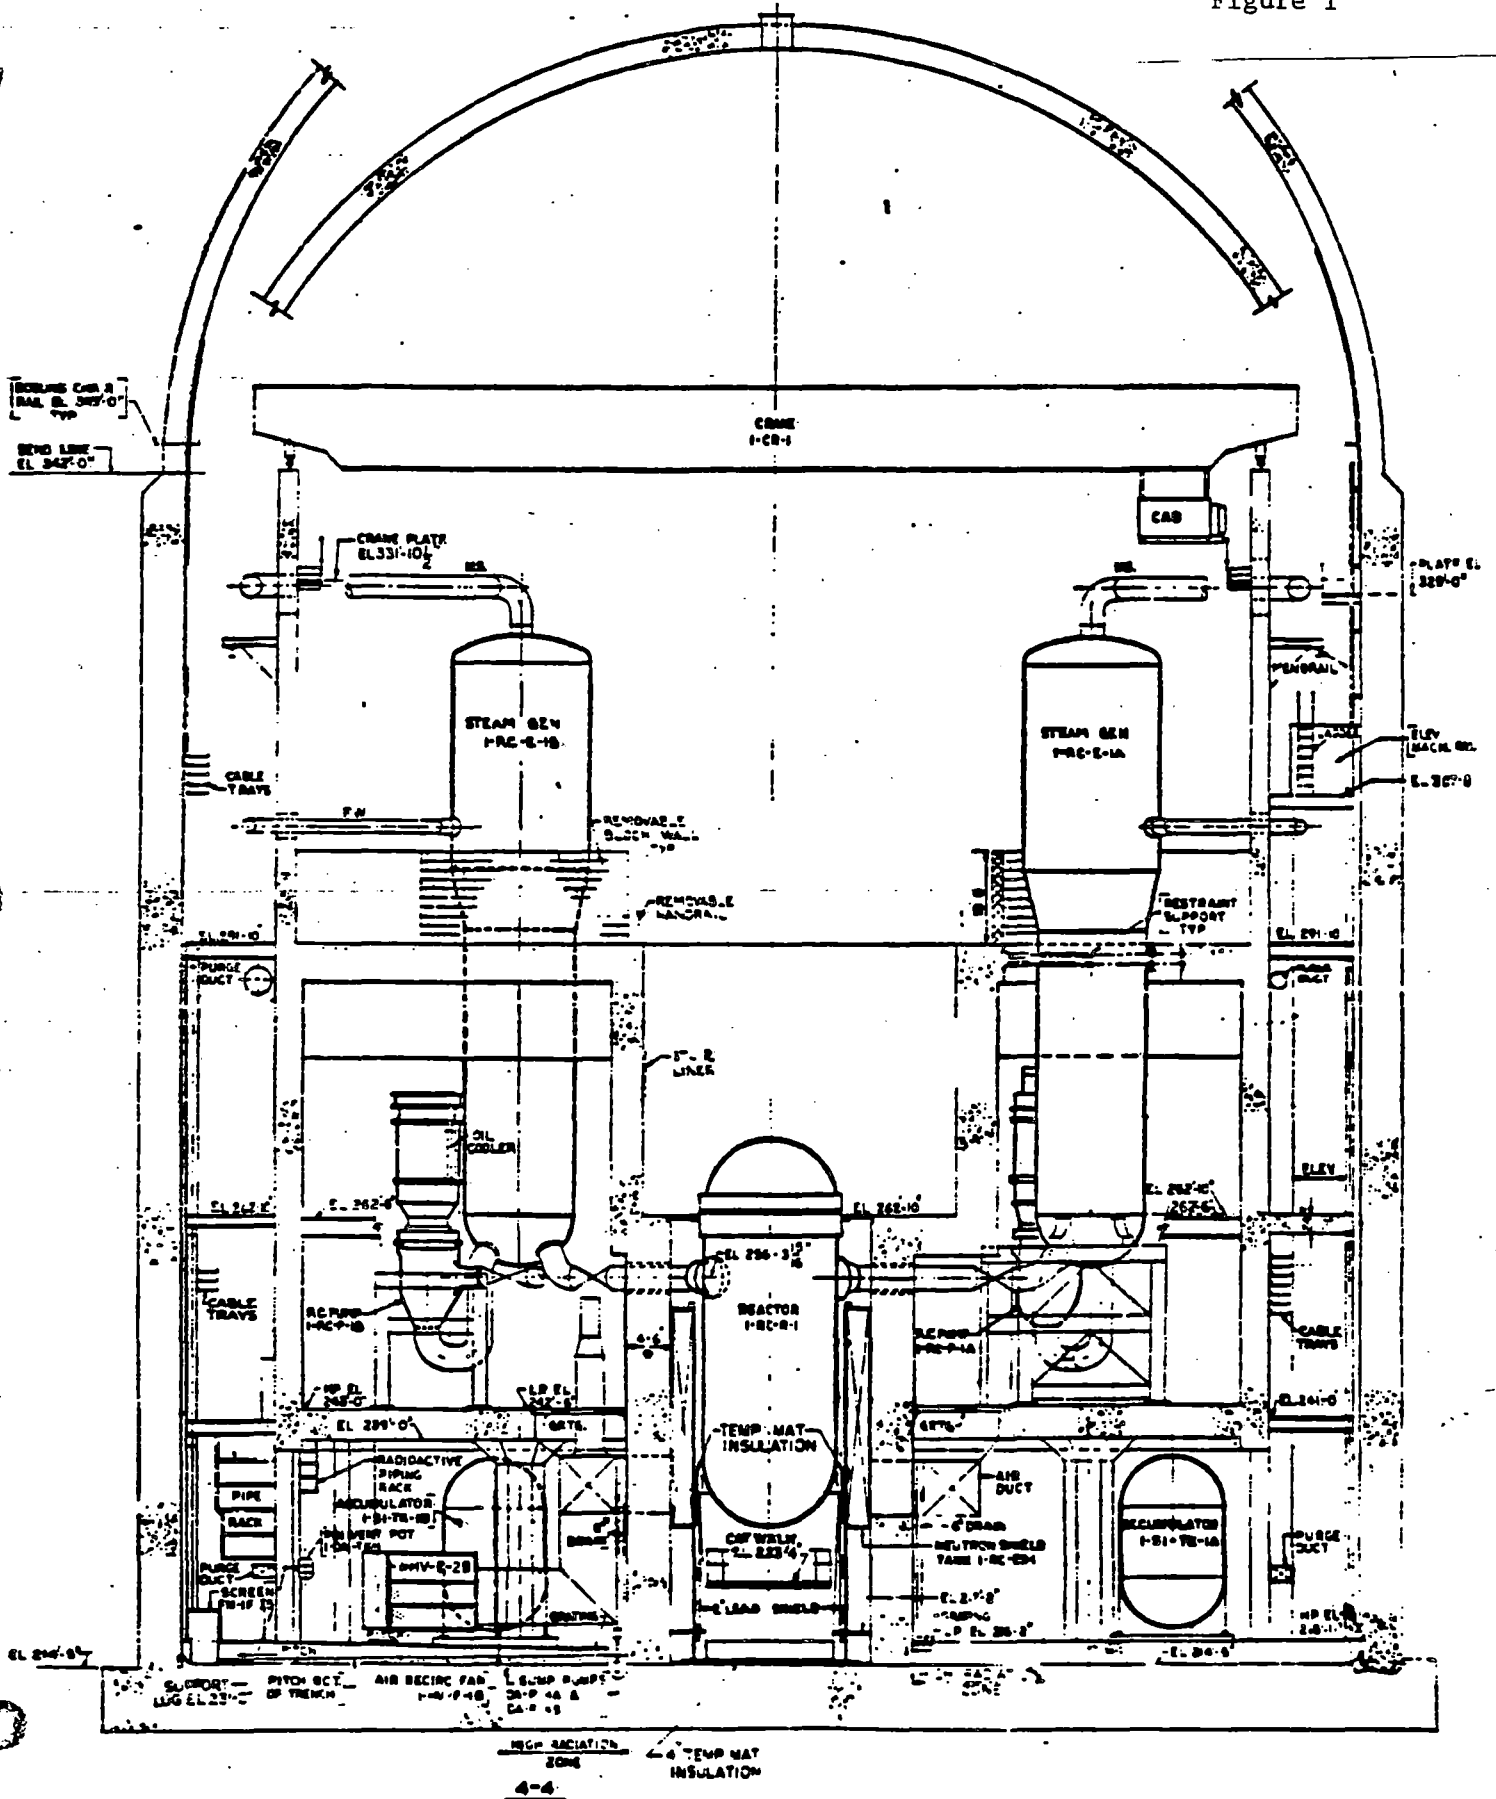
Enclosure 1
Figure 1

1. North Anna Power Station, Units 1 and 2, has no open cooling water systems supplying loads inside the containment which operate during routine operations. The service water system does supply cooling water to the recirculation spray heat exchangers during Containment Depressurization Actuation (CDA), and it is capable of supplying cooling water to the containment air recirculation fan cooling coils, but such operation is blocked by administrative control. The reactor vessel is located at such an elevation as to provide numerous diversified indications of flooding prior to reaching a level where the vessel would be exposed to external water. (Ref. Fig. 1).
