## LICENSEE EVENT REPORT (LER)

## Improper Routing of Appendix R Related Cables

**May 19, 1987**  
**Enforcement Conference**

**Improper Routing of Appendix "R"**  
**Related Cables in Surry Unit 2**  
**Cable Vault and Tunnel**

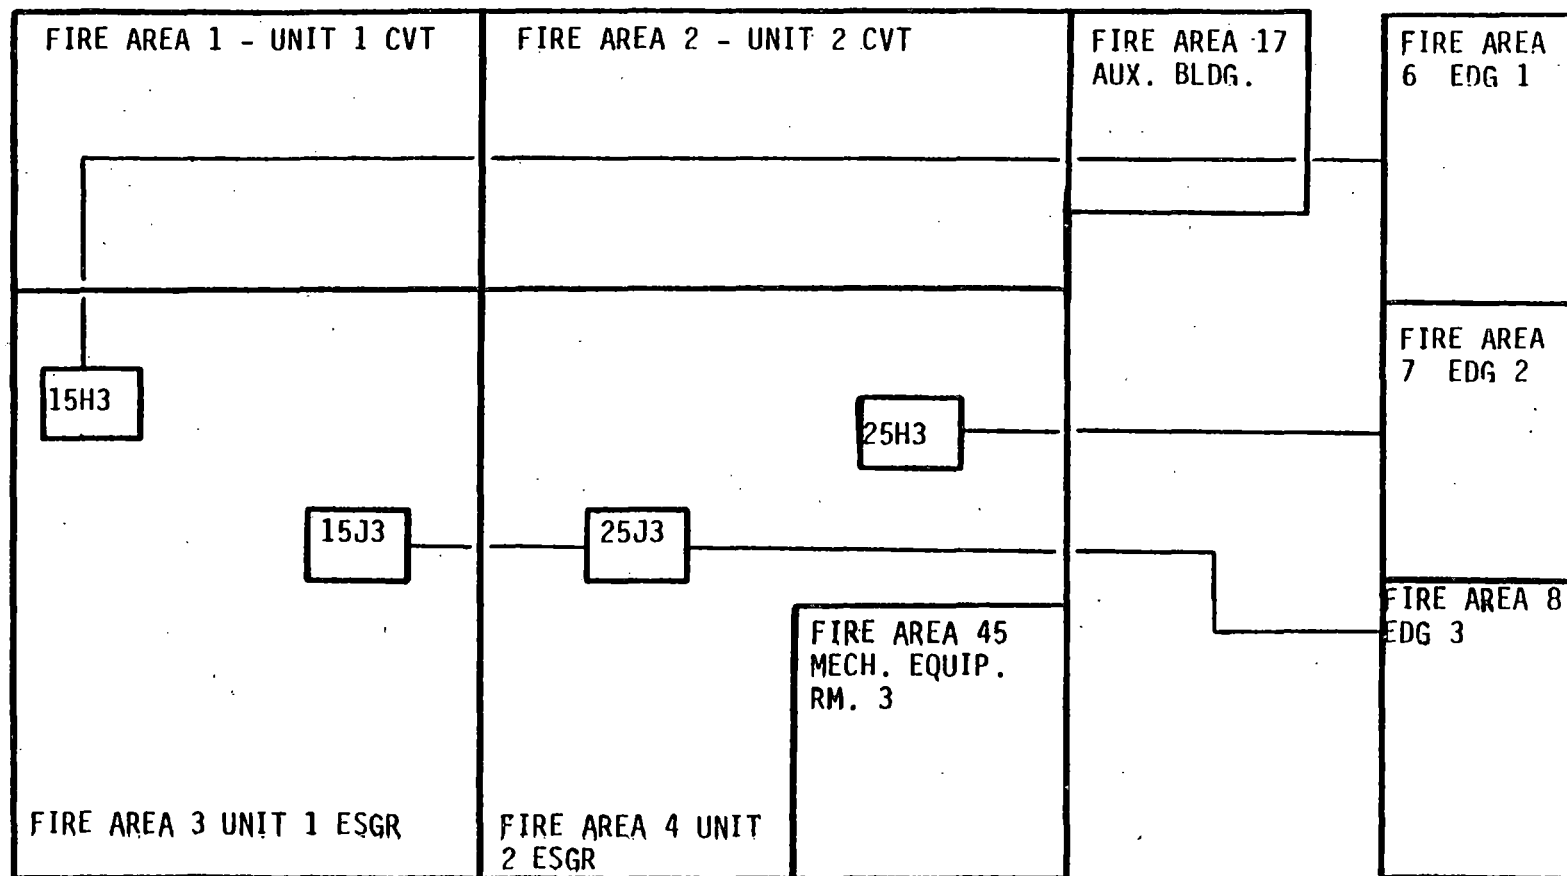
SURRY POWER STATION  
EMERGENCY DIESEL GENERATOR  
EXISTING MAIN LEADS  
SIMPLIFIED CABLE BLOCK DIAGRAM

- **Design Change 83-39A  
rerouted EDG #1 cables  
through #2 CVT**
- **Recent review revealed  
EDG 3 control cables in #2  
CVT**
- **A fire in #2 CVT could  
disable cables for both EDG 1  
and EDG 3, as well as Unit 2  
safe shutdown equipment**

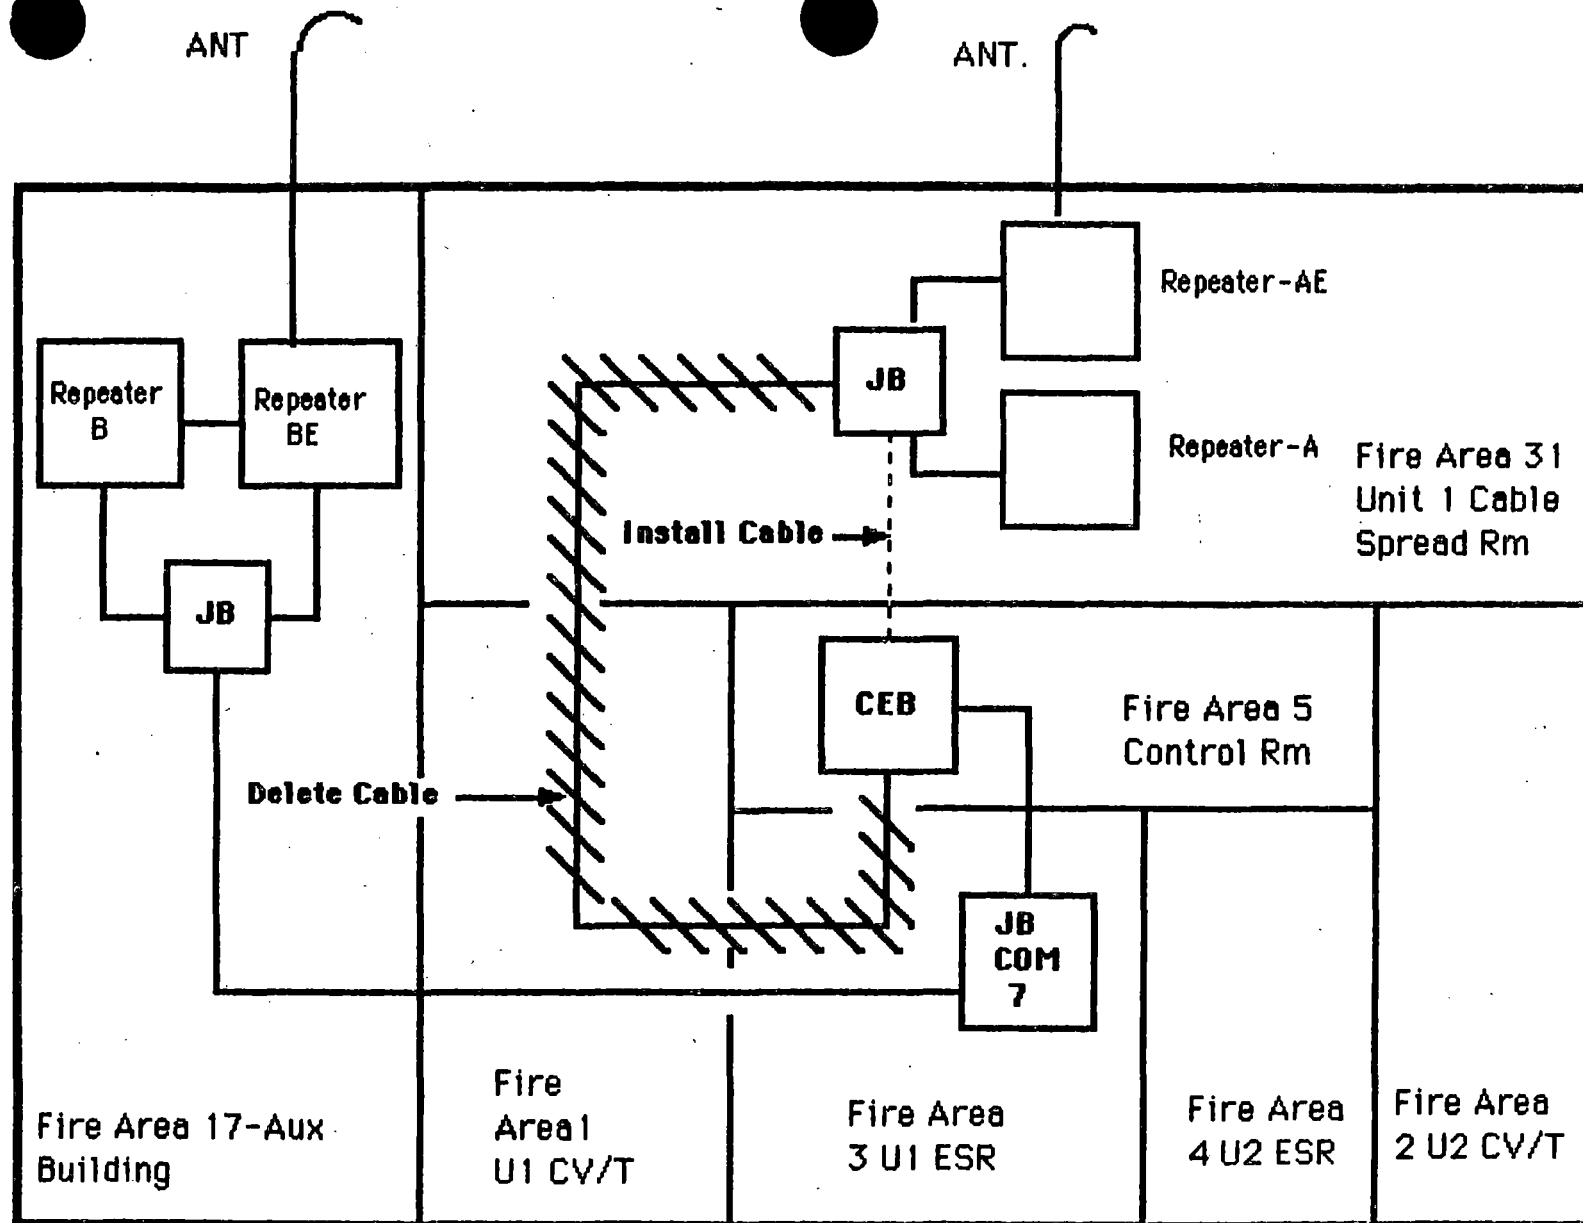
Surry Power Station  
Appendix "R" Communications System  
Simplified Block Diagram

- **Immediate Evaluation**
  - **Special Report**
- **Compensatory Measures**
  - **Two fixed fire detection systems**
  - **Two fixed fire suppression systems**
  - **Periodic fire watch**
- **Additional Reviews**
  - **North Anna DCP's**
  - **CYGNA DCP's**
  - **Appendix R annual review completed**
  - **One other discrepancy noted:**  
**communications cable**
