NRC INSPECTION MANUAL

OPERATING EXPERIENCE SMART SAMPLE (OpESS) 2007/02 Revision 3

ANALYSIS OF FLOODING VULNERABILITIES

Effective Date: 09/01/2018

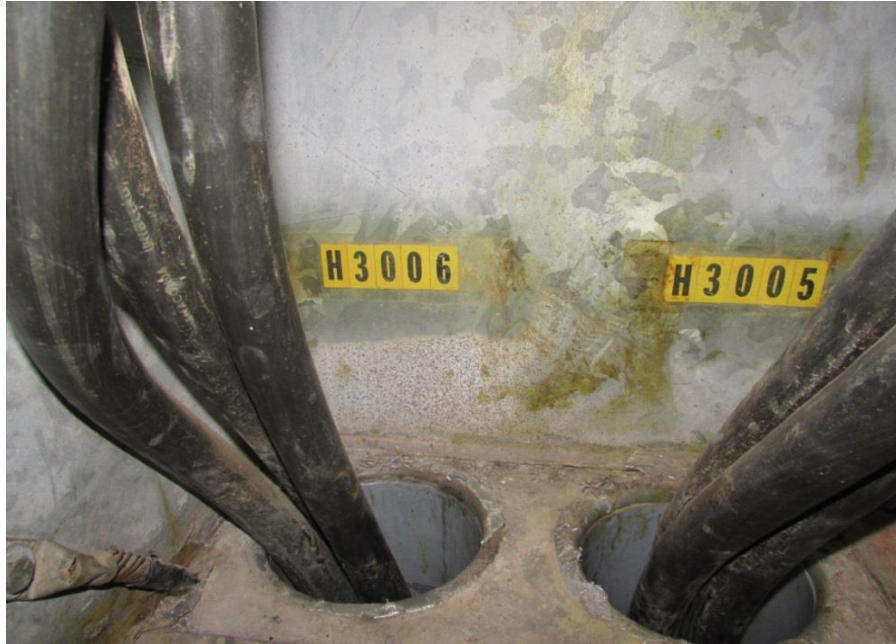
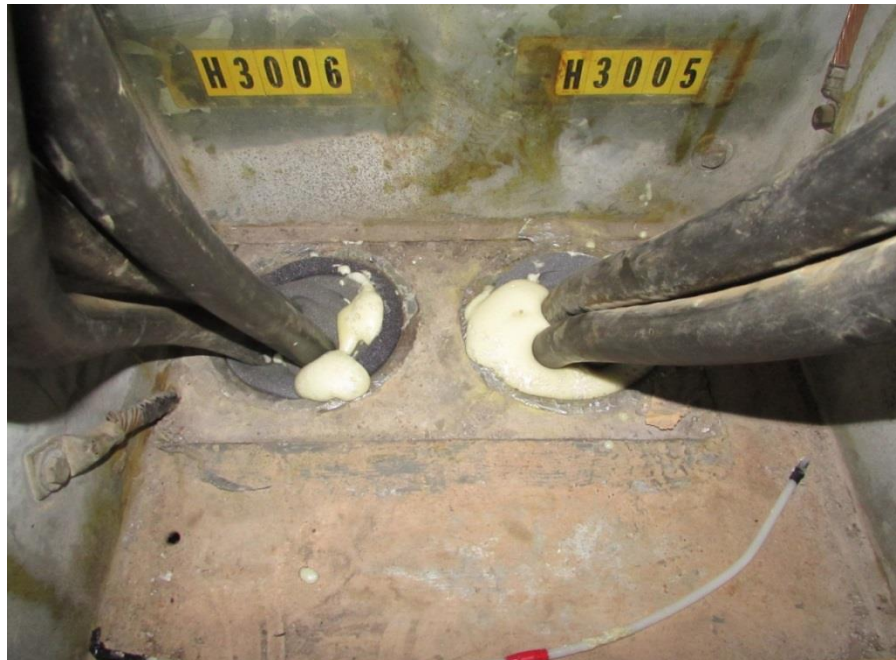
“As-found” (top) and “As-left” (bottom) condition of embedded 6.9kV conduits which penetrate the Turbine and Auxiliary Building at ANO-1. Some of the penetrations are in floors or walls that are flood boundaries.

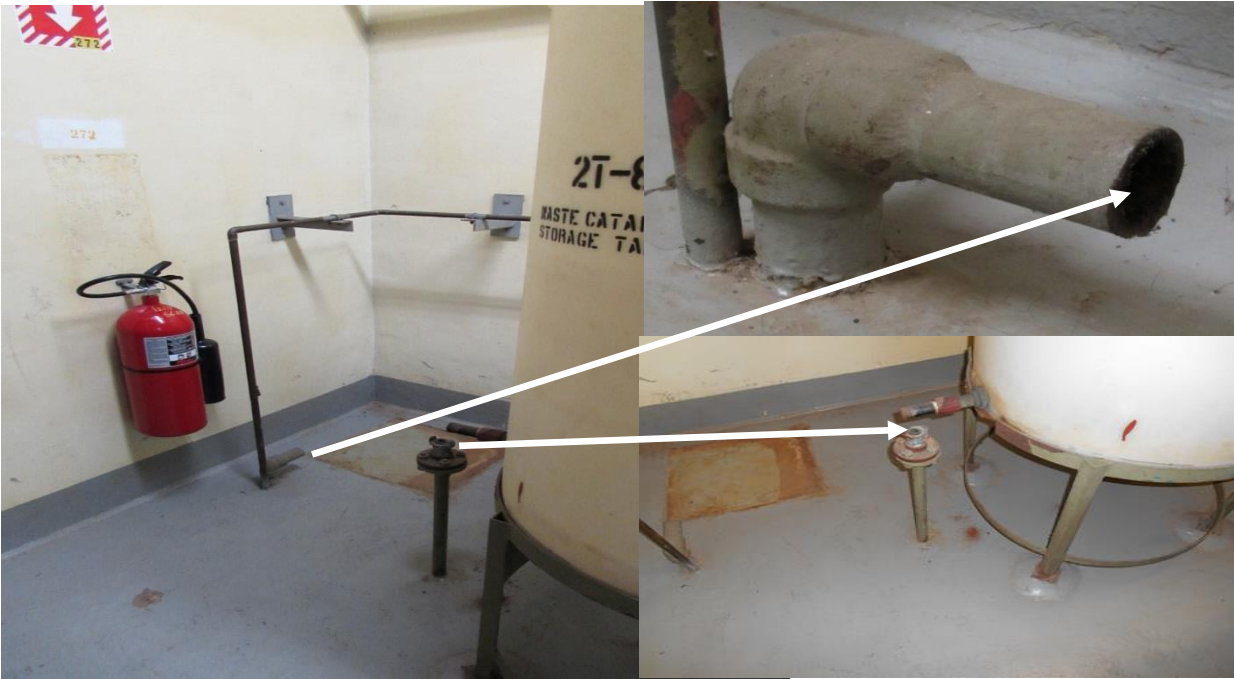
Above, pipes in the “as-found” images were cut and abandoned in place. They provided a potential pathway for flood water to flow into a flood-protected space underneath this room.
