MATERIALS ENGINEERING LABORATORY REPORT
NESML-Q-333

NES MATERIALS ENGINEERING LABORATORY
MATERIALS ANALYSIS REPORT

NESML-Q-333

3. **Sample Origin:** Let down orifices 2-CH-RO-20RLD1, 20RLD2, and 20RLD3.

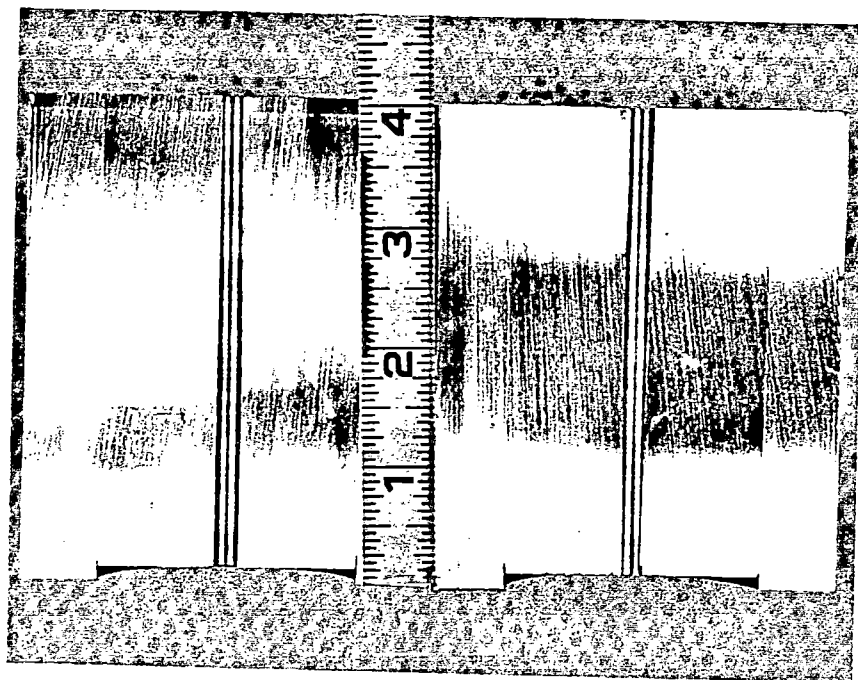
Figure 1: Photograph showing the Unit 2 let down orifice LD 1. No damage was observed along the ID of the orifice.

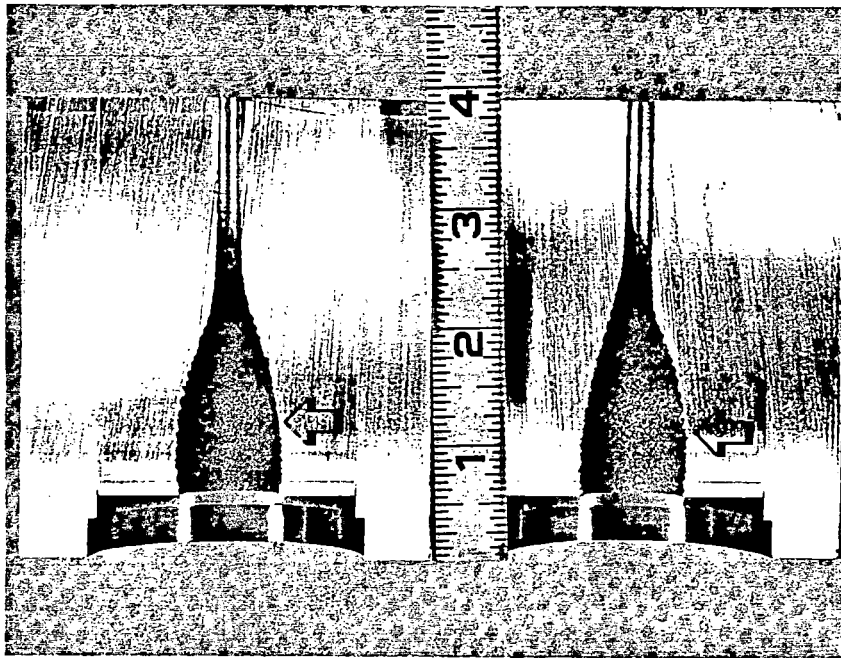
7. **Comments:** The damage to the two letdown orifices from Unit 2 was the result of cavitation. This was the same mechanism responsible for the wall loss experienced by the Unit 1 orifices, which were examined in report NESML-Q-309. The pattern of attack was very similar between the two units. The only exceptions noted were in the extent of the damage, and in which orifice was affected. On Unit 1, LD1 and LD2 were attacked, while LD3 showed no signs of material loss. Furthermore, the damage on LD1 from Unit 1 was slightly more extensive, extending approximately 5 inches along the ID. Both variations are undoubtedly the result of differences in age and operating conditions.

Figure 2: Photograph showing the Unit 2 let down orifice LD 2, after sectioning to reveal the ID. The damage, which is indicated with the arrows, measured approximately 2 ½ inches into the orifice from the discharge end.

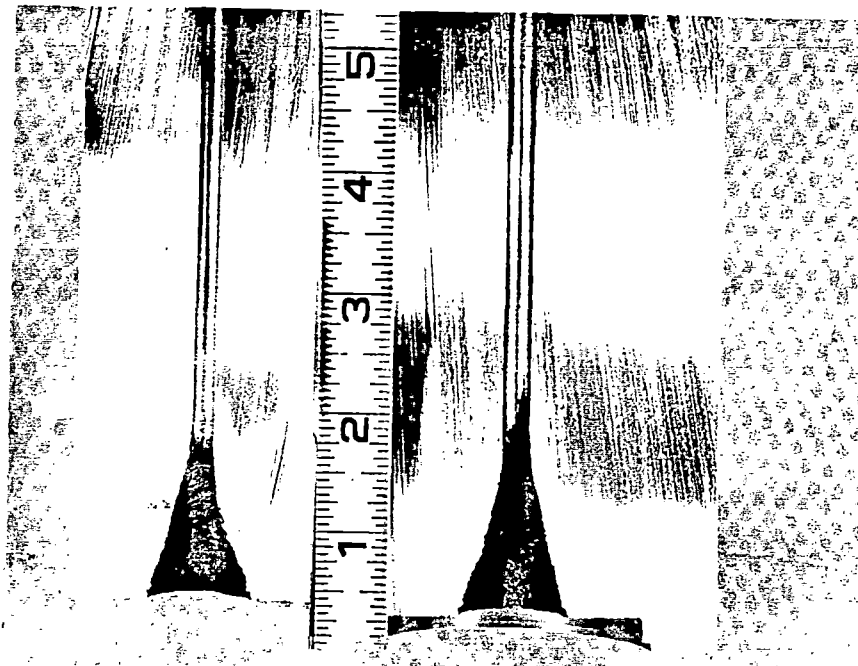
Figure 3: Photograph showing the Unit 2 let down orifice LD 3, after sectioning to reveal the ID. The damage along this orifice measured approximately 2 inches from the discharge end.
