## **Durita, Colorado, Disposal Site Inspection Report, May 22, 2008**

Participants: Dave Holland, Hecla Mining Co; Earl Reams, Reams Construction; Edgar Ethington, CDPHE; Tracy Ribeiro, DOE; Cheri Bahrke, Stoller; Marilyn Kastens, Stoller; Mike Widdop, Stoller

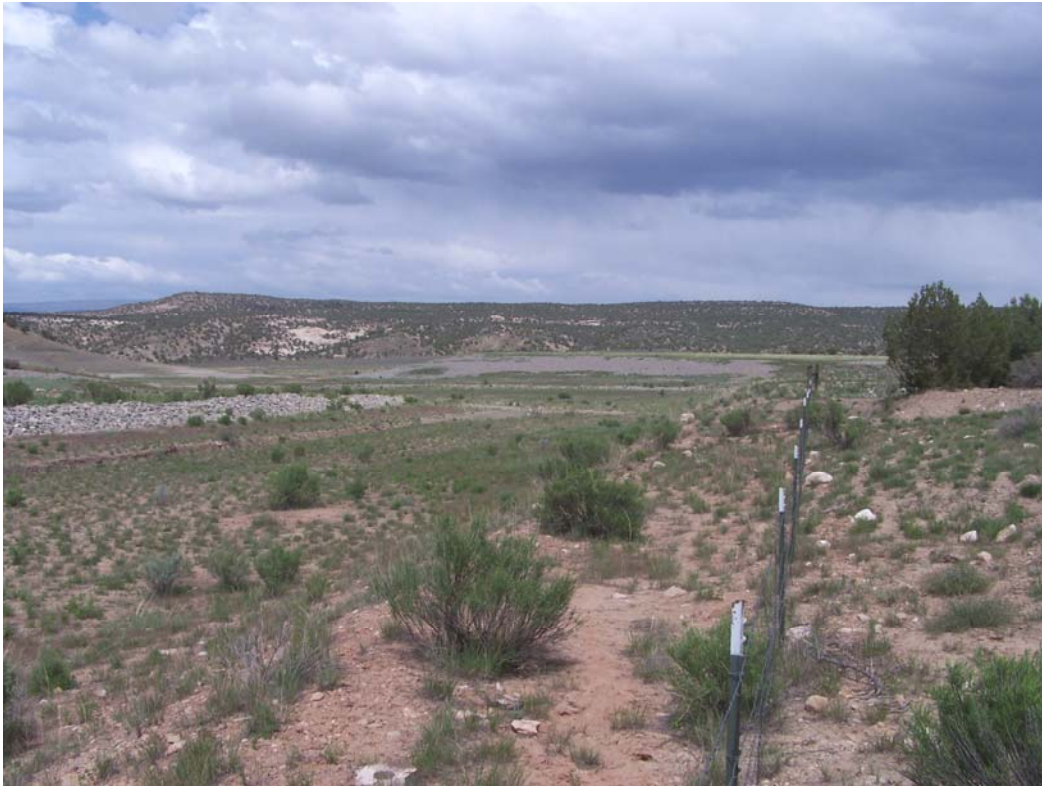
All diversion channels generally appeared to be functioning as designed with regard to containing storm water and conveying it past the disposal structures. The Central Diversion Channel is eroded at the south (upslope) end but the erosion is contained within the lateral limits of the floodplain. The slope of the floodplain appears steeper here, and storm water has incised several minor channels less than 2 feet deep from tributary sources into the normal flow channel, which also is incised. Nearby, a tributary channel from the upslope undisturbed area has been armored with large riprap that is dropping into a head cut, as designed. This area should be allowed to equilibrate, and no intervention is deemed necessary.

*South end of Central Diversion Channel looking east, showing minor incising along flow line, self-armoring tributary entering from right (south), and leach tank LT-203 in background.*

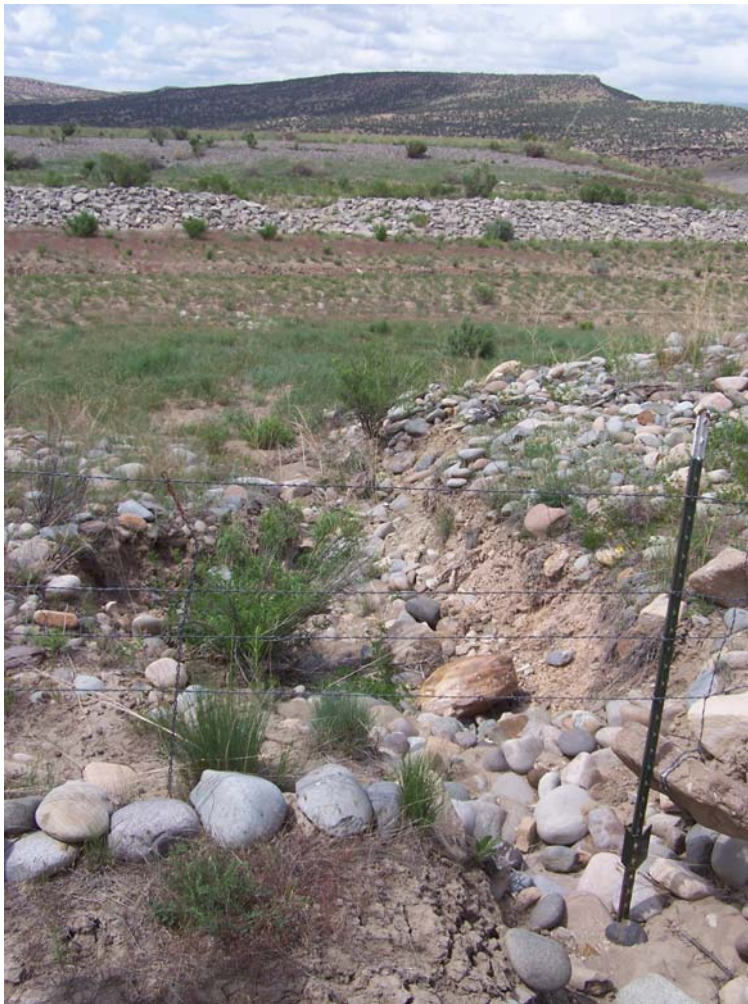
*Self-armoring tributary to north end of Central Diversion Channel. Incised flow channel, scour protection, and Leach Tank LT-202 in background.*

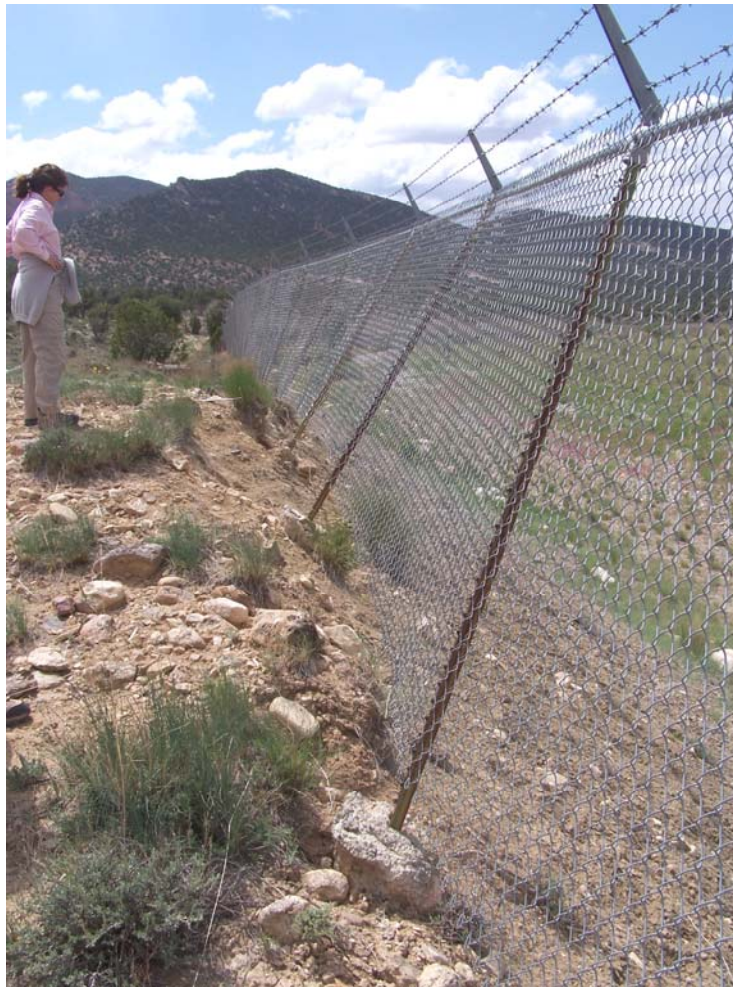
**Fencing**—Most of the fence surrounding the site is chain-link topped with three strands of barbed wire on angle brackets. Fence posts consist of 8-foot-long steel t-posts driven into the ground or steel tubing set in concrete. Portions of the fence were replaced in 1999 when construction was completed; these portions are in good condition. The remainder of the chain link fencing is in fair to poor condition but remains generally serviceable (i.e., it seems to keep livestock off the site). The fencing along the north half of the west side and the entire north side are the most deteriorated. Within this portion, many angle brackets are broken. The barbed wire is unattached or broken at many locations. Along the west side, the fabric is below the top rail and attached to the top rail with soft mechanic's wire, which rusts and breaks in only a few years. The fence is leaning at several locations.

*Chain link fence deterioration between southwest corner and Site B.*

Fencing is required at the Durita site to keep livestock off the vegetated top slopes of the leach tanks. Intrusion should not be an issue, so the barbed wire at the top of the chain link fencing can be removed rather than repaired. The deteriorated portions of the chain link fence should be repaired; ideally, those portions would remain serviceable for as long as the newer sections.

6. DOE will confirm that Closure Cell berms were constructed on clean material.
7. DOE will ask the licensee to repair or alter the deteriorated portions of the chain-link fence and move the wire fence away from the slope break in Site D.

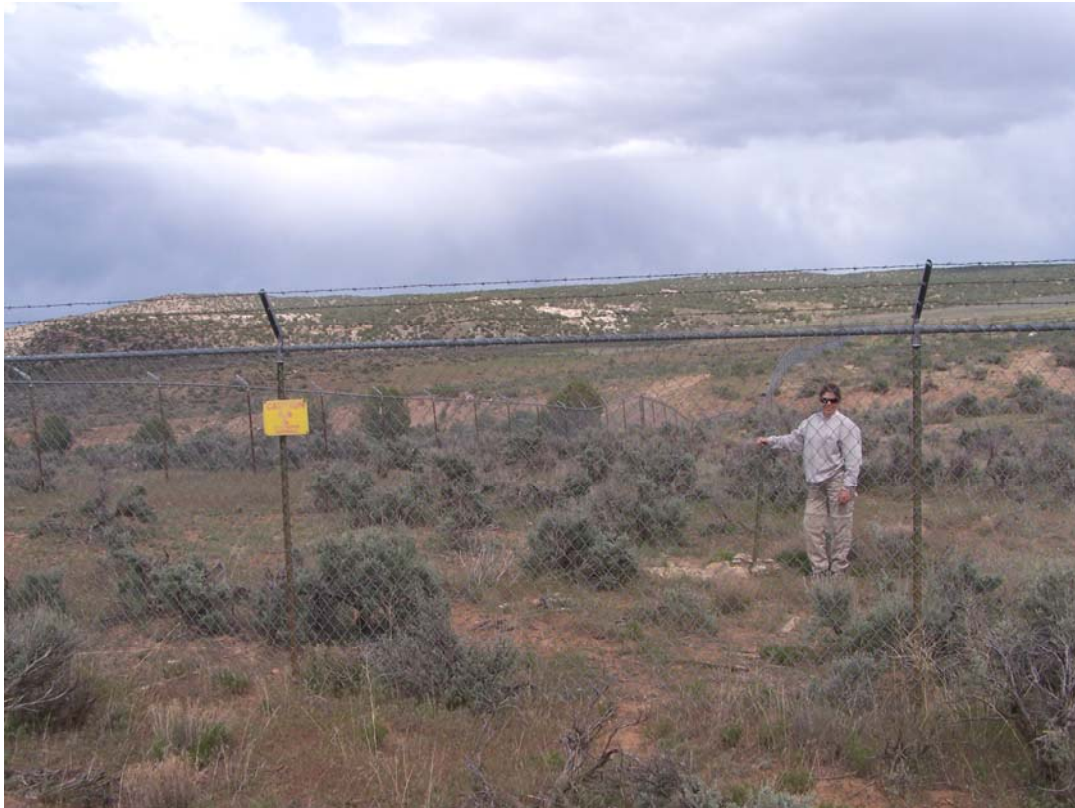
Fencing has been installed outside the site boundary on the west and north sides of the site. At the northwest corner, the encroachment appears to be 17 feet onto the private property to the west and 36 feet onto BLM property to the north, based on the location of the survey monument. The licensee must resolve this issue before transition.

*Northwest corner of site showing fence encroachment; looking east, visitor standing at boundary monument.*

8. The licensee must resolve the issue of fence encroachment.
9. Debris, mostly tumbleweeds, accumulates against the fence in places. Removal may be necessary if the debris interferes with drainage and this item will be added to the inspection checklist.

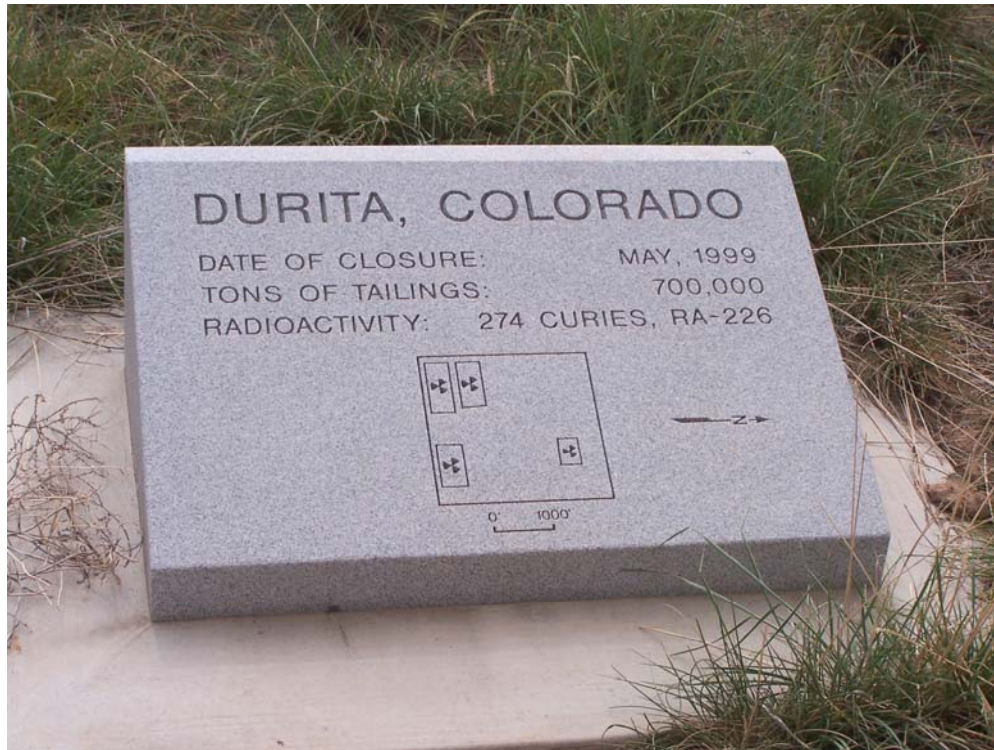
*Site marker.*

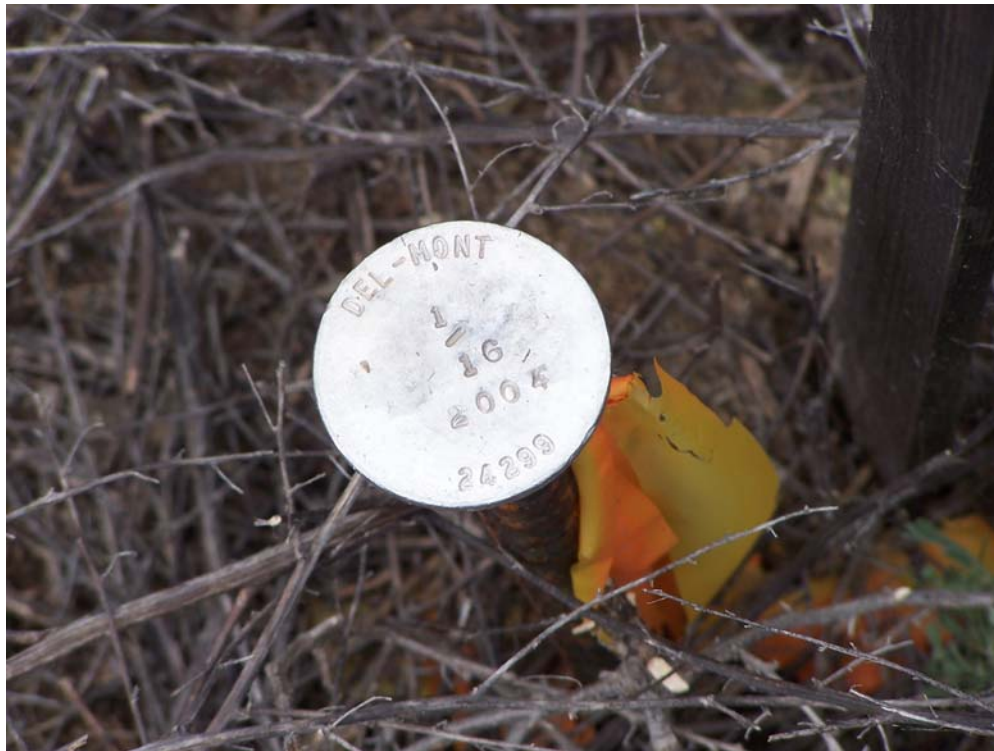
*Northeast corner boundary monument.*

11. DOE should confirm whether standard monuments were installed at the northeast corner and east side of the site.
12. DOE and the licensee should discuss installing the warning signs.

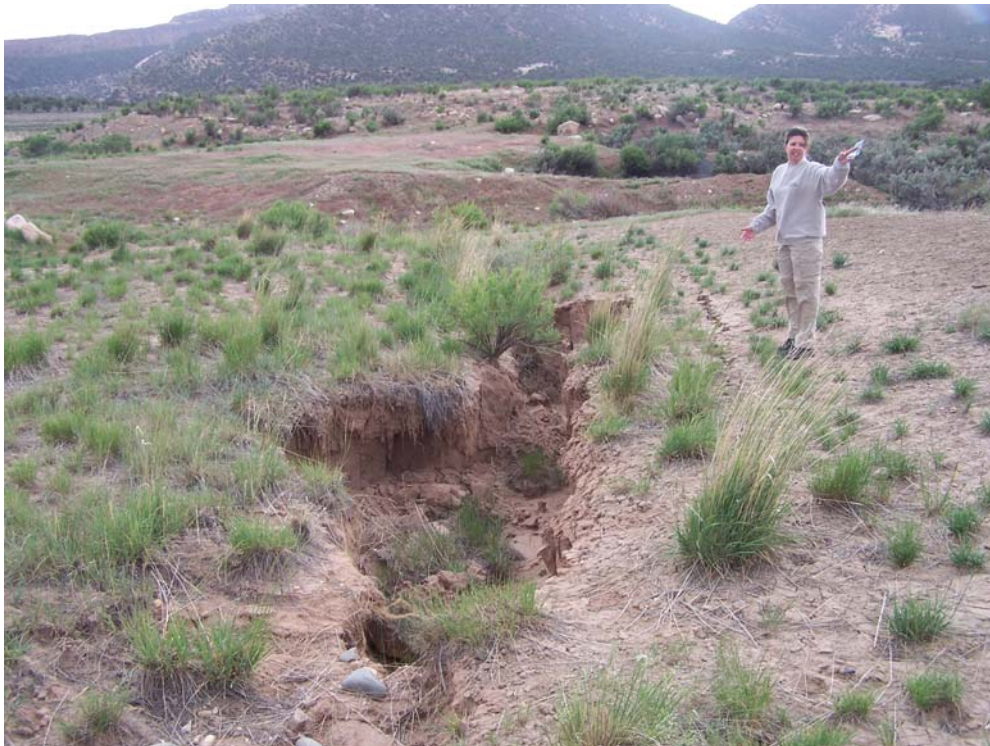
*Head cutting at south end of Central Drainage Channel.*

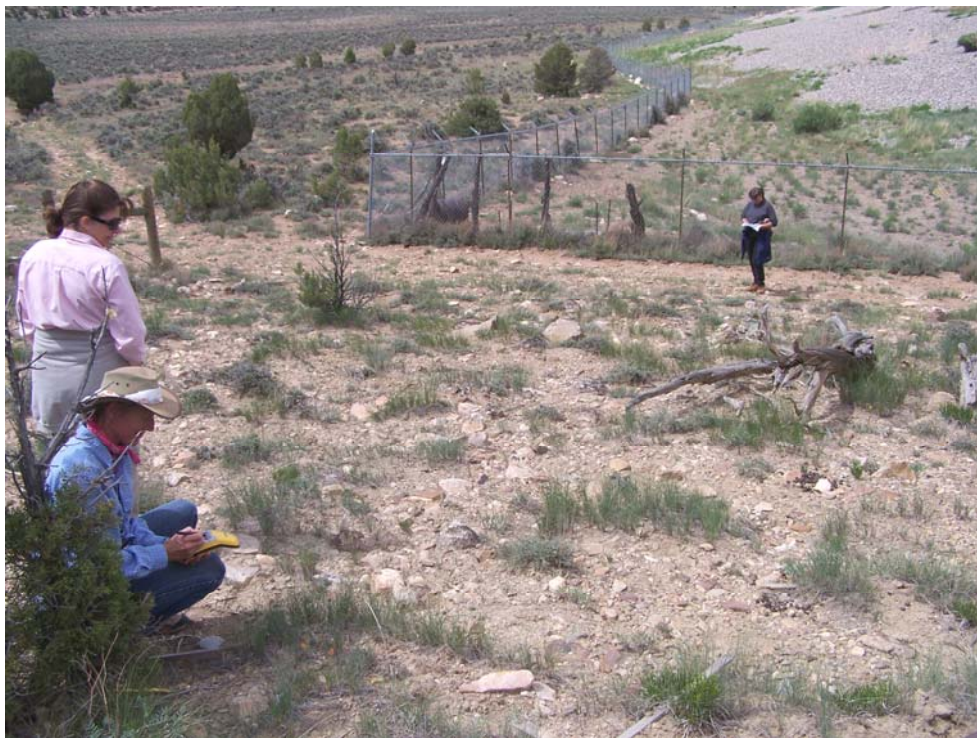
Debris was found inside the southwest corner of the site, which the licensee should remove.

*Southwest boundary monument, debris, and toe of leach tank LT-202 extending into Site A.*

19. DOE will ask the licensee to remove debris inside the southwest corner of the site.
20. DOE will request the profile of the Central Diversion Channel. DOE will evaluate the process that resulted in the incised drainage ditch below the Central Diversion Channel. DOE will request preconstruction topographical information and look for evidence of an abandoned drainage where the incised drainage rejoins the pre-existing watercourse. DOE will determine if the process presents a threat to site integrity or may result in property damage or regulatory noncompliance.

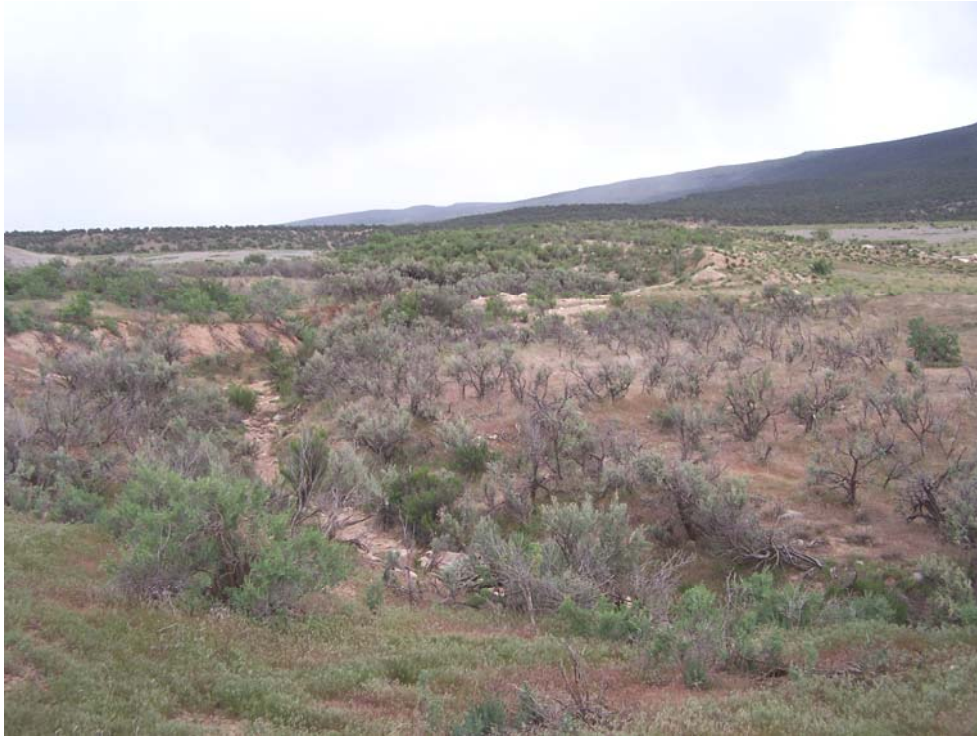
The Central Diversion Channel drains toward a natural drainage to the north. Below the bottom of the channel, the watercourse is deeply incised and the channel walls are vertical with an abrupt brink at the top of the walls. The channel has cut as much as 15 feet deep through a weathered shale knob with lenses of gravel. This incising is recent. Further down the drainage the walls are weathered to more mature and stable slopes.

The design flattened the gradient of the storm water diversion channels, more so over the reaches near the engineered structures. This would have created a hydraulic jump at the transition to the undisturbed drainage, and increased velocities would result in incising. Alternatively, the pre-existing drainage flow may have been diverted to accommodate tank construction and the drainage has incised a new channel. The profile for the Central Drainage Channel is not in the DOE records collection but should be acquired and reviewed.

*View upstream of incised drainage below the Central Diversion Channel, showing broad meander and topographic high through which the drainage has eroded.*

DOE will evaluate the process that resulted in the incised drainage ditch below the Central Diversion Channel. DOE will request preconstruction topographical information and look for evidence of an abandoned drainage where the incised drainage rejoins the pre-existing watercourse. The goal of this effort is to determine if the process presents a threat to site integrity or may result in property damage or regulatory noncompliance.

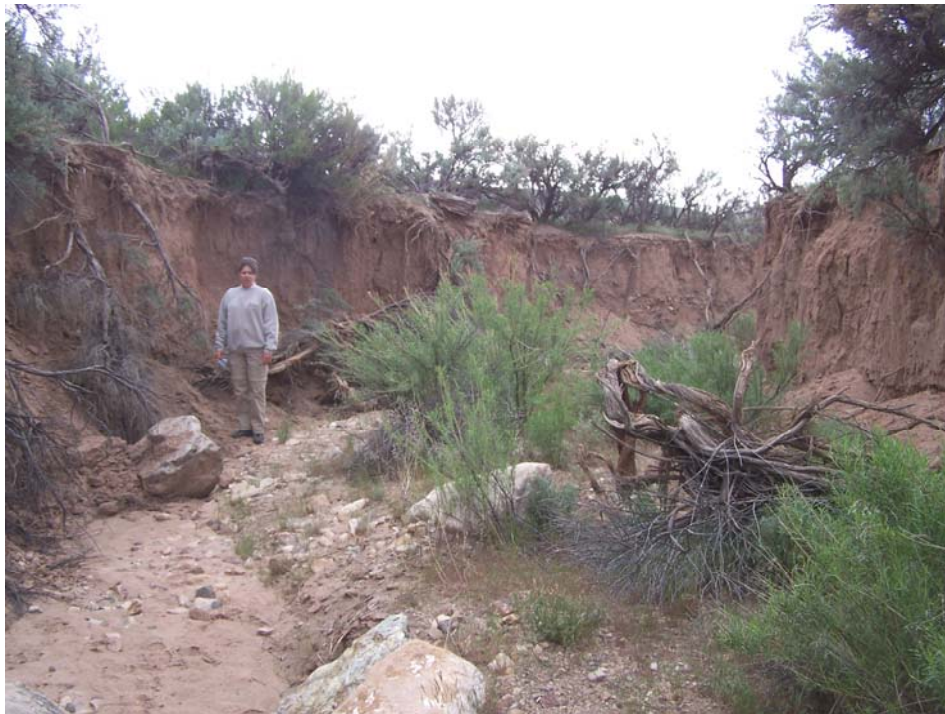
The floor of the incised portion of the drainage has a uniform gradient with only minor local changes and no head cutting. Therefore, it appears that the down cutting has reached equilibrium under “normal” conditions. If this incising occurred because of construction completed in the late 1990s, more severe storm events will result in additional erosion, and the likelihood of a storm causing significant erosion is enhanced in this young channel. Downstream, the drainage continues across BLM rangeland.

*Floor of incised drainage showing active lateral movement of meander, uniform gradient and armoring of floor, and steep, unstable walls.*

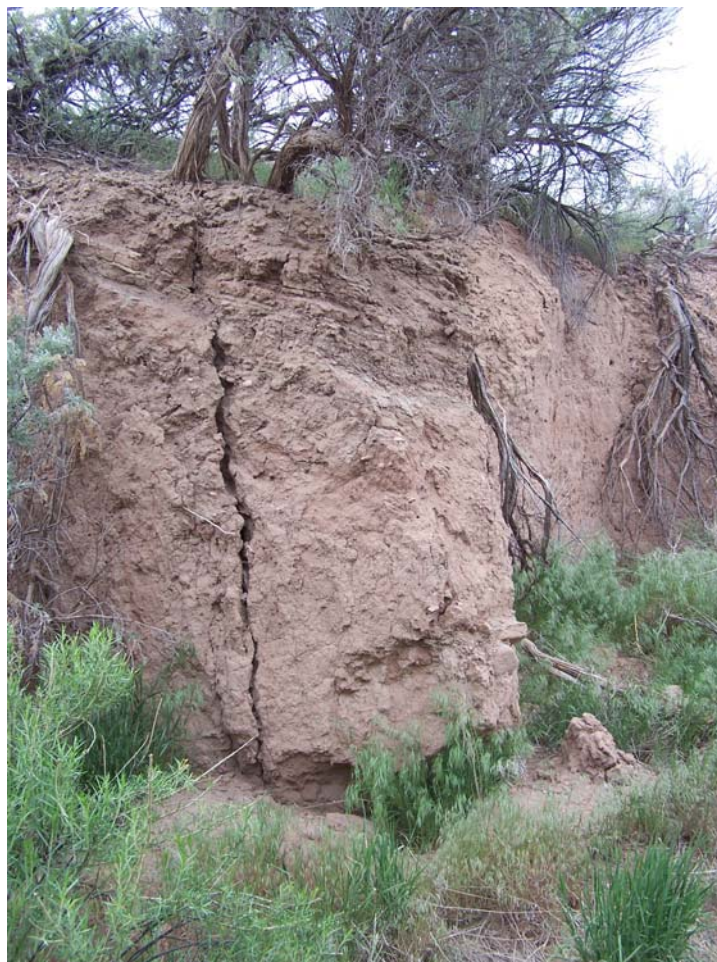
Much additional material will be transported downstream as the vertical walls slump, the channel meanders, and the walls erode back to stable slopes. Topographical data preceding site construction should be compared to the present topography. A 1964 USGS 7.5-minute quadrangle map was found but lacks sufficient detail to compare the present and past drainage locations.

*Unstable walls of incised channel will result in additional sediment transport.*
