Humboldt Bay
Independent Spent Fuel Storage Installation
Site-Specific License Renewal Application

Pacific Gas and Electric Company

Revision 0 July 2018
NRC Docket No. 72-27

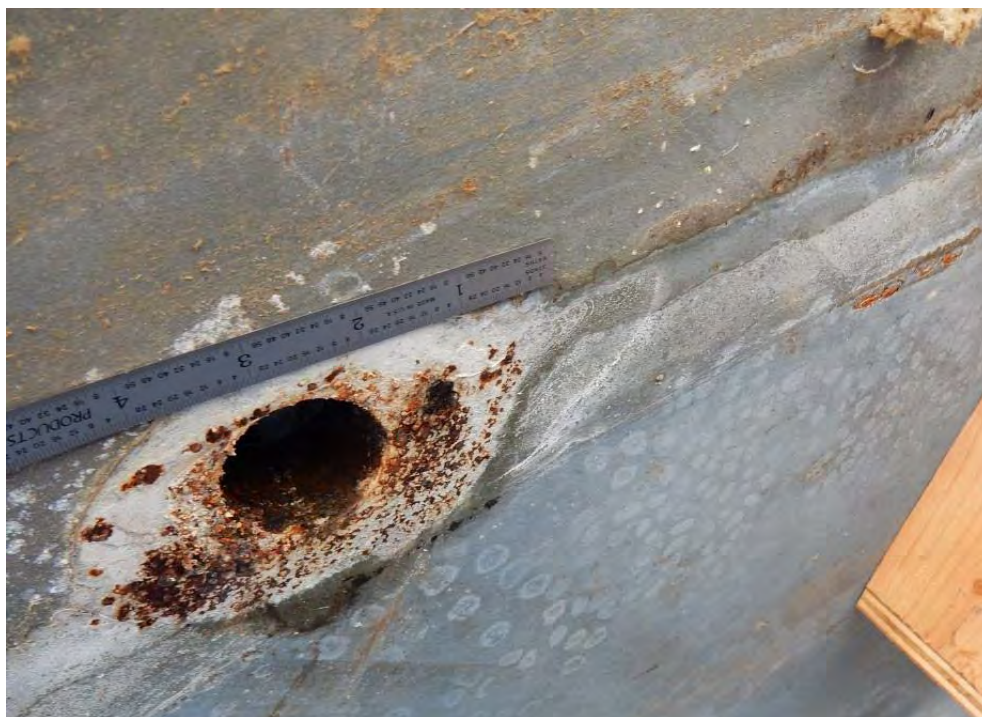
7. Underside hole #3 showing corrosion prior to cleaning

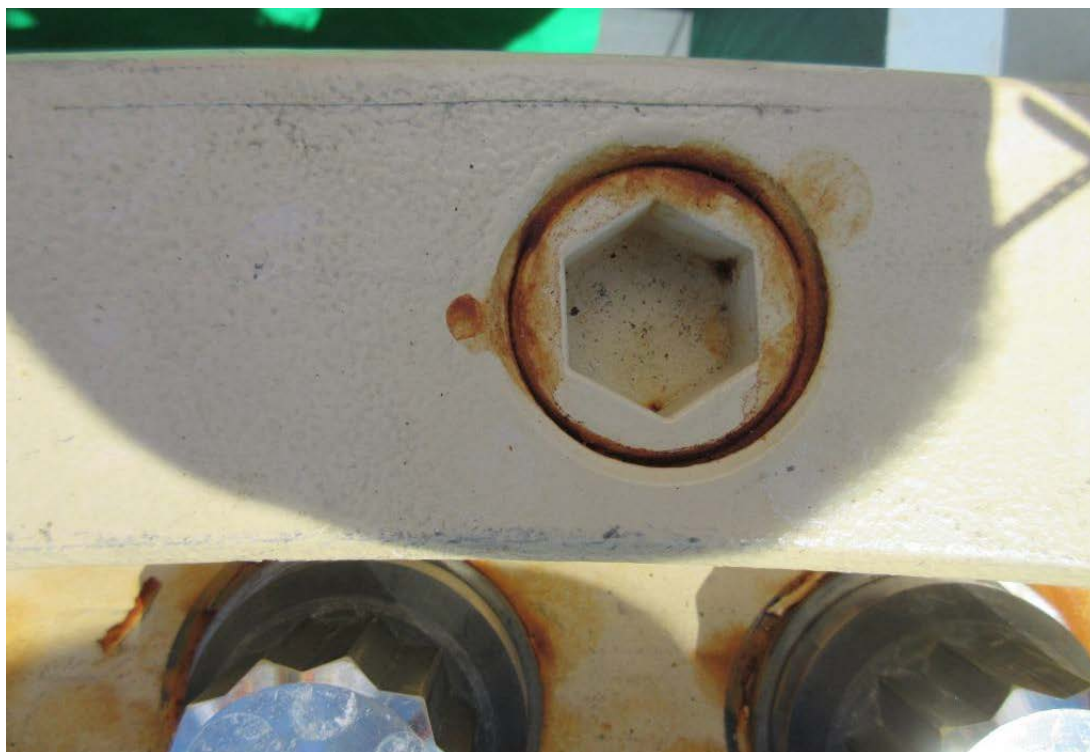
17. Rust staining around overpack lid closure bolting

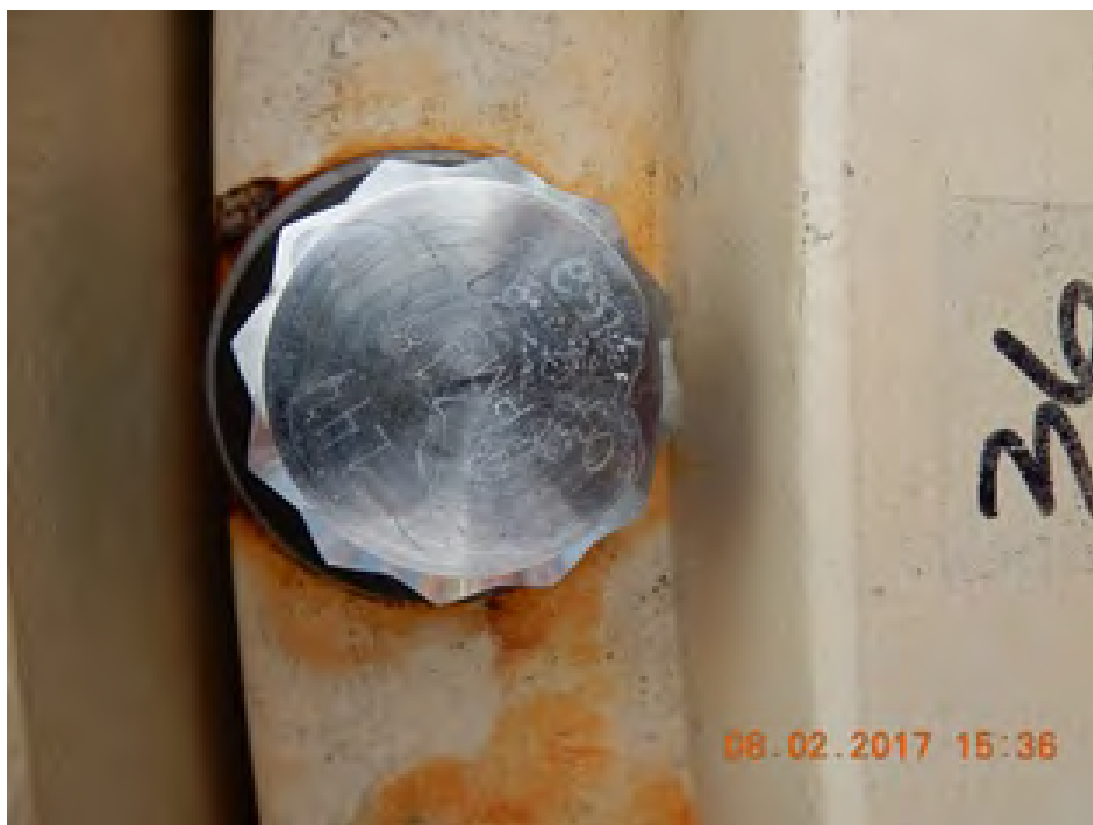
18. Typical rust staining around top flange closure plug set screws

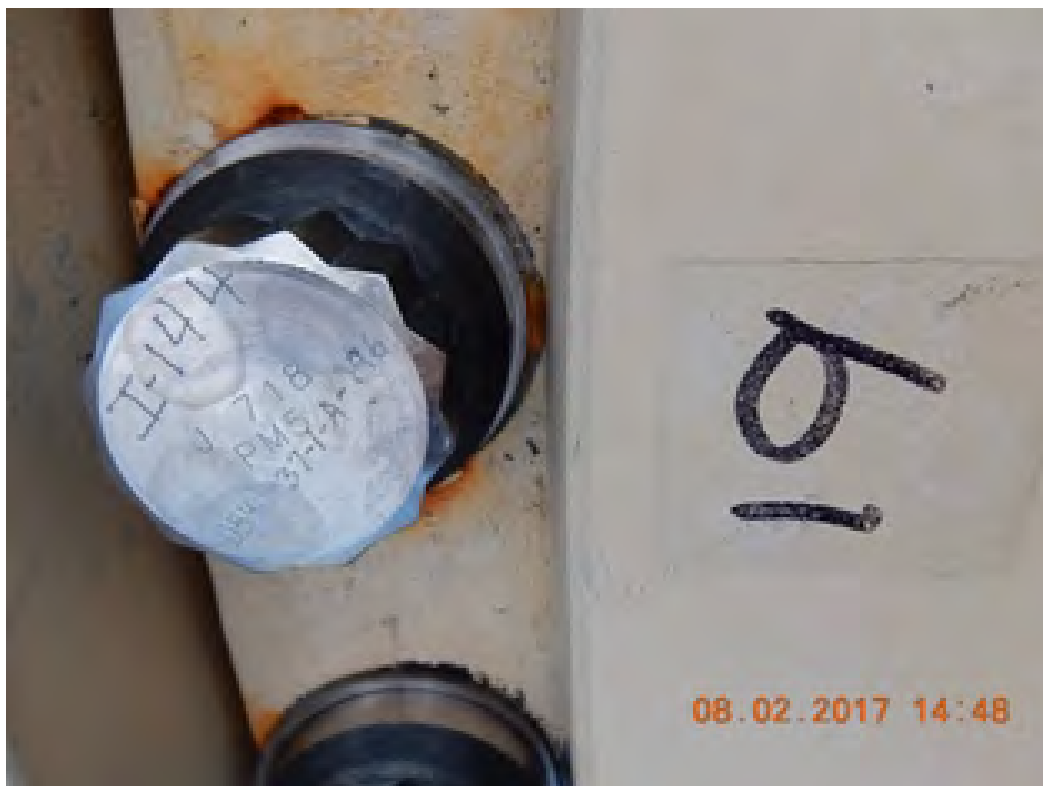
19. Chipped coating under overpack closure lid bolt (at 10 o'clock)

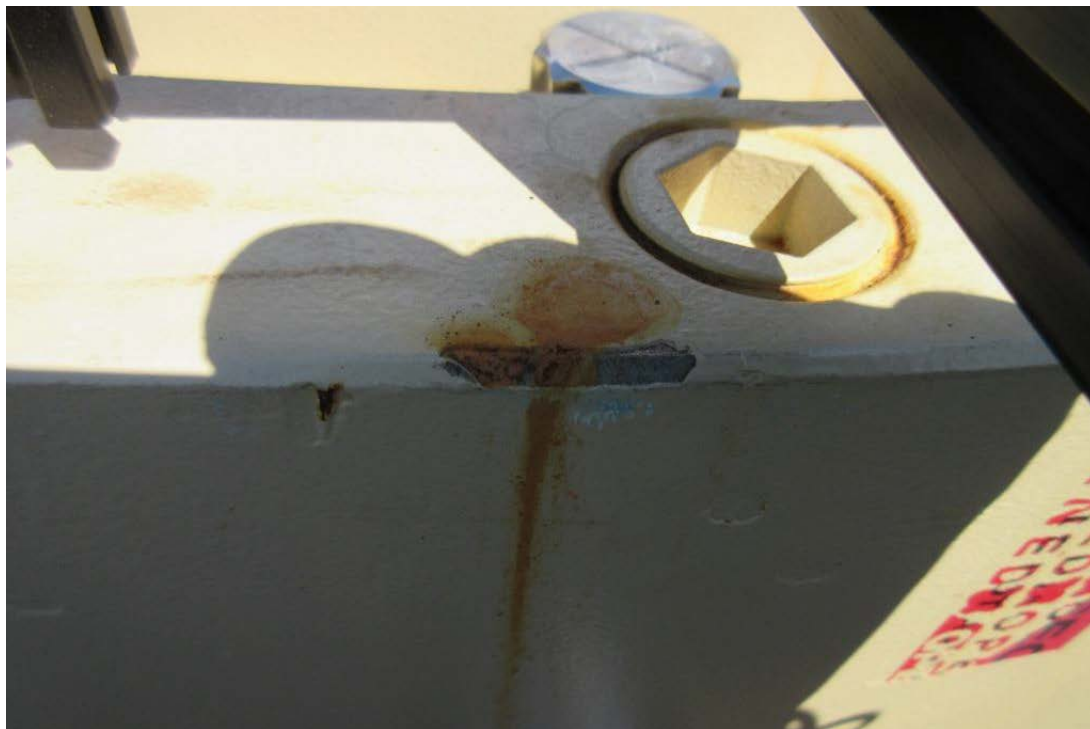
20. Cracked coating under overpack closure lid bolt

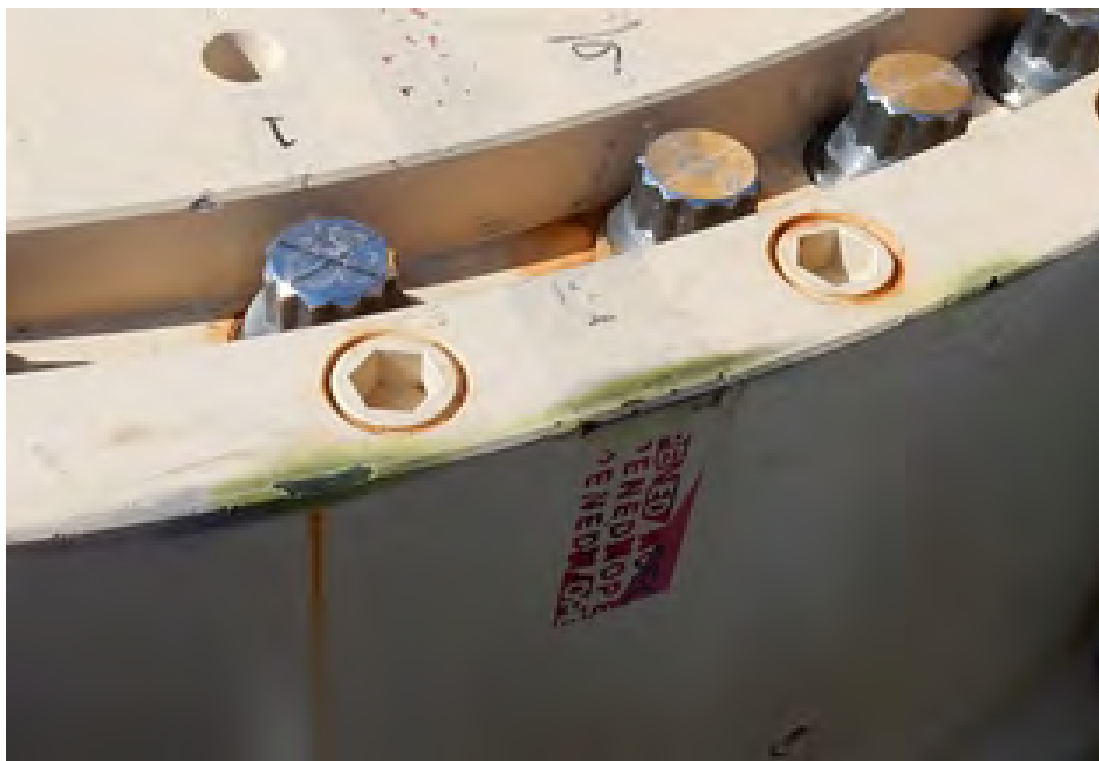
21. Coating chip with rust staining

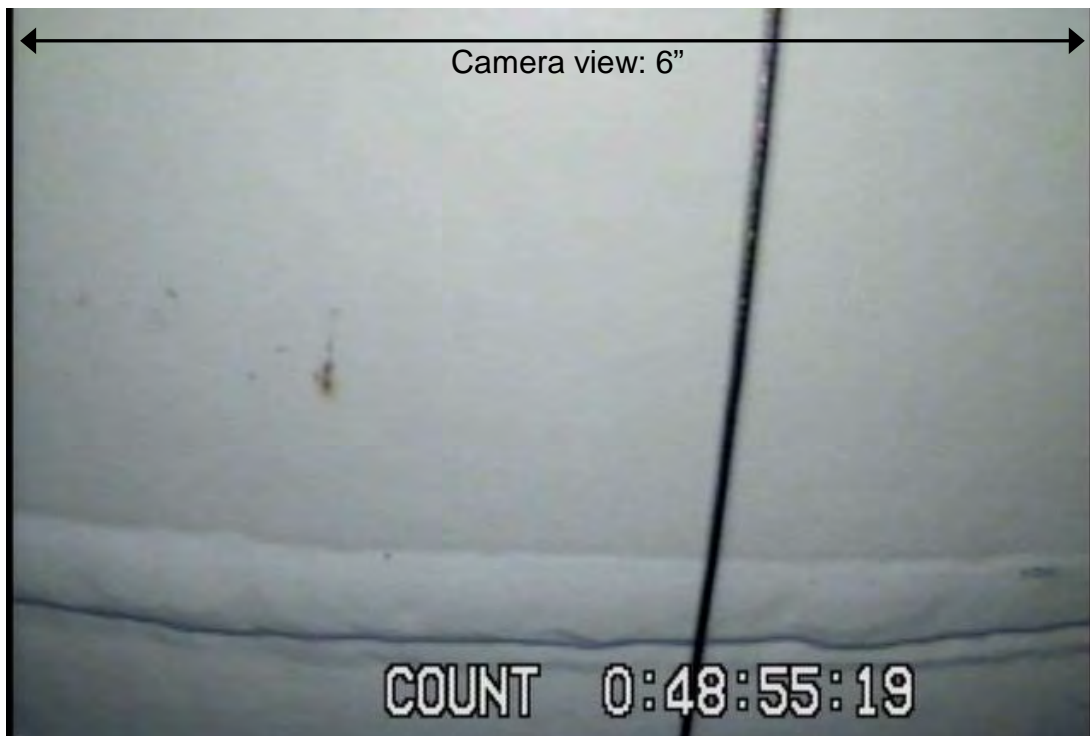
27. Scan 26 coating chip with slight rust discoloration

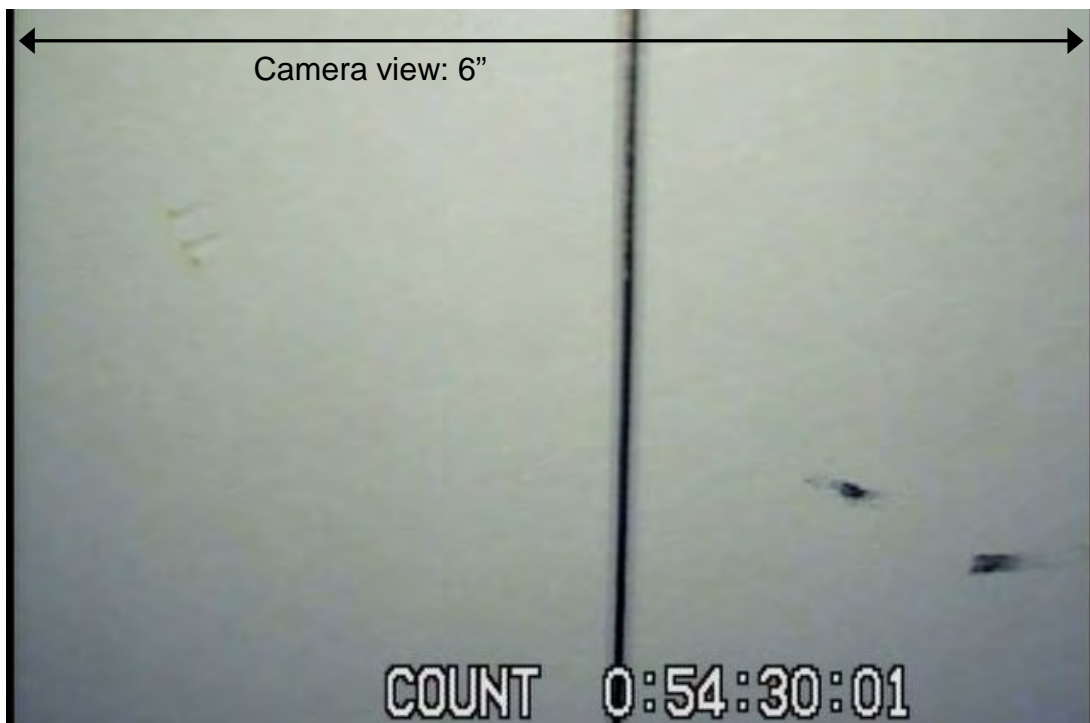
28. Scan 28 slight rust discoloration

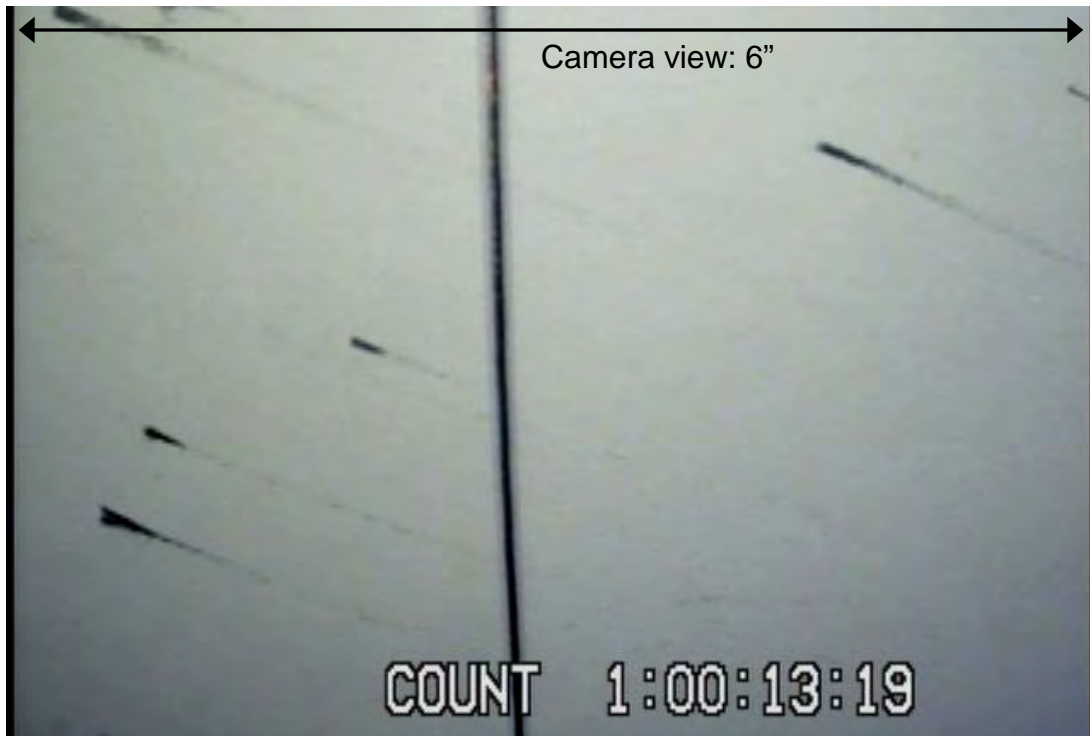
29. Scan 30 slight rust discoloration and black stains

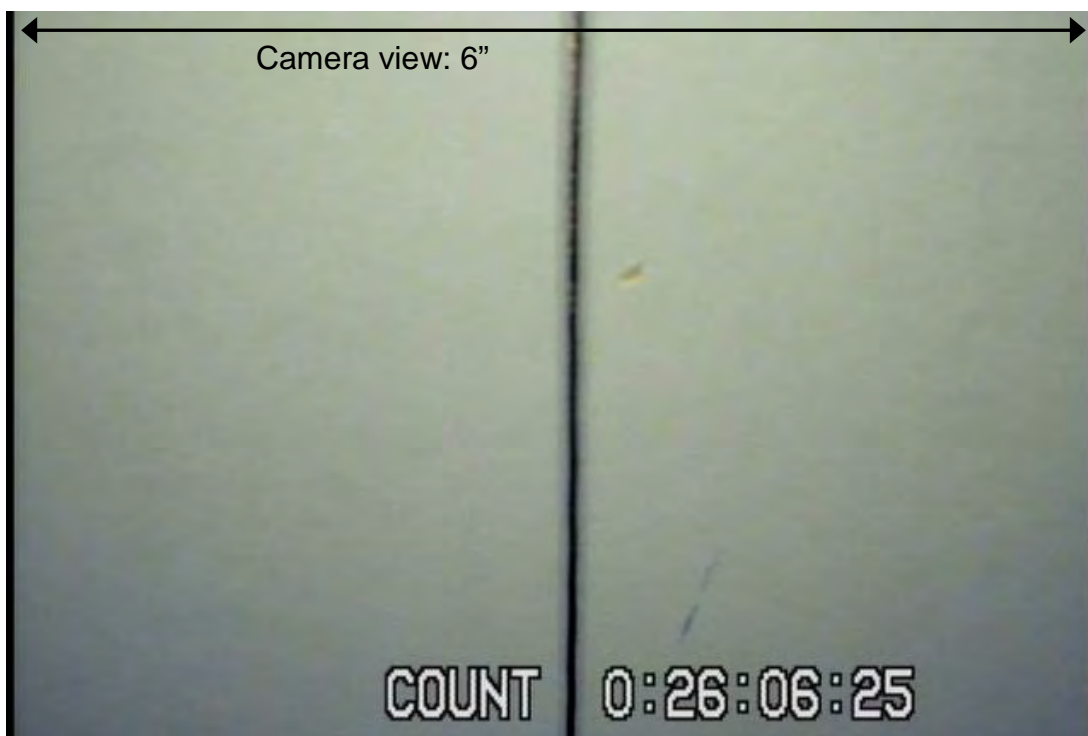
34. Scan 42 coating scrape

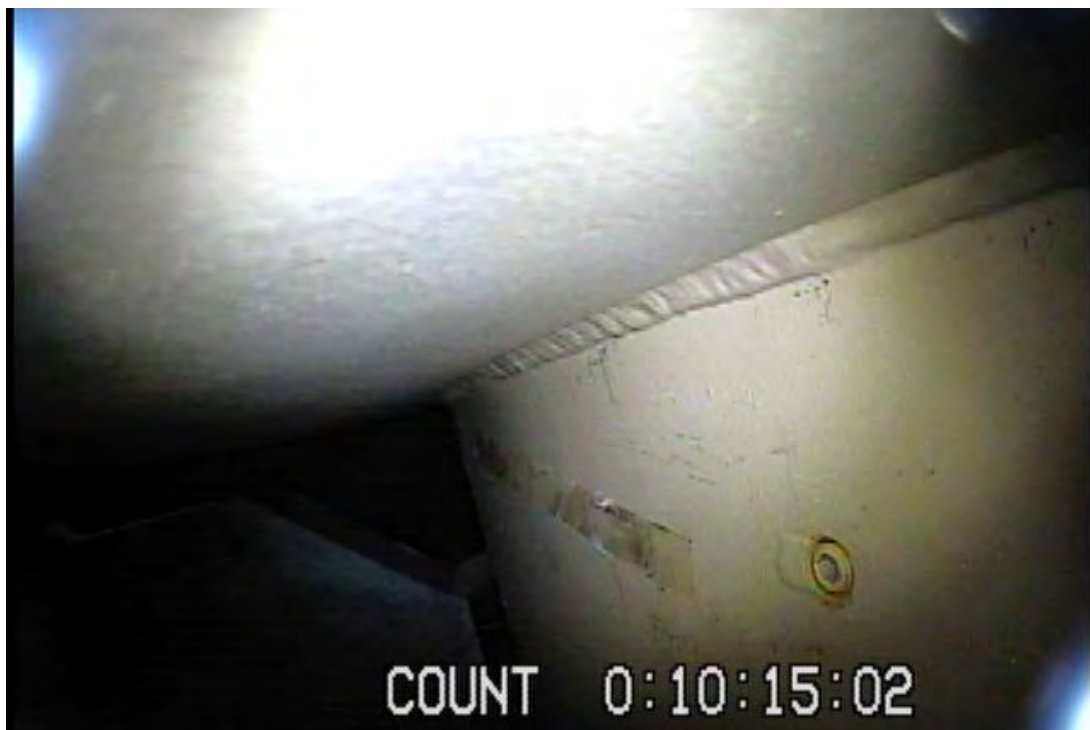
42. Overpack south east section coating scrape adjacent to seismic shim

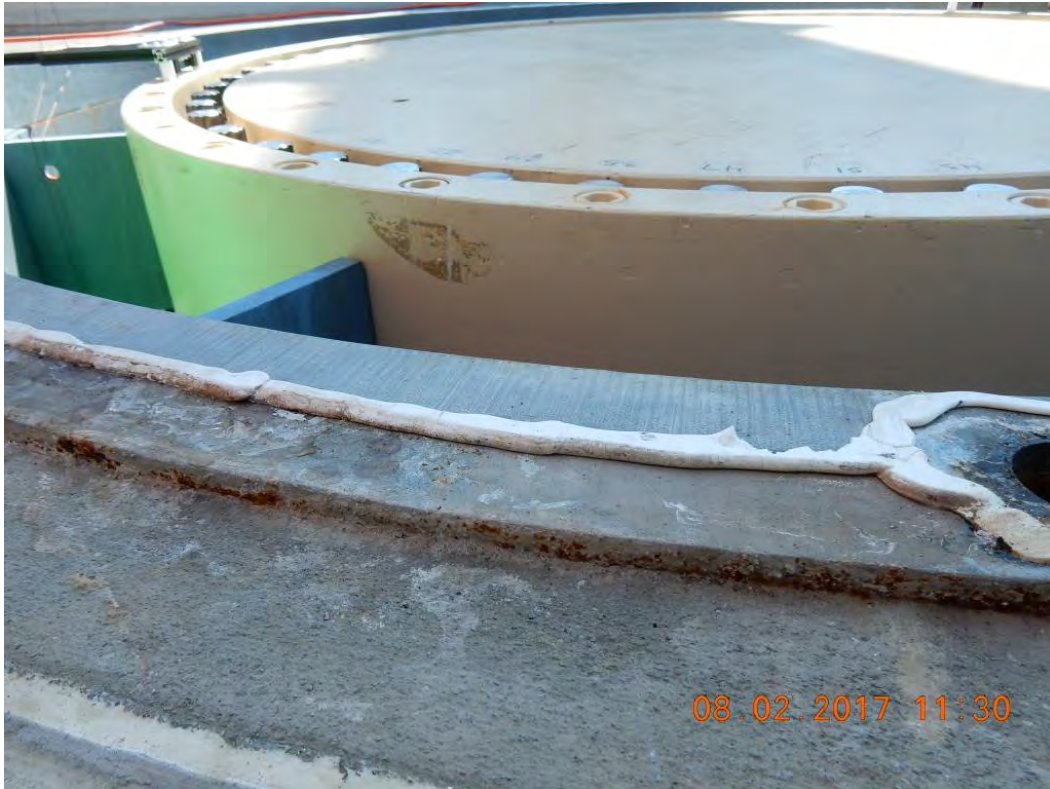
47. Vault lid ring bolt hole #6 corrosion products

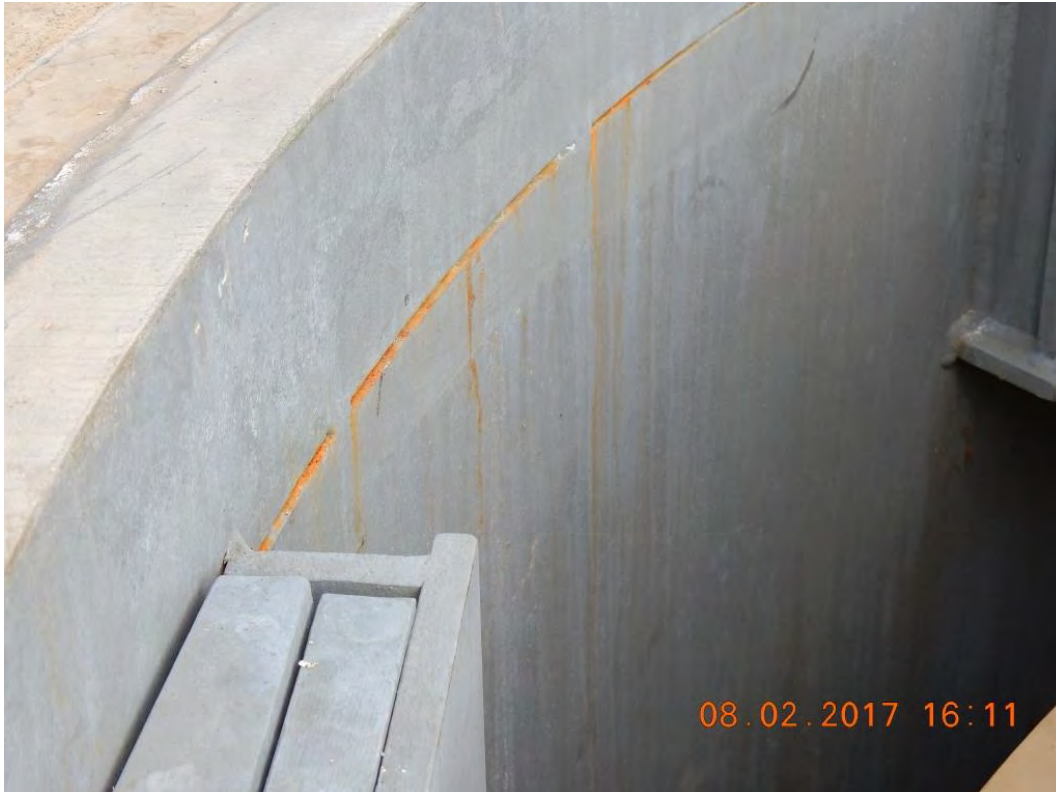
48. Rust at vault lid ring to concrete interface

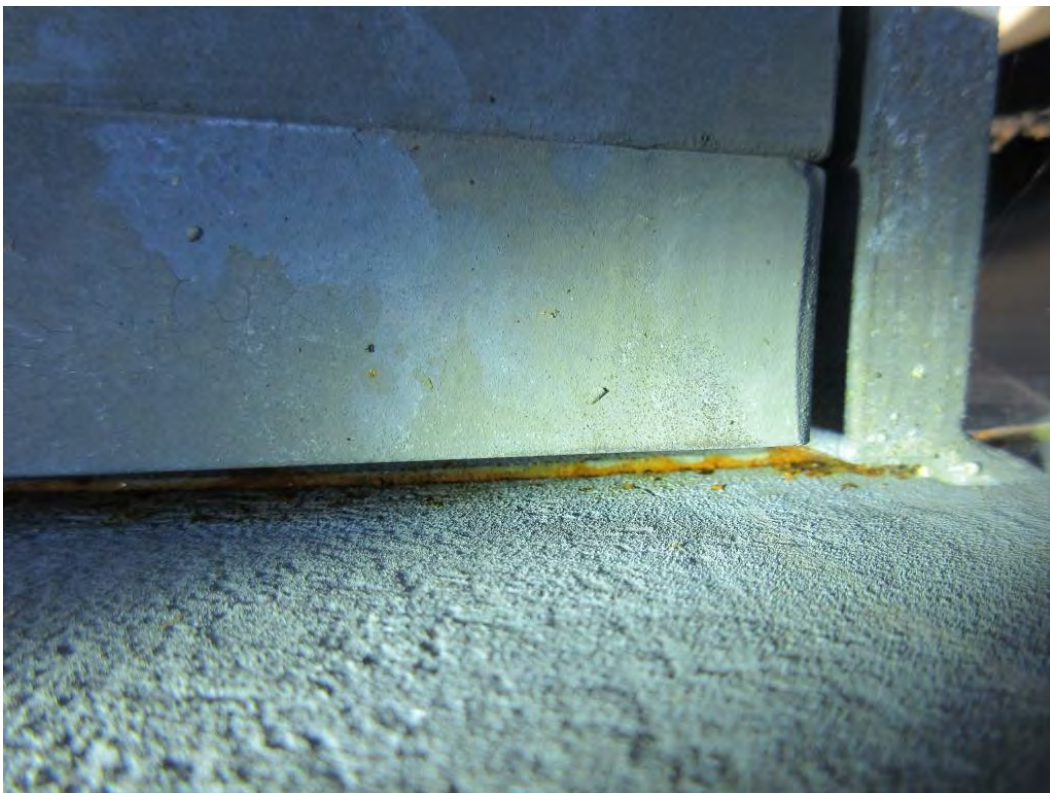
51. Rust staining at vault lid ring to vault liner interface

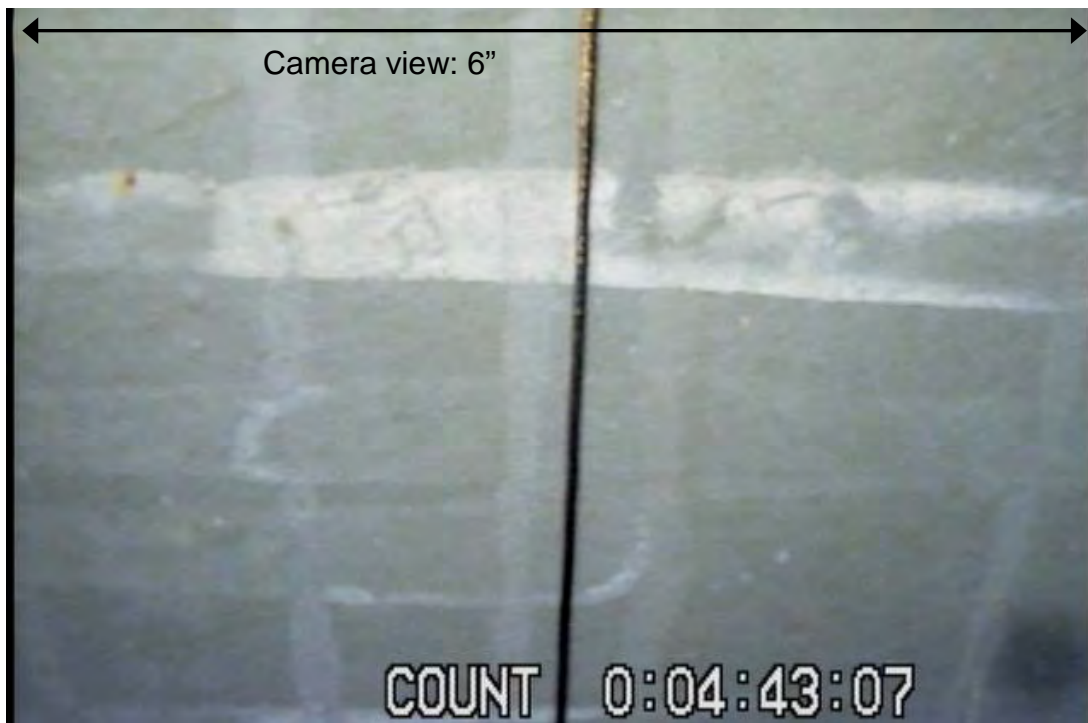
53. Scan 2 rust spot (for size comparison, the wire cable supporting the plumb
bob is 1/32" dia.)

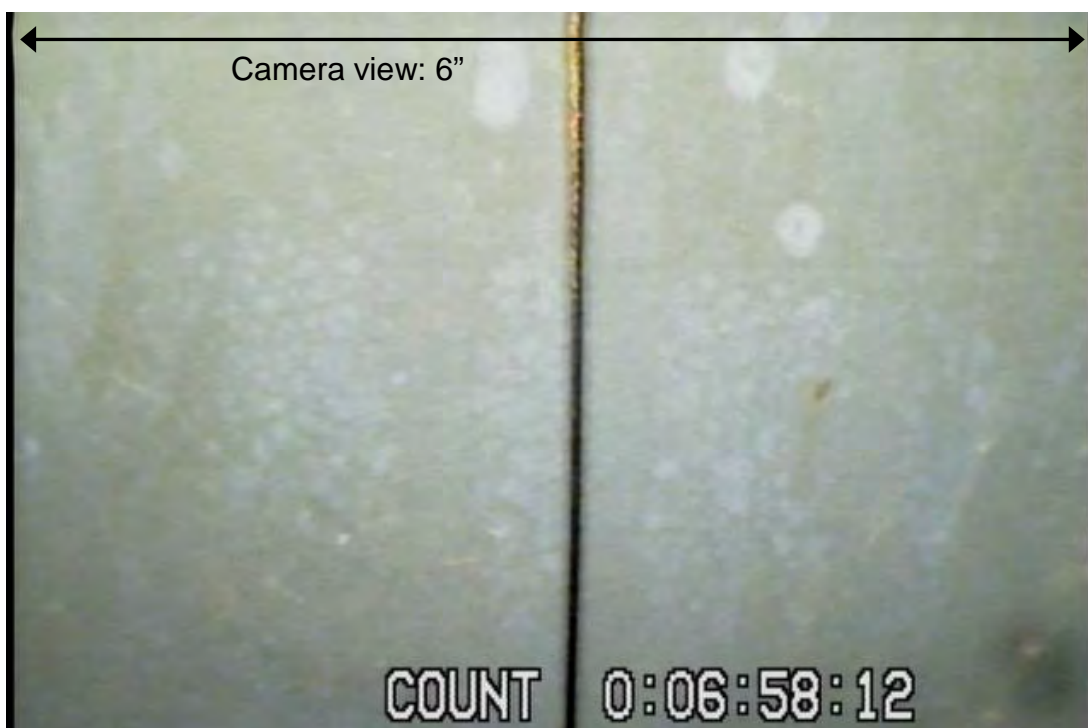
54. Scan 5 rust spot

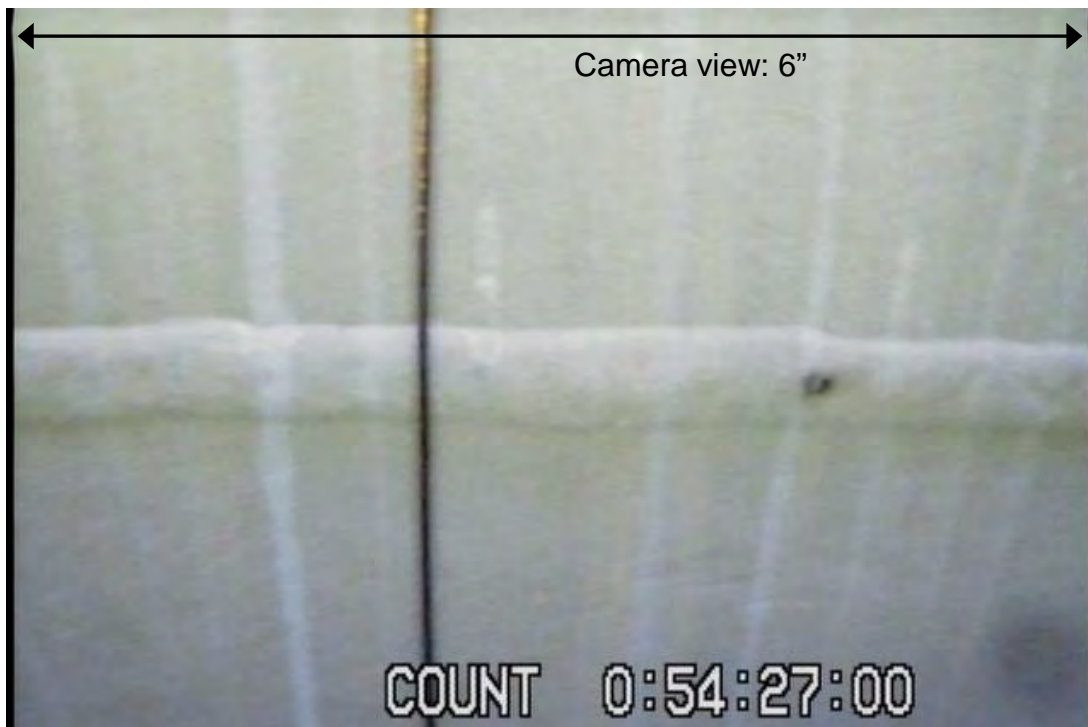
59. Scan 16 rust spot

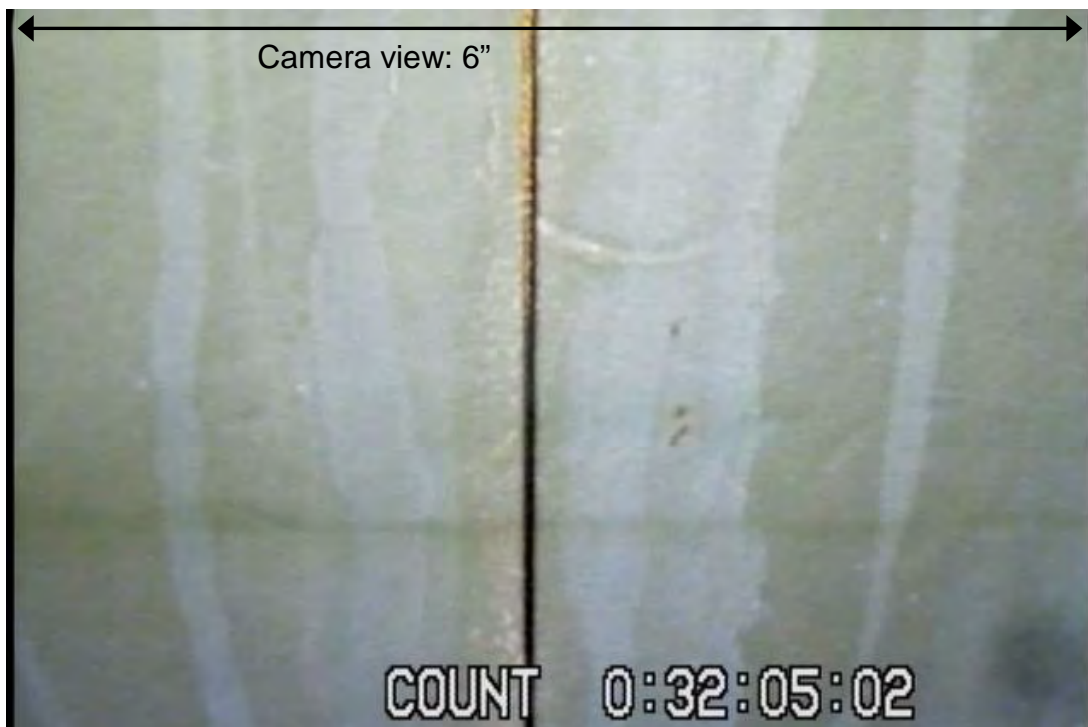
60. Scan 38 Dark spot – possible coating damage – no rust discoloration

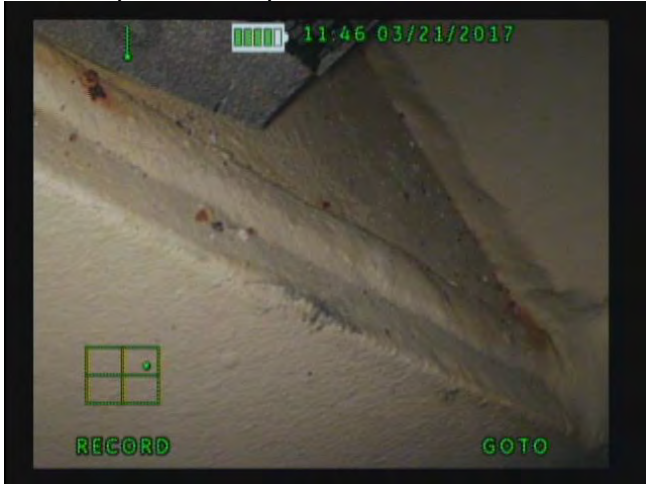
19. Overpack, rust spots

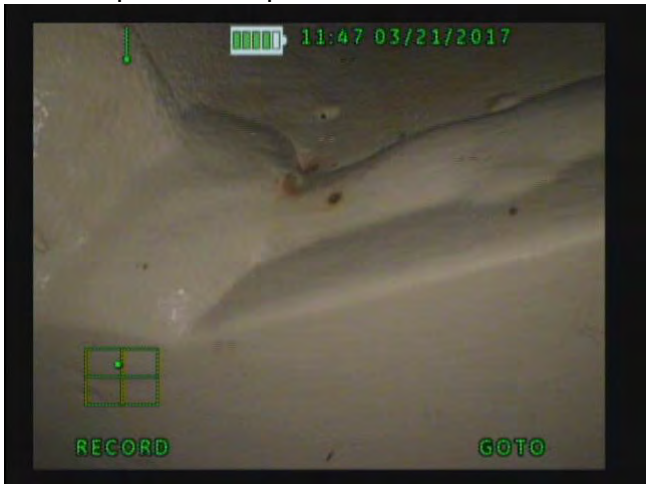
21. Overpack, rust spots
