Donald C. Cook Nuclear Plant
Units Nos. 1 and 2
Docket Nos. 50-315 and 50-316
DPR No. 58
CPPR No. 61

On September 21, 1977, we received Mr. Don K. Davis' letter dated September 15, which transmitted details of a limited boron dilution accident at an operating PWR facility due to the inadvertent injection of a portion of the coolant system while the reactor was in the cold shutdown condition. This letter further requested that we perform an analysis to evaluate the potential for and consequences of such a boron dilution accident at the Donald C. Cook Nuclear Plant.

FIG.1 POTENTIAL PATHS FROM NaOH TANK TO REACTOR COOLANT SYSTEM

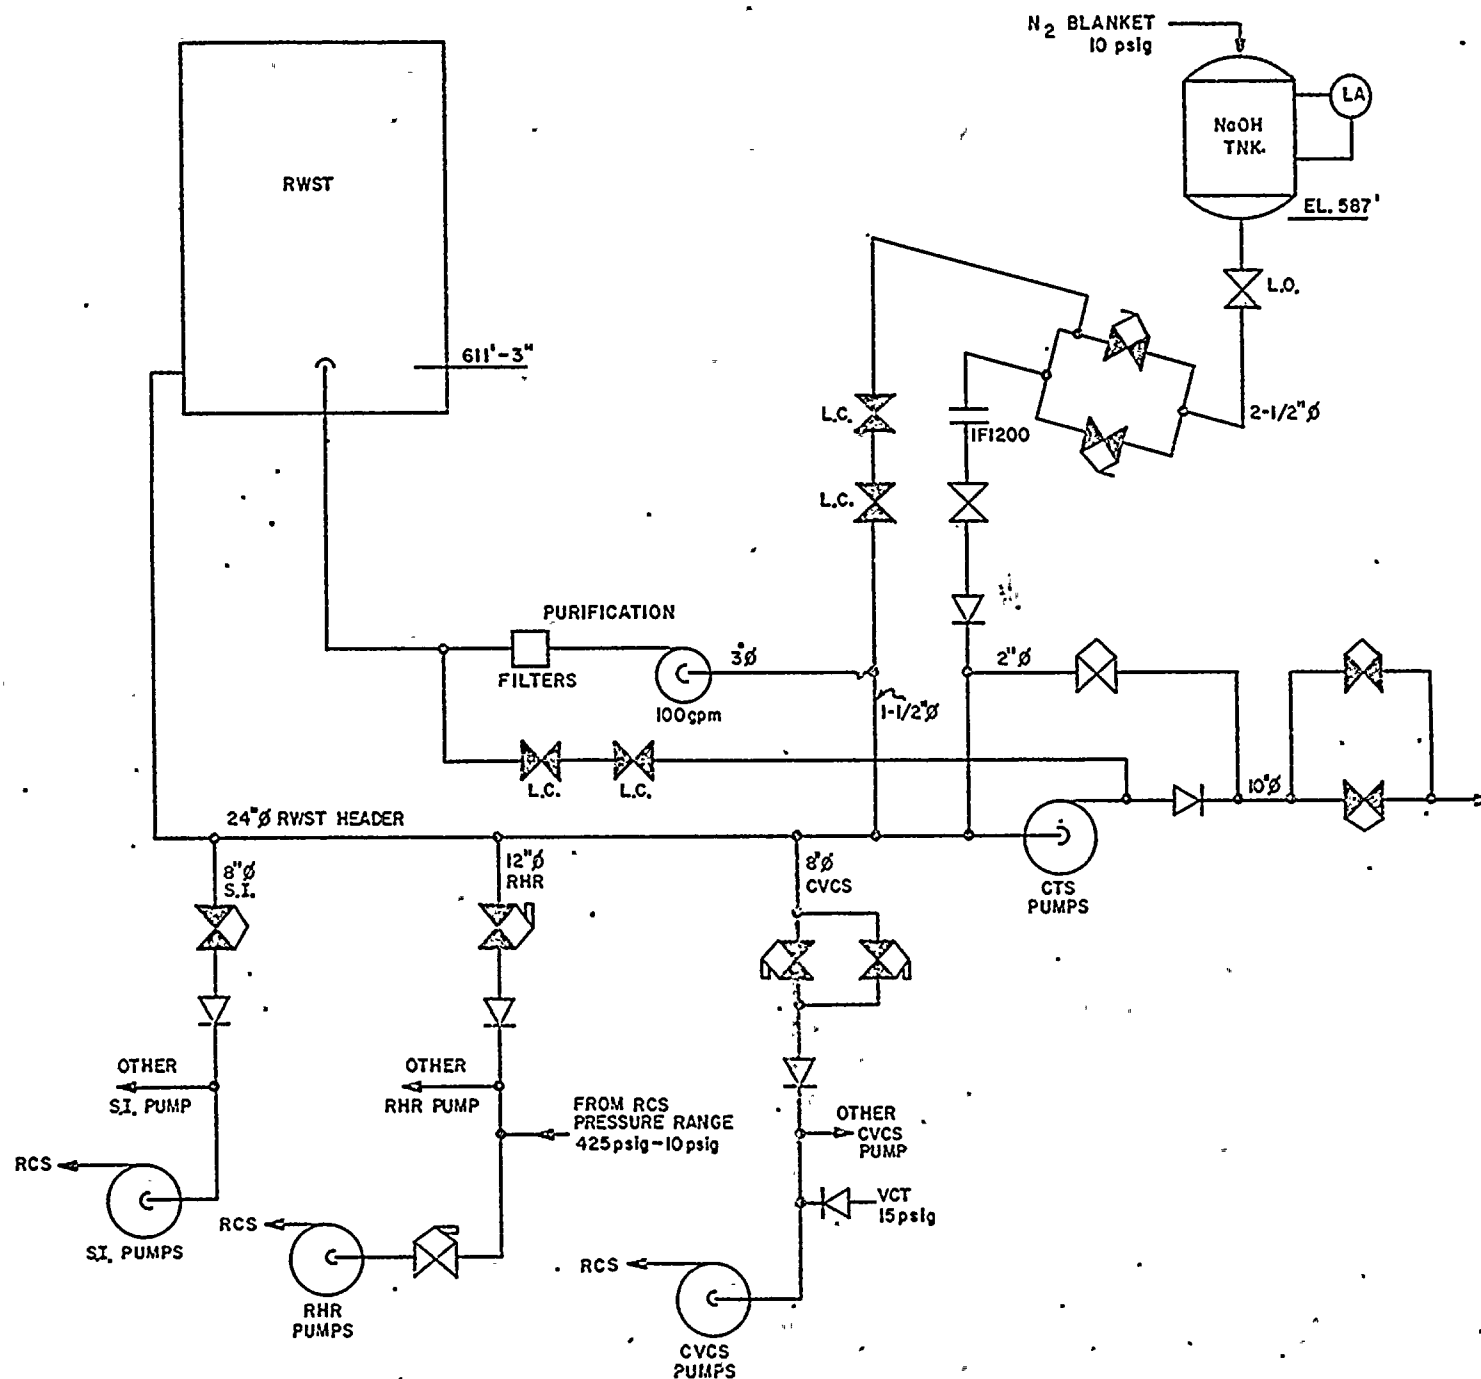
Attached Figure 1 is a schematic of the piping arrangement from the spray additive tank to its various discharge points.

The diagram represents the valving arrangement for the ECCS during recirculation. The schematic shows that a single valve failure or misposition will not lead to direct injection of NaOH in the Reactor Coolant System. The spray additive tank contents can only be added to the Reactor Coolant System by the mispositioning of four (4) valves in series, namely, tank discharge valve, 2 locked-closed hand valves and the ECCS pump suction valves from the refueling water storage tank. Thus, our evaluation has clearly shown that multiple component failures and/or operation errors would be required to initiate the incident cited by Mr. Davis' letter.

Based on this evaluation, it is concluded that this incident could not occur at Donald C. Cook Nuclear Plant by the misposition of a single isolation valve or a single active failure of a component. Hence no corrective action is considered necessary to mitigate the concerns addressed by Mr. Davis' above referenced letter.
