**Subject: License SUA-1341, Docket No. 40-8502
Willow Creek Project
August 1, 2018
Manhole across from Module 52
Christensen Ranch Mine Unit 5**

Uranium One USA, Inc. - Willow Creek Project
Spill Report Summary
Manhole next to Module 5-2 (Recovery) Fluid Releases

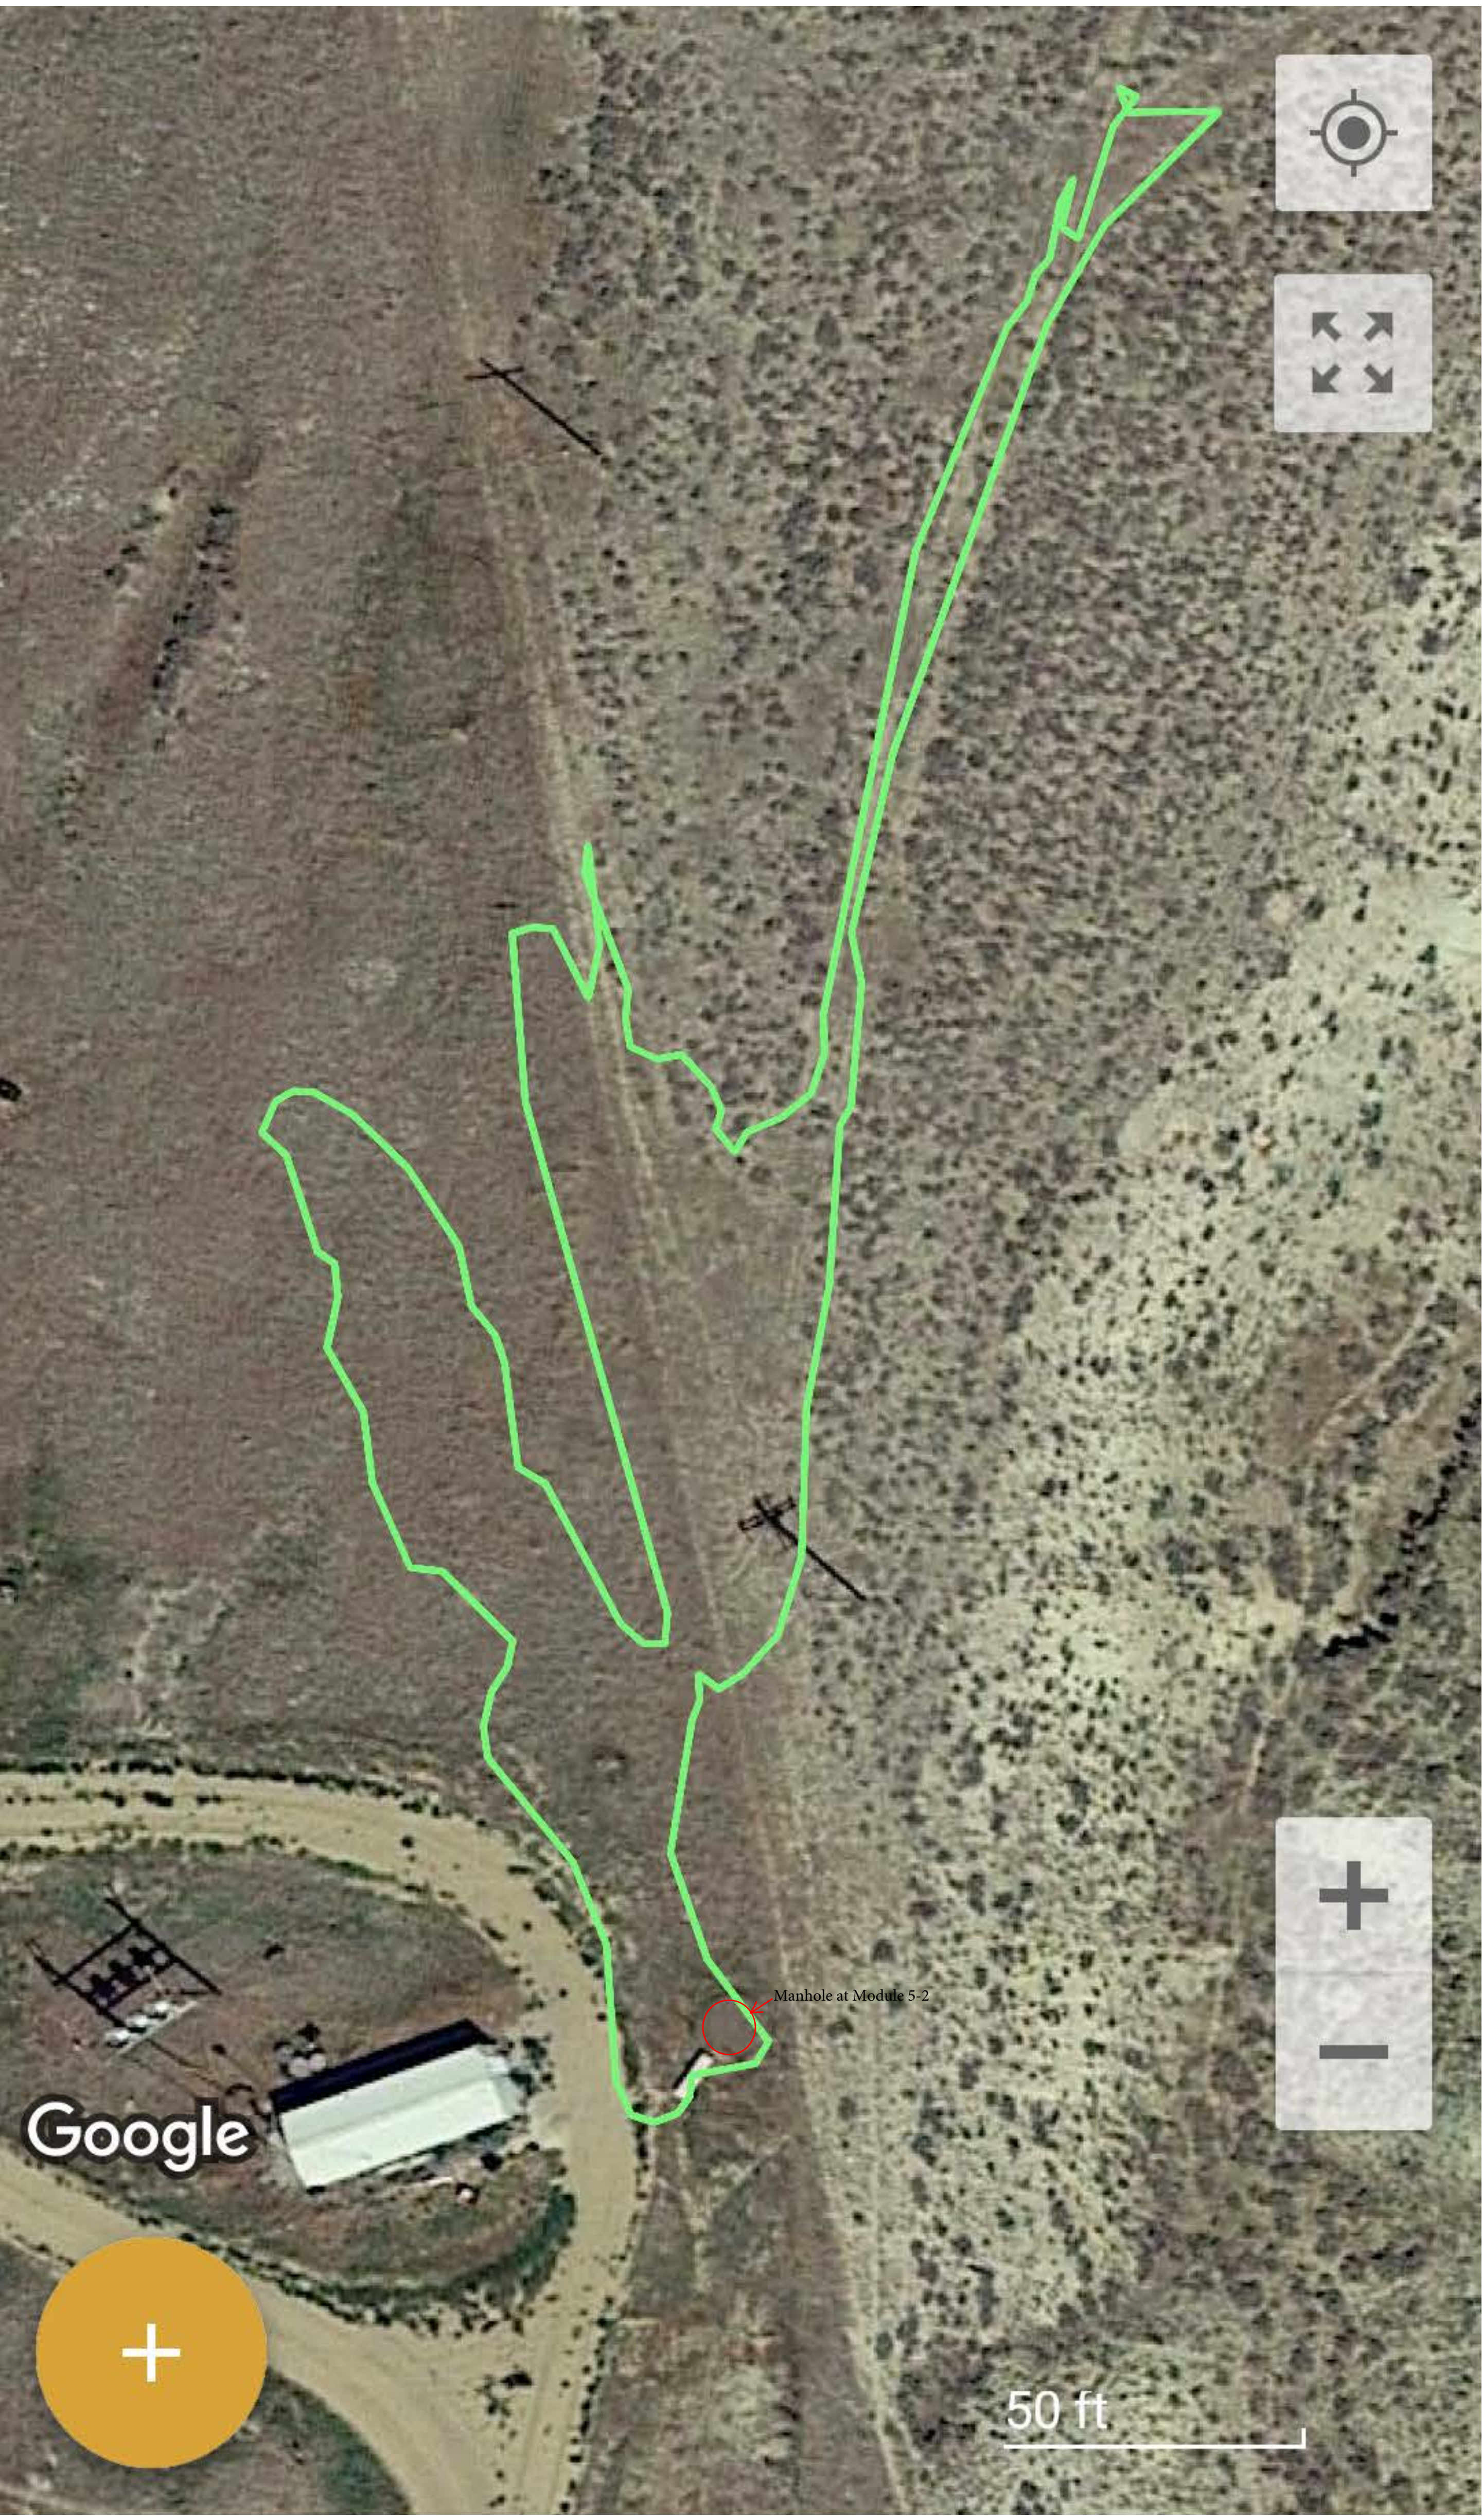
Attachement: Google Earth Photo of Manhole spill area next Module 5-2.

The release followed the existing grade, approximately 170' to the west of an ephemeral draw located near Module 5-2 in Mine Unit 5. The approximate surface area of the impacted was 8,770 square feet. No wildlife or livestock were impacted, nor did the spill reach surface water or the subsidiary to any waterways. No significant erosion resulted from the release.
