Subject: VIRGIL C. SUMMER NUCLEAR STATION (VCSNS) UNIT 1
DOCKET NO. 50-395
OPERATING LICENSE NO. NPF-12
RELIEF REQUEST RR-4-17, REQUEST TO UTILIZE CODE CASE
N-513-3 'EVALUATION CRITERIA FOR TEMPORARY ACCEPTANCE
OF FLAWS IN MODERATE ENERGY CLASS 2 OR 3 PIPING SECTION
XI, DIVISION 1' FOR A SERVICE WATER SYSTEM FLANGE

**South Carolina Electric & Gas Co. (SCE&G)
Virgil C. Summer Nuclear Station Unit 1 (VCSNS)
Relief Request RR-4-17**

**DESIGN CALCULATION SW050/03 REVISION 0 "THROUGH WALL LEAK
EVALUATION"**

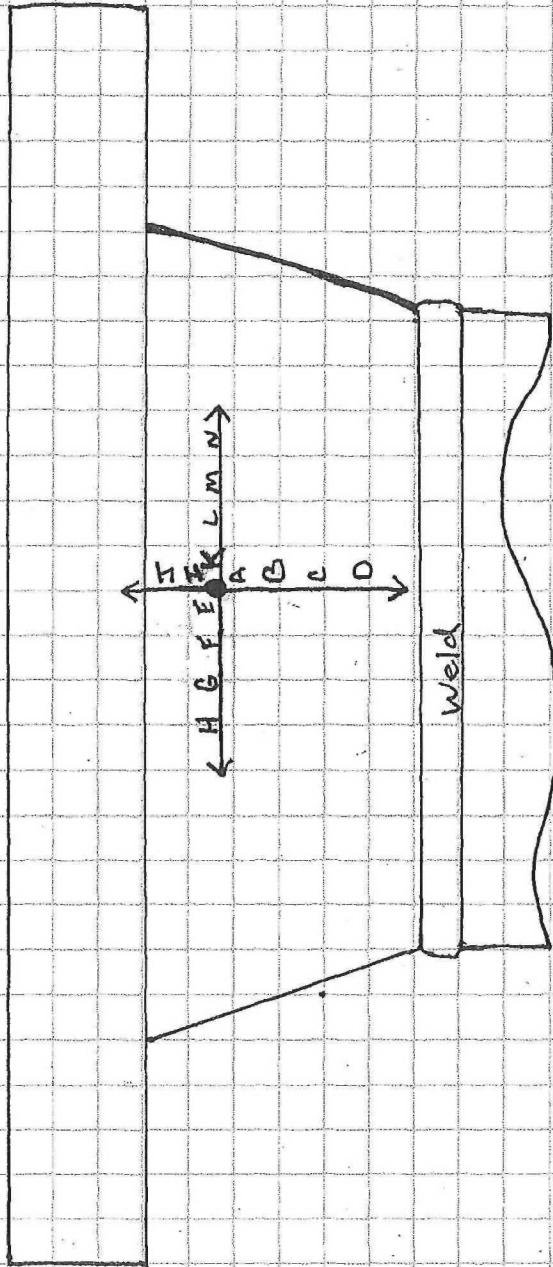
Letter Spacing = .5"

- A. .101
- B. .345
- C. .266
- D. .416
- E. .081
- F. .124
- G. .385
- H. .364
- I. .083
- * J. .324
- K. .052
- L. .270
- M. .318
- N. .291

Area out side of the cross pattern
was also scanned to make sure the
flow was not growing in the diagonals.

Pin hole leak is 2"
From weld and .75"
From Flang.

* Letter "J" data is on
the .05" spacing.

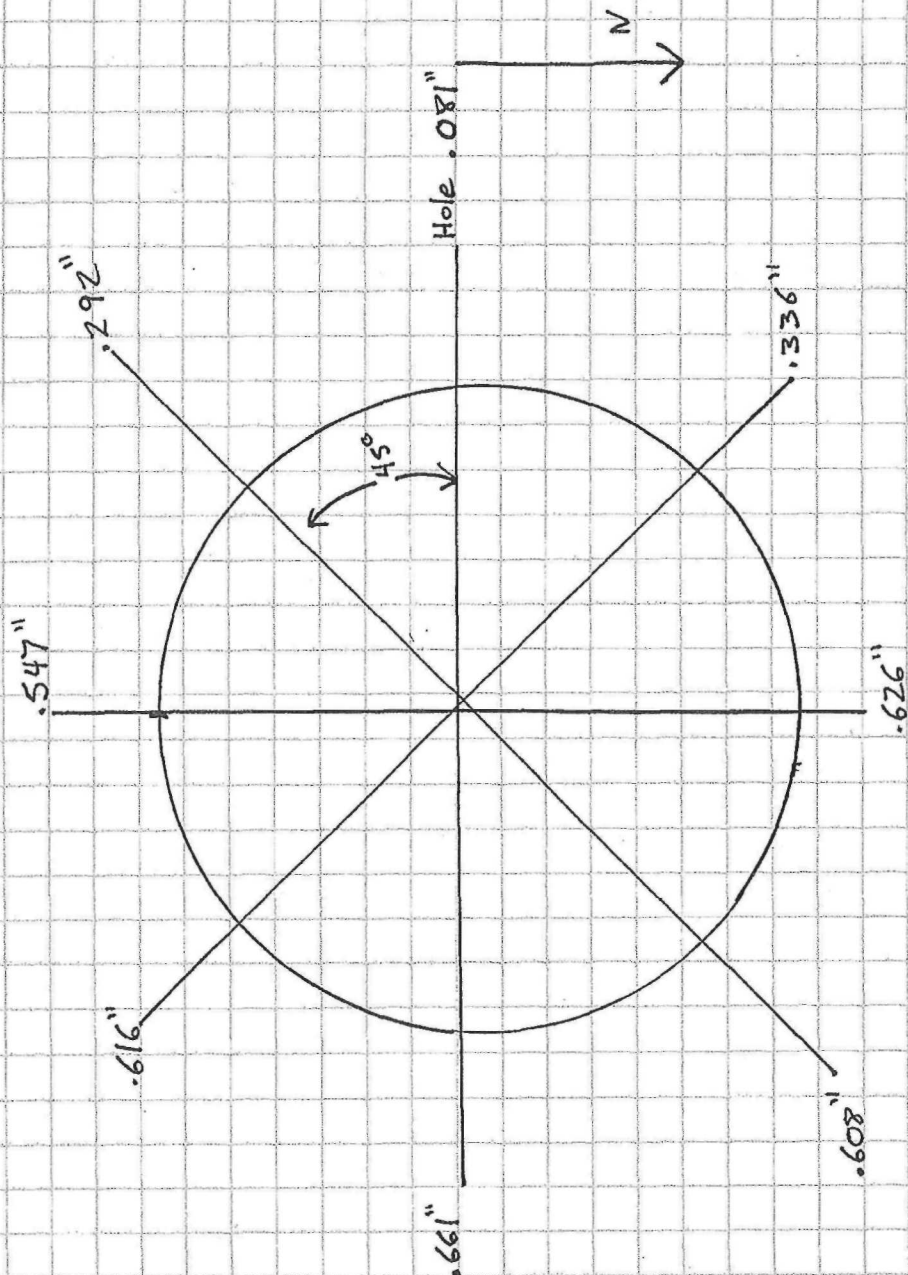
Scanned full circumference
and documented data
every 45 degrees.
