**RE: 2018 Annual Inspection Report, Cameco Resources (Power Resources Inc. dba),
North Butte ISR Project, PT0632**

IN SITU MINE INSPECTION REPORT

Permit Number:	PT0632	Permittee:	CAMECO RESOURCES (POWER RESOURCES INC DBA)
Inspection Date:	5/3/2018	Inspector(s):	Luke McMahan
Report Date:	6/1/2018	Participant(s):	Cameco Resources: Larry Reimann, Erik Heide, Tyler Spence, Devin Collins
Last Inspection:	10/5/2017	Current Bond:	\$27,738,300
Inspection Reason(s):	Annual	Field Conditions:	Partly cloudy, calm, dry, ~65° F
		Approval Date:	1/30/1991

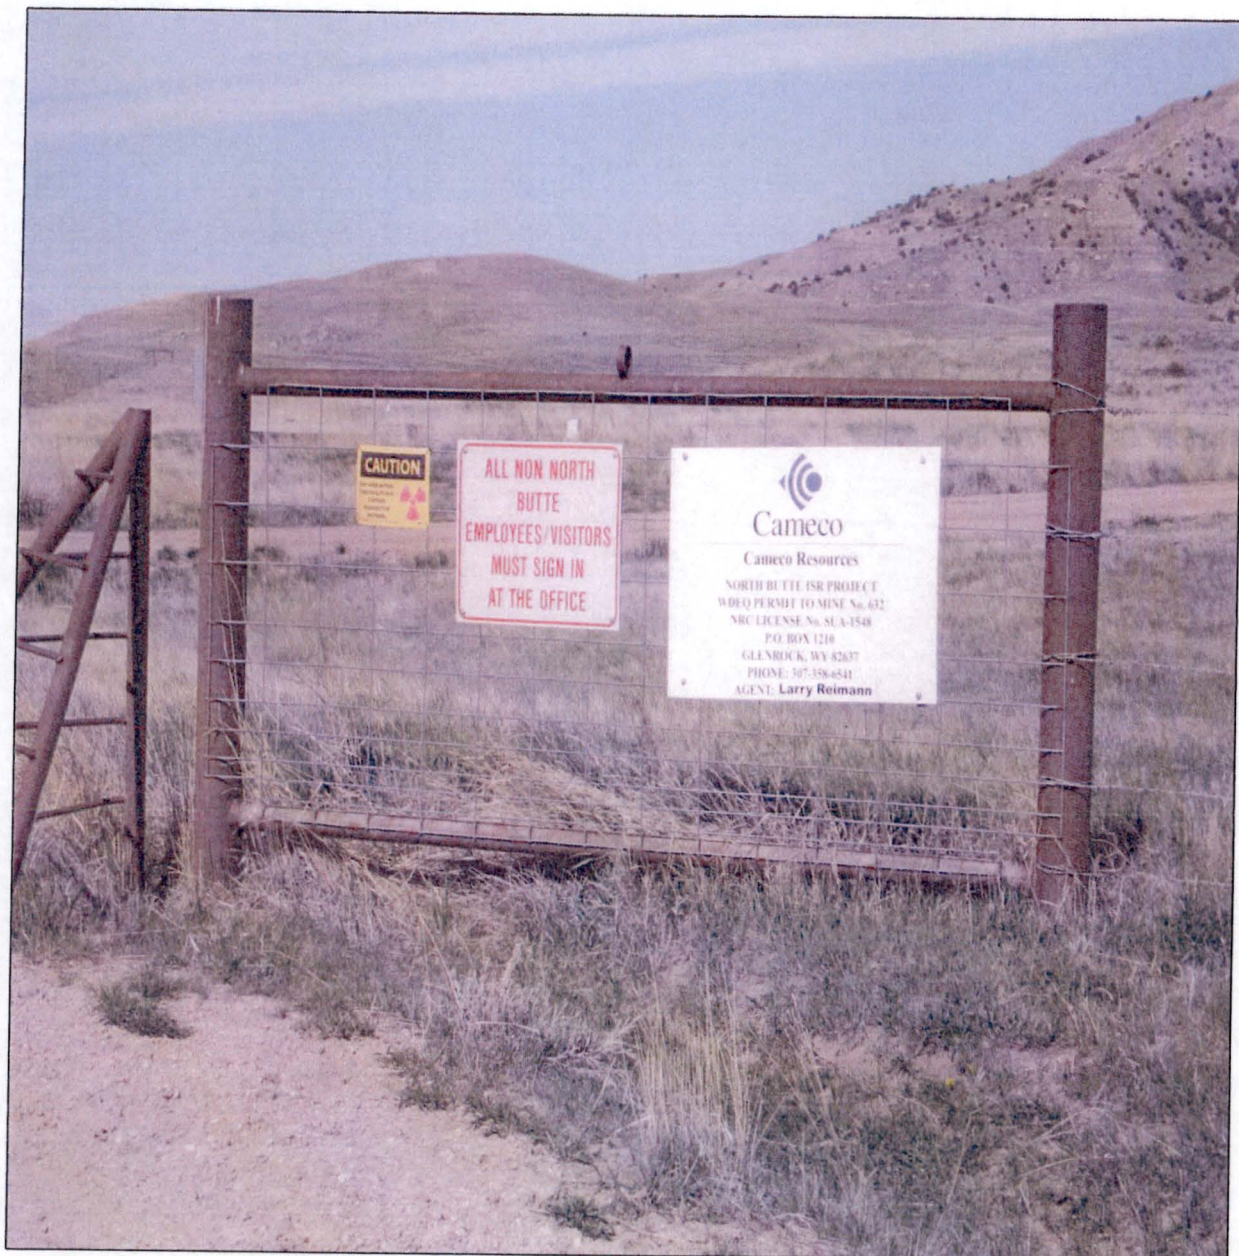
• Signs	Yes
The permit identification sign was viewed at the east entrance. The sign was found to have the appropriate information (Photo #1).	
• Staging Areas	Yes
The staging area at the deep disposal well site and the laydown area located near the office buildings were viewed. The miscellaneous equipment and supplies stored in these areas were found to be orderly and the areas were well maintained (Photo #7). No windblown trash or evidence of spills was observed.

Photo #1: View of signage along east entrance to mine permit area.

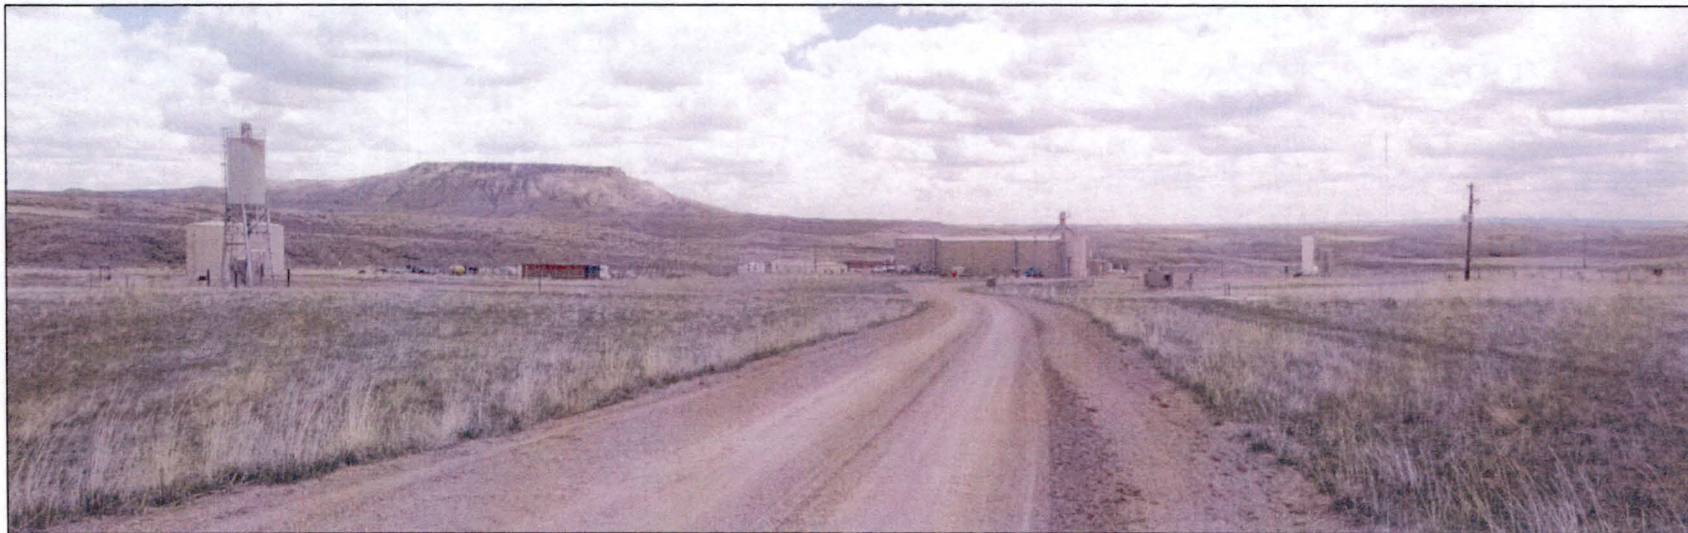
• Facilities	Yes
The facilities area around the exterior of the office buildings and plant building was briefly viewed (Photo #2). The area was well maintained, no evidence of spills (soil staining) was observed, and the area was free of windblown trash. Carbon dioxide and oxygen storage tanks are located within the secured (chain link fence) plant and office area. With the injection of lixiviant being discontinued, the oxygen and carbon dioxide used to produce the mining lixiviant were no longer in use. Cameco indicated that the oxygen tank was not yet empty whereas the carbon dioxide tank was empty at the time of the inspection (Photo #4).

Photo #2: Plant Facilities overview looking south from main access road.

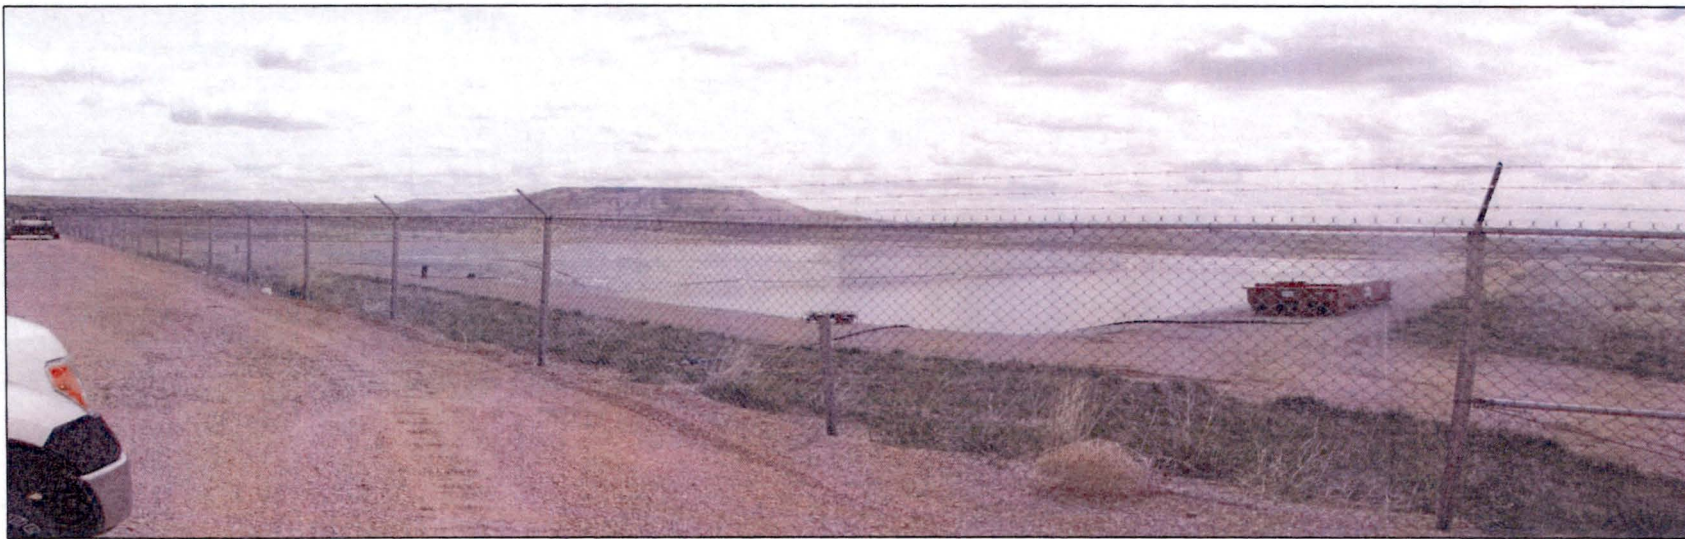
• Ponds	Yes
The Surge Ponds were viewed in passing. The ponds were noted to be holding water (approximately 1/3 full) and the liners appeared to be intact (Photo #3). The ponds are inspected daily by Cameco.

Photo #3: View of surge ponds adjacent to the plant facility.

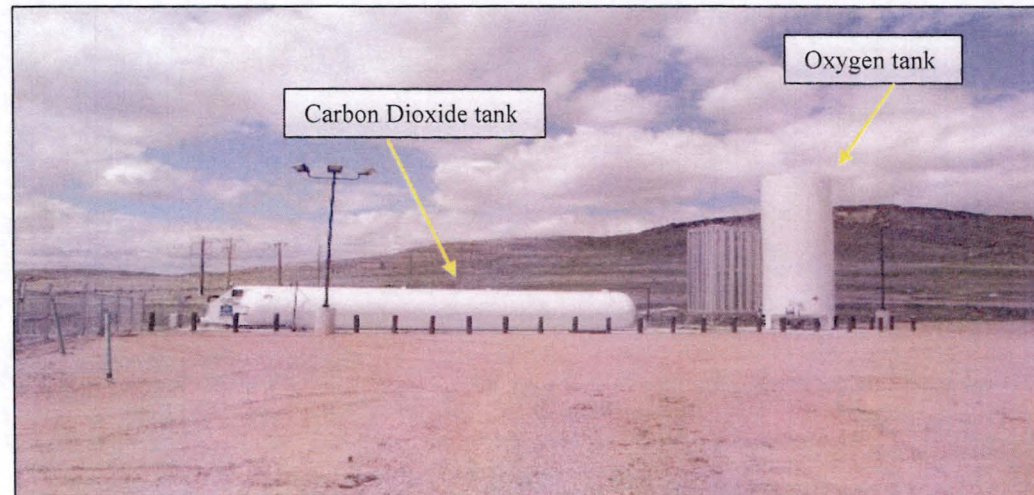
Photo #4: View of carbon dioxide and oxygen tanks located adjacent to the plant and office area.

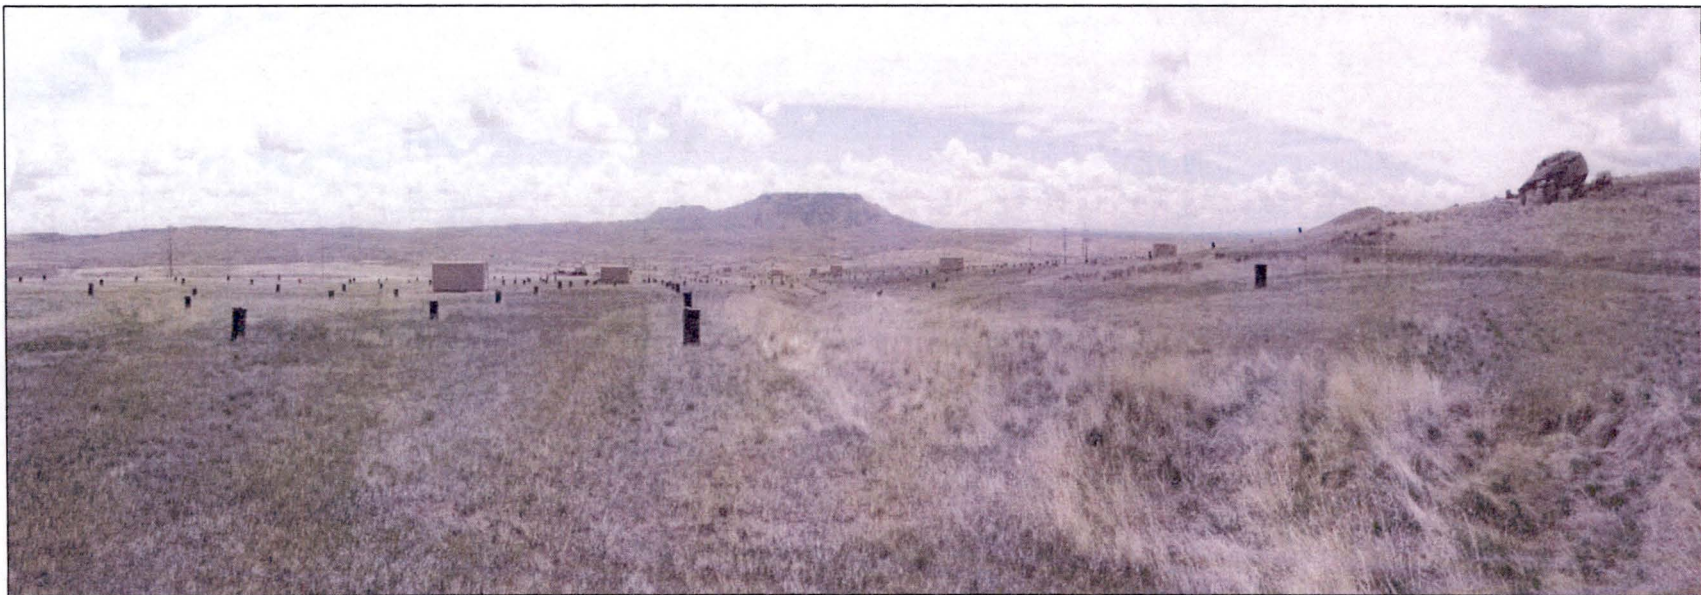
Inspection Topic	In Compliance
<ul style="list-style-type: none"> • Surface Water Control 	Yes
Viewed surface water monitoring locations NBSU-3, NBSD-3, NBI6, and NBI2. All locations were dry at the time of the inspection (Photos #5 & #11).	
<ul style="list-style-type: none"> • Topsoil Stockpiles 	Yes
All topsoil stockpiles were viewed in passing. All stockpiles were found to be stable with effective erosion protection and posted with a topsoil identification sign (Photos #7 & #18).	
Well Field Development	N/A
<ul style="list-style-type: none"> • Infrastructure 	Yes
Mine Unit 3 North, Header House 3-1 (and associated wells) is plumbed-in for production, however injection has not been initiated for Header House 3-1. Although the majority of the wells for Header House 3-2 have been constructed and MIT'd, Header House 3-2 and the associated wells have not been plumbed-in for production and therefore this header house and the associated wells remain under construction (Photos #13, #14 & #15).

Photo #5: View of Mine Unit 1 and Mine Unit 2 looking south/southeast from NBSU3 upstream surface water sampling location.

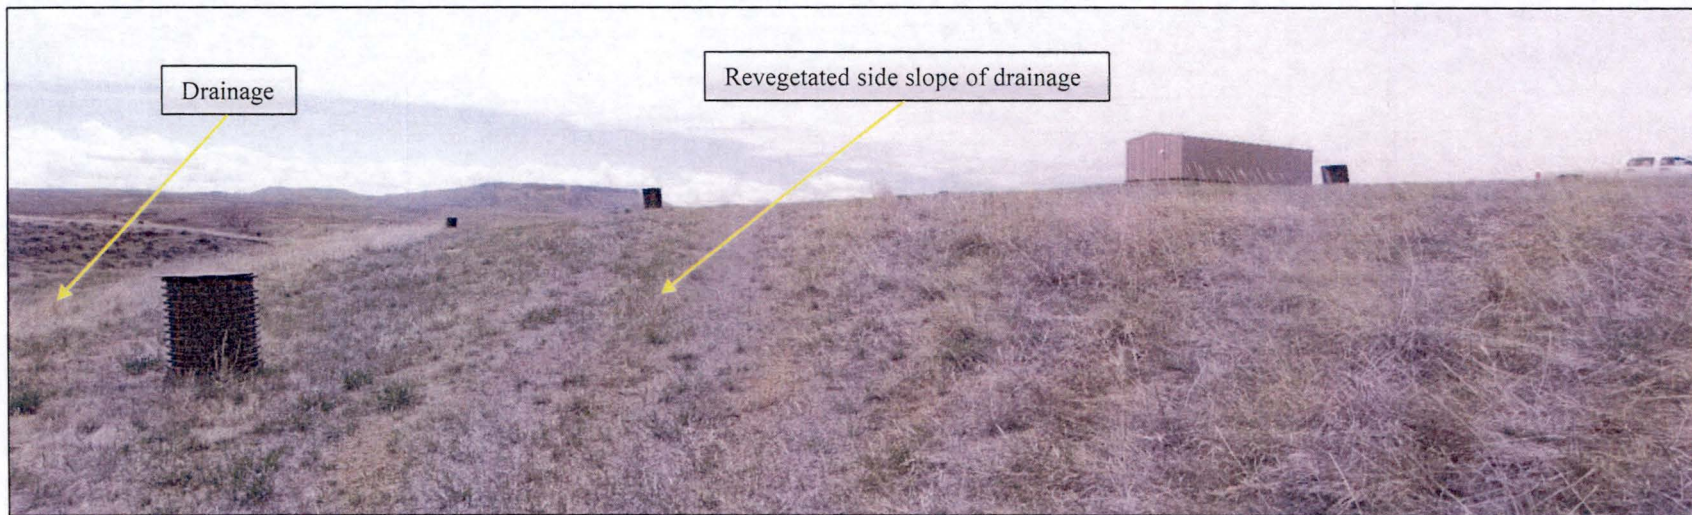
Photo #6: View of Mine Unit 1, Header House 1-1 area, vegetative growth from interim seeding of wellfield construction.

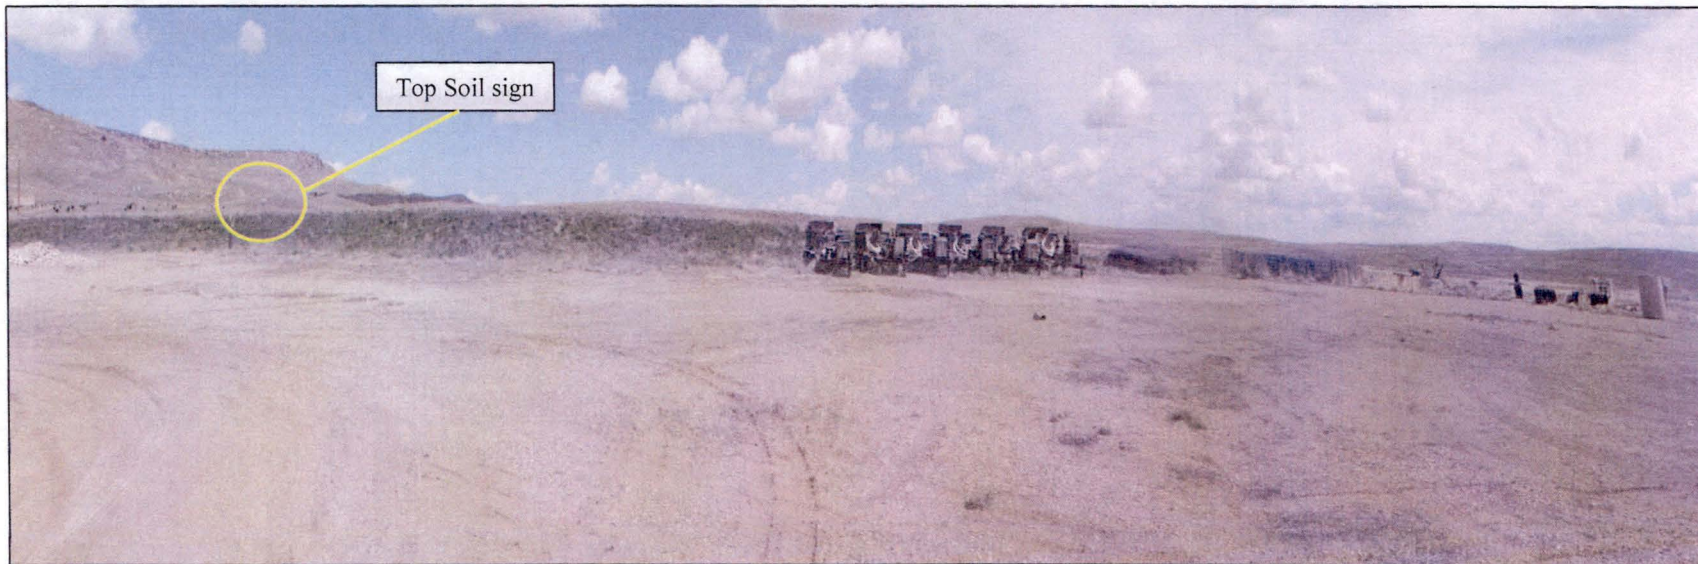
Photo #7: View of staging area around Class 1 Injection Well site; grout machines, and Topsoil Stockpile NBSP5 in background.

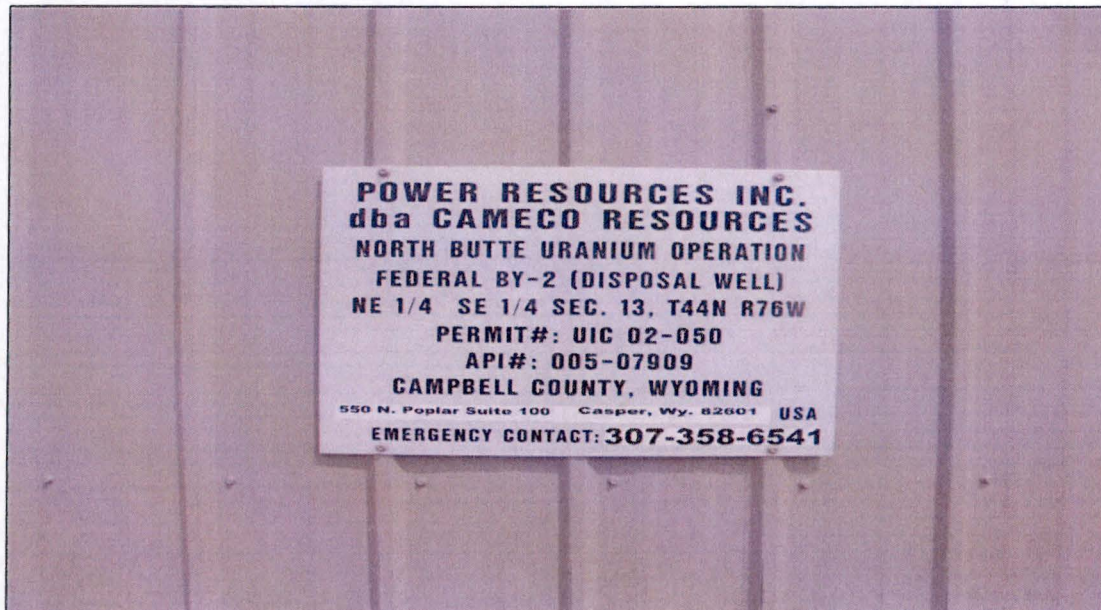
Inspection Topic	In Compliance
General	N/A
• Deep Disposal Wells	Yes
The Class 1 Injection Well Facility (deep disposal well) was viewed during the inspection (Photos #8, #9 & #10). No staining or indication of spills in the area of the well house and the pump house was observed. Although Mine Unit 1, Mine Unit 2 and Mine Unit 3-North are receiving no injection, a bleed is maintained from Mine Units 1 & 2 for hydrologic control. Since injection has not been initiated in Mine Unit 3-North, a bleed is not necessary. The bleed from Mine Unit 1 and Mine Unit 2 is transferred through IX columns at the facility plant and the waste is directed to the deep disposal well.

Photo #8: View of Class 1 Injection Well Permit sign.

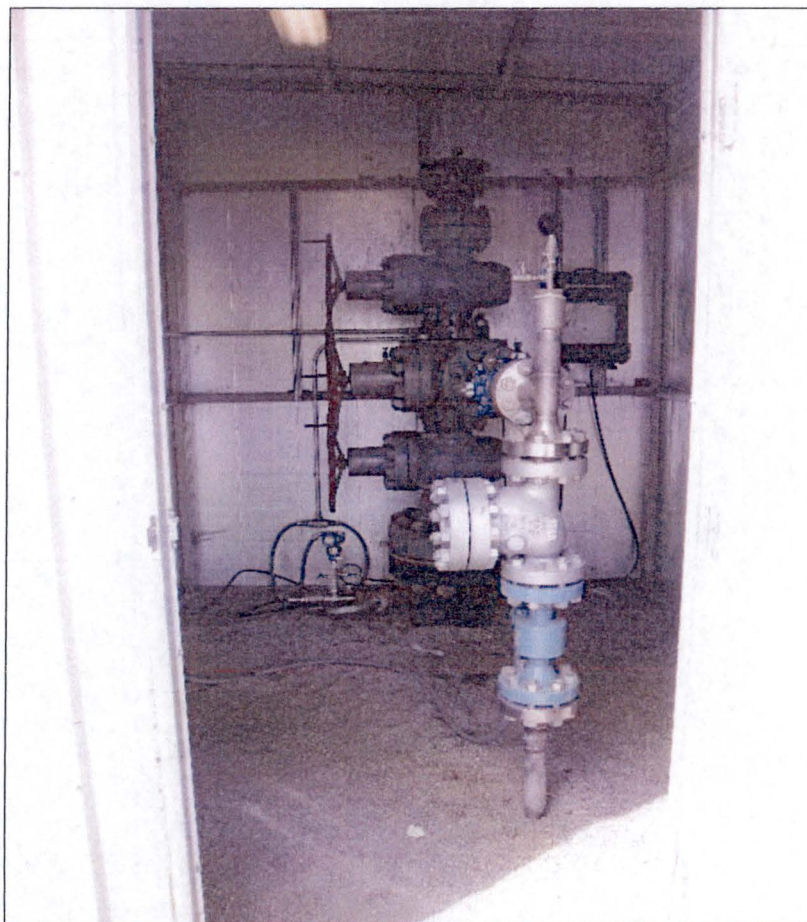
Photo #9: View of Class 1 Injection Well.

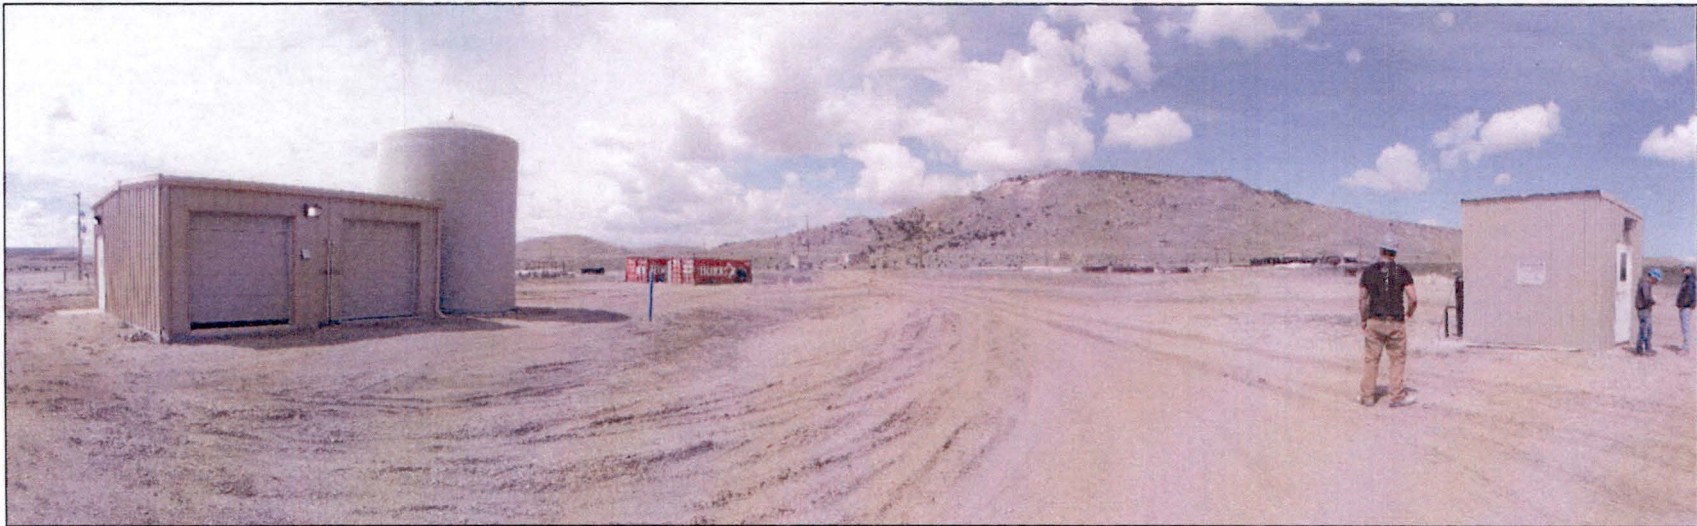
Photo #10: View of Class 1 Injection Well facility pump building (left) and well building; area around facility is used for staging.

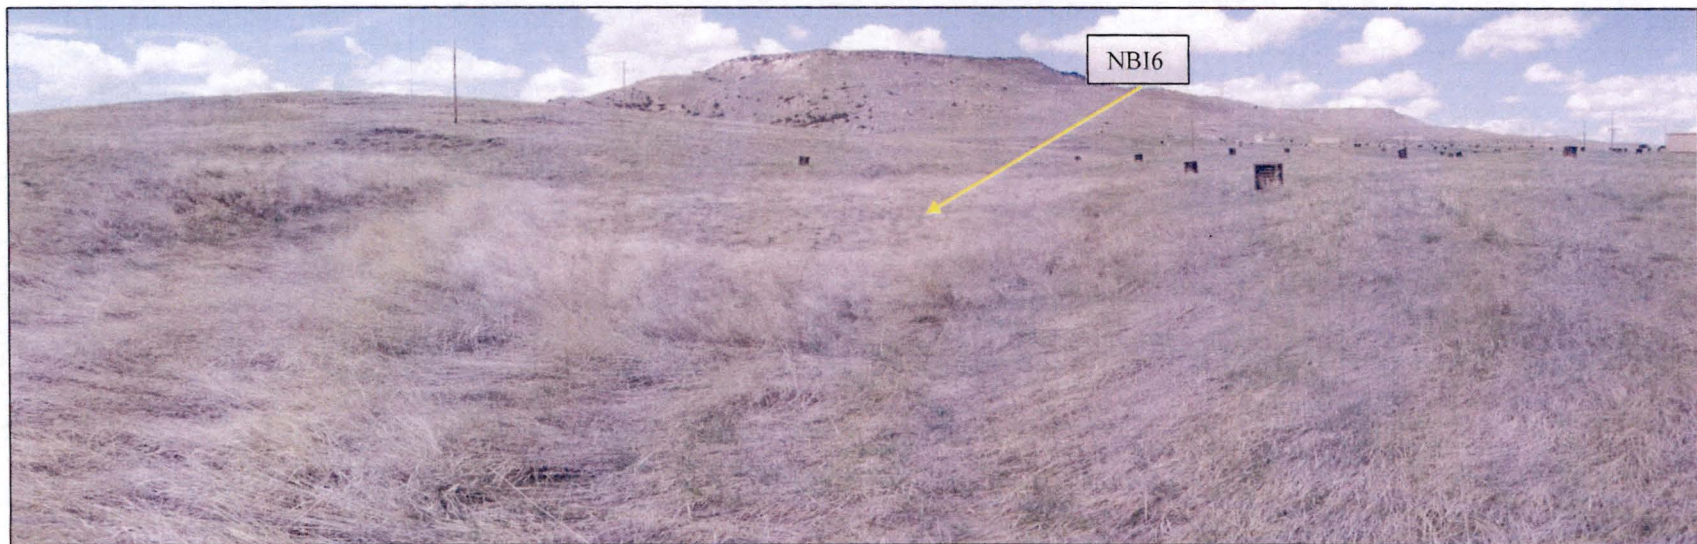
Photo #11 View of impoundment surface water sampling location NBI6, dry.

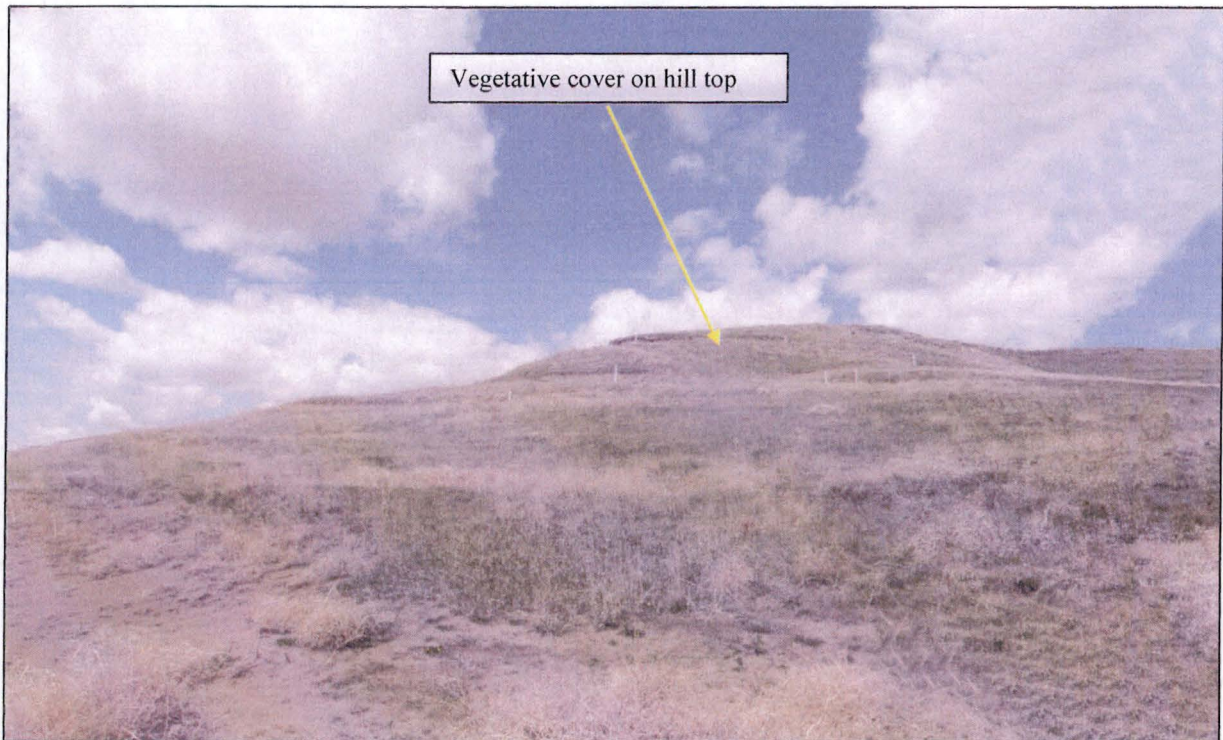
Well Fields	N/A
<ul style="list-style-type: none"> • Erosion Control 	Yes
<p>Erosion control in wellfield areas is largely provided by revegetation of interim reclamation, particularly in areas where surface disturbance from wellfield construction was along the side-slopes of drainages. An example of this is seen in the area of Mine Unit 1 Header House 1 (Photo #6).</p> <p>During the development of Mine Unit 3-North, Cameco implemented additional revegetation efforts on a prominent hilltop located in the northwest portion of the wellfield. The relatively steep slopes of the hilltop were draped with matting to promote growth of vegetation and in-turn stabilize the area that was disturbed due to well installation. This area, located north of Header House 3-2, was viewed during the inspection and found to be stabilized with vegetative growth which is providing erosion control (Photo #12).</p>

Photo #12: View of Mine Unit 3-North hill top; wells and vegetation.

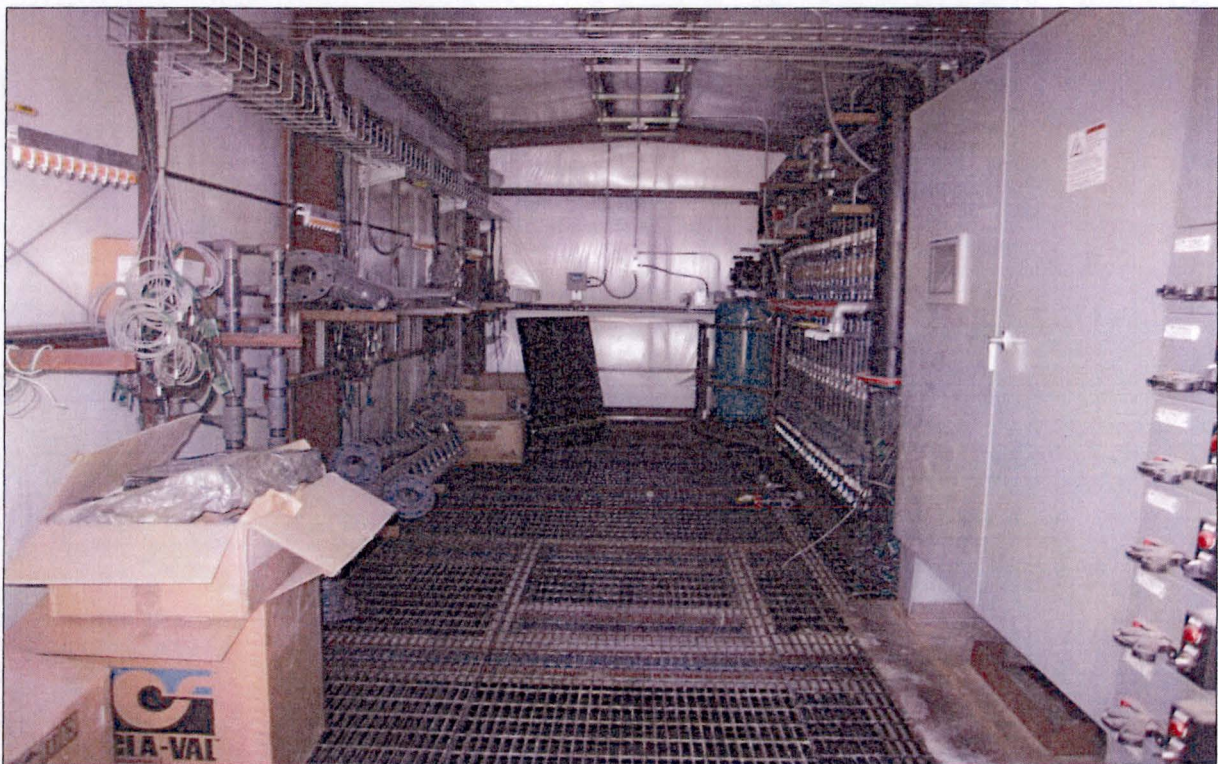
Photo #13: View of Mine Unit 3-North Header House 3-2; non-operational, under construction.

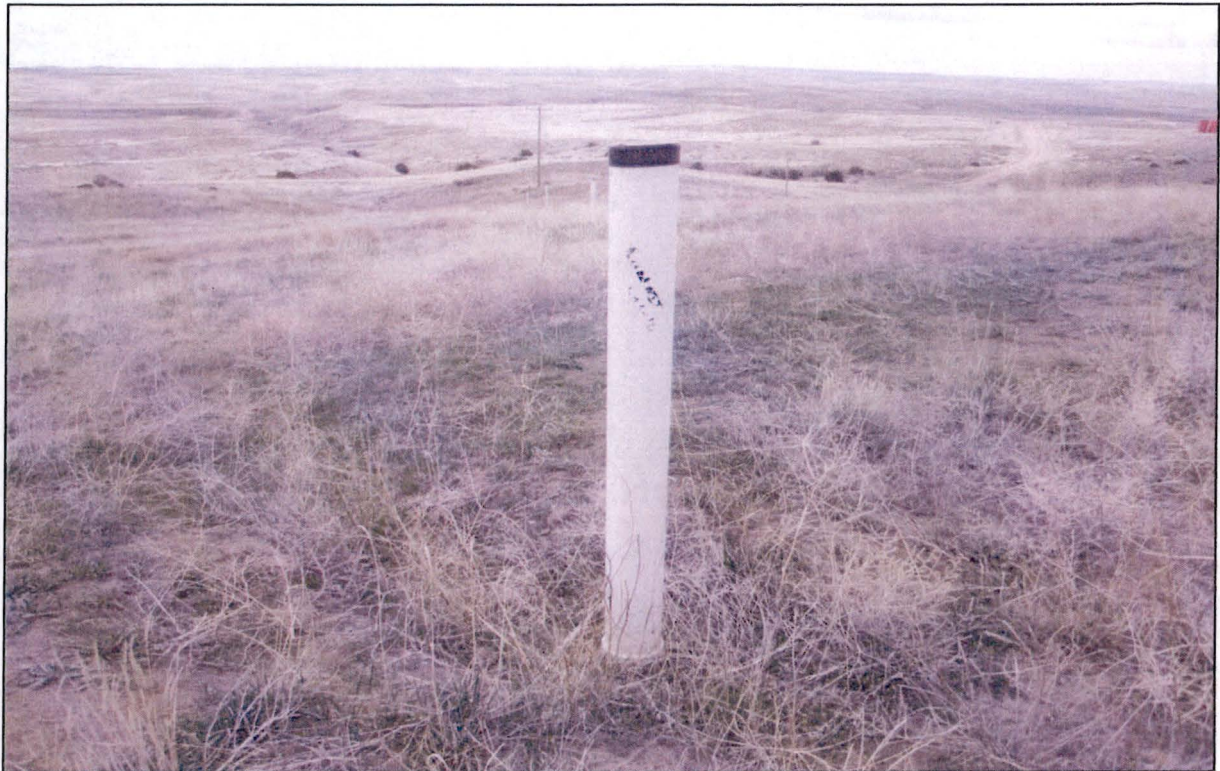
Photo #14: View of MU3N well head NB3I-73 as completed, not yet plumbed to HH3-2.

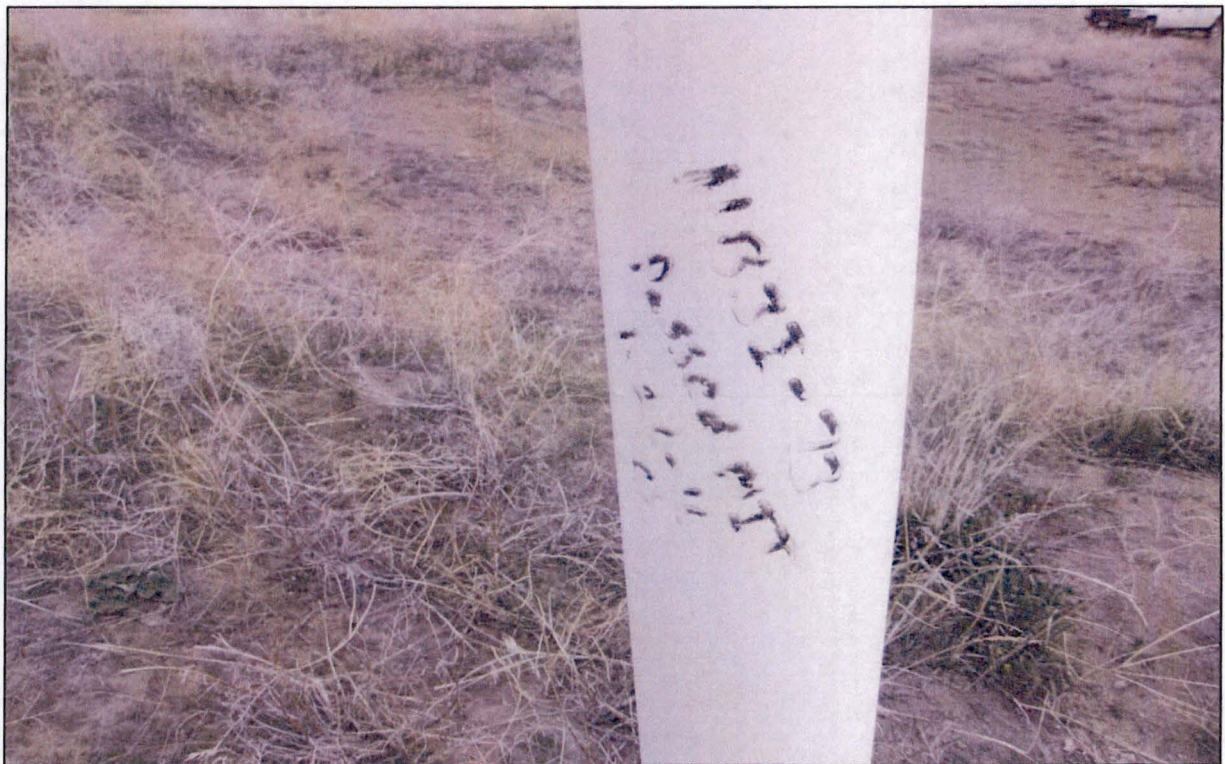
Photo #15: View of NB3I-73; initial MIT passed 1-26-16.

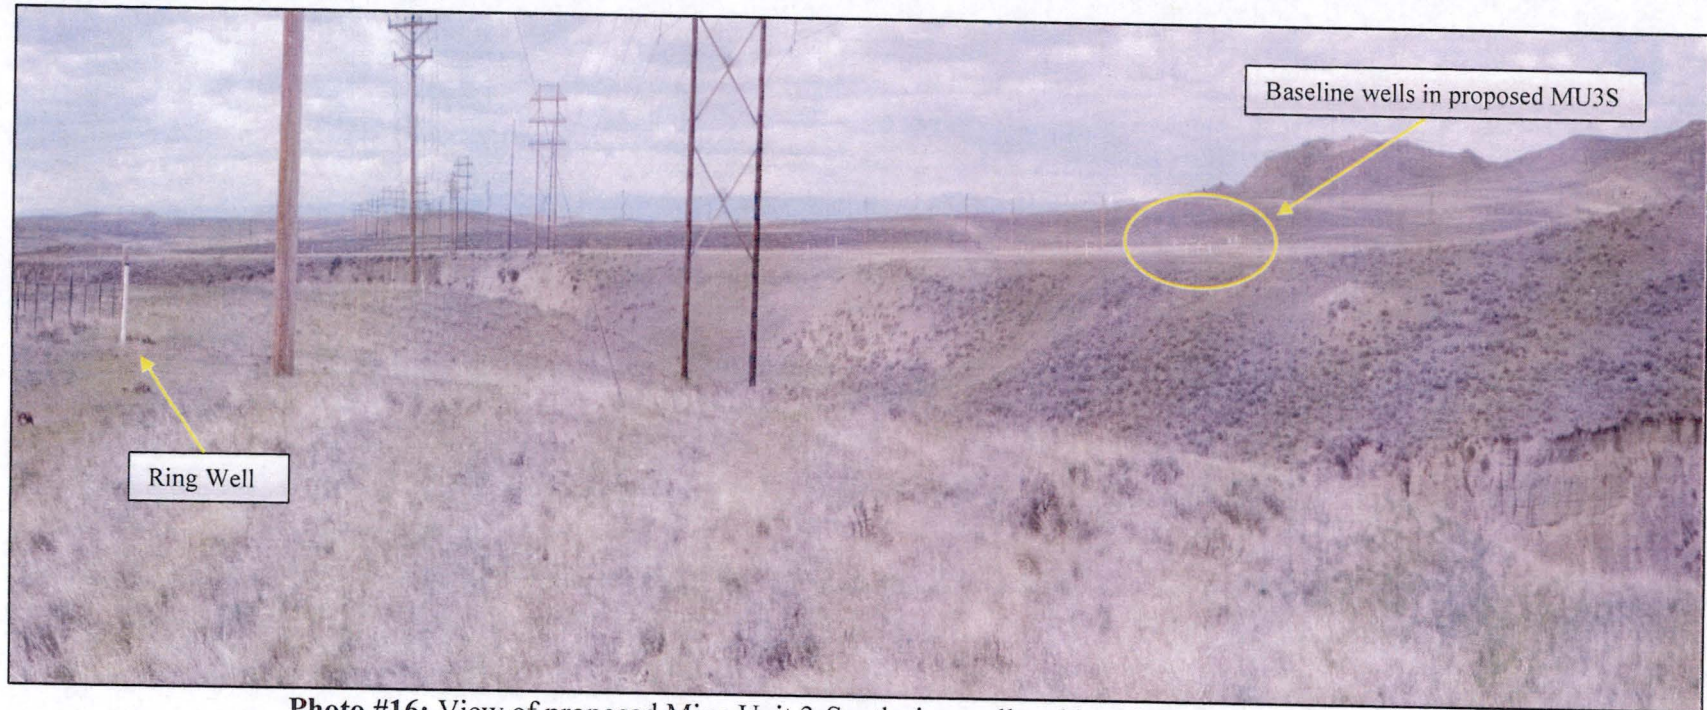
Photo #16: View of proposed Mine Unit 3-South ring well and baseline monitoring wells.

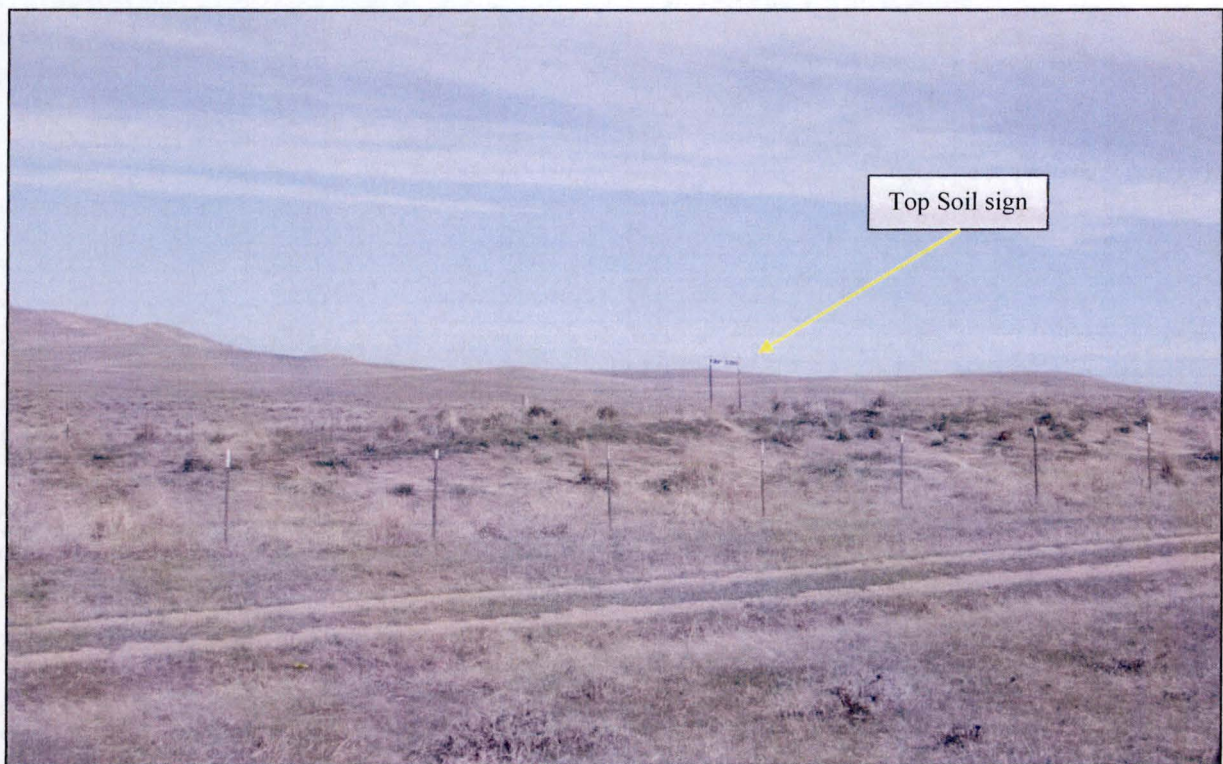
Photo #18: View of Topsoil Stockpile NBSP8.

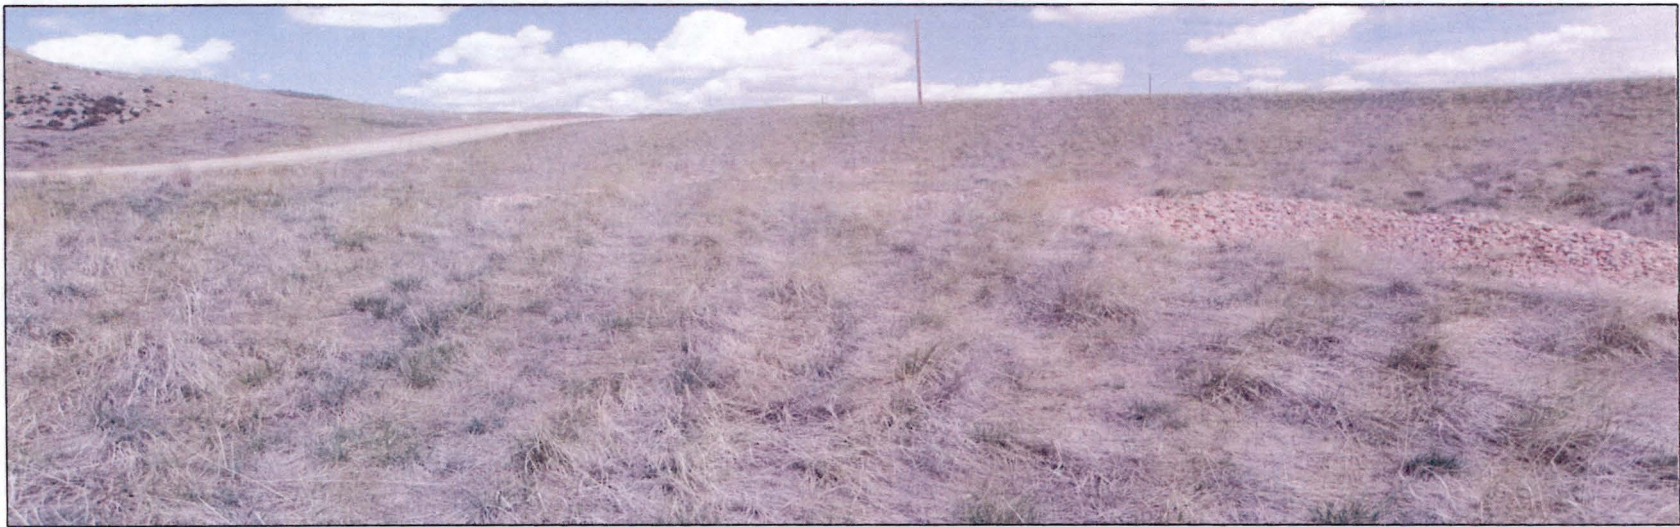
• Erosion Control	Yes
Viewed gabion structure and culvert associated with erosion control for a main access road drainage crossing (Photos #19 & #20). The culvert and gabion structure appeared to be stable and functioning as intended. Vegetation along the road and top portion of the structure was well established.

Photo #19: View of revegetation of area above gabion structure.

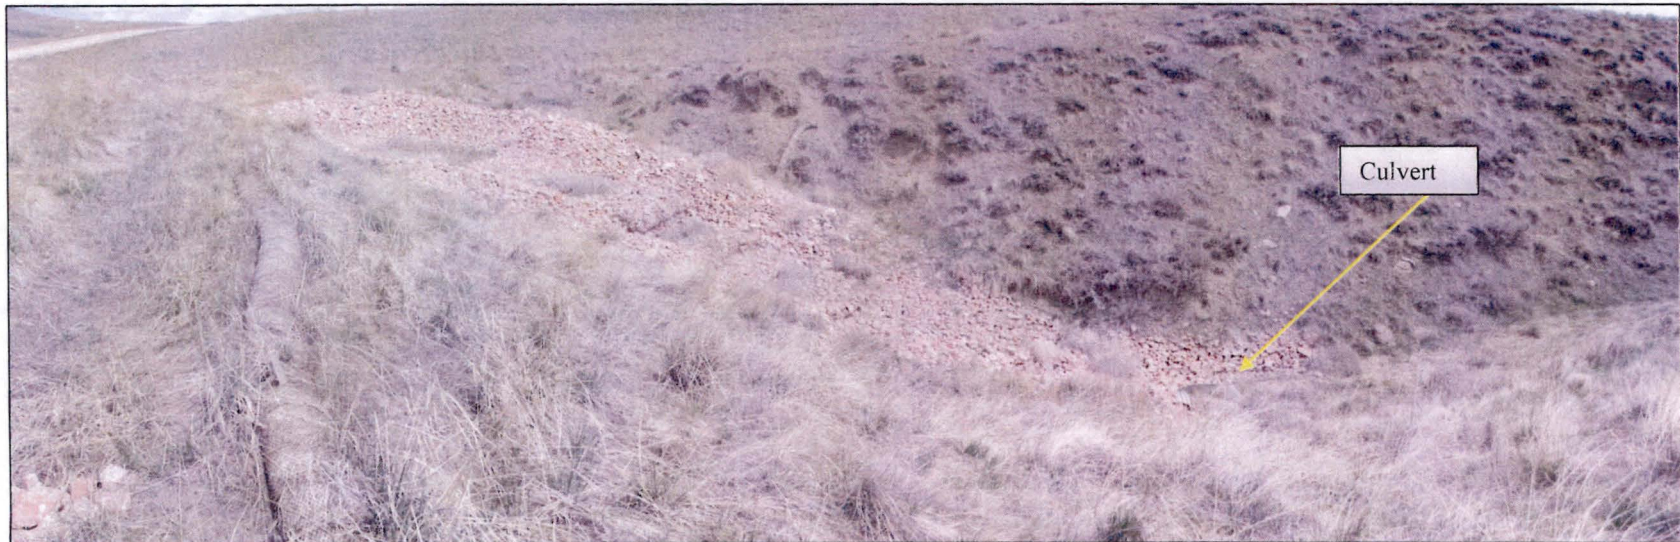
Photo #20 View of gabion structure extending into drainage.
