Subject: License SUA-1341, Docket No. 40-8502 (Electronic Submittal Only)
Willow Creek Project
August 6, 2018
Pump Station 8 Release
Christensen Ranch

**Uranium One USA, Inc. - Willow Creek Project
Spill Report Summary
Pump Station 8 (Recovery) Fluid Releases**

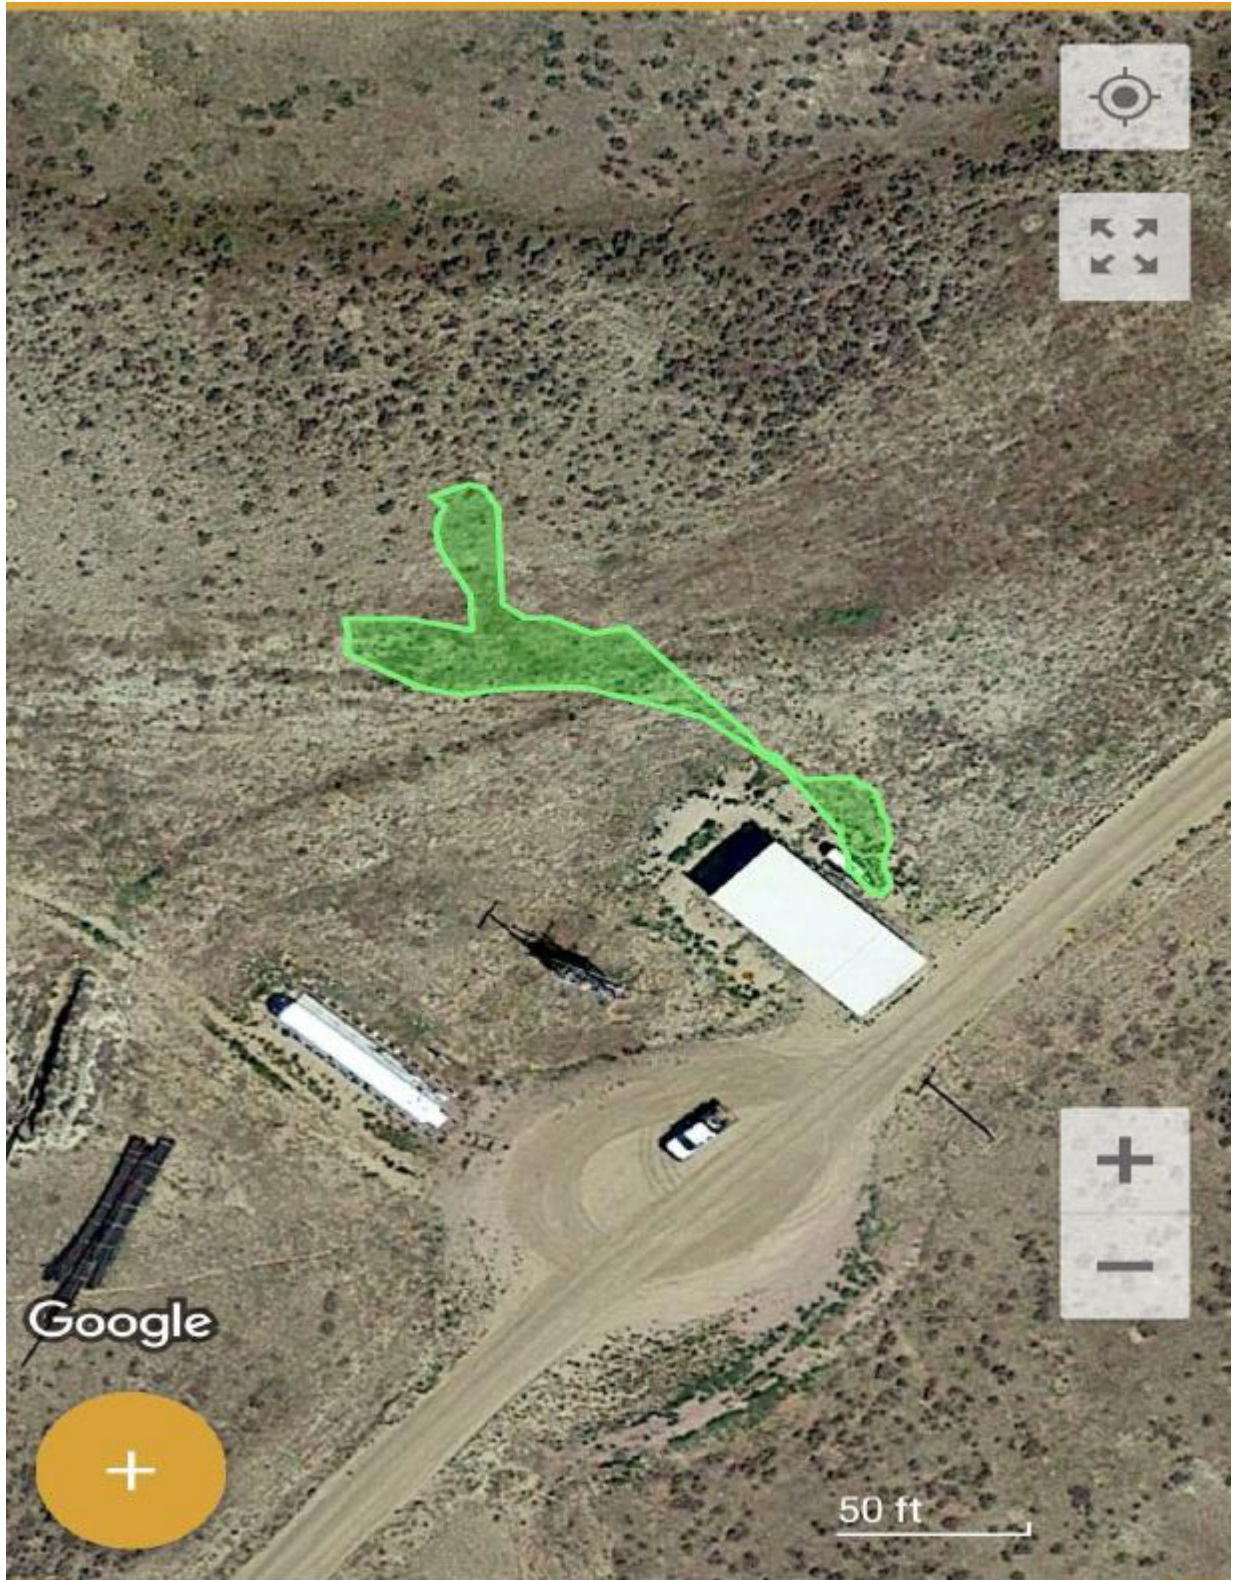
Attachement: Google Earth Photo of Pump Station 8 spill area.

The release followed the existing grade, approximately 100 foot to the south of an ephemeral draw located near Pump Station 8. The approximate surface area of the impacted was 2,803 square feet and flowed . No wildlife or livestock were impacted, nor did the spill reach surface water or the subsidiary to any waterways. No significant erosion resulted from the release.
