Department of Environmental Quality

RE: 2018 Annual Inspection Report, Cameco Resources (Power Resources Inc. dba),
Ruth ISR Project, PT0631

IN SITU MINE INSPECTION REPORT

Permit Number:	PT0631	Permittee:	CAMECO RESOURCES (POWER RESOURCES INC DBA)
Inspection Date:	5/3/2018	Inspector(s):	Luke McMahan
Report Date:	5/30/2018	Participant(s):	Cameco Resources: Larry Reimann, Erik Heide, Tyler Spence
Last Inspection:	5/3/2017	Current Bond:	\$419,000
Inspection Reason(s):	Annual	Field Conditions:	Partly cloudy, calm, dry, ~65° F
		Approval Date:	12/26/1990
Status:	Inactive	Approved Acreage:	1414
County:	Johnson	Mineral:	Uranium

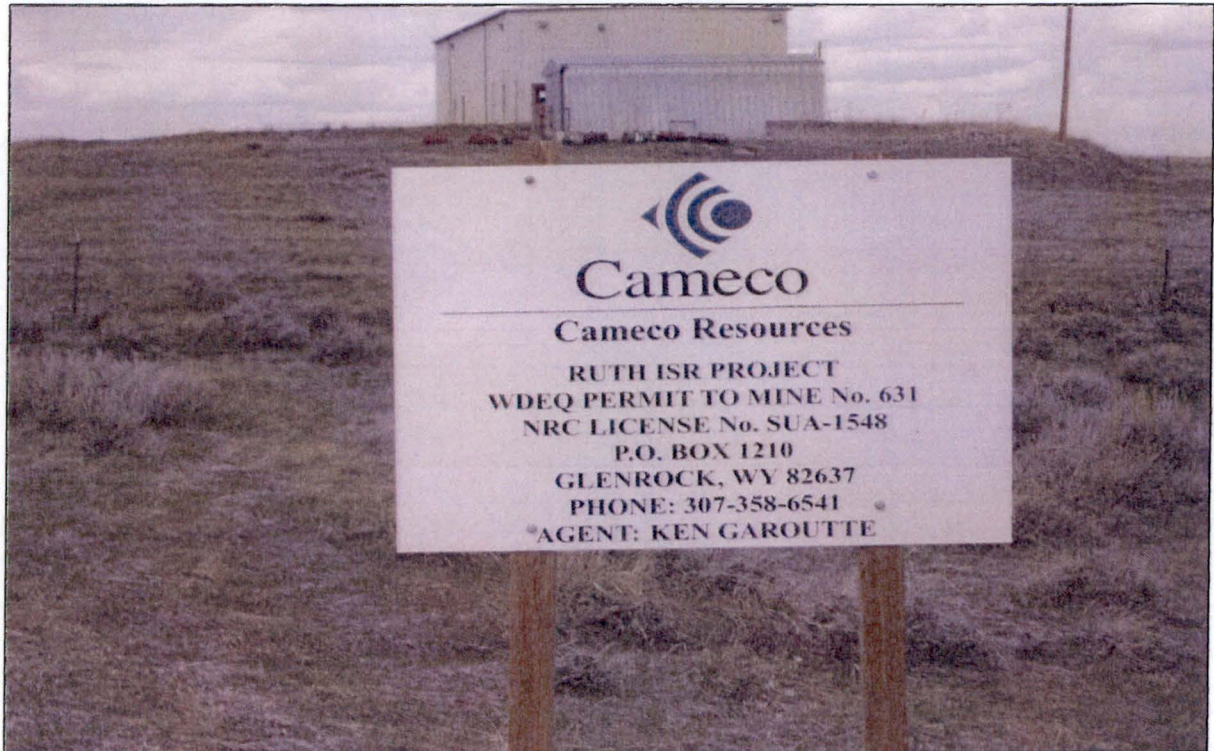
The site continues to be well maintained. There are no outstanding compliance issues at the Ruth ISR Project. One maintenance item was identified during the inspection. Due to recent personnel changes with Camceco, the permit sign located at the entrance to the facility area needs to be updated with the current Agent.

Photo #1: View of permit identification sign. Update needed for current Agent.

Inspection Topic	Inspection Date	Proposed Resolution Date
Signs	5/3/2018	8/1/2018
Update the Permit Sign with the current Agent.

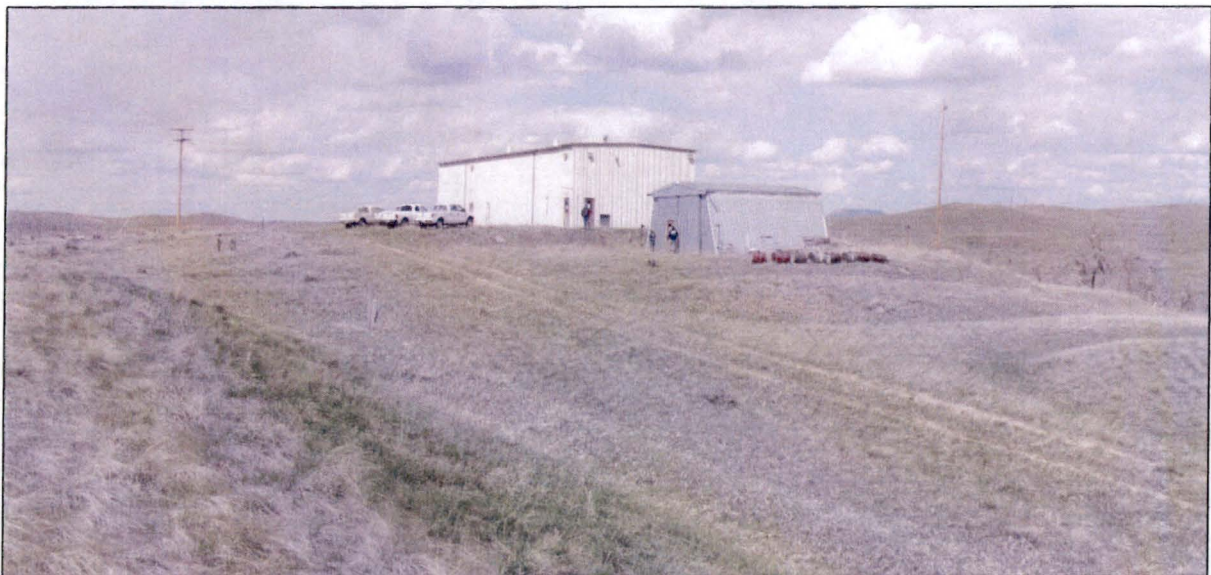
Photo #2: View of process building (left) and warehouse building (right) looking northeast.

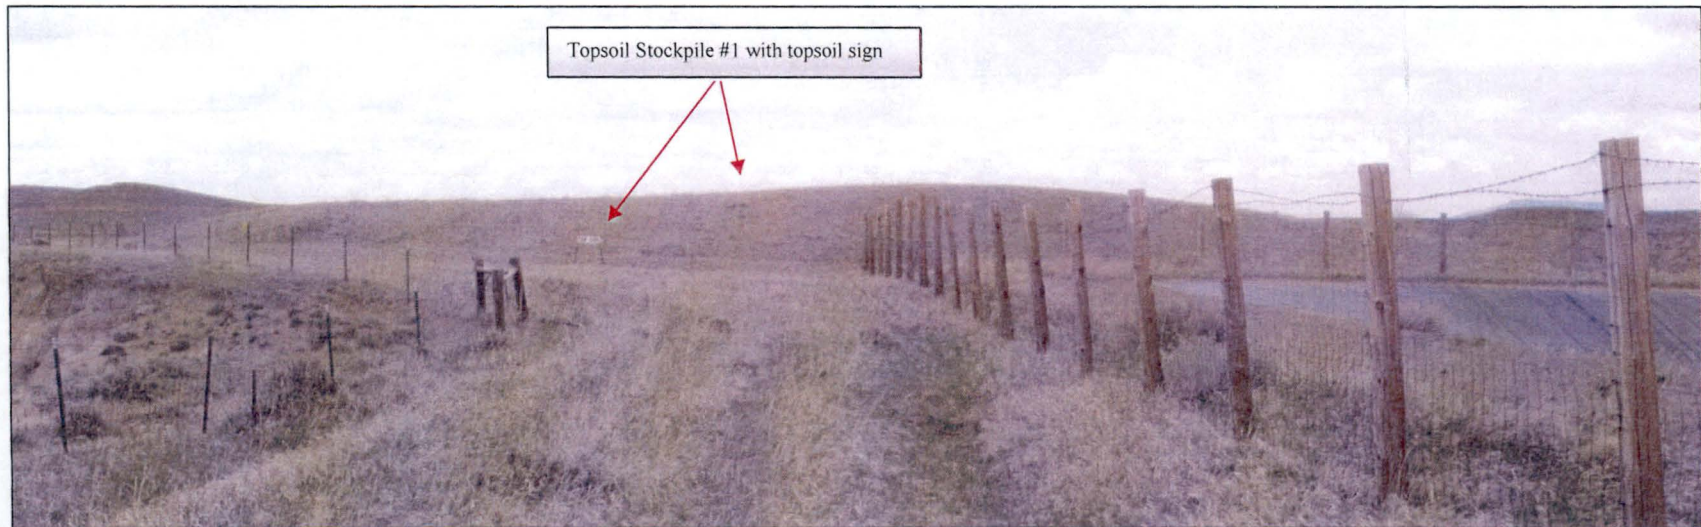
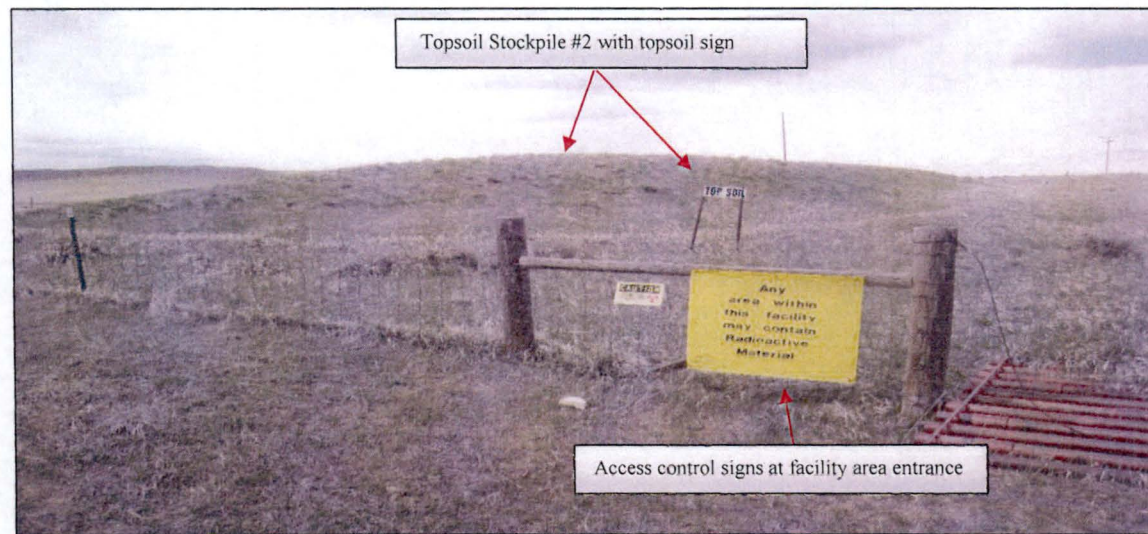
● Topsoil Stockpiles	Yes
The two topsoil stockpiles present at the site were viewed. Both stockpiles had adequate erosion control, were stable and posted with a topsoil identification sign (Photos #3 & #4).

Photo #3: View of Topsoil Stockpile #1 (north end of facilities area) looking northeast.

Photo #4: View of Topsoil Stockpile #2 (south end of facilities area) looking northwest.

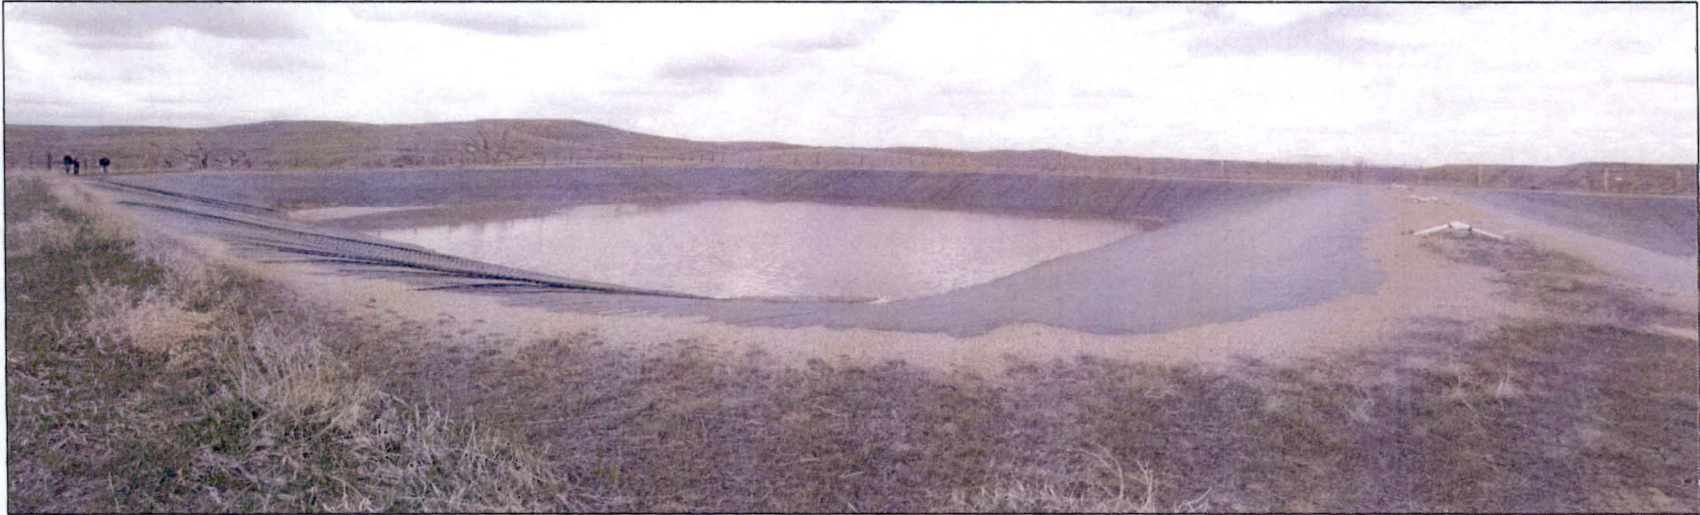
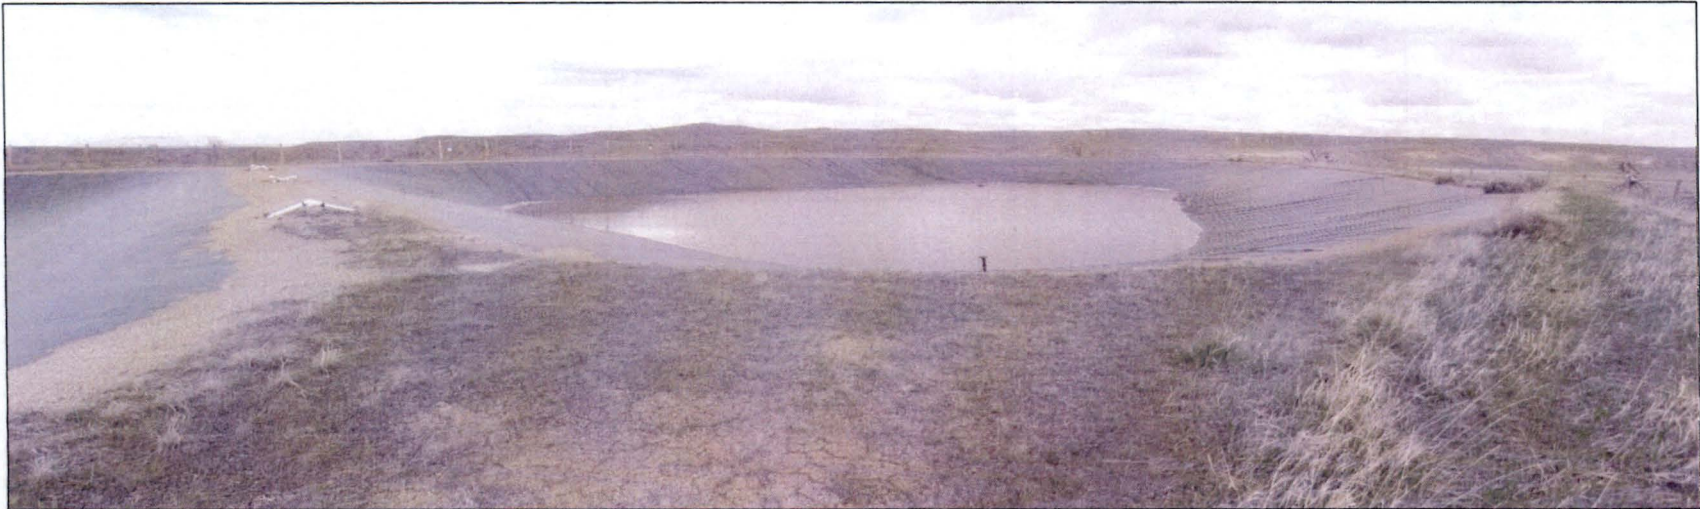
Inspection Topic	In Compliance
● Ponds	Yes
The two lined evaporation ponds were viewed and no issues were identified during the inspection (Photos #5 & #6). The game fence around the ponds was well maintained and locked. Both pond liners appeared to be intact and were holding water from recent precipitation. As indicated in the Annual Report, Cameco conducts quarterly inspections of the evaporation pond fence and embankments, evaporation pond liners, and pond water levels.	
● Signs	Yes
<p>The permit sign was found to contain the required information, however it was noted that the contact person needed to be updated (Photo #1). The proposed resolution date for this maintenance item has been set 90 days from the date of the inspection (see "Actions Required" in this report). Cameco may demonstrate completion of this task by emailing the inspector a photograph of the updated sign.</p> <p>Site security and control signage was present on the perimeter fence and on facility buildings and pond fence.</p>

Photo #5: View of Pond #1 (West Pond) looking northwest.

Photo #6: View of Pond #2 (East Pond) looking northeast.
