SHEARON HARRIS NUCLEAR POWER PLANT  
FAULT INVESTIGATION

PROGRESS REPORT

EBASCO SERVICES INCORPORATED

VOLUME 1 of 2

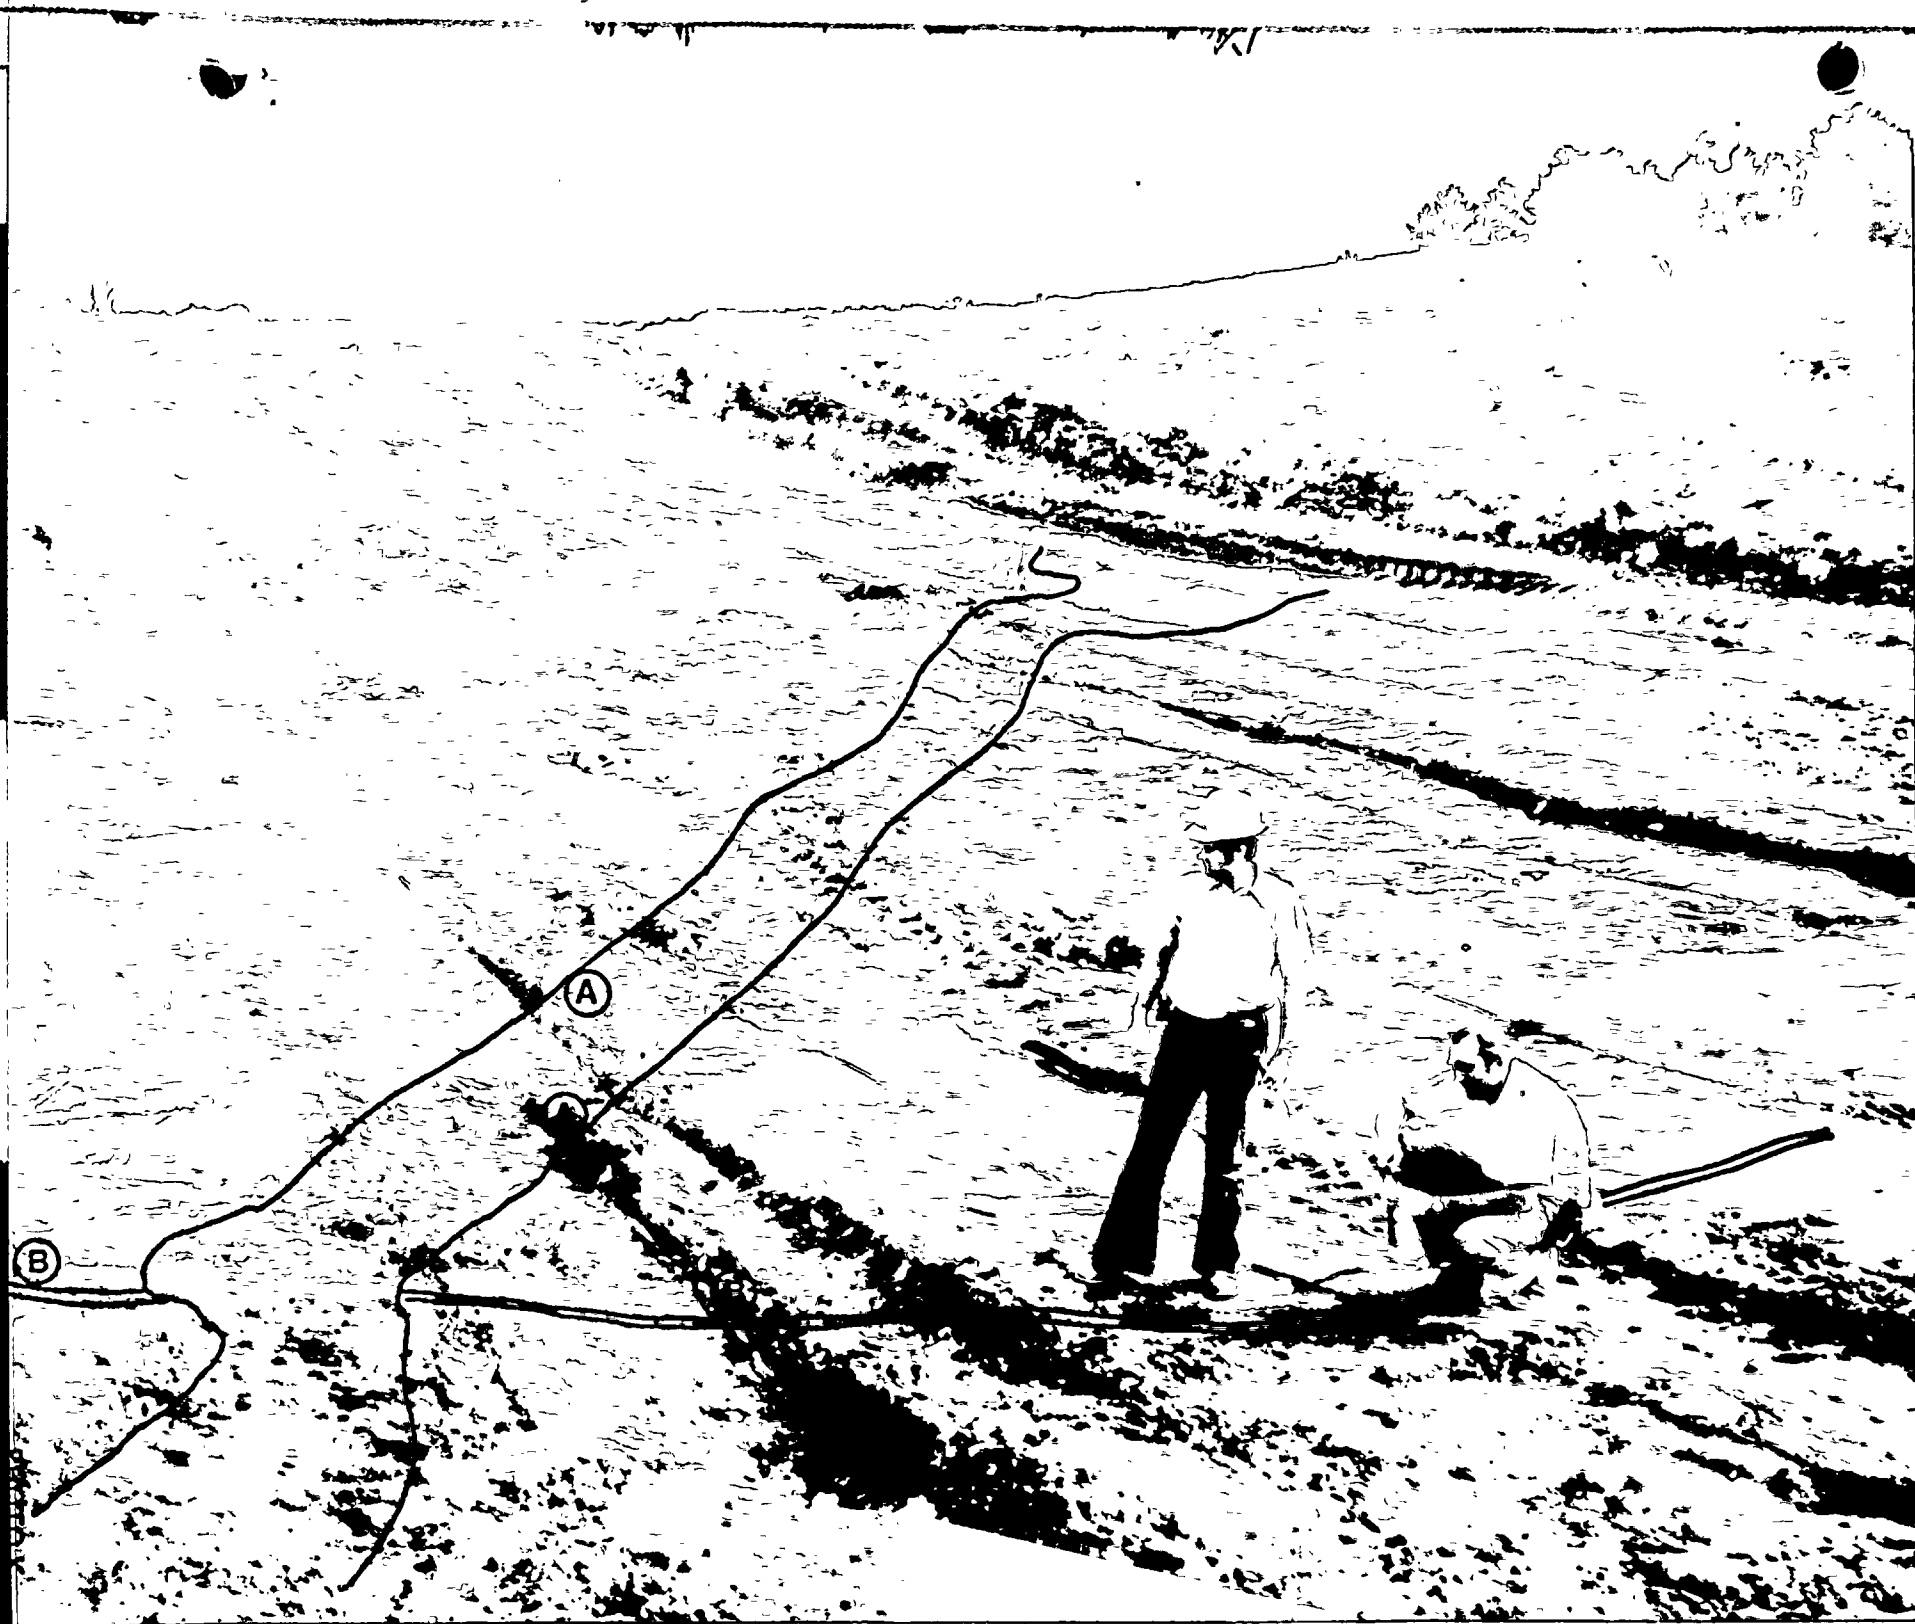
C54-487  
Photo L Caption

View southward along West Dike 3S, at elevation 239. Compare this photo to Photo K. Line segments (A) represent the limits of the diabase dike. Line segments (B) represent the trace of the fault. Line segment (C) represents the limits of the zone of alteration between the two northern segments of West Dike 3S. Compare with Photo Q.
