Annual Radioactive Waste Tank Inspection Program – 2017

July 2018

**Savannah River Remediation
Savannah River Site
Aiken, SC 29808**

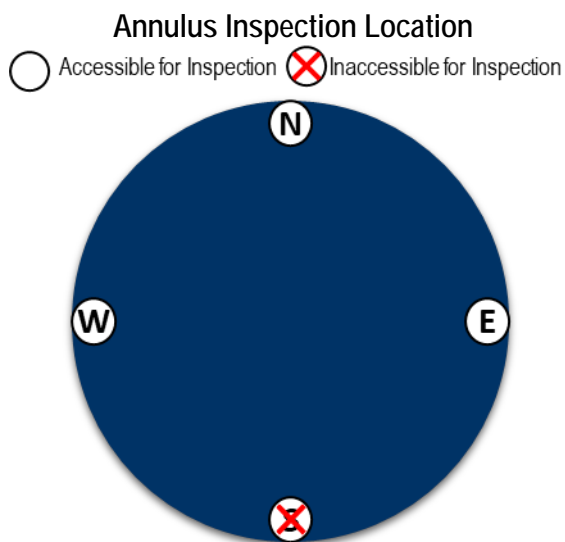
Number of Known Leak Sites	Date of Discovery	Waste on Annulus Floor	Location	Elevation from Tank Bottom
≥ 1	Feb 1969	Small deposits on floor	Unknown	Unknown

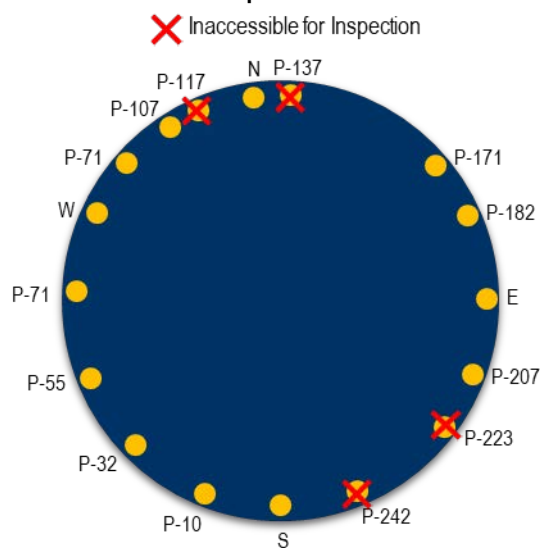
Annulus Inspection Locations

Last Visual Inspections: Thirteen of 17 annulus inspection ports in September and October 2017

Summary of Visual Inspections: **Inspections in 2017 revealed two new leak sites at 30 and 160 in. above the tank bottom. Visual examinations have shown mild corrosion of the steel surfaces in the tank annulus. Periodic visual inspections continue to be performed since Tank 15 was rewetted, bulk waste removal efforts were completed, and heel removal was initiated.**
