Subject: Senasys Selector Switch P/N 910CMC-5240X, Part 21 notification

To: Victor Sacket, Calvert Cliffs Station
From: Skip Booz, (610) 380-2440
Skip.Booz@ExelonPowerLabs.com
Project: CCN-00852
Subject: Failure Analysis of a Selector Switch
Manufacturer: Senasys, Inc.
Model: 910CMC-5240X
Stock Code/Cat ID: 0001774009
AR/CR/WO: 04130071/ MO C93664356
Quantity Received: 1
Date: 25 June 2018

CONCLUSIONS

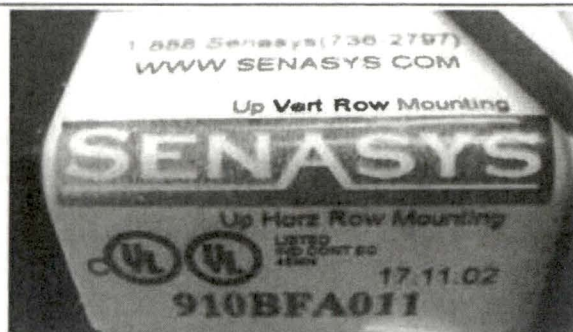
Photos 1, 2 & 3: Switch Nameplate

Date Code: 17.11.02 (likely Nov. 2, 2017)

Dedication: Switch was dedicated by Curtiss-Wright under Exelon PO 00630804

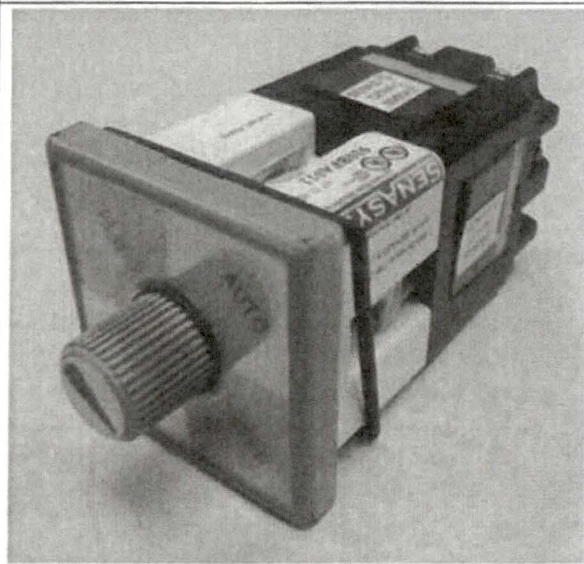
Photo 4: Selector Switch

The selector switch was in good condition. There were a few minor scratches on the body and cover lens, and no evidence of physical damage.

The switch had a solidly constructed feel. There was no exterior evidence of physical, electrical or thermal damage. It emitted no unusual aroma.

The mounting gasket was intact and the (4) mounting fasteners were loose on the screws.

When manipulated, there was a slight rattle in the bulb area of the switch.

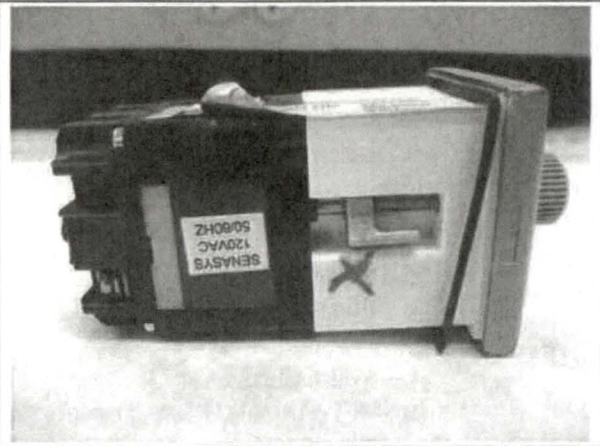
Photo 5: Station Marking on Switch

Switch was new from stock, installed in 2018 RFO (April 2018) and found failed during subsequent testing. Control circuit found grounded isolated to inside hand switch. Appears that switch mounting screw penetrated one of the internal lighting transformers. Marked on switch with "X".

There was a blue 'X' on the side of the body near one of the mounting fasteners.

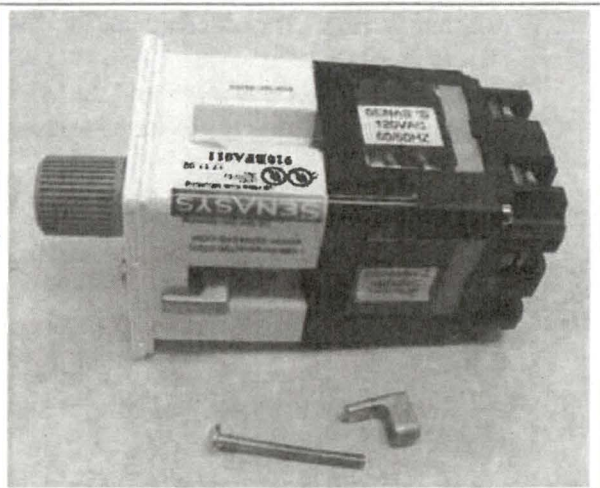
Photo 6: Switch Disassembly

The selector switch was disassembled to investigate the issue. The photo shows one of the mounting fasteners removed from the switch and one still installed. The fasteners swing out when the switch is installed in the panel cutout and draws it in snug to the panel when tightened. There are (4) mounting fasteners, one on each side.

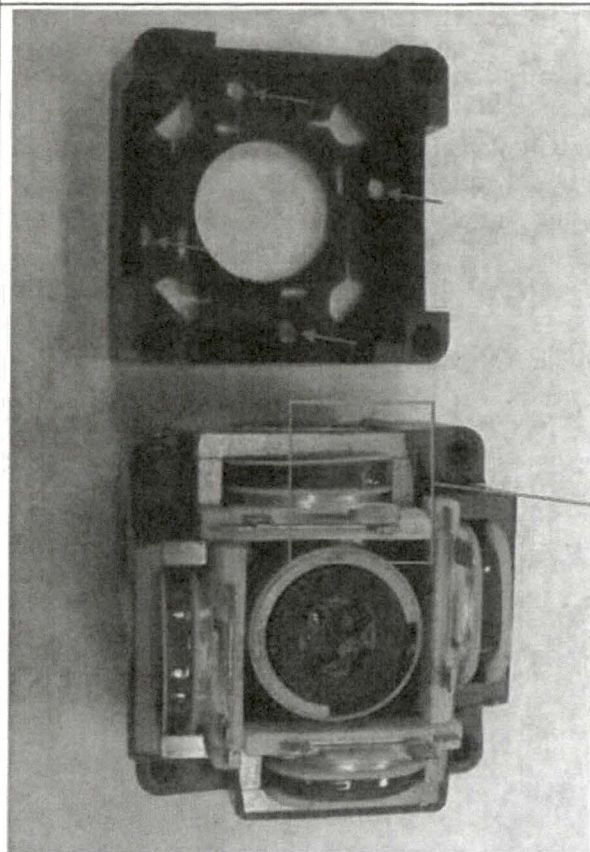
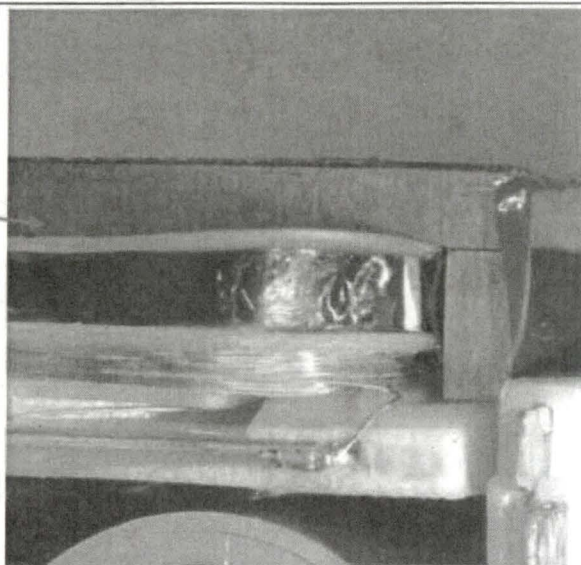
Photos 7 and 8: Switch Lamp Transformers

PowerLabs confirmed that one of the four mounting fastener screws penetrated the associated internal lighting transformer, causing it to short to the grounded panel board. The cause was a wrong length screw being supplied with the switch. Three of the mounting fastener screws were 1-3/8" long, but the fourth screw was 1-1/2" long. The extra 1/8" allowed it to puncture the transformer when the fastener screw was tightened as part of switch installation. All (4) switch lamps had previously been illumination tested satisfactorily at PowerLabs as part of Parts Quality Initiative (PQI) testing, substantiating the theory that the damage occurred as part of switch panel mounting.

When the switch was disassembled far enough to expose the lamp transformers, the suspected damage was evident. The mounting fastener screw appeared to have punctured the transformer windings. There are (4) holes in the molded plastic cover (blue arrows) that help keep the fastener screws in place, but the screws should not be able to reach the transformer.

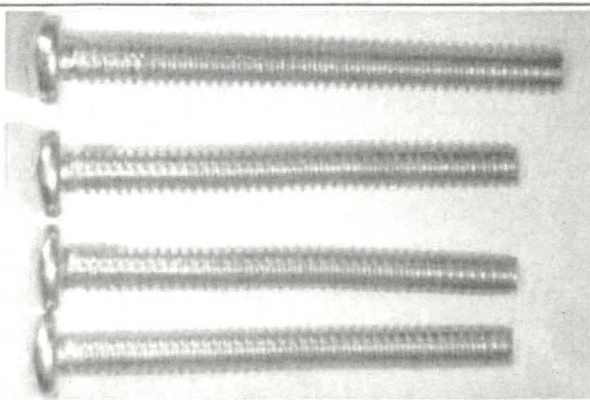
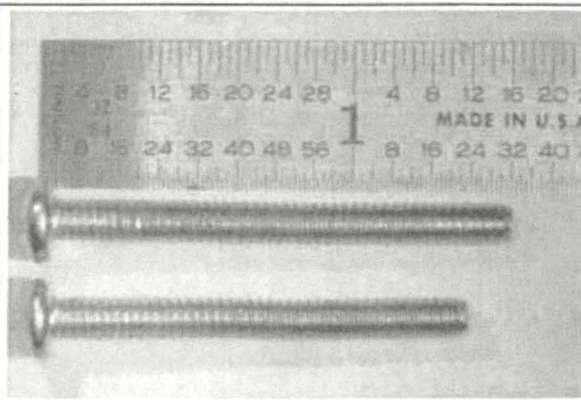
Photos 9 and 10: Mounting Fastener Screws

The root cause was determined in our inventory – it seems the ‘found’ screws had been dumped into an open box of screws for the CMC units and they were not correct. This created the issue you are seeing. This was reported as a handful of screws - After they first reported problem, our inventory was quarantined and all the screws were inspected. The time frame has been determined to be the end of 2017 (seems to be November and December).

The mounting fastener screws were inspected and one was found to be 1/8" longer than the rest. When the switch was installed in the panel and tightened, the longer screw punctured the lamp transformer causing a short to ground. During CCN-74260 PQI testing at PowerLabs, a lamp illumination test was performed satisfactorily on this switch. This confirmed the switch was not damaged when shipped from Curtiss-Wright, but the incorrect screw caused the damage during installation.

Curtiss Wright's dedication plan will be revised to include a note to ensure no selector switches, for this part number are manufactured with the November and December 2017 date codes.

Any remaining switches should be checked to confirm none of the mounting fastener screws are the wrong length. There were (5) switches PQI tested in January 2018, so there is likely at least (3) in stock. Based on the nature of this failure installed switches would not be impacted by this issue since the problem would be apparent during post-installation testing.

The PowerLabs PQI testing templates for this switch and similar models will be revised to include inspection of the mounting fastener screws to confirm proper length.
