# LIST OF VARIOUS Inspection Rpt. IN 75

IE Inspection Report No. 50-285/75-06

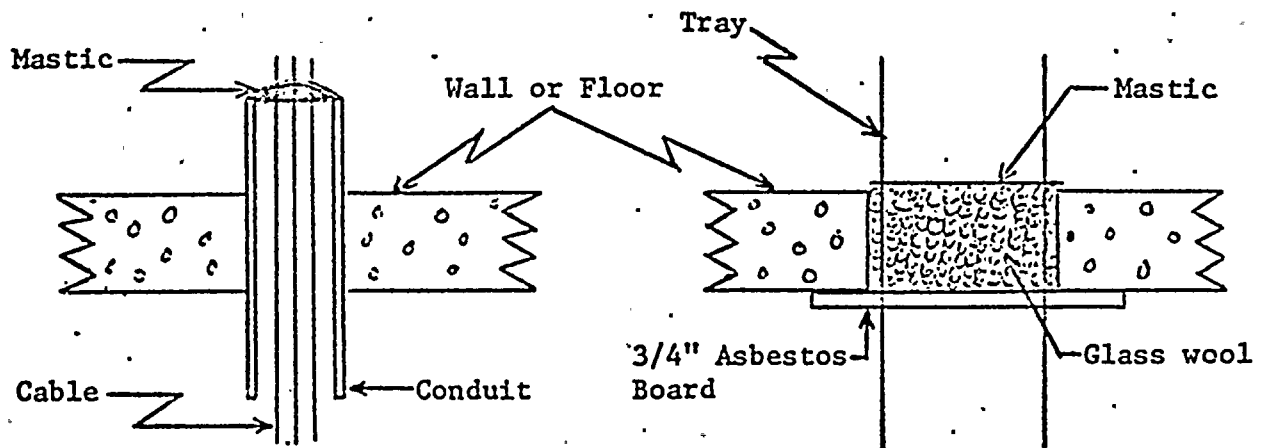
A visual examination of the installed barriers was conducted by the inspector to determine the as-is status. Two basic type wall penetrations were identified. Conduit and tray.

The licensee and the inspector estimate that approximately 50 percent of the conduits containing safety related cable have been sealed as shown in the sketch, with the remainder unsealed. The requirements for sealing, and the material used is unknown. Most unused conduits were capped but numerous instances were noted where caps were missing.
