U.S. DEPARTMENT OF  
**ENERGY**

## 2018 Annual Site Inspection and Monitoring Report for Uranium Mill Tailings Radiation Control Act Title II Disposal Sites

December 2018

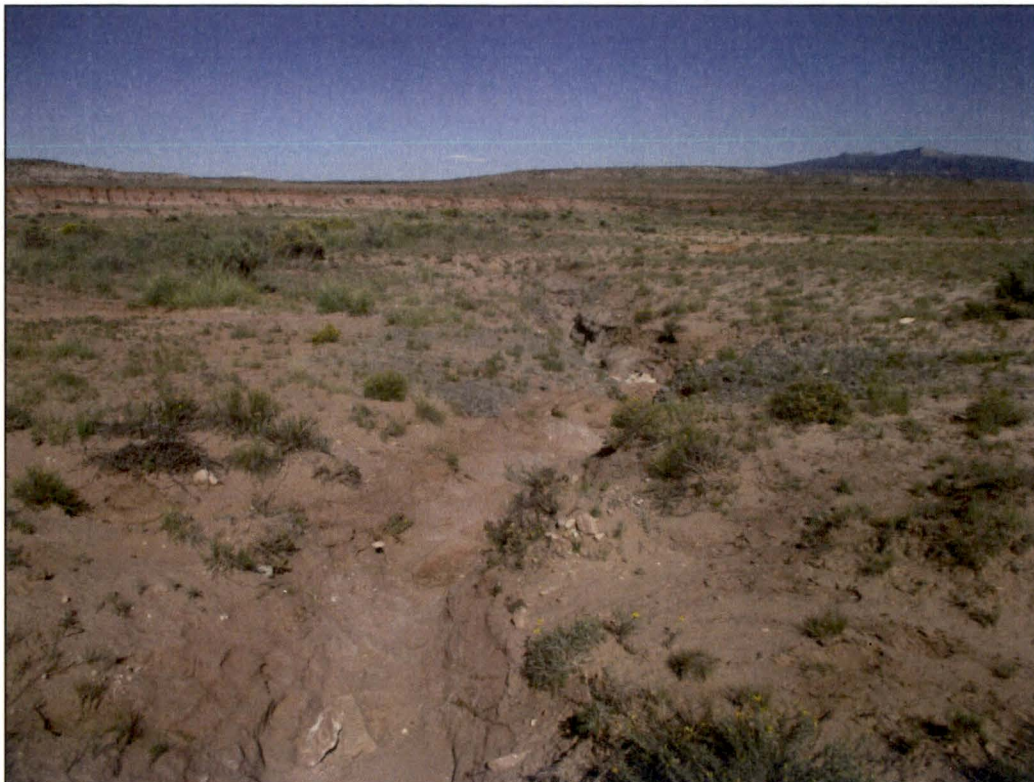
Interior roads used to access LM assets consist of a dirt track covered at places with crushed basalt. The roads are susceptible to erosion and are repaired when they become impassable. Increased erosion was observed on a road northwest of the main tailings disposal cell (PL-1). A gully intersecting the road at this location required maintenance in the past. Riprap previously was added to repair this section of the road; other repair options will be evaluated in 2019. This portion of road is not necessary to maintain access to the disposal cells; it is used to access the northern portion of the site and monitoring well 11(SG), which can be accessed by utility terrain vehicles when necessary. No other maintenance needs were identified.

*PL-1. Gully Intercepting Interior Site Road*

Additional fence maintenance needs identified during the April 25, 2018 fence inspection will be addressed and repairs made in 2019. Potential options to address erosion impacting the interior site road will be evaluated in 2019. No other maintenance needs were identified.

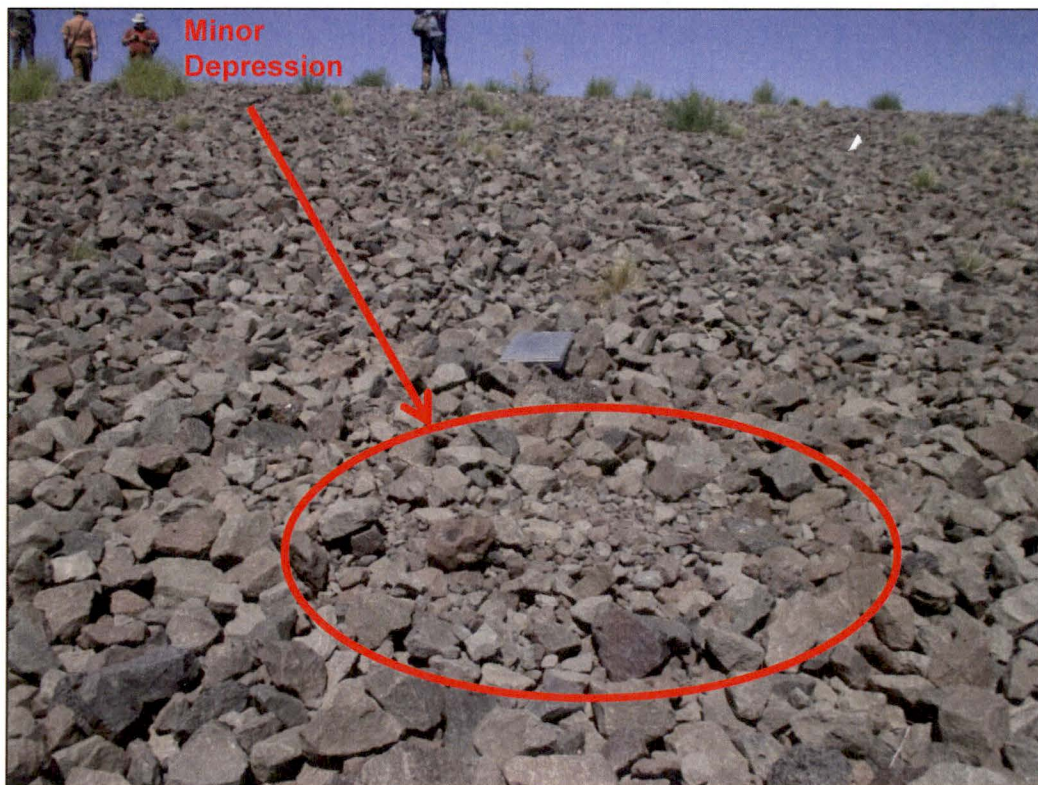
The side slopes and toe of the main tailings disposal cell were inspected for signs of erosion or sediment deposition. An area of minor depression was observed on the southern side slope of the main tailings disposal cell (PL-10). The area was approximately 3 feet wide and 3 inches lower than the surrounding areas. The depression area consisted of smaller sized riprap than that found on the surrounding side slope and is believed to be a construction artifact. This depression will continue to be inspected and will be evaluated using periodic LIDAR survey results. No other

*PL-10. Minor Depression on Main Tailings Disposal Cell South Side Slope*

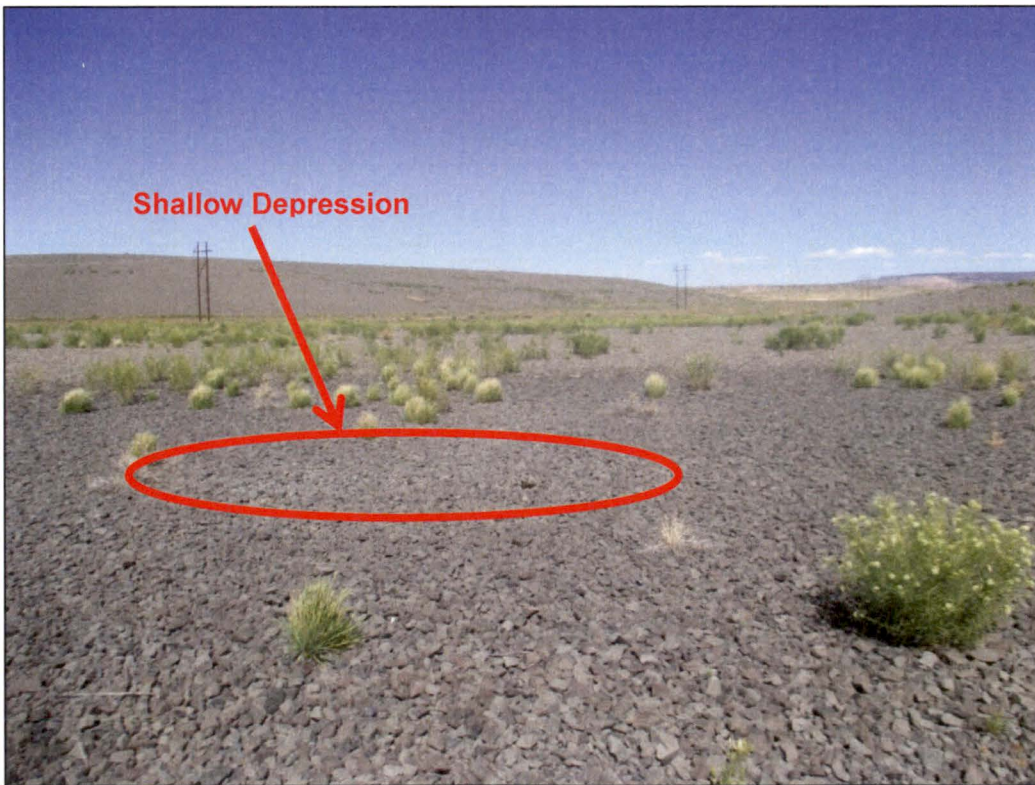
*PL-12. Shallow Depression on Northwest Extension of Carbonate Tailings Cell*

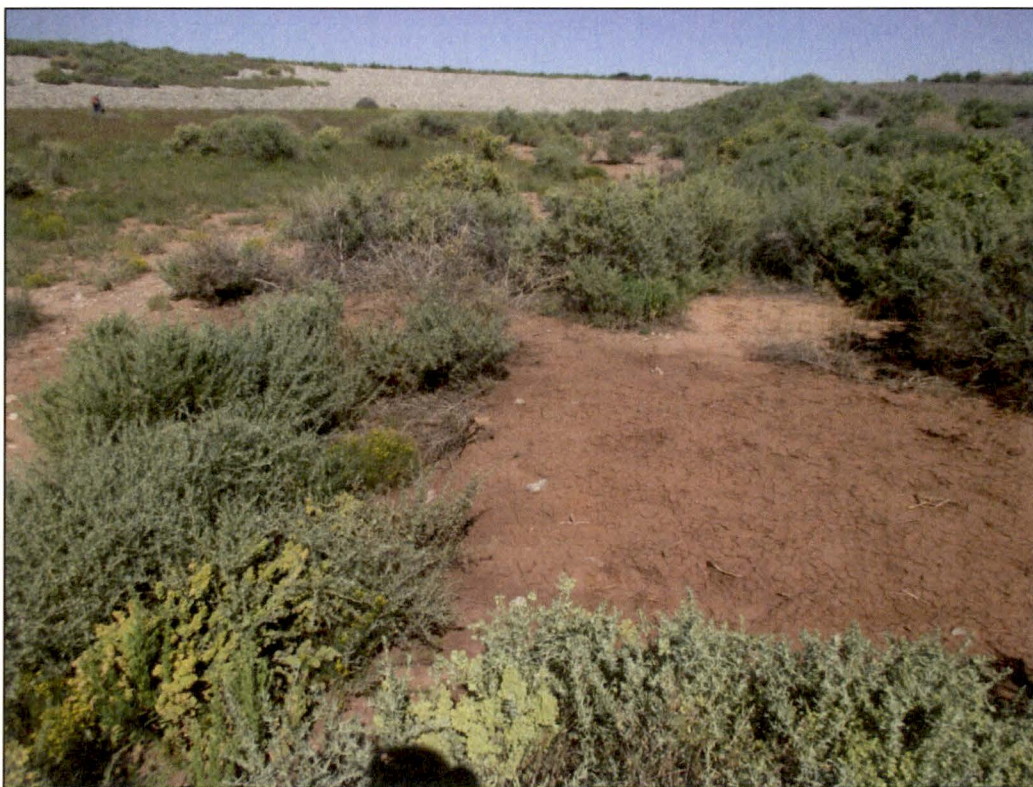
The 2-acre asbestos disposal area is a bowl-like feature just south of the carbonate tailings disposal cell (PL-13). The north, west, and south side slopes of this feature are covered by limestone riprap; the bottom of the bowl (the asbestos cell cover) is grass covered. Several small depressions were identified during the 2017 annual site inspection around the perimeter of the disposal area where relocated clean soil (placed for slope grading) and small-diameter riprap has filtered down through basalt joints and fractures. These depressions were repaired on May 22, 2018, by filling the depressions with either rock or soil, depending upon the surrounding material. These areas were inspected during the 2018 annual site inspection, and no negative impacts were observed (PL-14). No maintenance needs were identified.

*PL-14. Repair of Depression in Asbestos Disposal Cell*

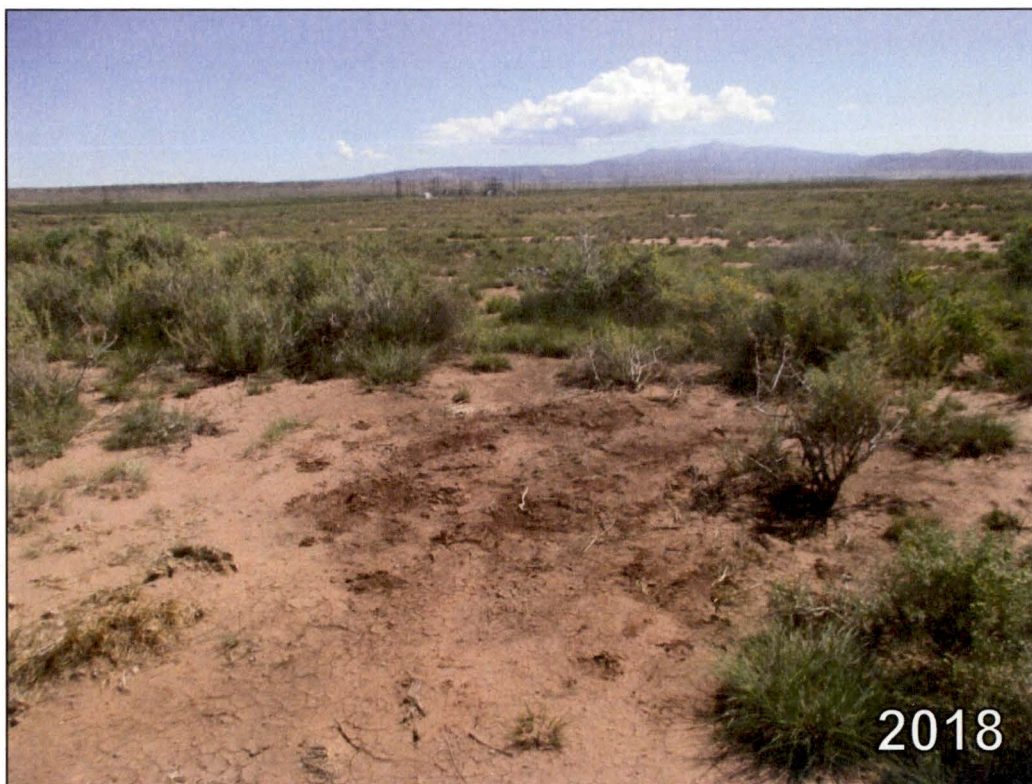
PL-17. (a) Repaired Settlement on Soil Cover of Disposal Area No. 1–September 12, 2018

- The perimeter fence was repaired at multiple locations to eliminate gaps, and a new corner post was replaced.
- Scattered tamarisk shrubs and other noxious weeds were treated with herbicide.
- Small depressions near the perimeter of the asbestos disposal area and a small settlement area on Disposal Area No. 1 were repaired.

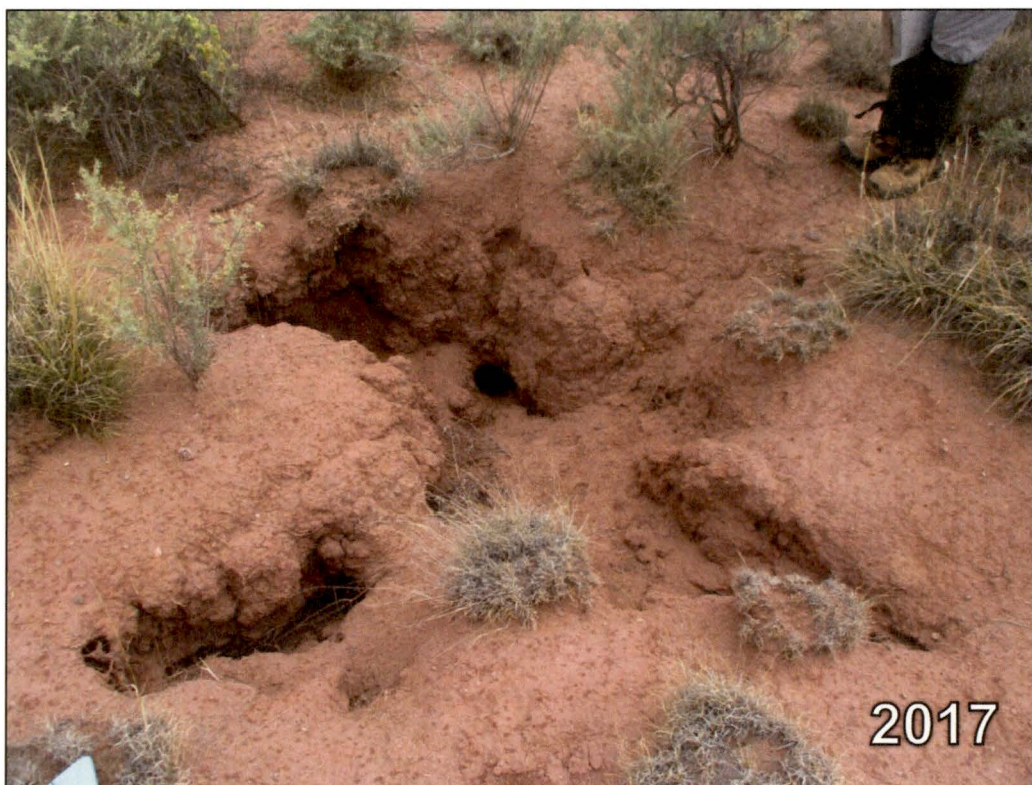
PL-17. (b) Settlement on Soil Cover of Disposal Area No. 1–2017 (Photo for Comparison)

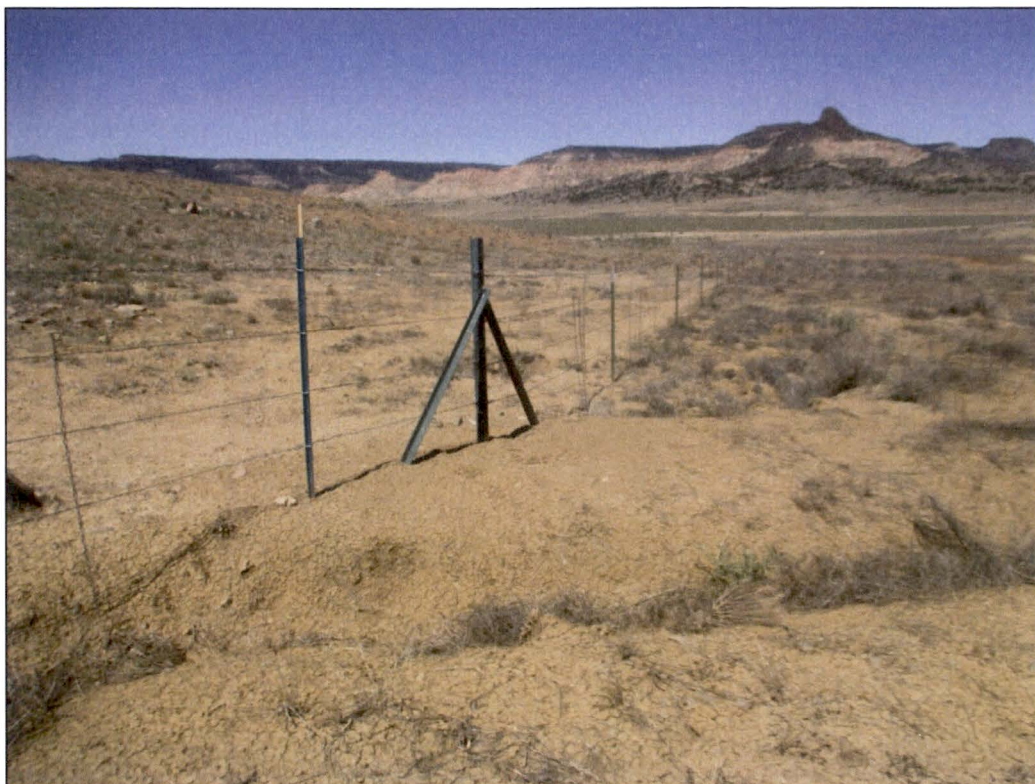
*PL-1. Loose Fence Post Repair South of Perimeter Sign P33*

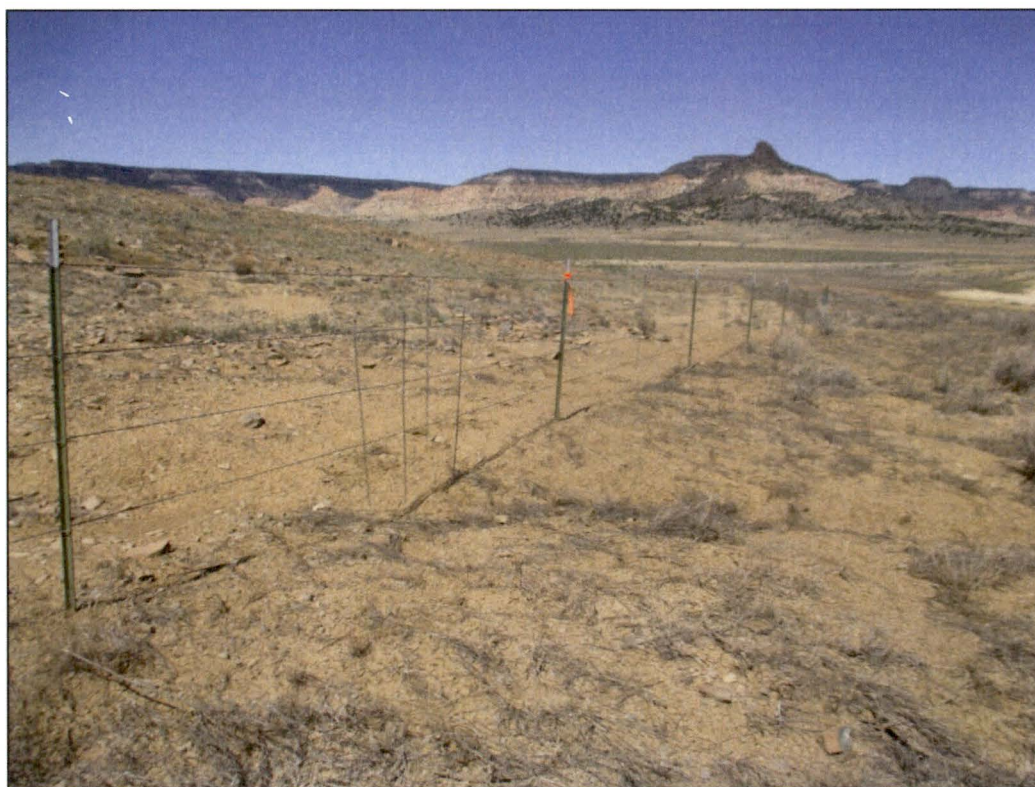
*PL-2. Erosion Under Perimeter Fence and Fence Repair*

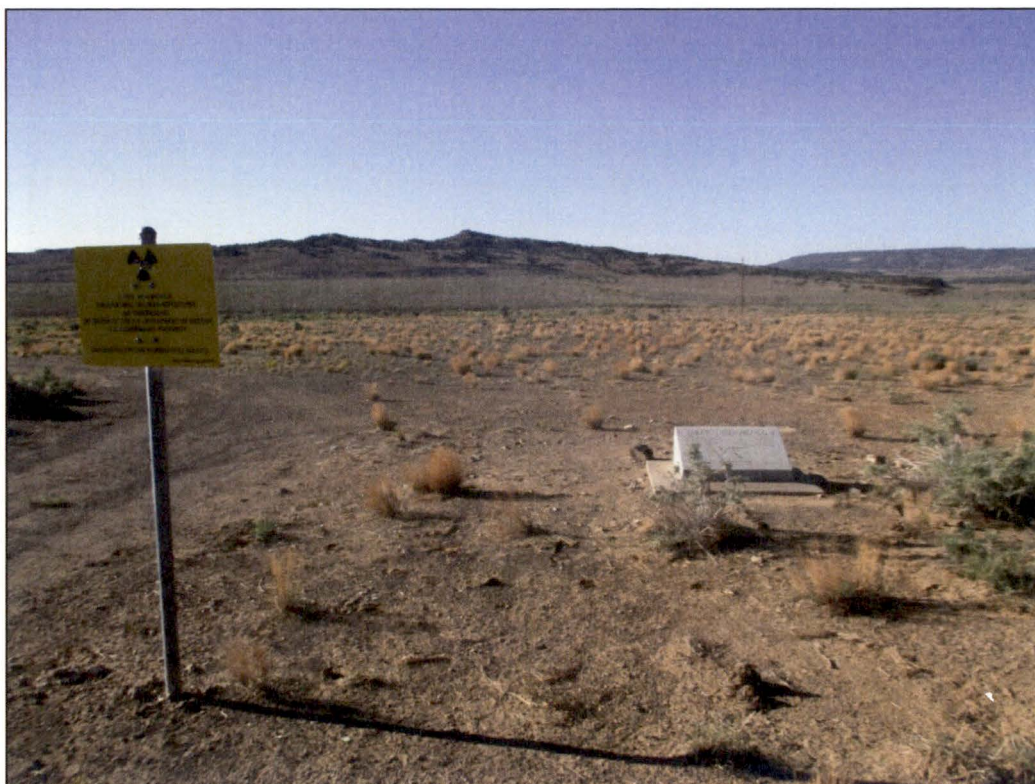
The entrance sign is on the main site access road near the site marker. It has several bullet holes but was legible (PL-3). Thirty-three warning or perimeter signs are attached to the barbed-wire fence that surrounds the disposal site structures and an area of excessive gully erosion in the southeast portion of the site (PL-4). Perimeter sign P1 was replaced during a previous 2018 site visit. No other maintenance needs were identified.

*PL-3. Entrance Sign and Site Marker*

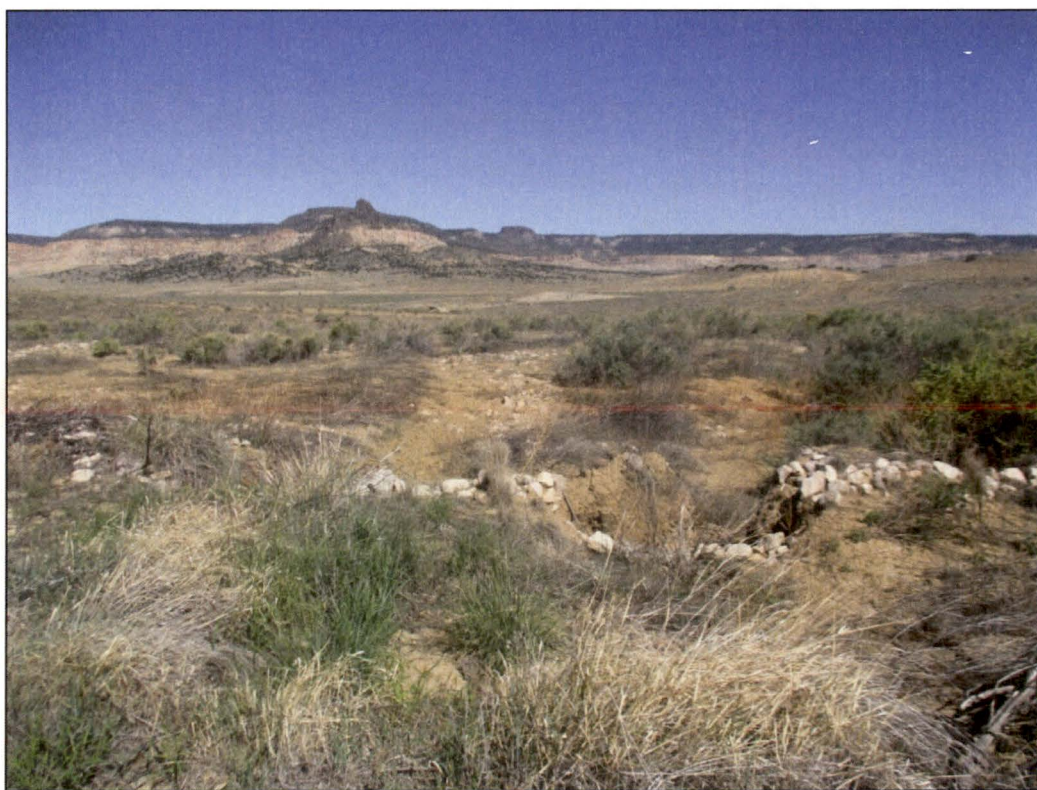
*PL-12. Breach of Runoff Control Structure A Berm*

- **L-Bar, New Mexico:** In 2018 LM developed conceptual designs to repair damaged erosion control structures that LM had installed in 2009. In 2019, LM will continue to work on the designs and coordinate with NRC, as needed, regarding its concurrence.

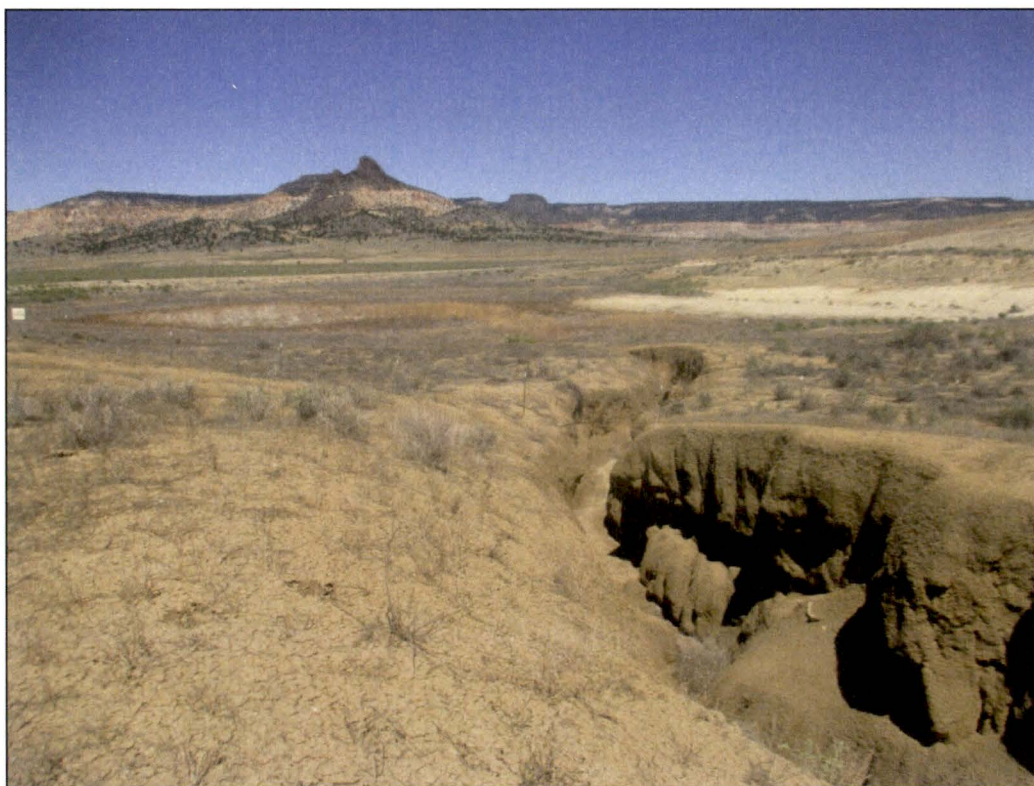
*PL-14. Gully Upgradient of Sediment Trap*

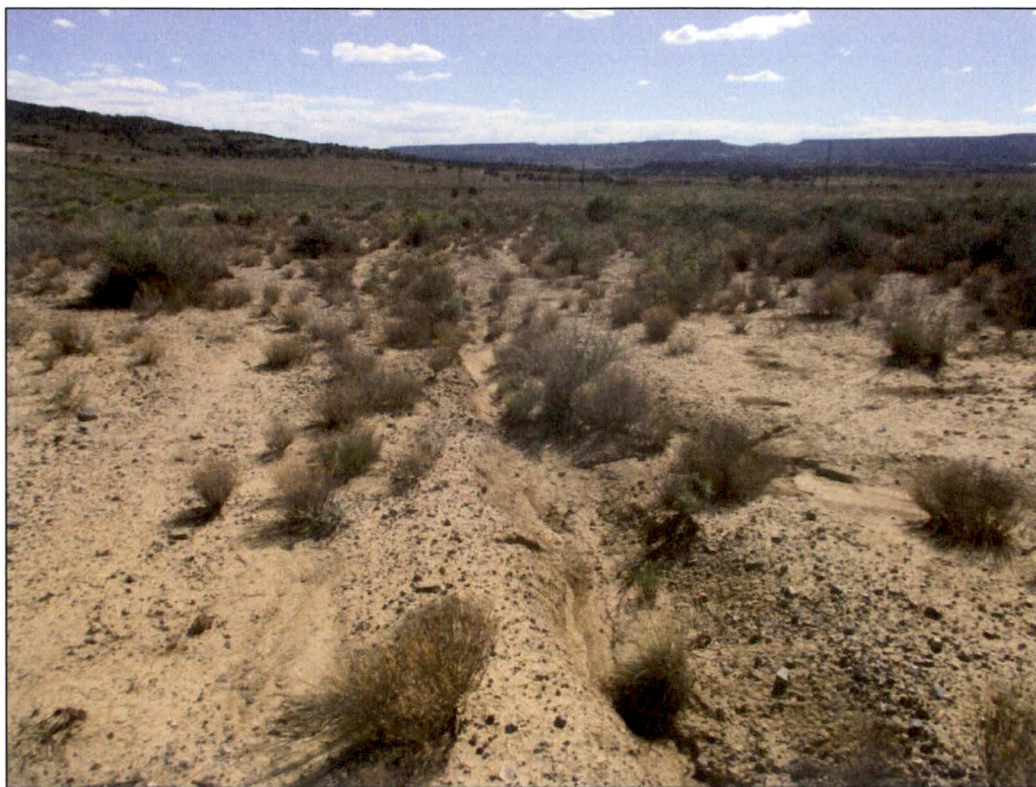
*PL-17. Erosion East of Riprap Cutoff Wall at Outlet of North Channel*

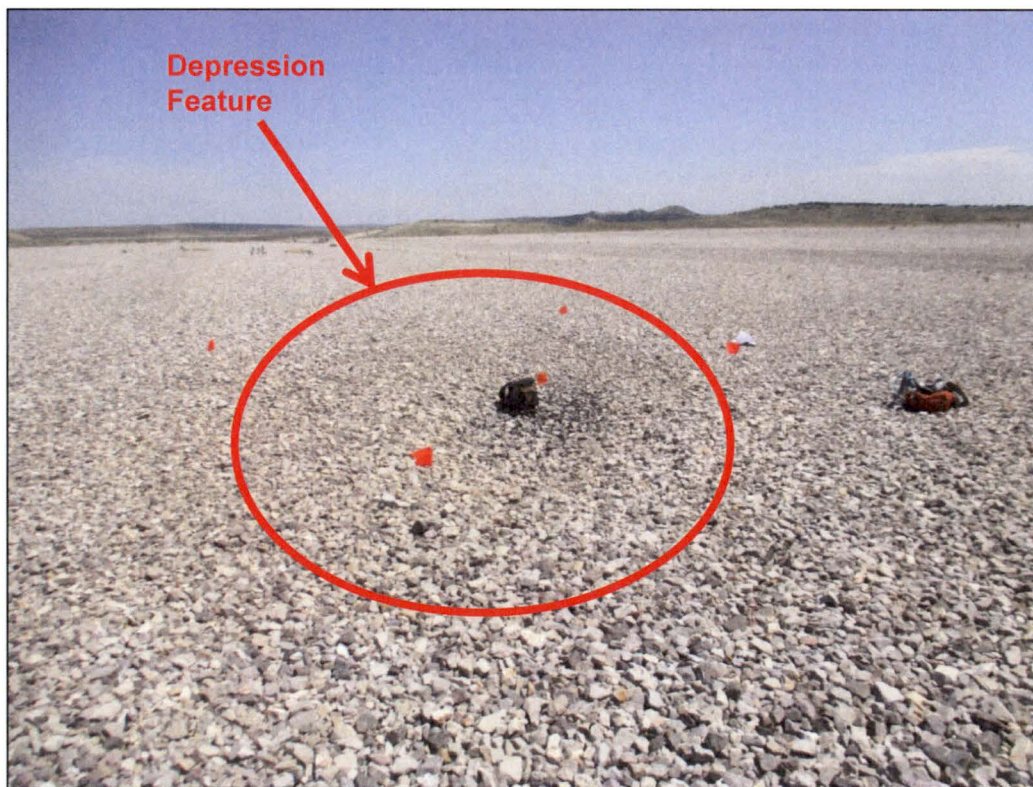
*PL-6. Depression No. 1 on Top Slope of Disposal Cell*

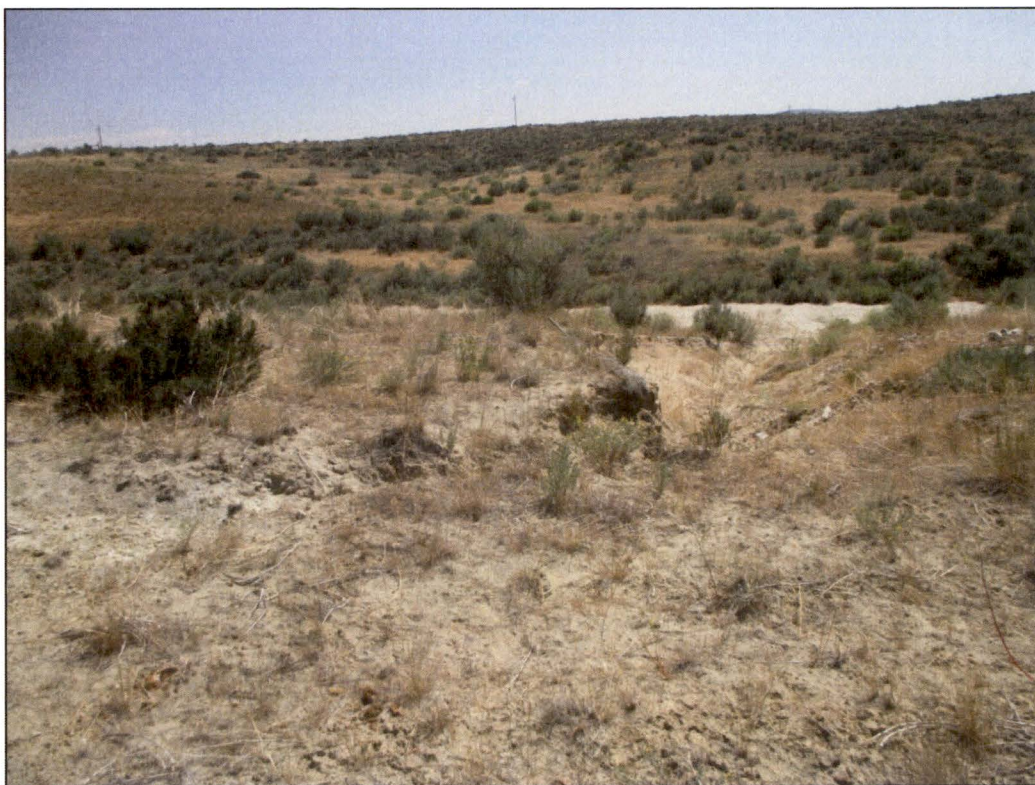
*PL-17. Gully West of Diversion Channel No. 2*

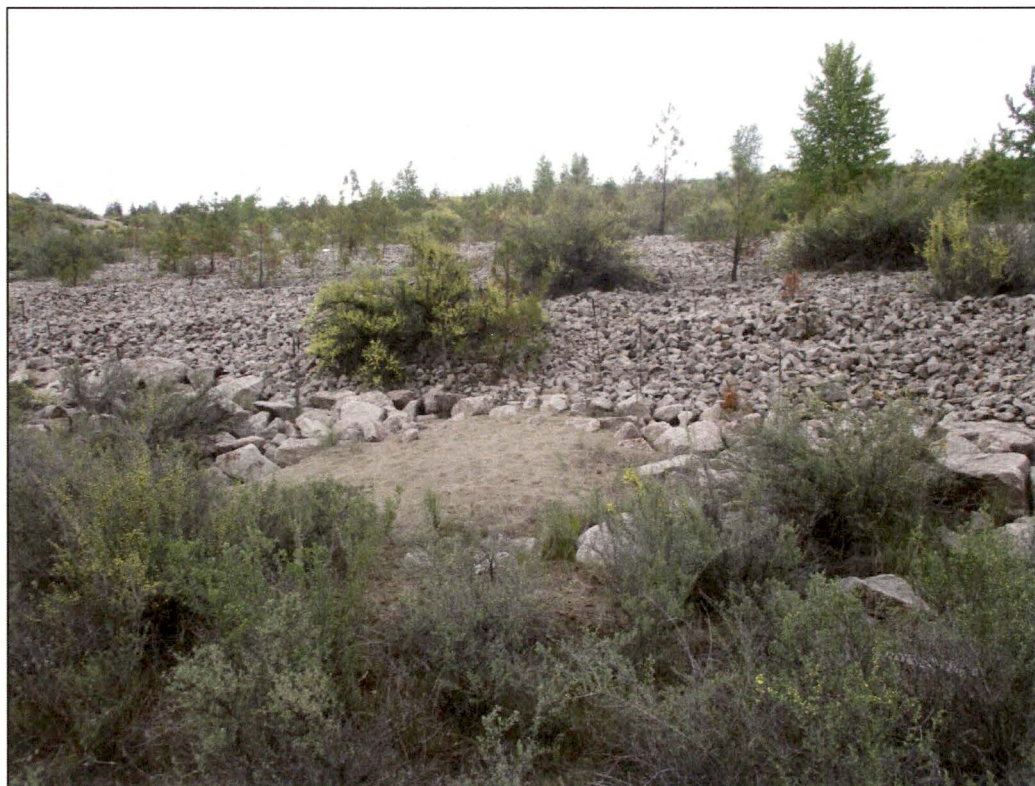
*PL-8. Sand Washout Watch Area at Base of Outslope*
