DOCKET 50-255 - LICENSE DPR-20 - PALISADES
PLANT - FEED-WATER LINE WATER HAMMER

February 24, 1977

EVALUATION OF
AUXILIARY FEEDWATER AND MAIN FEEDWATER
WATER HAMMER POTENTIAL AT
PALISADES PLANT

Prepared for
CONSUMERS POWER COMPANY
by
NUCLEAR SERVICES CORPORATION
Campbell, California

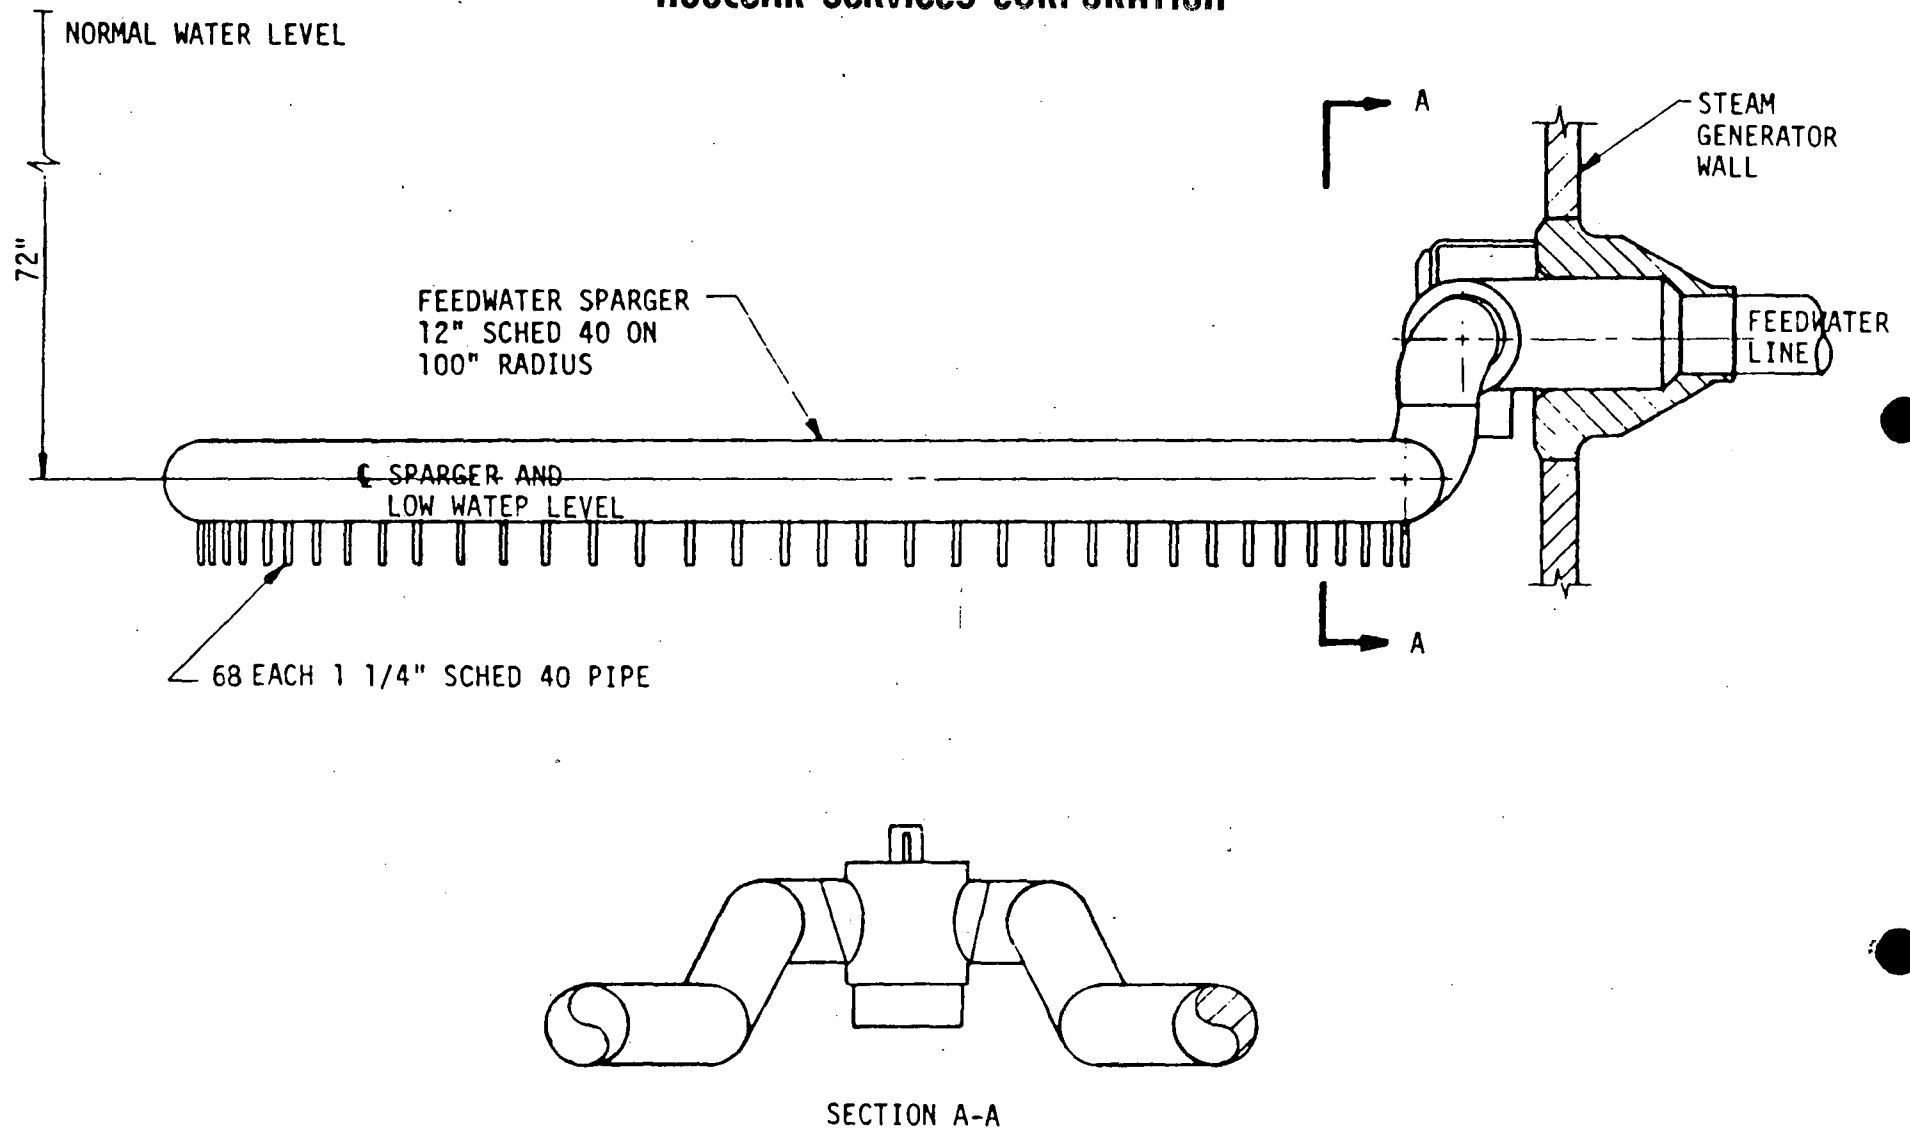
Figure 2-2. Palisades Plant
Feedwater Sparger

Inside each steam generator two 12" piping branches carry flow from the feedwater line to the feedwater sparger which is located two feet below the feedwater nozzle as shown in Figure 2-2.

The design of the Palisades feedwater and auxiliary feedwater system is similar to that of many other pressurized water reactors. The Palisades sparger, however, differs from most plants in its connection to the feedline. In the most common sparger design the sparger centerline is coincident with the feedwater line centerline as shown in Figure 3-3. The Palisades sparger is approximately two feet below the feedline and connected by two branches as shown in Figure 2-2. A study of this design indicates that it contains no unique features that will preclude the water sealing condition conducive to initiation of slugging type water hammers observed in other designs. The remainder of the sparger design is similar to that of other plants examined and should have no unique effects on the probability of water hammer occurrence.

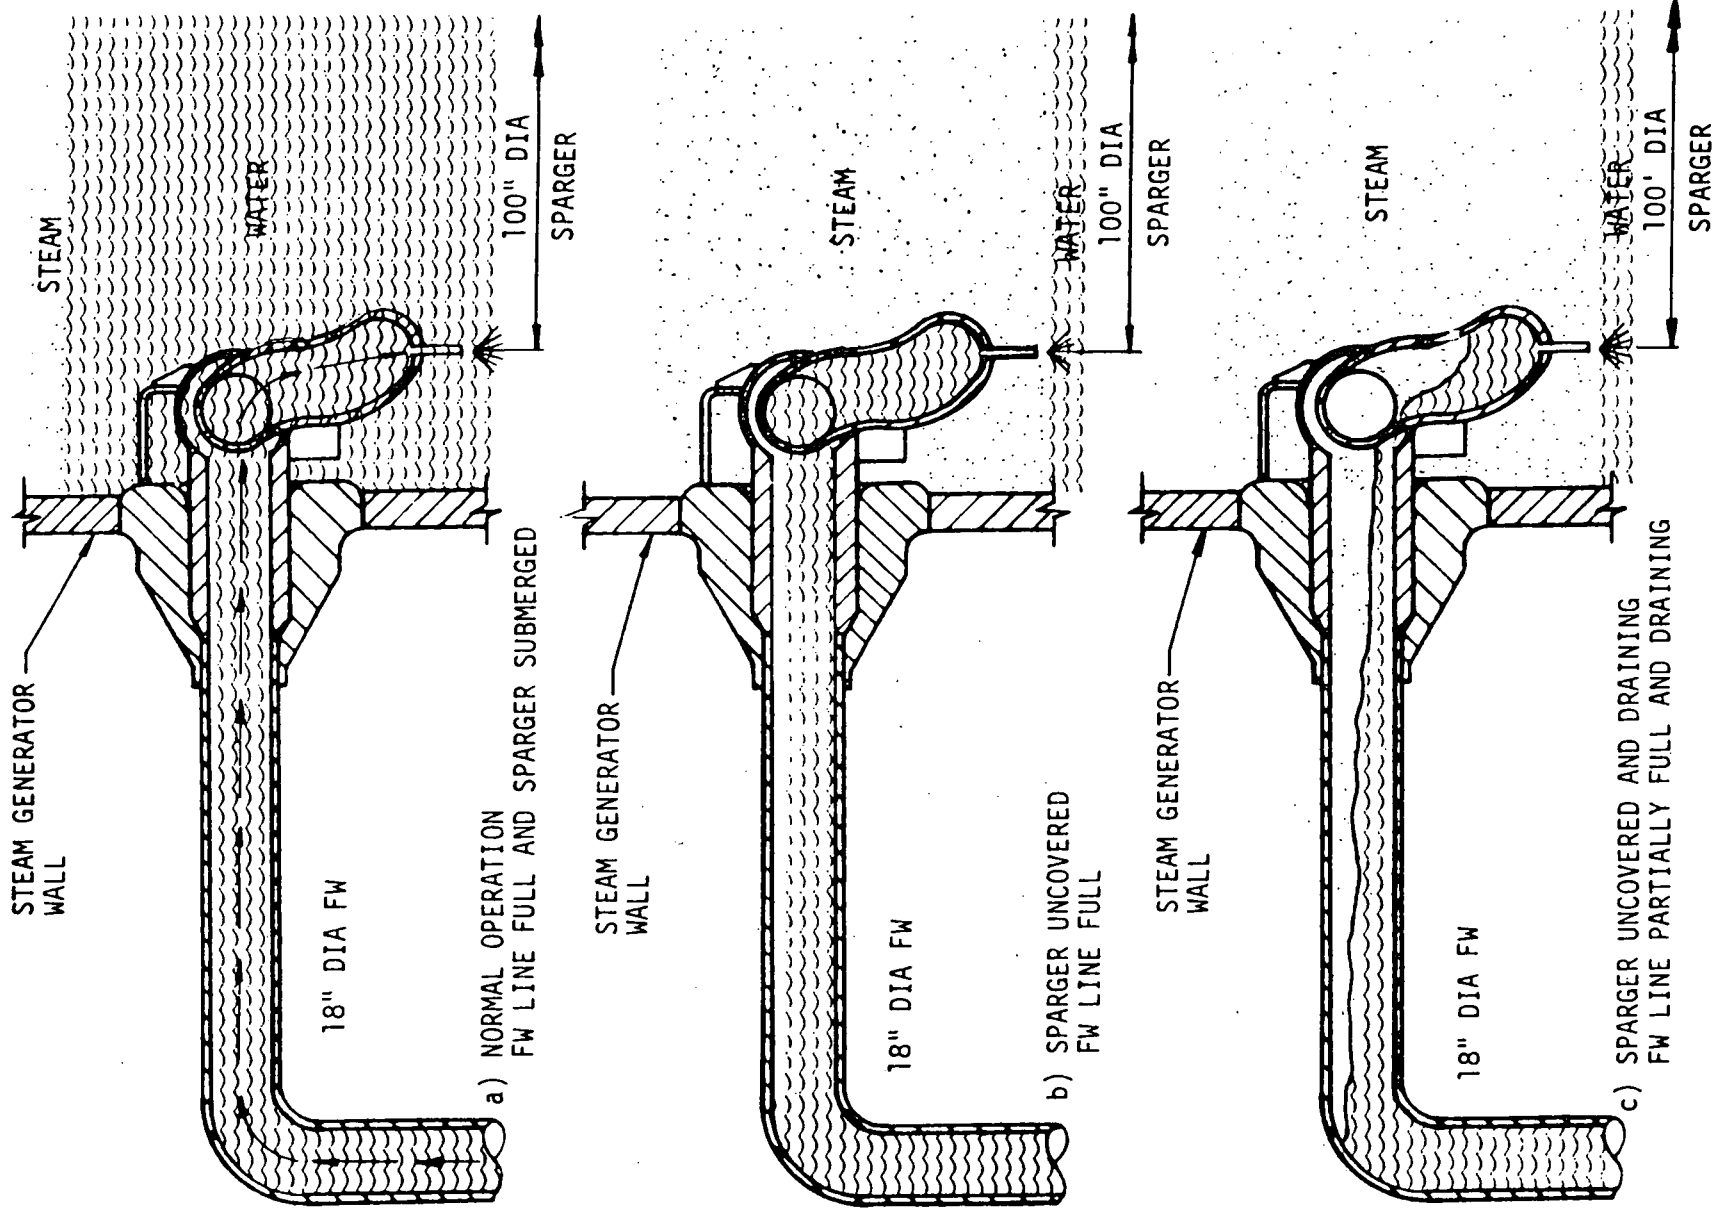
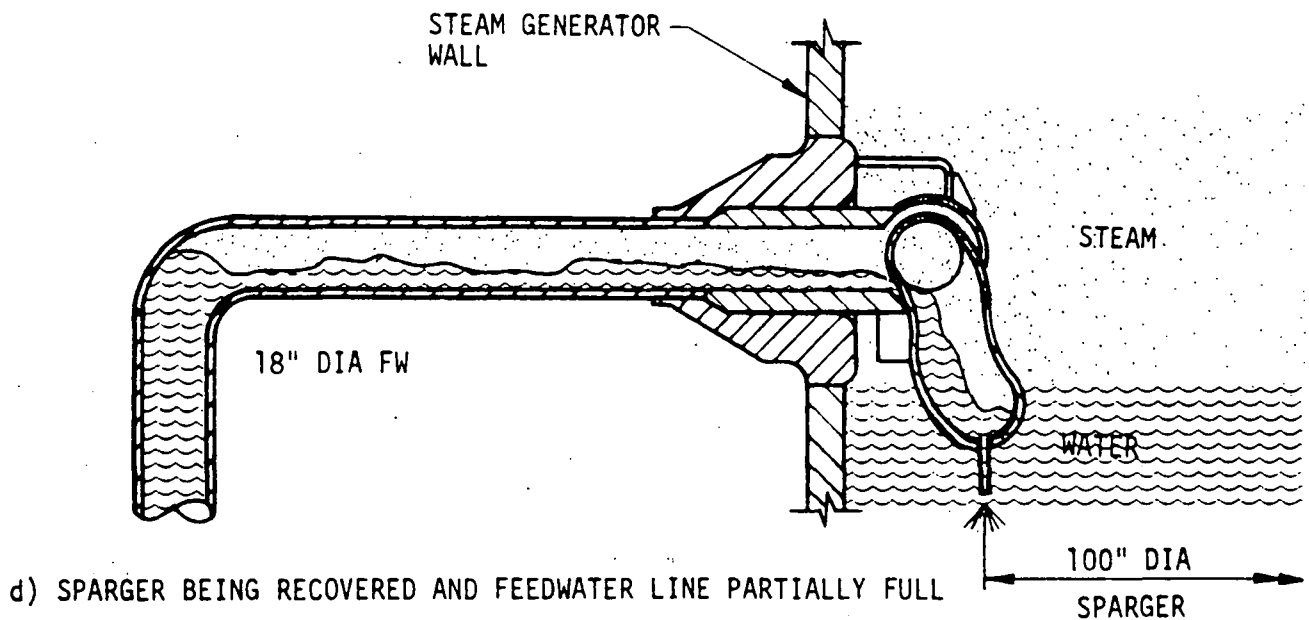
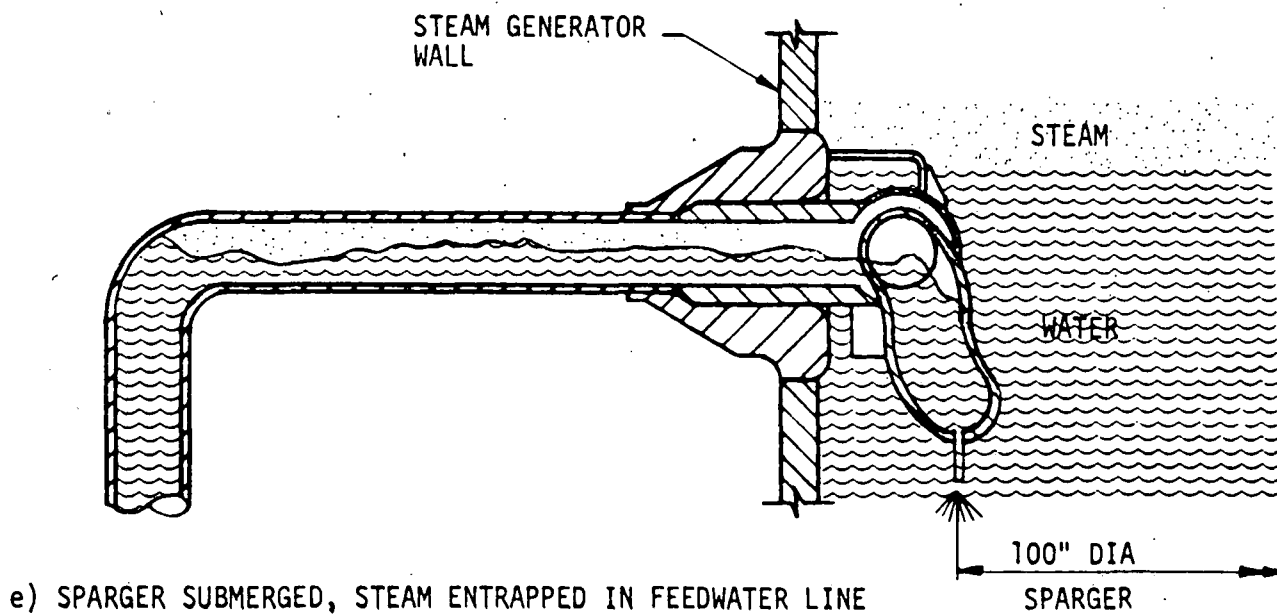
Insufficient data is available to quantitatively identify all parameters and mechanisms conducive to the steam-water slugging water hammer occurrence. However, a mechanism as discussed below is generally accepted as the mechanism for water hammer occurrence. Figure 3-1 shows the sequence of events in the vicinity of the sparger which leads to the uncovering of the sparger and subsequent draining of the feedwater line prior to steam generator water level recovery. Figures 3-2a and 3-2b show the feedline conditions prior to and at the start of feedline slug formation, respectively. The slug seals the main feedwater line and prevents the normal flow of steam from the steam generator to replenish the entrapped steam being condensed by the cold water layer. As steam is condensed at the steam-water interface, the pressure of the entrapped steam drops, accelerating the water slug away from the steam generator, as shown in Figure 3-2c and 3-2d. As the

Figure 3-1. Palisades Plant
Sheet 1 Feedwater Sparger Conditions
Following Level Drop

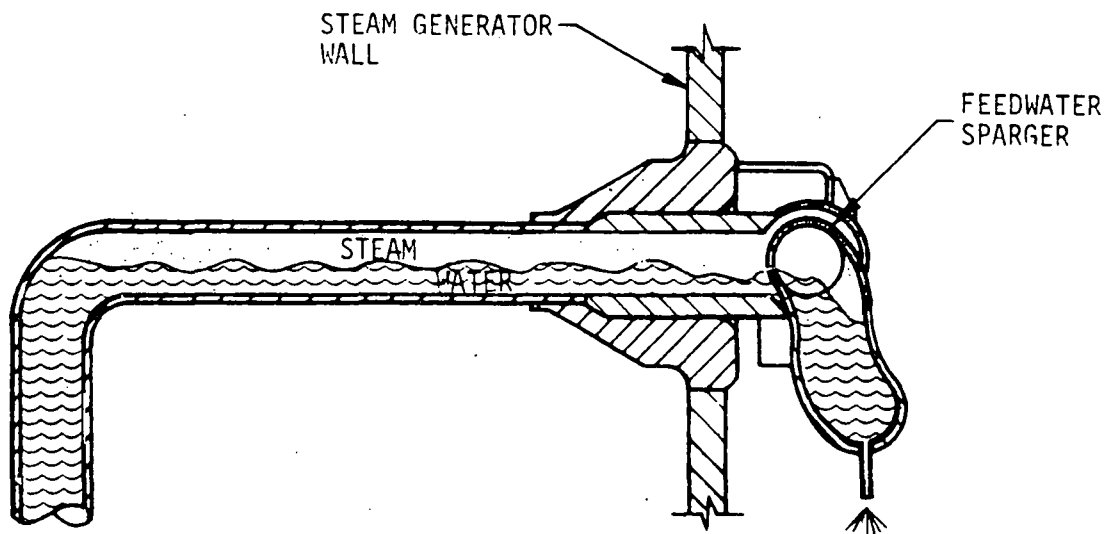
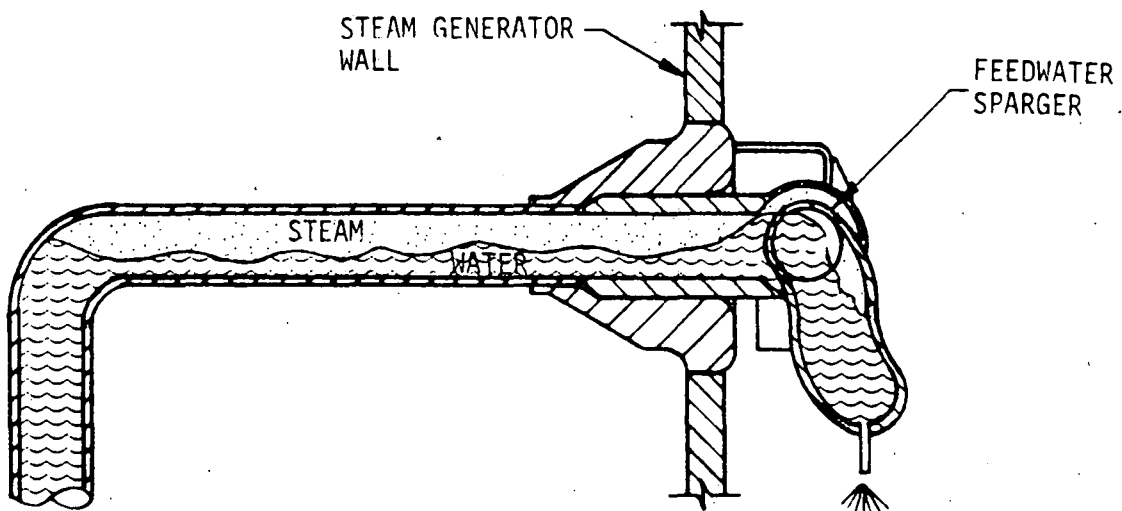
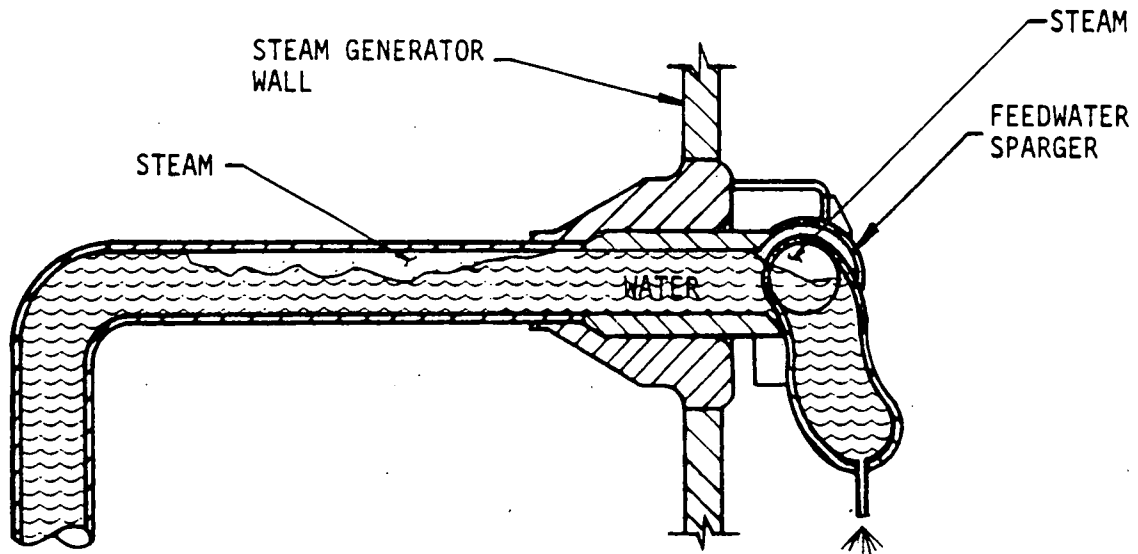
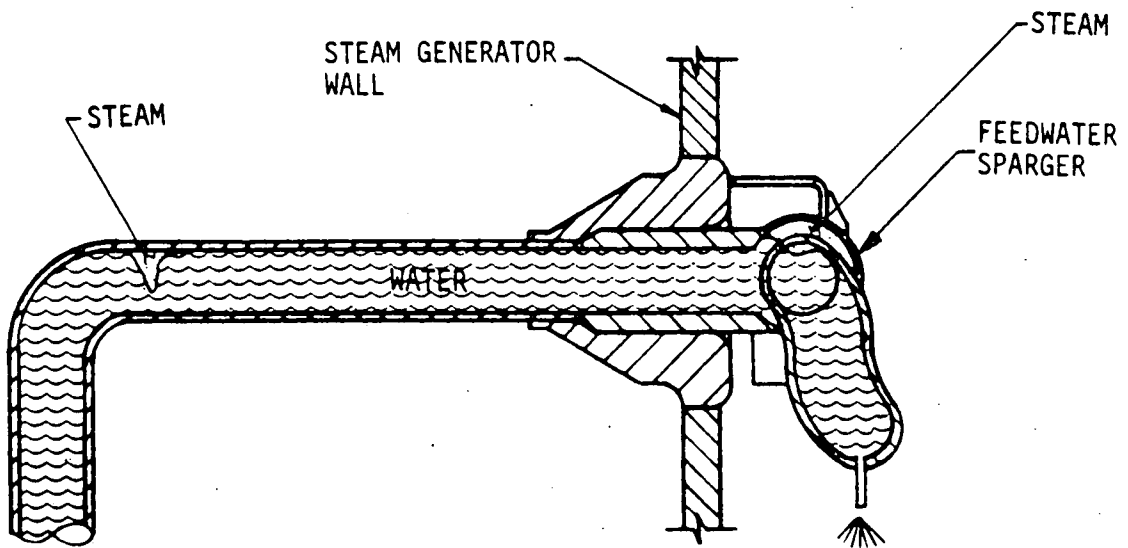
Figure 3-2. Palisades Plant
Sheet 1 Postulated Slug Formation
In Feedwater Line

pressure continues to drop, more feedwater flow is accelerated into the entrapped steam bubble increasing the depressurization process until the bubble eventually reaches zero pressure. The slug continues to travel down the feedline until it impacts the column of feedwater upstream of the bubble as shown in Figure 3-2d. The rapid deceleration of the slug causes an overpressure spike to form. This pressure wave is then propagated down the piping.

a) FEEDWATER LINE RUNNING PARTIALLY FULL

b) START OF SLUG FORMATION
PIPE IS SEALED BY SLUG

c) SLUG BEING ACCELERATED THRU FEEDWATER LINE AS STEAM BUBBLE IS BEING DEPRESSURIZED

d) FEED LINE CONDITIONS PRIOR TO SLUG IMPACT

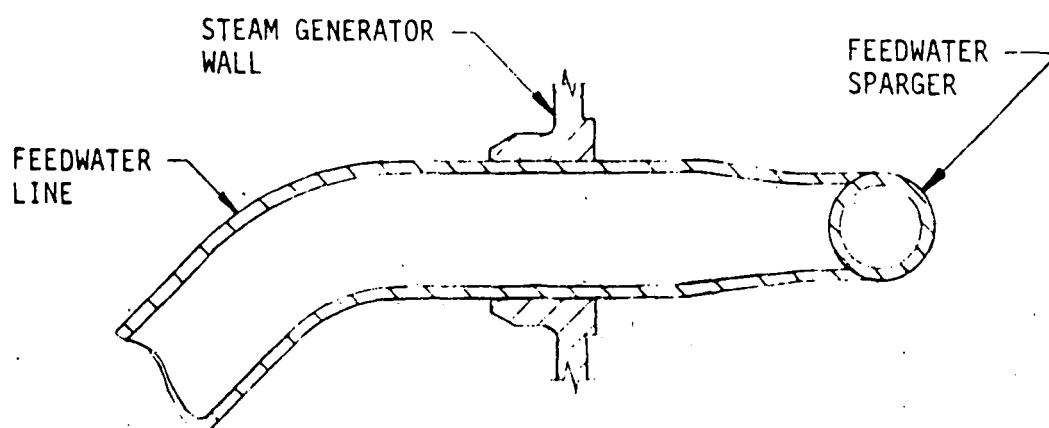
Figure 3-3. Common Feedwater Sparger Design
(Not Used at Palisades Plant)
