**Consumers
Power
Company**

DOCKET 50-255 - LICENSE DPR-20 -
PALISADES PLANT - LICENSEE EVENT
REPORT 81-01 - STATION BATTERIES

LICENSEE EVENT REPORT

Attachment to Licensee Event Report 81-01
Consumers Power Company
Palisades Plant

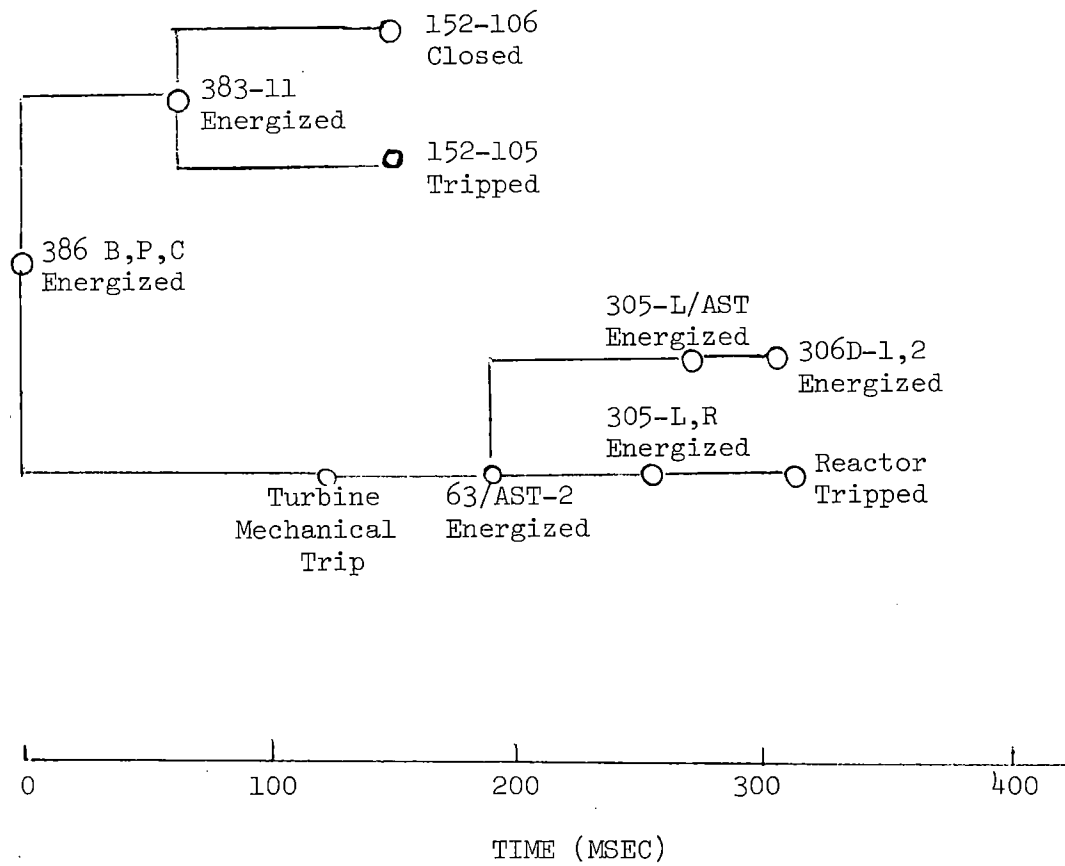
ATTACHMENT 1

The first plant transient considered is one in which the main generator trips. The sequence of events following such an occurrence is presented on Attachment 1. At time zero, one of the main turbine generator protection relays 386B, P or C is energized. The fast transfer relay 383-11 is energized 65 milliseconds (msec) later and following this the 2400 V bus 1C startup power breaker 152-106 closes and station power breaker 152-105 opens. Bus 1C breakers and associated relays have been referred to in this scenario but it should be noted that the events are mirrored on bus 1D. With the fast transfer having been executed, power to the DC buses is maintained and the sequence of events continues as normal with the diesel start relays being energized at 310 msec and the control rod drive clutch relays de-energized shortly thereafter.

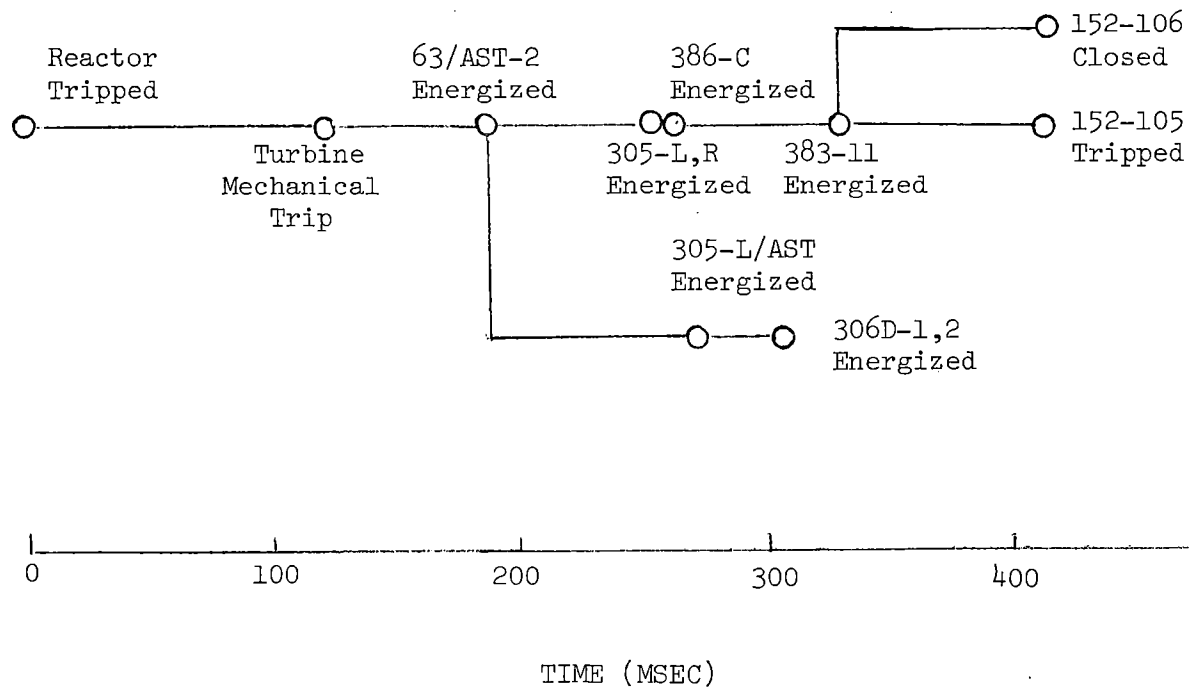
ATTACHMENT 2

Attachment 2 presents the sequence of events for a reactor trip. It can be seen that as with the previous transient analyzed, the fast transfer maintains power to the DC buses and the sequence of events progresses as normal.

As in any reactor trip, voltage is maintained on the 2400 volt bus 1C through the station power breaker 152-105 until the fast transfer relay 383-11 is energized. Since DC power to the station power breaker and startup power breaker 152-106 is supplied from panel D-11A which is connected directly to the battery, the fast transfer is executed. Similar breakers and relays are associated with bus 1D. The diesels are started during this transient as can be seen at the 310 msec time on Attachment 2.

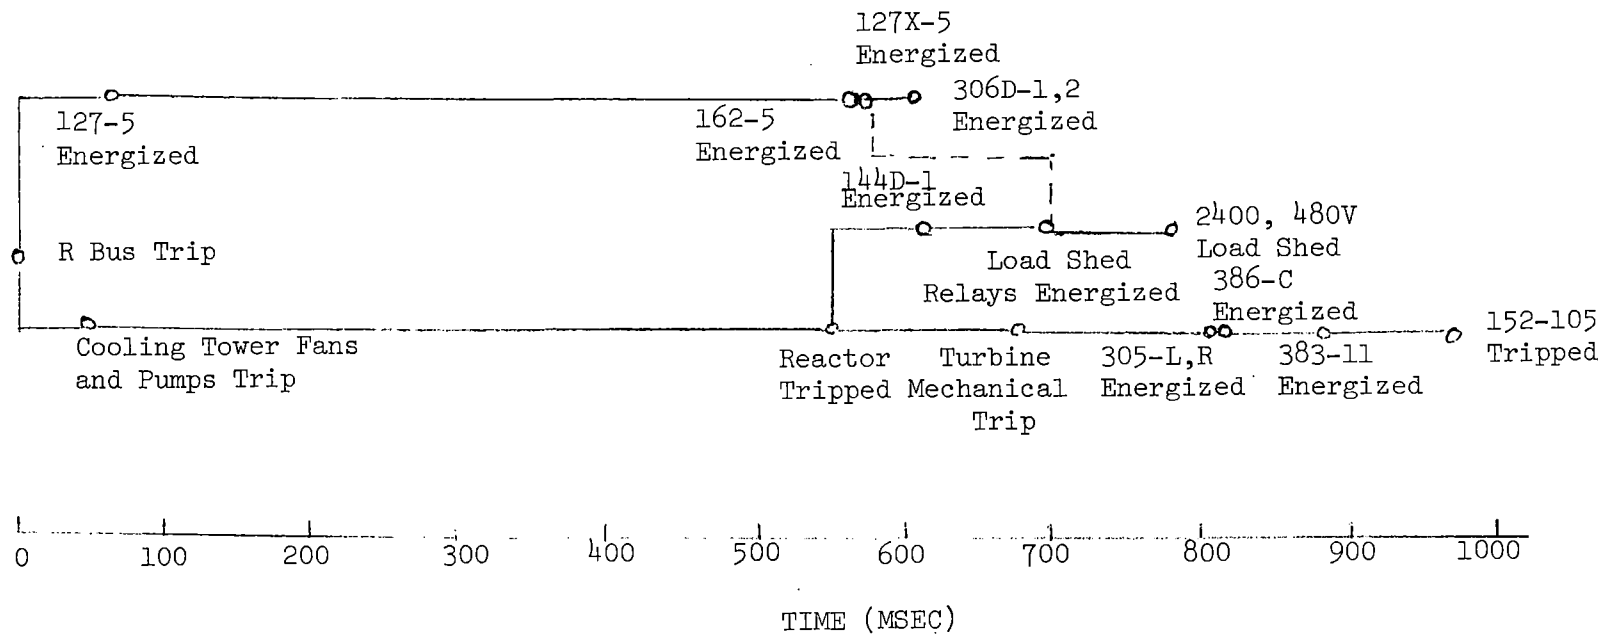
ATTACHMENT 3

R bus trip represents a loss of offsite power event in which the plant is simultaneously tripped. It has occurred only three times during the history of Palisades; therefore, it is not considered high probability event. Attachment 3 presents the initial sequence of events during such a transient. Following the trip of the R bus, startup transformer 1-2 low voltage relay 127-5 is energized and the cooling tower fans and pumps are tripped since they receive power from startup transformers 1-1 and 1-3 which, in turn, receive power from the R bus. At 575 msec into the transient, the auxiliary undervoltage relay 127X-5 is energized and 30 msec later the diesel start relays are energized. The lack of cooling water to the condenser would produce a mechanical vacuum trip at about 30 seconds. However, normal operating procedure is to trip the reactor as presented in the Emergency Operating Procedure EOP2. This time has been arbitrarily chosen on Attachment 3. The sequence of events after the reactor trip is similar to that presented on Attachment 2 with the following exceptions:

1. The load shed relays are energized at time 695 msec. For these relays to be energized, both the preload shed relay 144D-1 and the startup transformer low voltage auxiliary relay must be energized.
2. The 2400 V loads on bus 1C and load control center 11 are shed.
3. Startup breaker 152-106 is not closed.

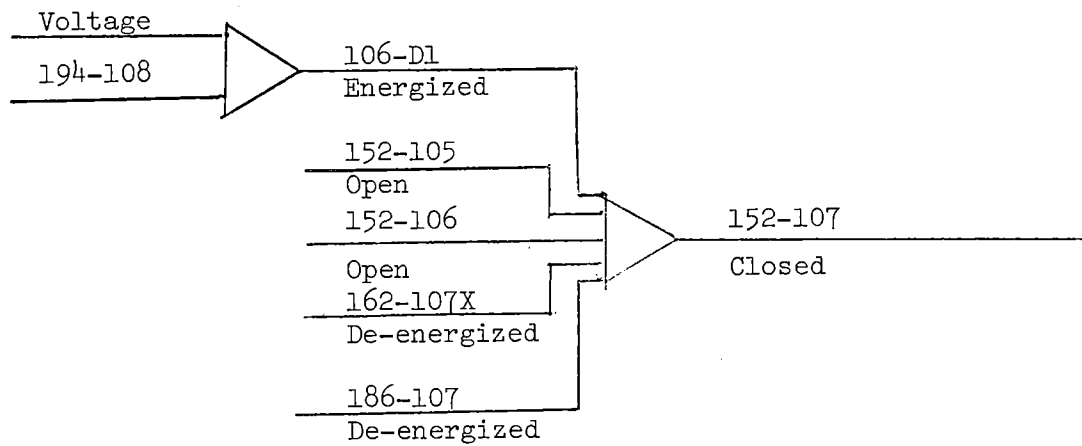
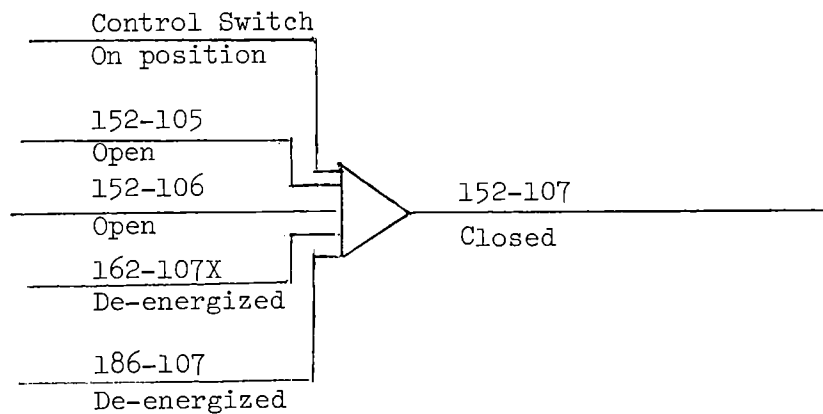
ATTACHMENT 4
DIESEL BREAKER 152-107

Following the above events and with the opening of station power breaker 152-105, the plant is without power except for the DC loads connected to the batteries for a short period of time. This time is less than 10 seconds since this is the maximum time required for the diesels to start and acquire proper voltage. At this time, the operator would manually close the diesel generator breaker 152-107 since the load shed relay 194-108 de-energizes during the short period of time without power and, as displayed on the logic diagram of Attachment 4, automatic closure is not possible. As can be seen from the same attachment, manual closure

of the breaker is possible after positioning the control switch to the "on" position. It should be noted that DC power for breaker 152-107 is supplied from panel D-11A which is connected directly to the battery. With the diesel connected to the 2400V bus 1C, manual start of the normal shutdown sequencer is necessary to return the sequence of events to normal. Similar breakers and relays to those described in this scenario for bus 1C are associated with 2400V bus 1D.
