DOCKET 50-255 - LICENSE DPR-20 -
PALISADES PLANT - UPDATE OF LICENSEE
EVENT REPORT 80-008 - VALVE LEAKAGE

ATTACHMENT TO LER 80-08, Rev.1
CONSUMERS POWER COMPANY
PALISADES PLANT
DOCKET 50-255

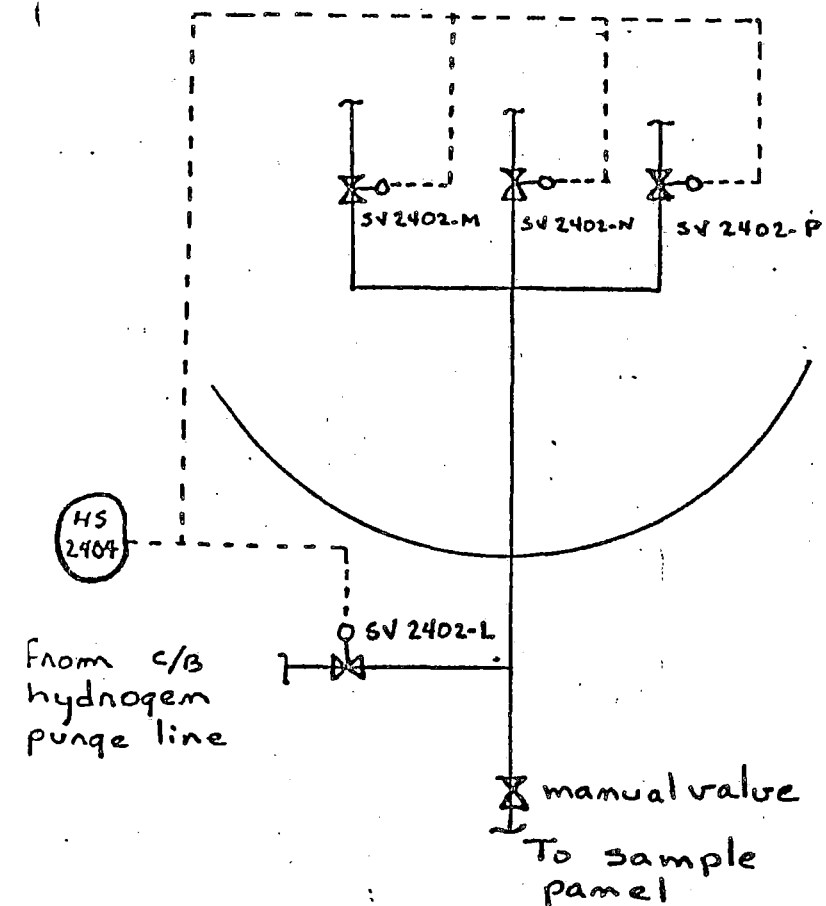
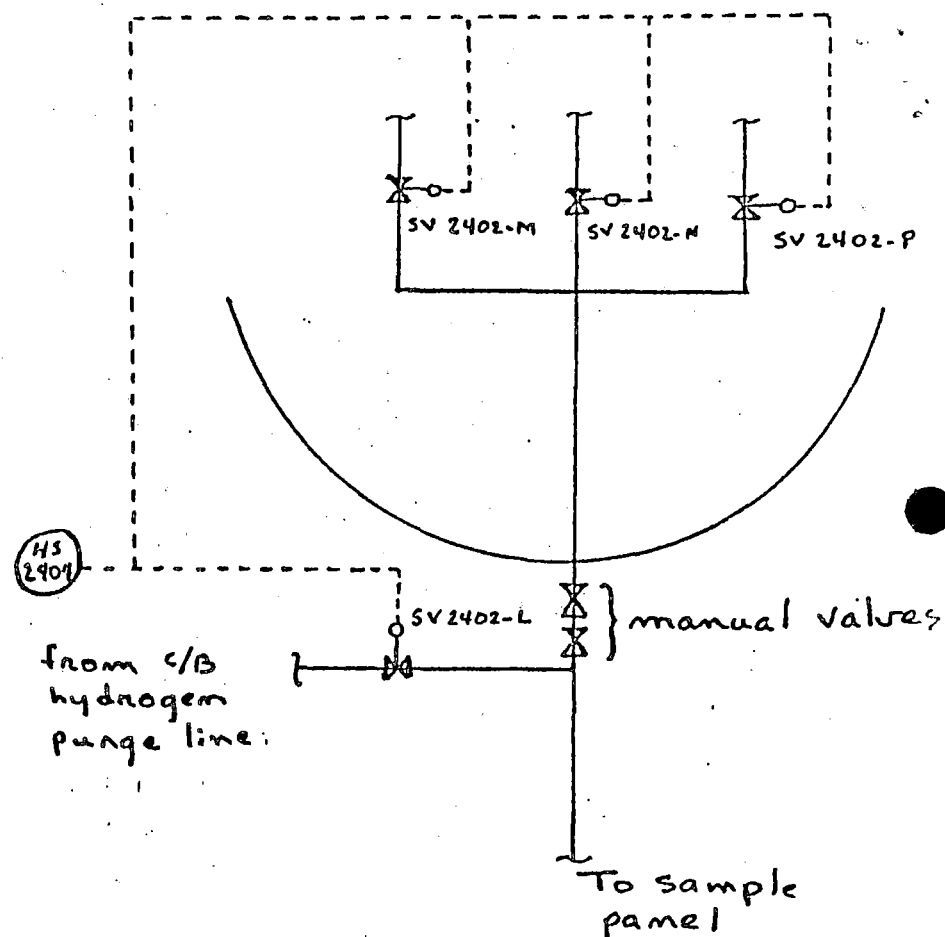
FIGURE 1

Refer to Figure 1 for the following discussion. Regarding penetration 28 (containment air sample) the design of the handswitch which operates the solenoid valves is such that one of the solenoid valves (2402-L,M,N, or P) is always energized (open). As a result, a single valve boundary existed between containment atmosphere and the containment hydrogen vent line.

This penetration has been modified by the addition of two manual valves which provide containment isolation. Additionally, valve SV-2402-L was previously oriented such that it provided an essentially leak-tight boundary for flow from the hydrogen exhaust line but not in the reverse direction. The valve orientation has been reversed such that leakage through the valve should not occur during containment sampling operations.

Corrective Action. Corrective action to reduce leakage has consisted of valve repair, valve replacement, packing adjustment, valve reorientation, and in the case of penetrations which are no longer used, installation of blank flanges to "eliminate" those penetrations.
