Entergy Operations, Inc.
River Bend Station
5485 U.S. Highway 61N
St. Francisville, LA 70775
Tel 225-635-5000

Subject: Licensee Event Report 50-458 / 2018-011-00, "Condition Prohibited by Technical Specifications due to Inadequate Design Change of Under Voltage Relay Trip Set Point Range".
River Bend Station, Unit 1
NRC Docket No. 50-458
Facility Operating License No. NPF-47

4. Title Condition Prohibited by Technical Specifications due to Inadequate Design Change of Under Voltage Relay Trip Set Point Range

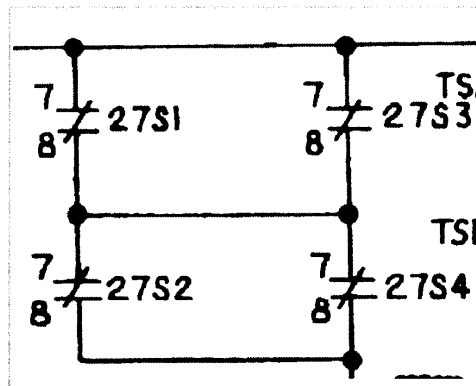
The 27S relays are arranged in a one-out-of-two-twice arrangement as seen below. The contacts are normally open. When the relay actuates the associated contact closes. In order for the safety function to occur the 27S1 or 27S3 and the 27S2 or 27S4 must actuate.

The out of tolerance conditions of the 27S relays would not have prevented the safety function. Due to the one-out-of-two-twice arrangement, the 27S relays that were found within the TS allowable range would have performed the safety function in both the October 2016 and October 2018 occurrence.
