**Summary Report and Analysis of Data from Operating Experience Smart Sample,
OpESS 2018/01, “Evaluation of Licensee Actions Taken in Response to 10 CFR Part 21
Notification of the Potential Existence of Defects Related to Control Rod Drive
Mechanism (CRDM) Thermal Sleeves”**

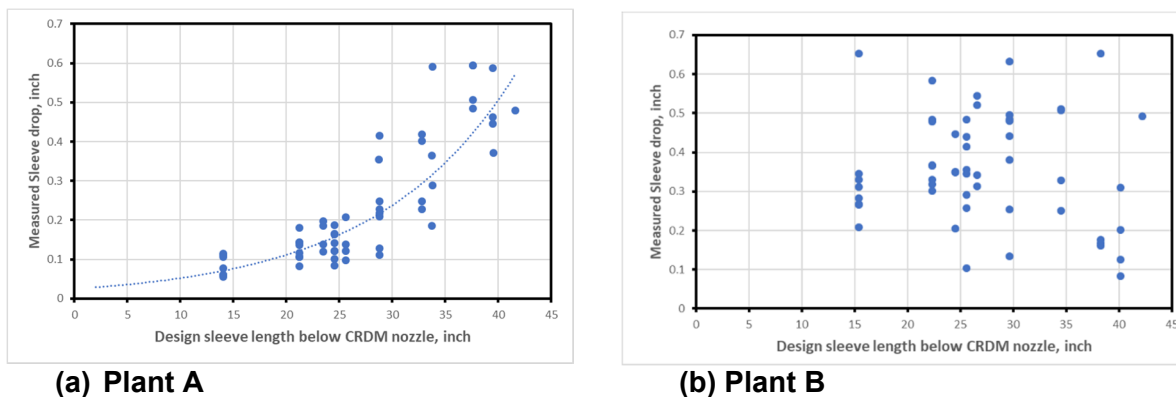
Figure 1 Thermal sleeve wear measurements

Note that the thermal sleeves near the top of the head have a greater portion of the thermal sleeve exposed to cross flow than the thermal sleeves on the periphery of the head. The “design sleeve length,” on the above graphs corresponds to the length of the thermal sleeve that is exposed. In some cases, a clear trend with location is seen—more wear occurred near the center of the head. In other cases, the wear appeared location independent. It is currently unknown why these differences occurred.

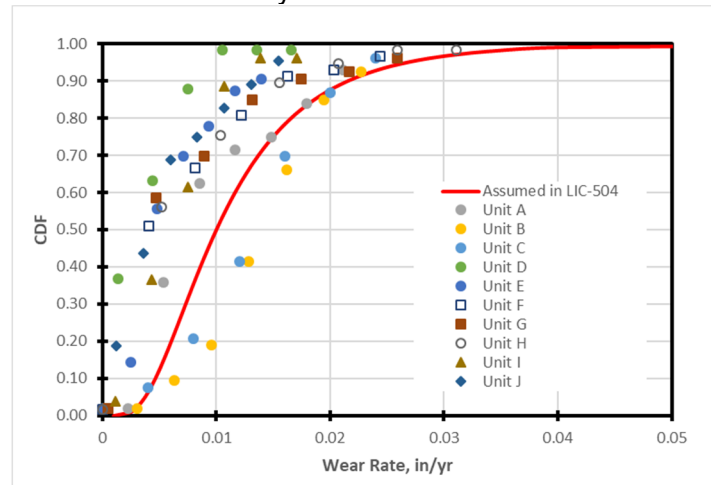
Figure 2 Comparison of smart sample wear rates and assumption in LIC-504 analysis

Even though this data only represents one point in time, a wear rate can be estimated from this data and the design or as-built conditions. These wear rates can then be displayed as a cumulative distribution function and compared against what was used in the LIC-504 analyses [2] as shown in Figure 2. In this figure, the different color circles represent the data¹ from the sampled plants, while the solid red line represents the distribution assumed in the LIC-504 analyses [2]. Data that falls above and to the left of the red line is considered conservative and data that falls below and to the right is considered nonconservative. It is suspected that the nonconservative values would produce probabilities of failure that are higher than those calculated in the LIC-504 analyses.

From Figure 2, most of the collected data falls above the assumption used in the LIC-504 analyses. Of the two plants that fall below the curve, the difference is relatively small.

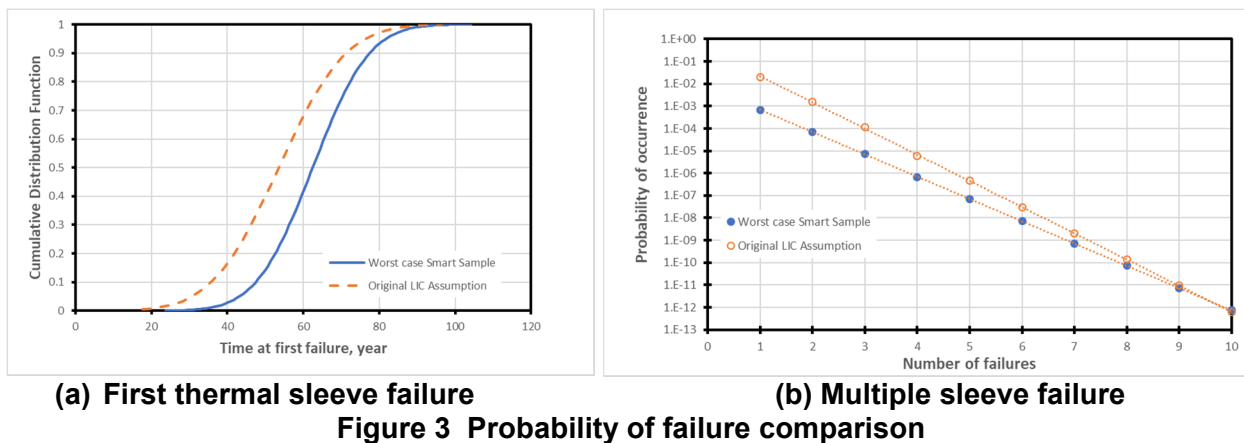
Taking the worst-case wear data, the staff conducted an analysis to compare the probability of failure results with those in the LIC-504 analysis. Using the same analysis procedure as in the LIC-504 [2], staff calculated the probability of failure shown in Figure 3.

In these figures, the orange open circles represent the results presented in the LIC-504 analysis, while the blue solid circles represent the results using the worst-case wear rate in Figure 2. Surprisingly, even though the wear-rate data appears to be nonconservative, the probability of failure numbers are conservative compared to those in the LIC-504 analyses. The reason for this behavior becomes clear when the worst-case data is investigated more closely. See Figure 4.

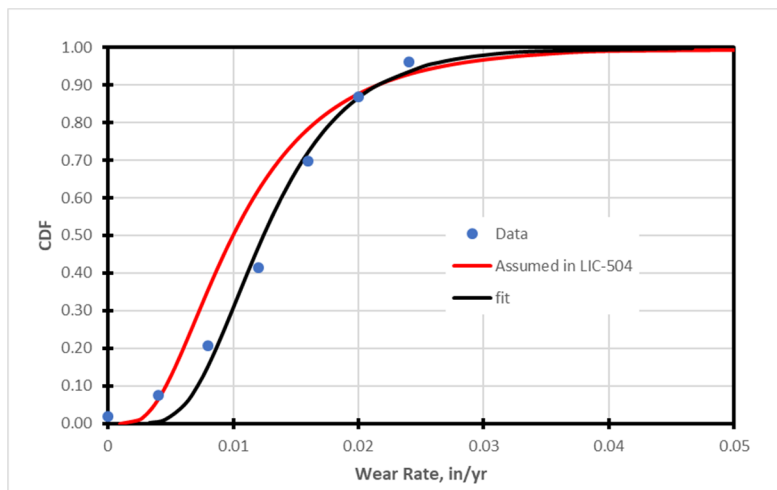
Figure 4 Comparison of worst case wear rate data with LIC-504 assumption

Figure 4 shows the worst-case wear data and its fit compared with the assumption used in the LIC-504 analyses. While most of the data is nonconservative with respect to the LIC-504 assumption, the data at the high wear rates are conservative (i.e., the data above 90 percent probability falls above the assumption in the LIC-504 analyses). Since the probability of first thermal sleeve failure is driven by the upper tail of the wear rate distribution, the data and fit shown in Figure 4 would produce probability a first failure greater than that from the LIC-504 analyses. In looking at the data in Figure 2, the maximum measured wear rate was 0.030 inches/year with all of the high wear rate data falling above the assumption made in the LIC-504 analyses.
