Subject: Restoration Report for the Disposal Cell Cover Study at the Bluewater, New Mexico,
Disposal Site (Docket No. 40-8902)

Effects of Soil-Forming Processes on Cover Engineering Properties, Study Restoration Report, Bluewater, New Mexico, Disposal Site

January 2019

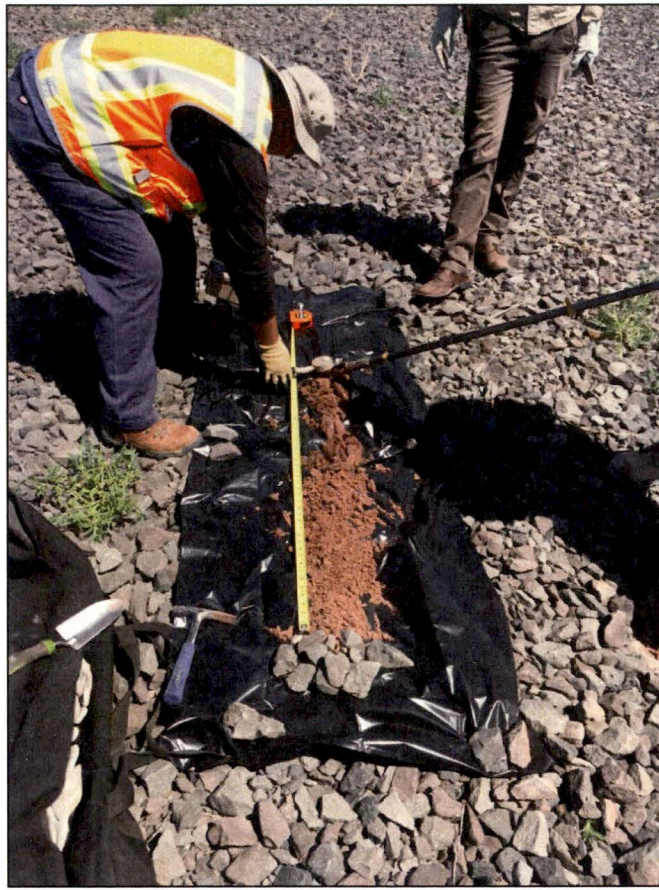
PL-1. Pre-excavation Soil Boring Through Cover

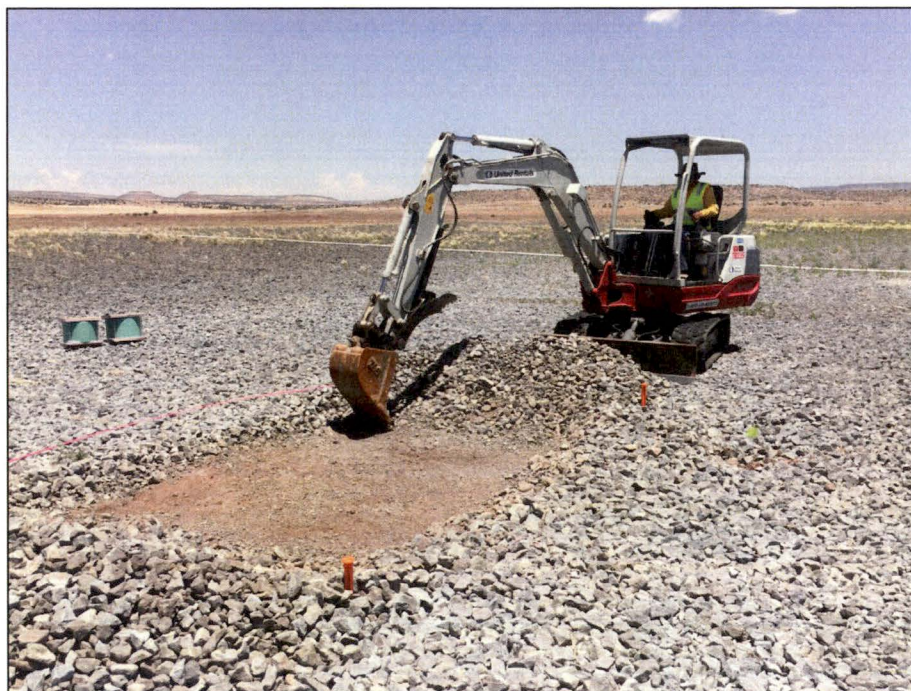
PL-2. Pulling Back Rock Riprap

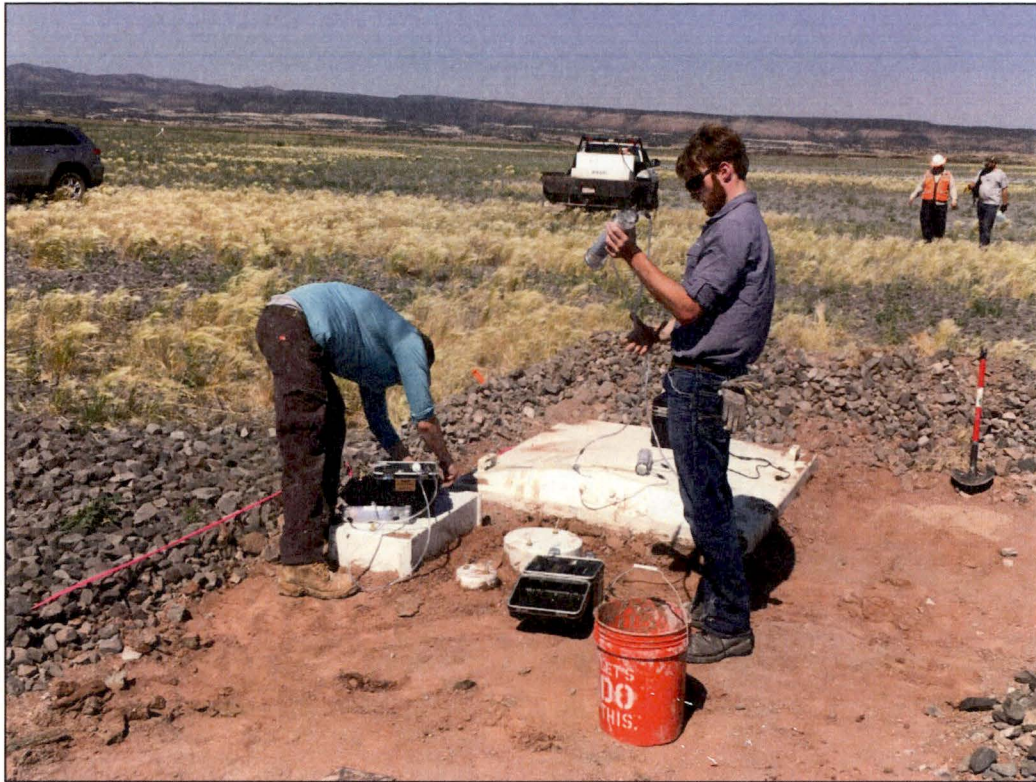
PL-3. Top of Radon Barrier Radon Flux Monitoring

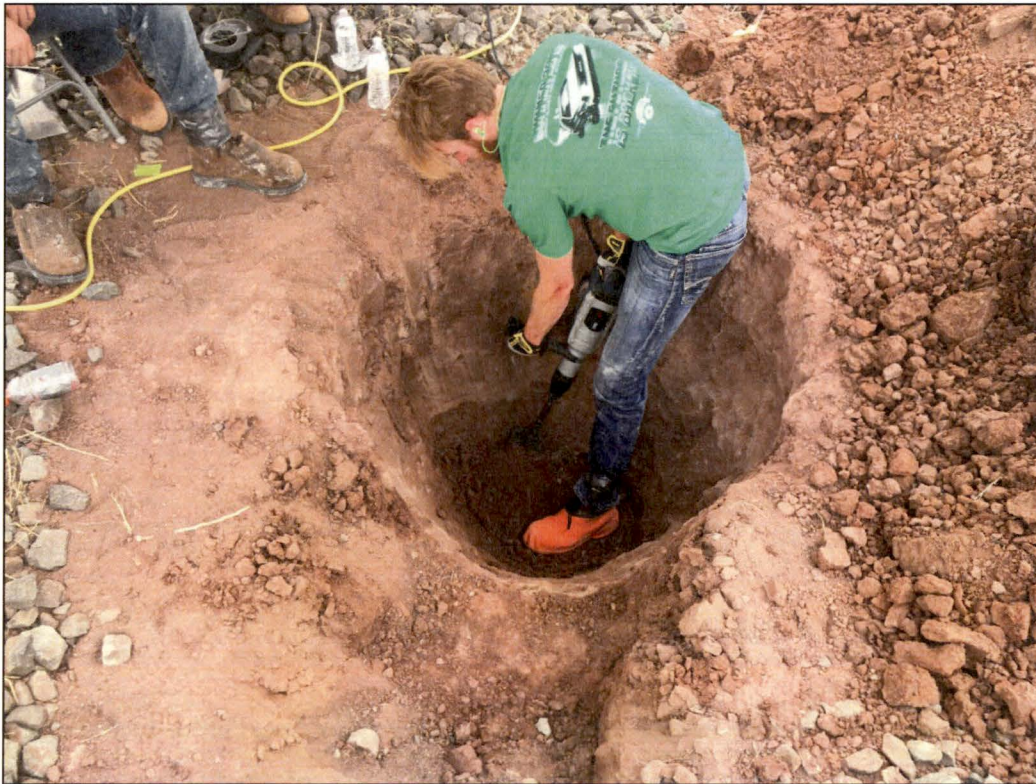
PL-4. Excavation through the Radon Barrier

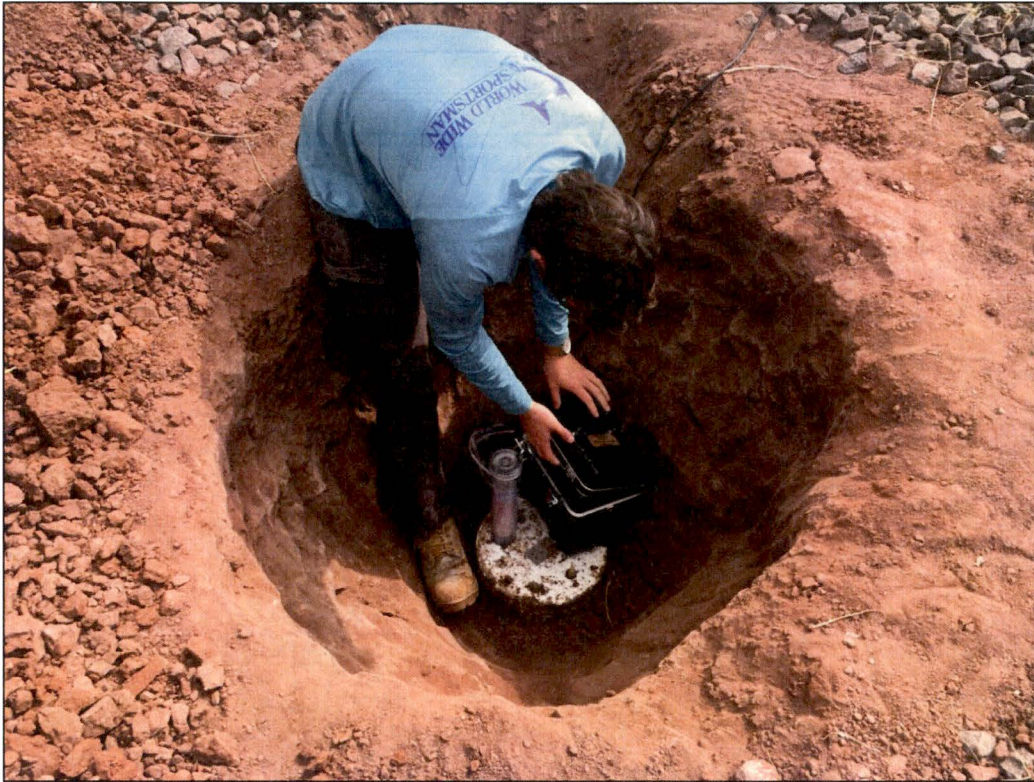
A smaller footprint of the radon barrier, generally less than 2 yd^2 , was then excavated to a depth of 21–29 inches to expose the top of contaminated materials and create a clean pit face to the base of the radon barrier for soil morphology characterization (PL-4, PL-6, PL-7, and PL-8). Multiple lines of evidence were used to confirm the interface with buried contaminated materials including as-built thicknesses, auger cuttings, gamma radiation survey results, soil characteristics (e.g., color, grain size), and geomorphic features. Radon flux was also measured on the surface of the contaminated materials (Benson et al. 2017) (PL-5).

PL-5. Measuring Radon Flux at the Bottom of the Radon Barrier

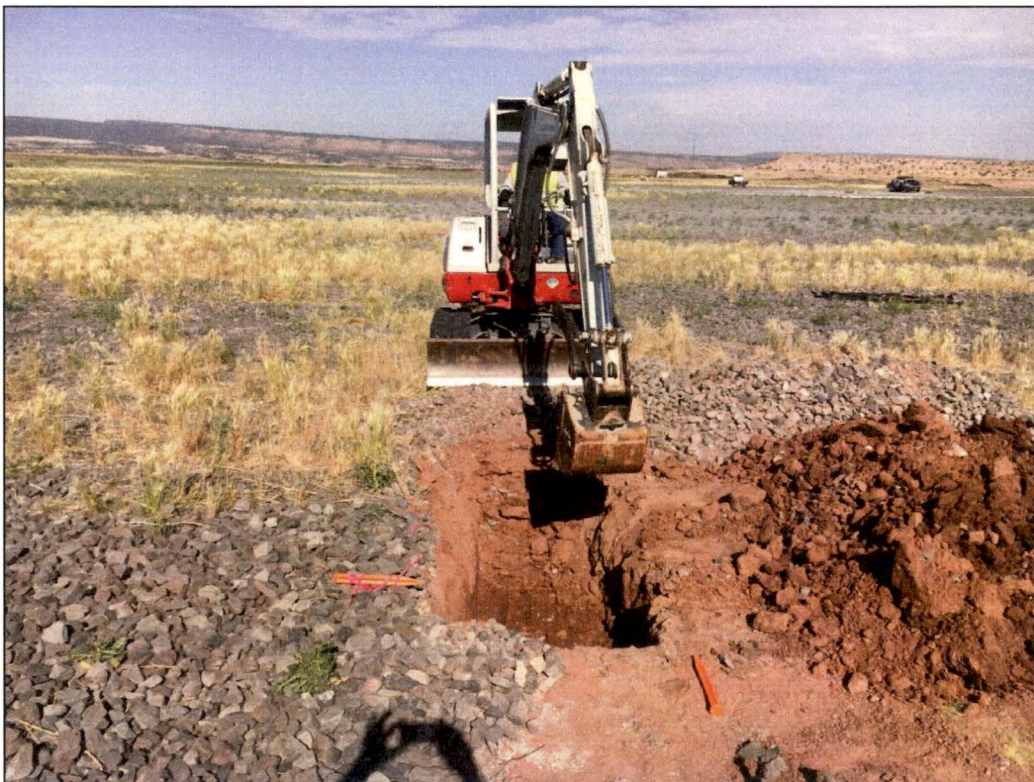
PL-6. Excavation Through the Radon Barrier at Micro Pit 2

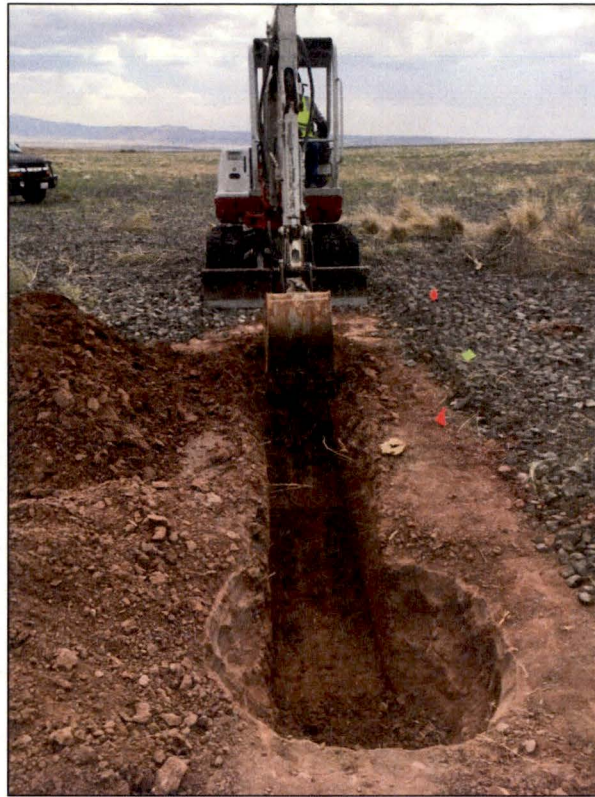
PL-7. Excavation Through the Radon Barrier at Test Pit 5A/B

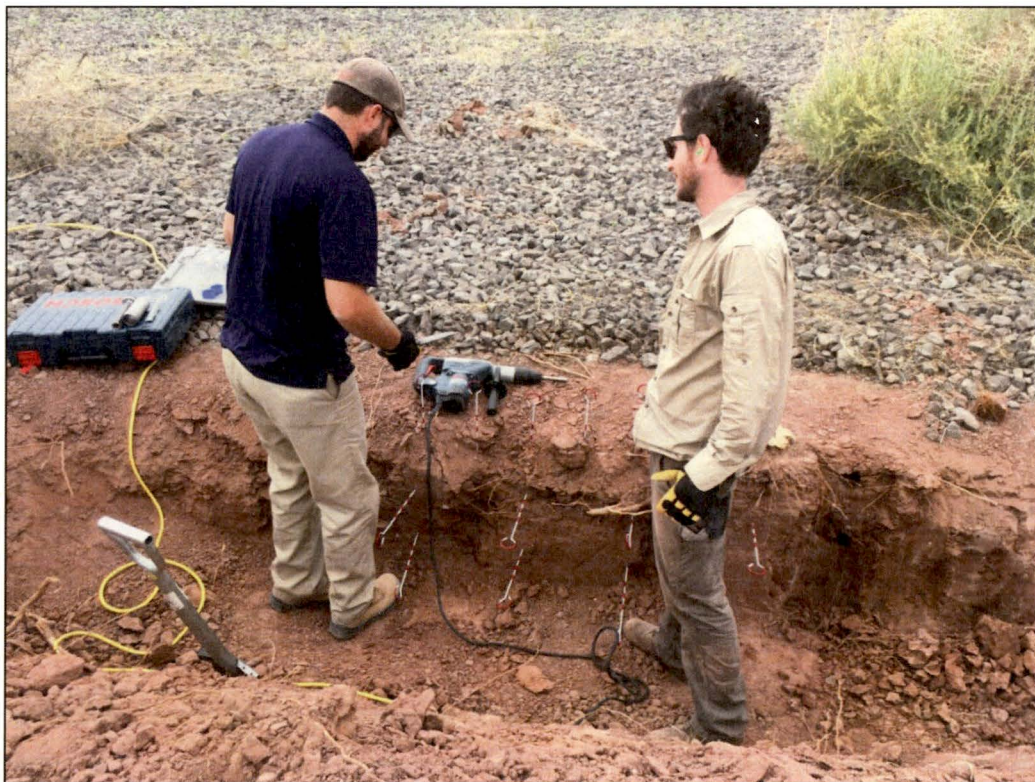
PL-8. Continuous Face Exposed for Soil Morphology Logging

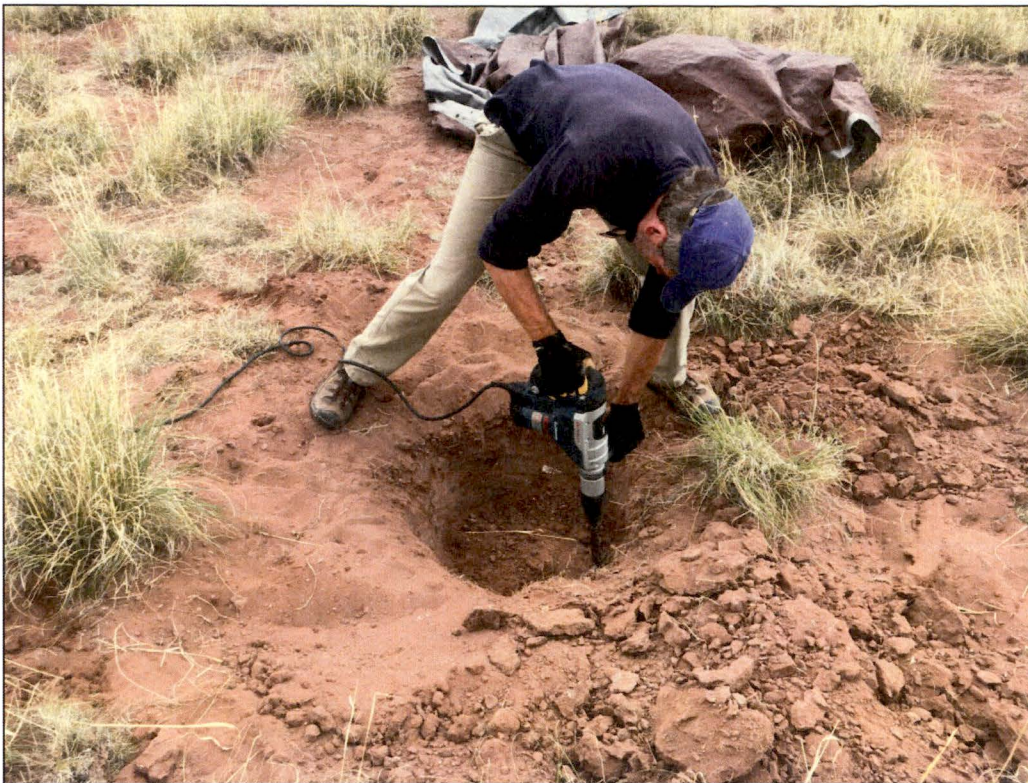
PL-9. Test Pit 9A/B Excavation of Radon Barrier

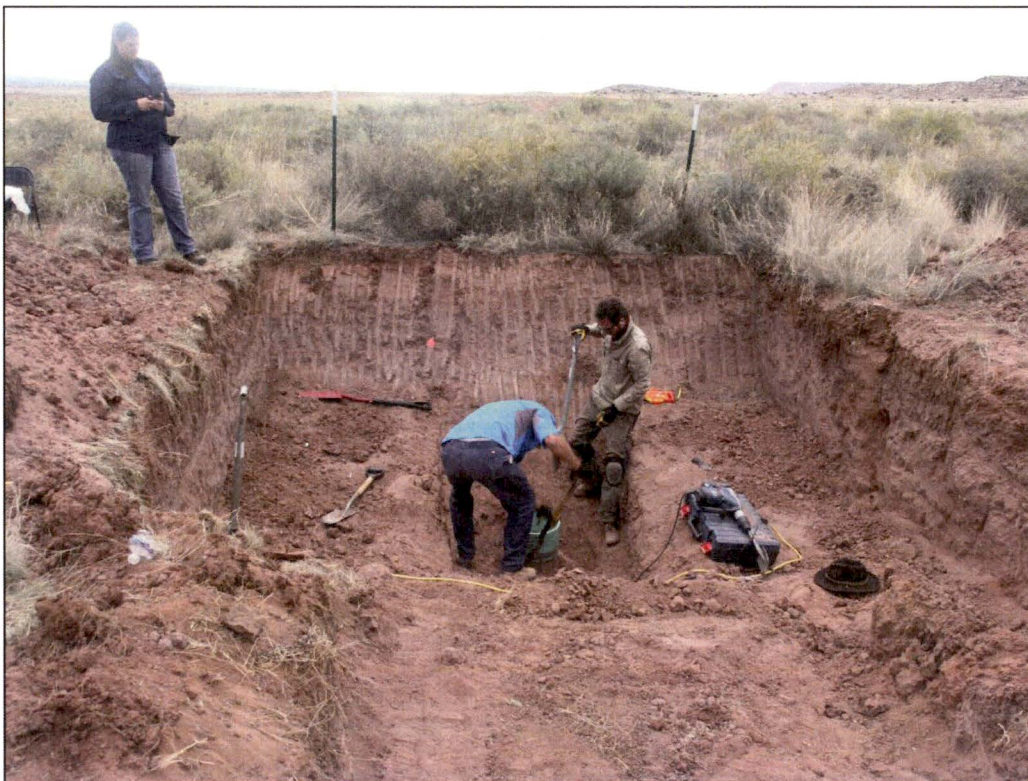
PL-10. Off-Cover Analogue Pit 3 and Borrow Source Excavation

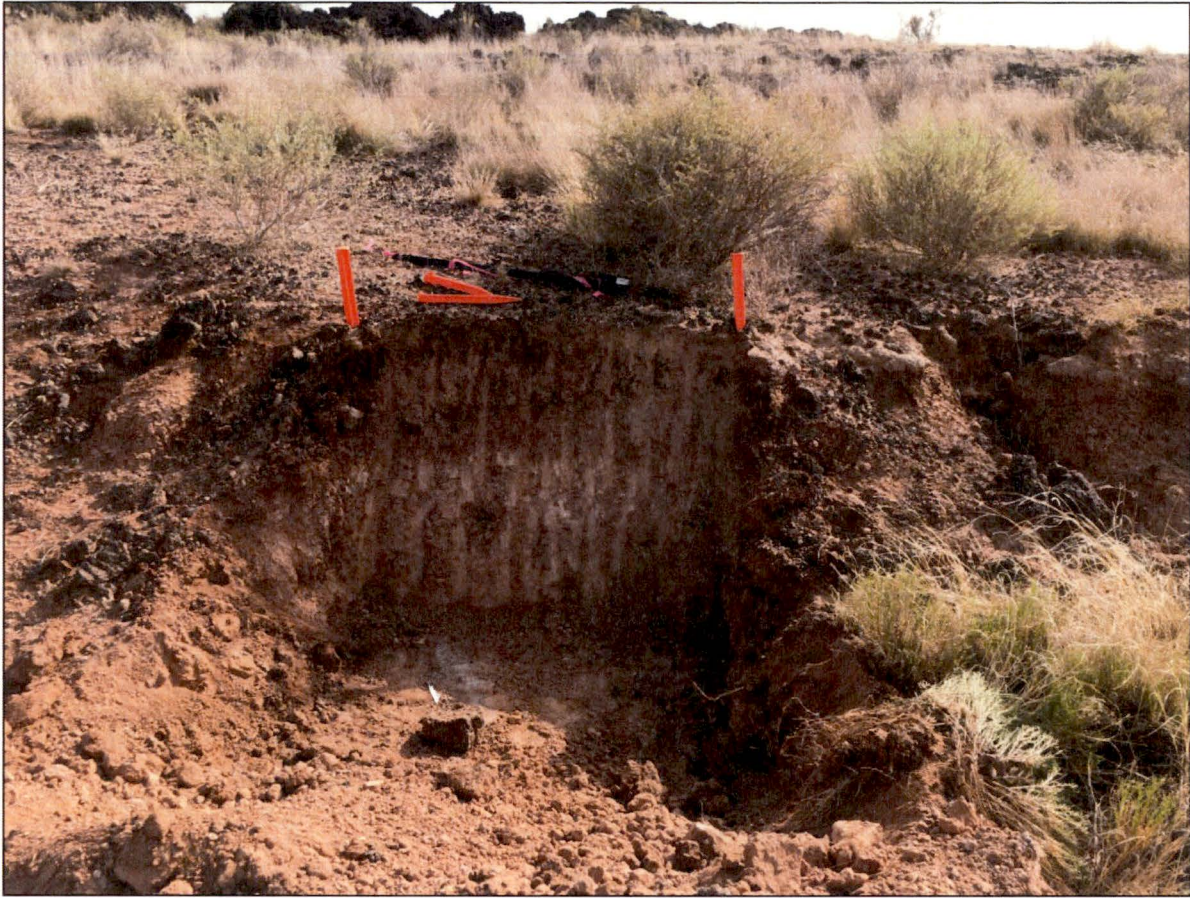
Two test pits were excavated and sampled at analogue locations (undisturbed off-cover locations) within the site boundary. One pit was excavated adjacent to the former borrow area. This pit, Analogue Pit 3, shown in Figure 2, was excavated to a depth of about 6 feet and had an area of about 25 yd² (PL-10). This pit was also the source of borrow material for the restoration of the radon barrier (about 0.5 cubic yard total). The other test pit was on a small hillside adjacent to the road leading to the main tailings disposal cell. This test pit, Analogue Pit 6, also shown in Figure 2, was excavated to a depth of about 3 feet in an area of about 4 yd² (PL-11).

PL-11. Excavation of Analogue Pit 6

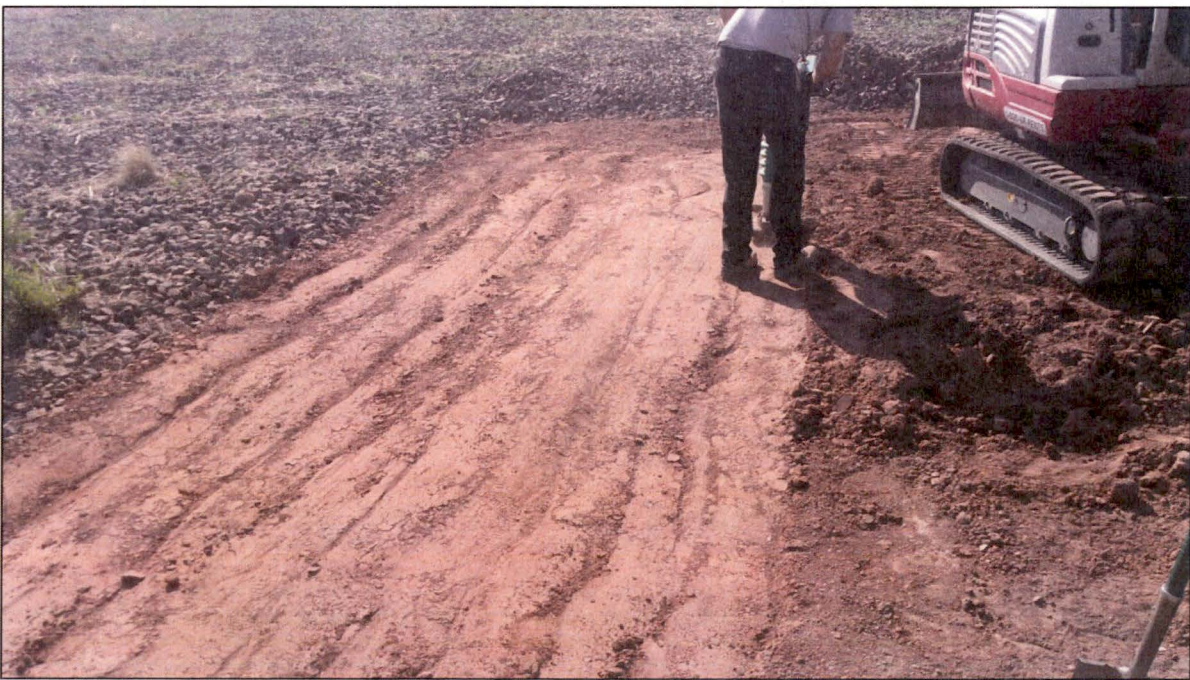
PL-12. Restoration Compaction at Test Pit 7

The radon barrier was restored by placement of the material in 12-inch loose moisture-conditioned lifts. Compaction of the radon barrier layer was achieved using a hand-operated large rammer delivering 2900–3600 pounds per blow with three or more passes over all backfilled areas on each lift (PL-12). In all cases, the restored radon barrier was level with the surrounding undisturbed barrier.

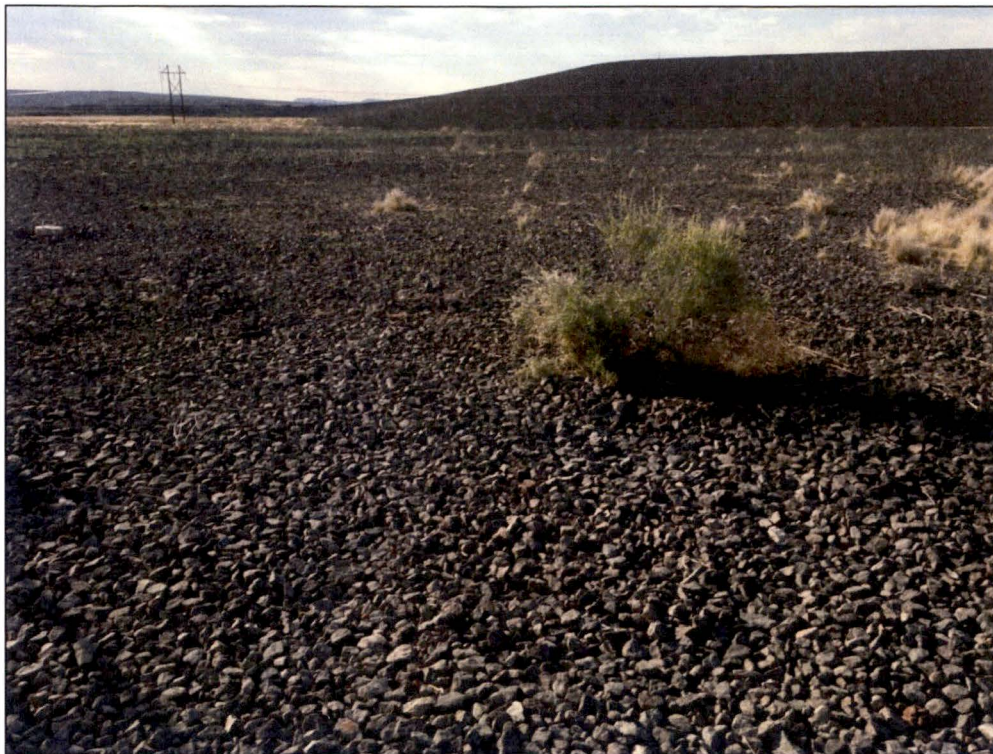
PL-13. Restored Condition of Test Pit 7 with Post-restoration Radon Flux Measurement at Test Pit 8 in the Background

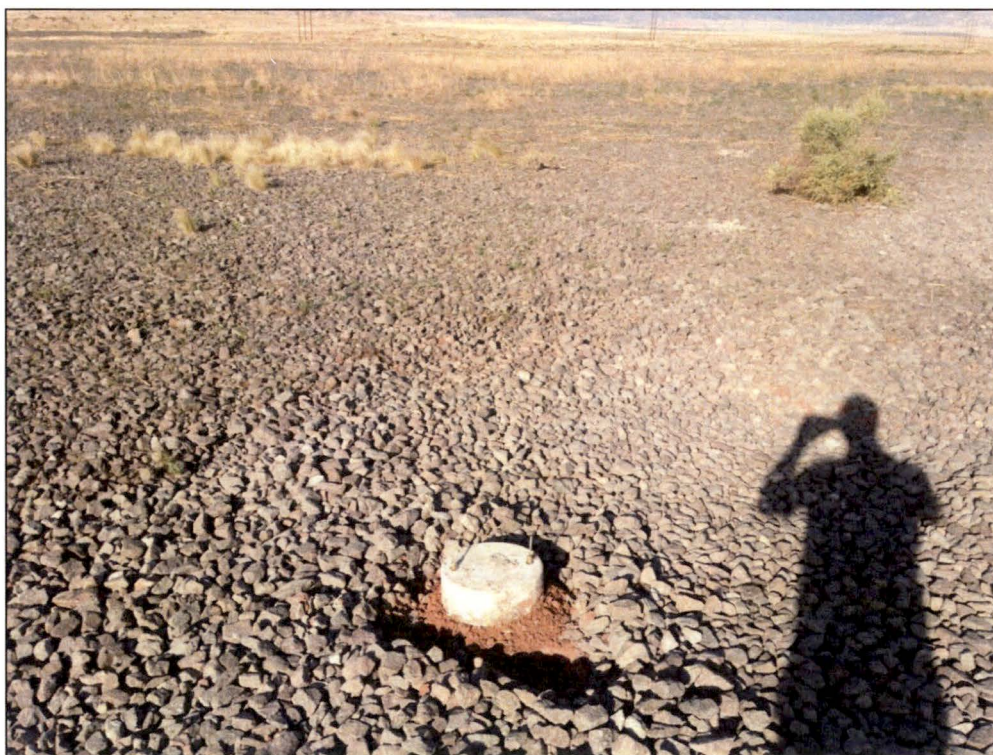
PL-14. Post-restoration Radon Flux Measurement at Test Pit 8 with Restored Test Pit 7 in the Background

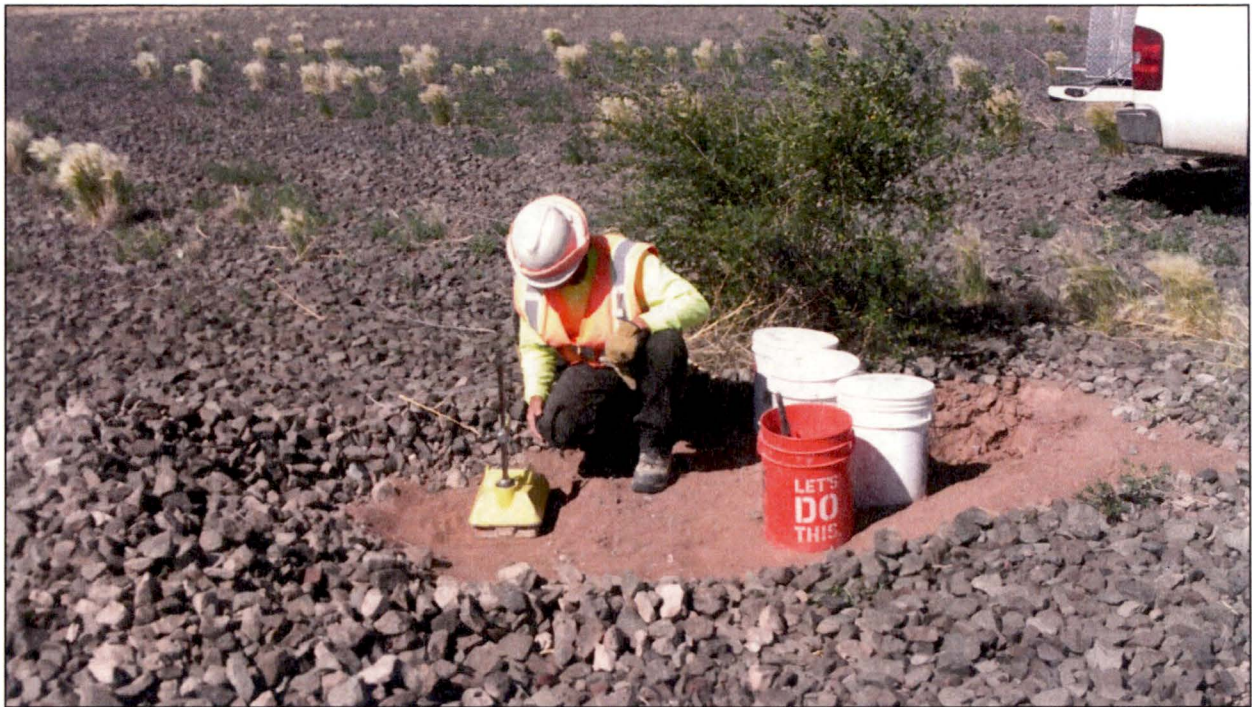
PL-15. Nuclear Density and Moisture Testing

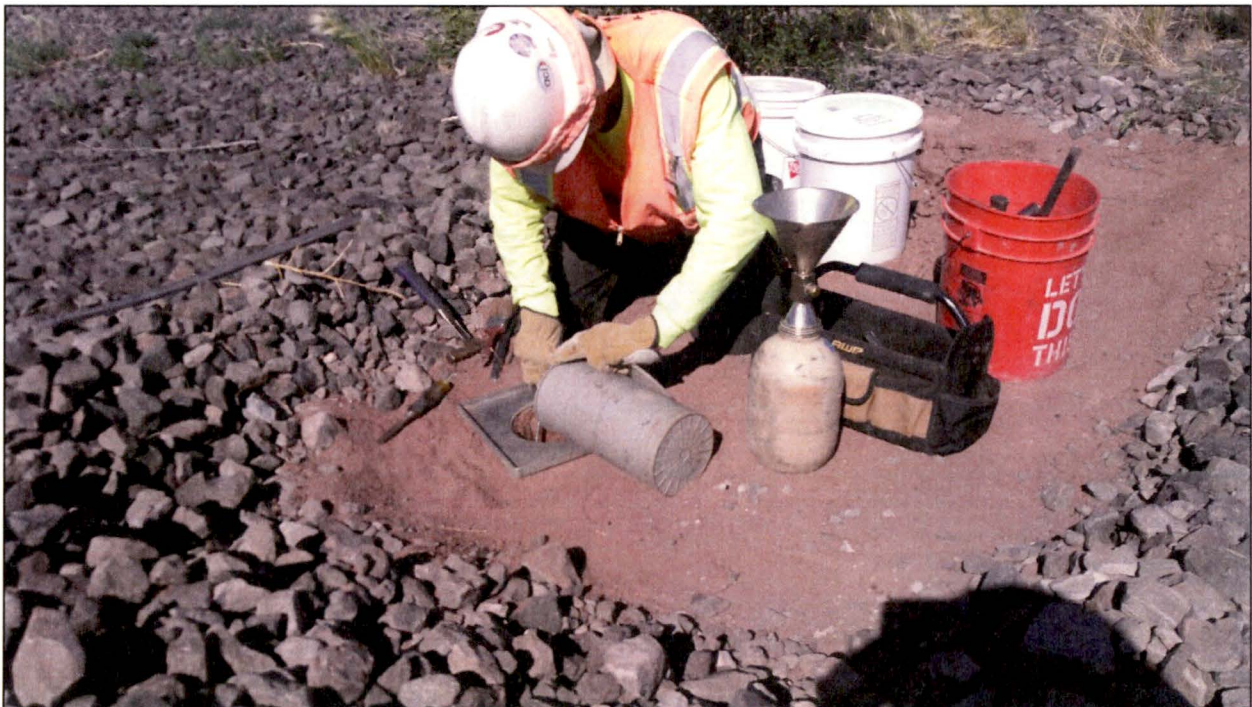
PL-16. Sand Cone Density and Moisture Testing

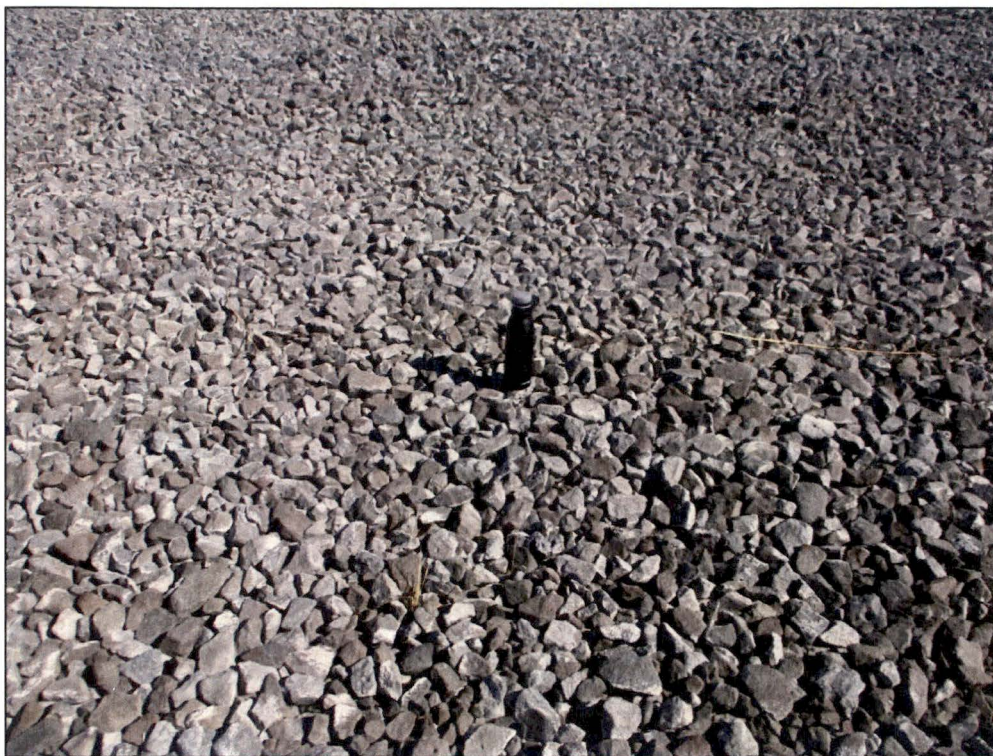
PL-17. Post-restoration Condition at Test Pit 1A/B on Main Tailings Disposal Cell, September 2017

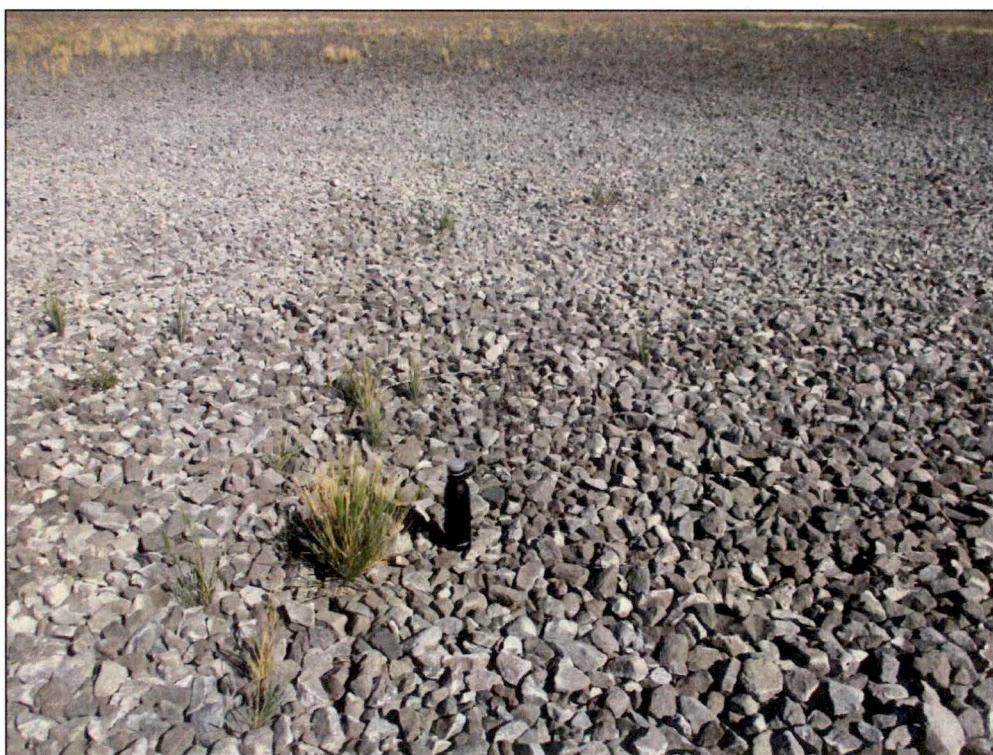
PL-18. Post-restoration Condition at Test Pit 2A/B Under Ponded Area on Main Tailings Disposal Cell, September 2017

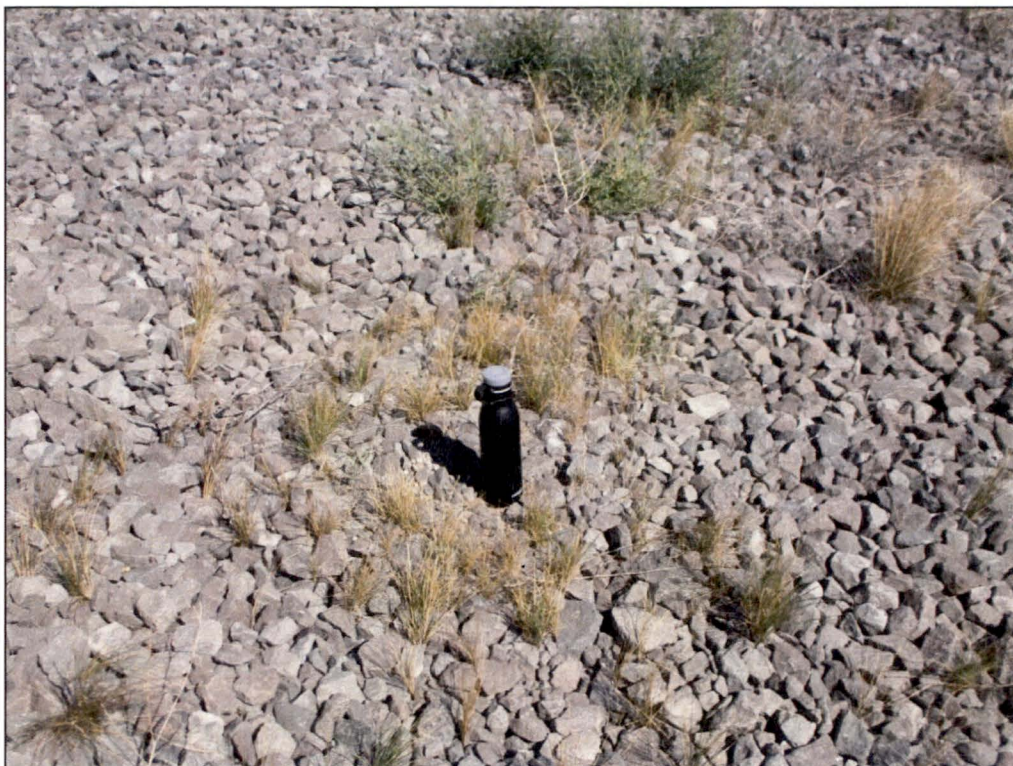
PL-19. Post-restoration Condition at Test Pit 3A/B on Main Tailings Disposal Cell, September 2017

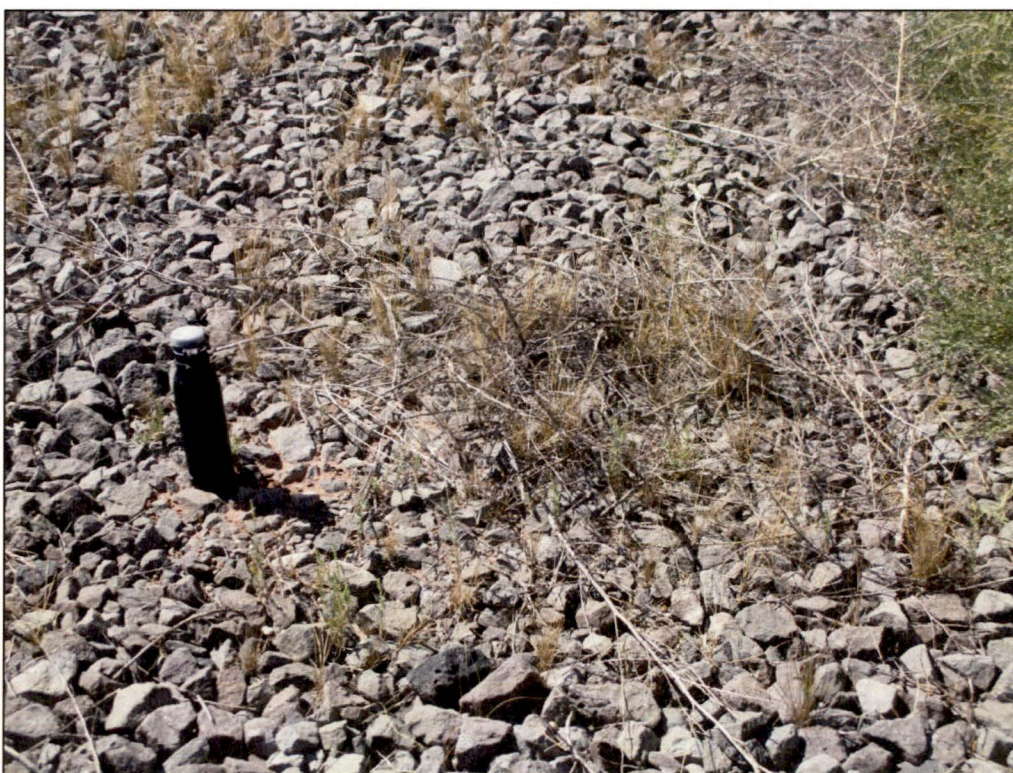
PL-20. Post-restoration Condition at Test Pit 4 on Main Tailings Disposal Cell, September 2017

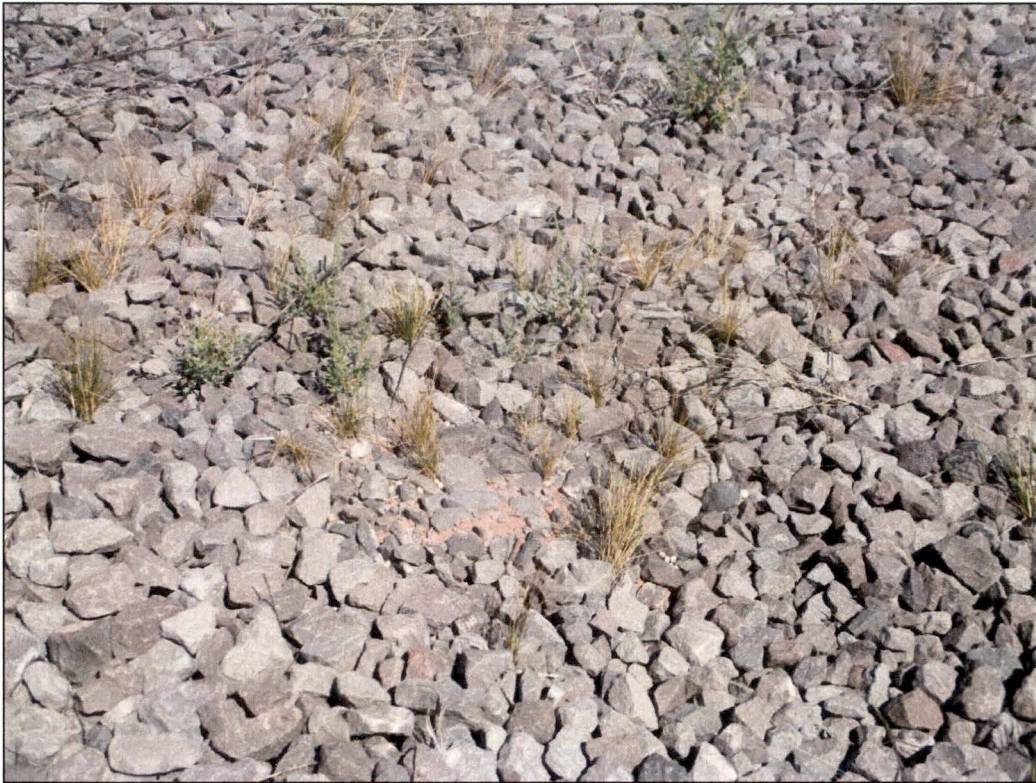
PL-21. Post-restoration Condition at Test Pit 5A/B on Main Tailings Disposal Cell, September 2017

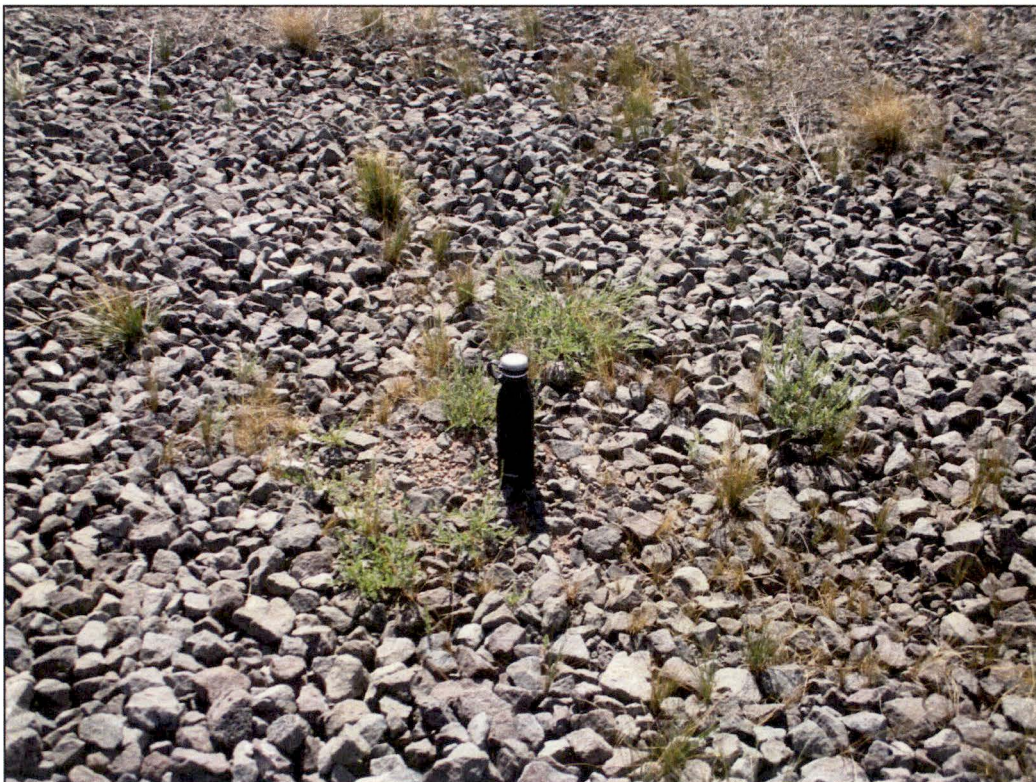
PL-22. Post-restoration Condition at Test Pit 6 on Main Tailings Disposal Cell, September 2017

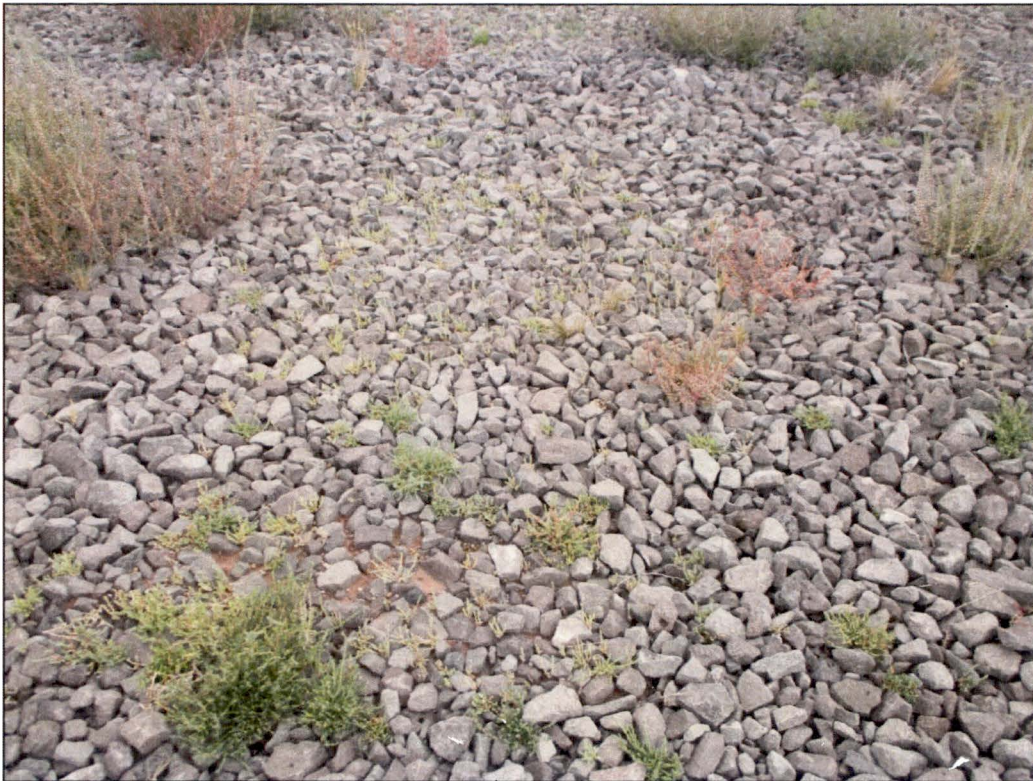
PL-23. Post-restoration Condition at Test Pit 7 on Carbonate Tailings Disposal Cell, September 2017

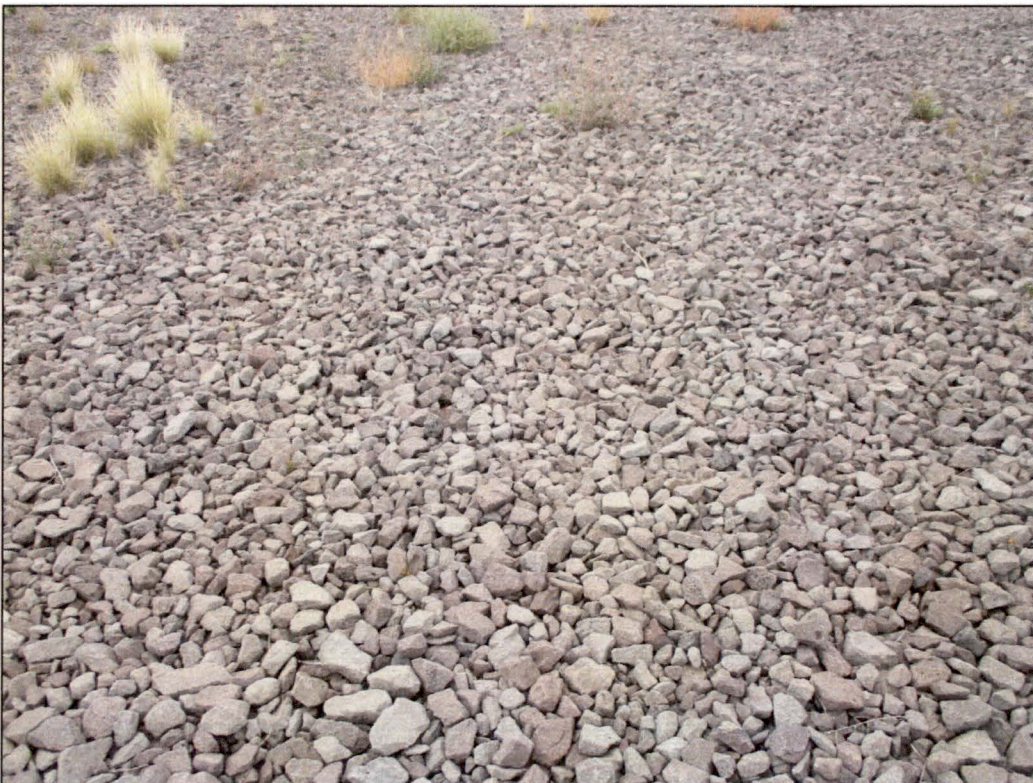
PL-24. Post-restoration Condition at Test Pit 8 on Carbonate Tailings Disposal Cell, September 2017

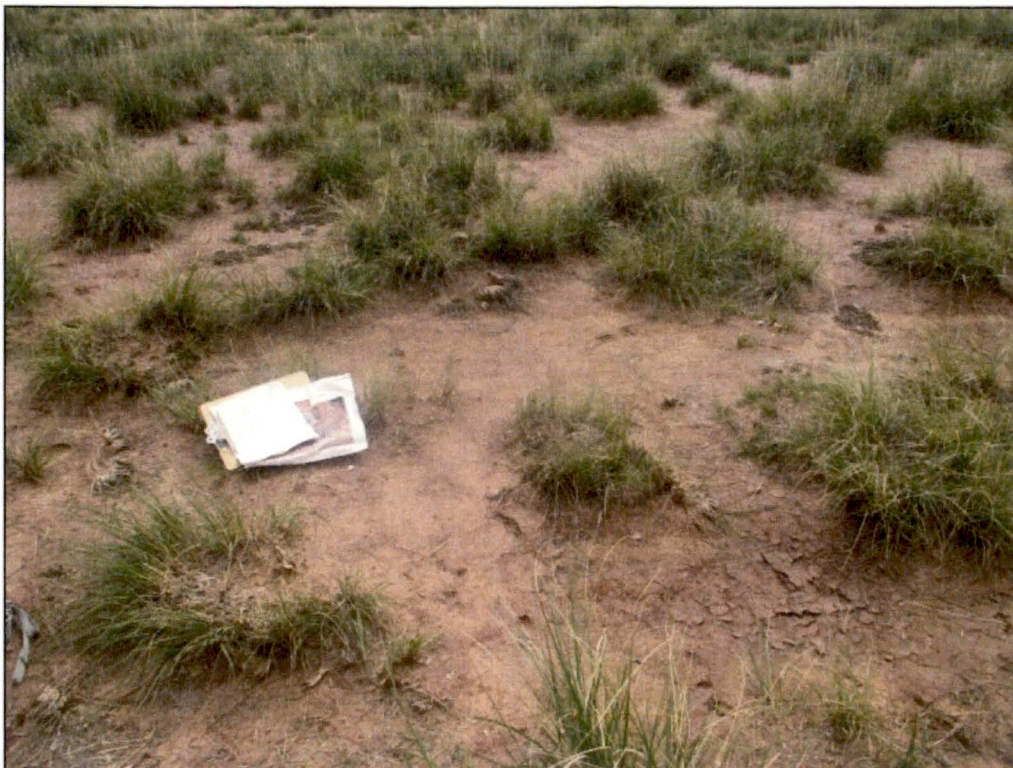
PL-25. Post-restoration Condition at Test Pit 9A/B on Acid Tailings Disposal Cell, June 2016

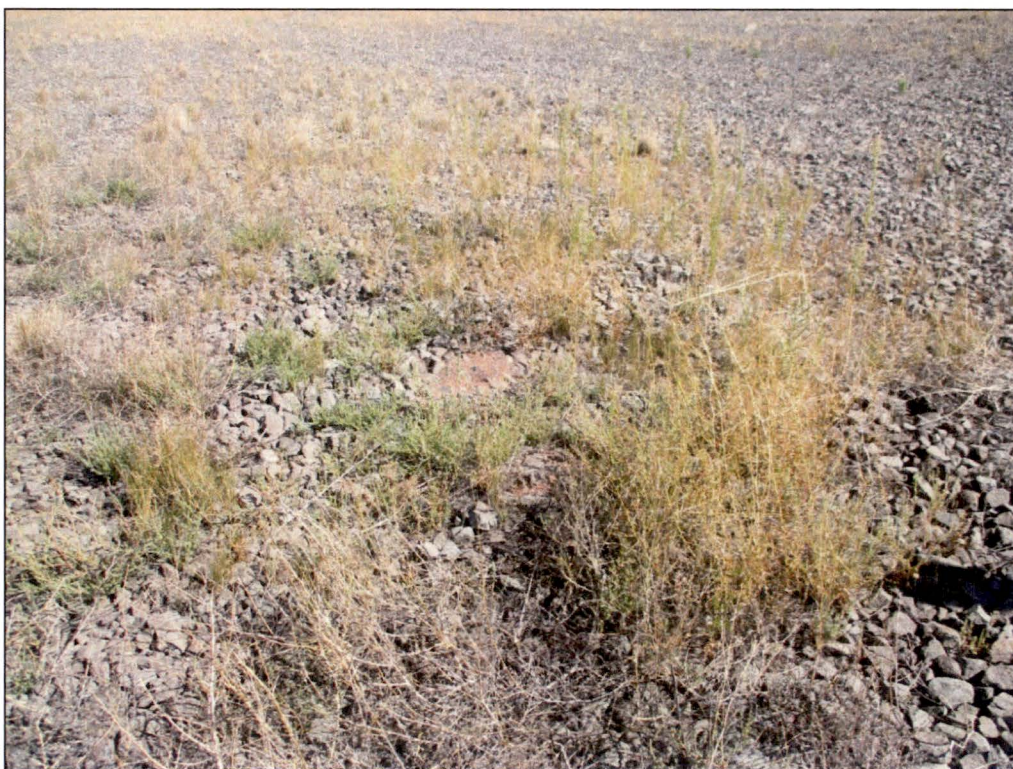
PL-26. Post-restoration Condition at Micro Pit 2 on Main Tailings Disposal Cell, September 2017
