U.S. DEPARTMENT OF
ENERGY

2018 Annual Site Inspection and Monitoring Report for Uranium Mill Tailings Radiation Control Act Title I Disposal Sites

March 2019

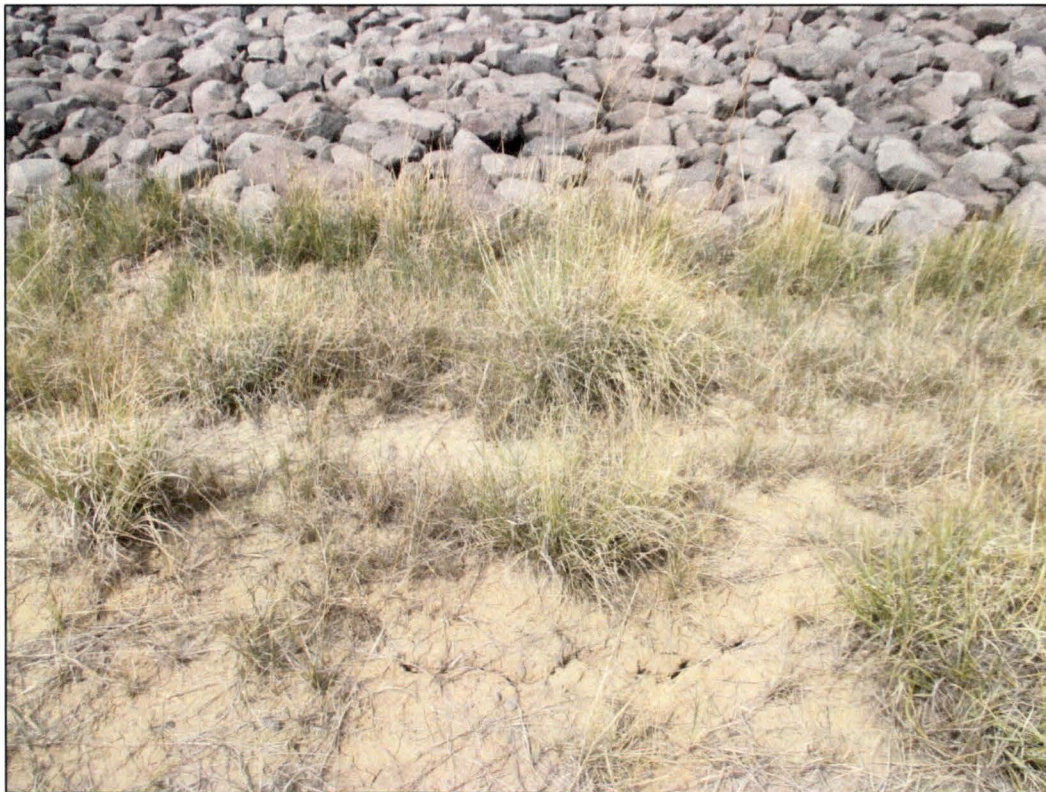
The basalt riprap-covered side slopes and apron showed no evidence of erosion, settling, slumping, or cracking (PL-7). Standing water is occasionally observed in a portion of the south apron, but the area was dry during the inspection. This location is the topographic low spot along the base of the disposal cell, and rainfall runoff collects in this area. A potential desiccation crack

(PL-8) and formation of small rills, less than 6 inches deep, (PL-9) were observed at the base of the disposal cell in this area. Neither impacts the disposal cell. Inspectors will monitor for further impact or additional erosion in this area. No maintenance needs were identified.

PL-8. Potential Desiccation Crack at Base of Disposal Cell Southern Side Slope

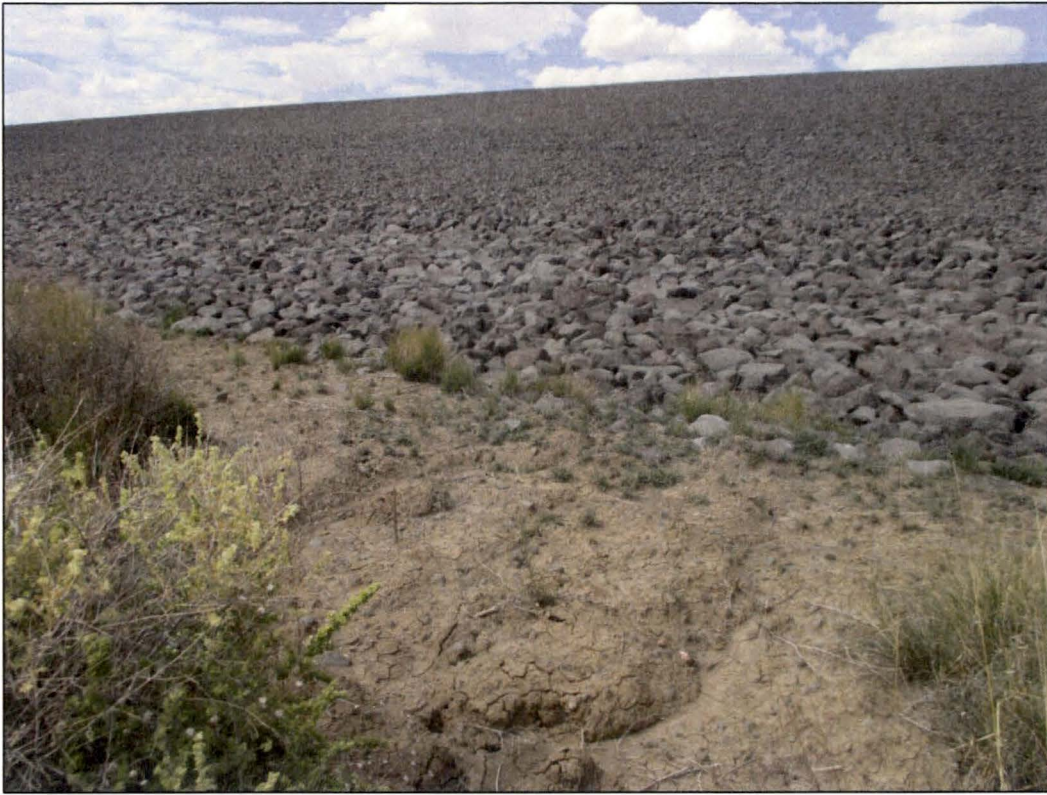
PL-9. Rills at Base of Disposal Cell Southern Side Slope

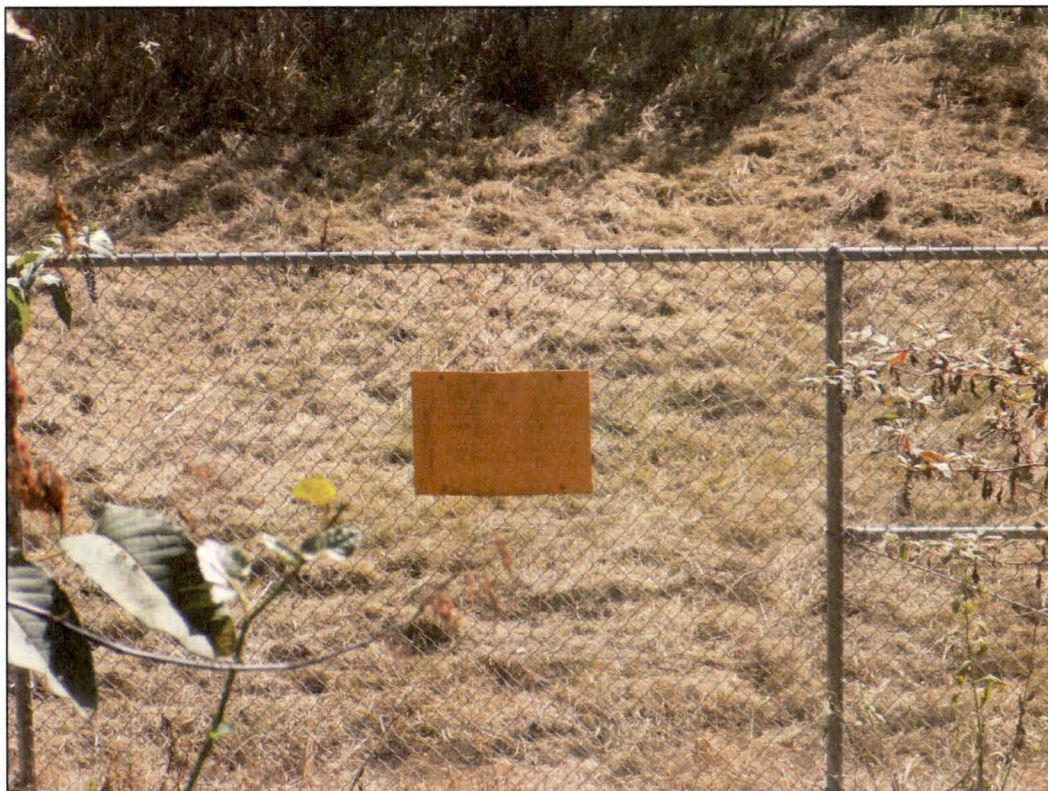
There are 16 perimeter signs attached to the outside of the security fence. Two perimeter signs were missing (P2 and P16) and will be replaced in 2019. Perimeter sign P8 was faded and illegible; it will be replaced in 2019 (PL-2). An information sign that was posted on the personnel gate at the west end of the site was missing and will be replaced in 2019. All other perimeter signs were present and legible. No other maintenance needs were identified.

PL-2. Faded Perimeter Sign P8 (to Be Replaced)

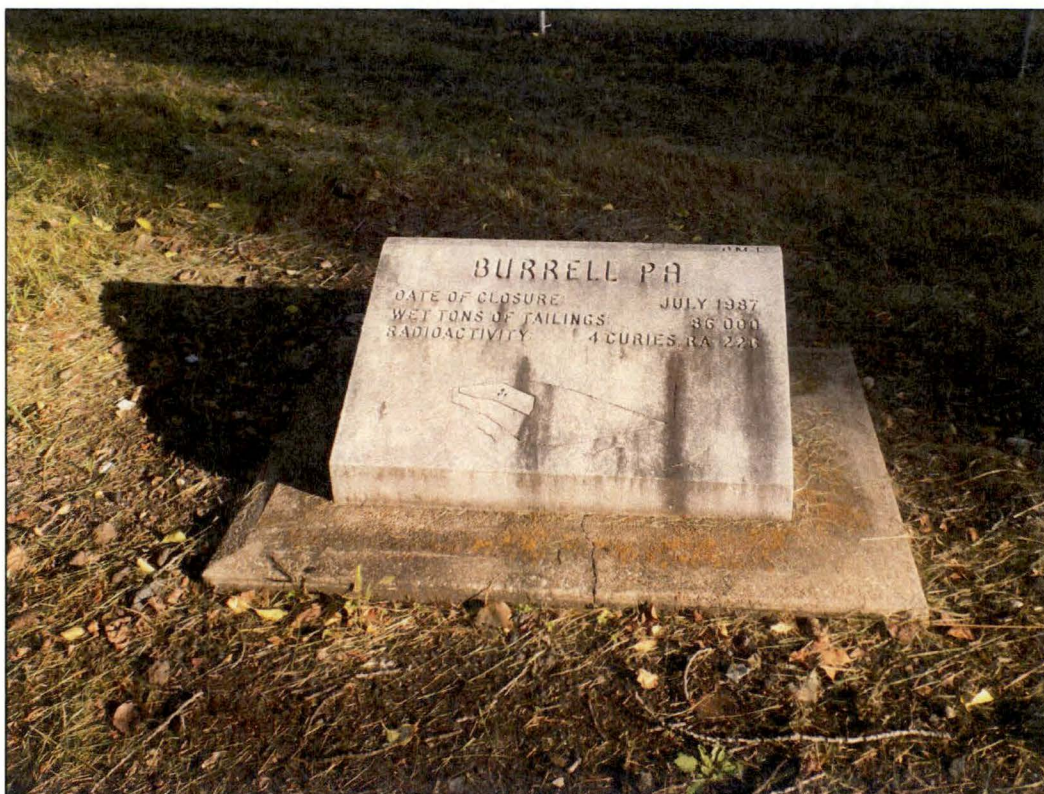
The site has one granite site marker just inside the main entrance gate (PL-3). The concrete pad is cracked but remains functional. No maintenance needs were identified.

PL-3. Site Marker with Crack in Concrete Pad

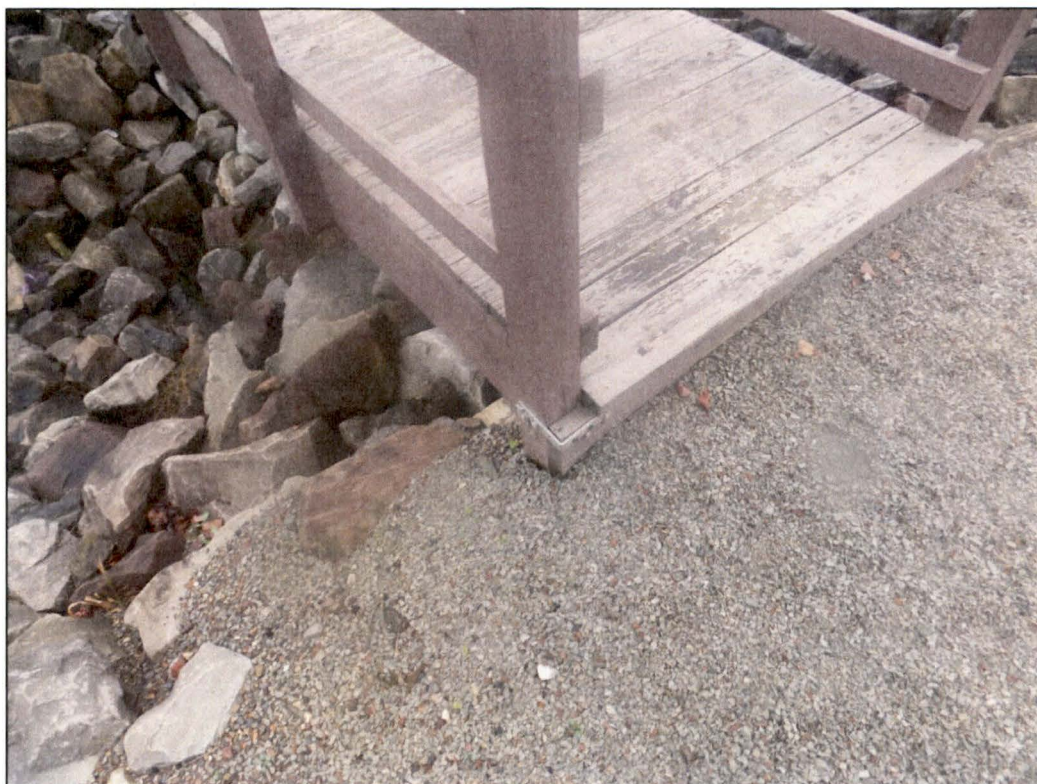
PL-7. Temporary Repair to Pedestrian Footbridge Rail Support

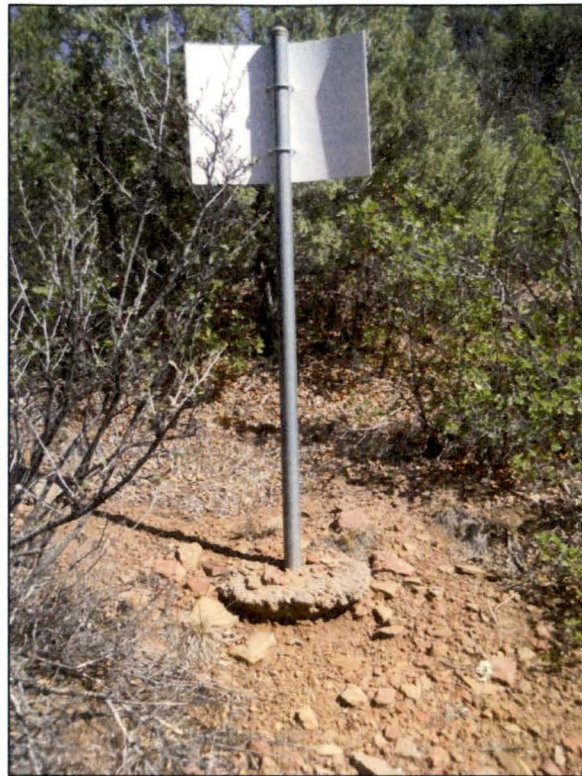
The concrete bases of several perimeter signs have been and continue to be undercut (PL-1), but the position of the signs remain uncompromised. The concrete base of perimeter sign P45, located in the natural drainage on the north end of the site, was almost entirely free-standing (PL-2). Following the inspection, LM moved perimeter sign P45 approximately 25 feet (ft) to the east, a location less prone to erosion. Vegetation was encroaching on perimeter sign P51 (PL-3) and was removed in fall 2018 following the inspection. No other maintenance needs were identified.

PL-1. Base of Perimeter Sign P62 (Undercut)

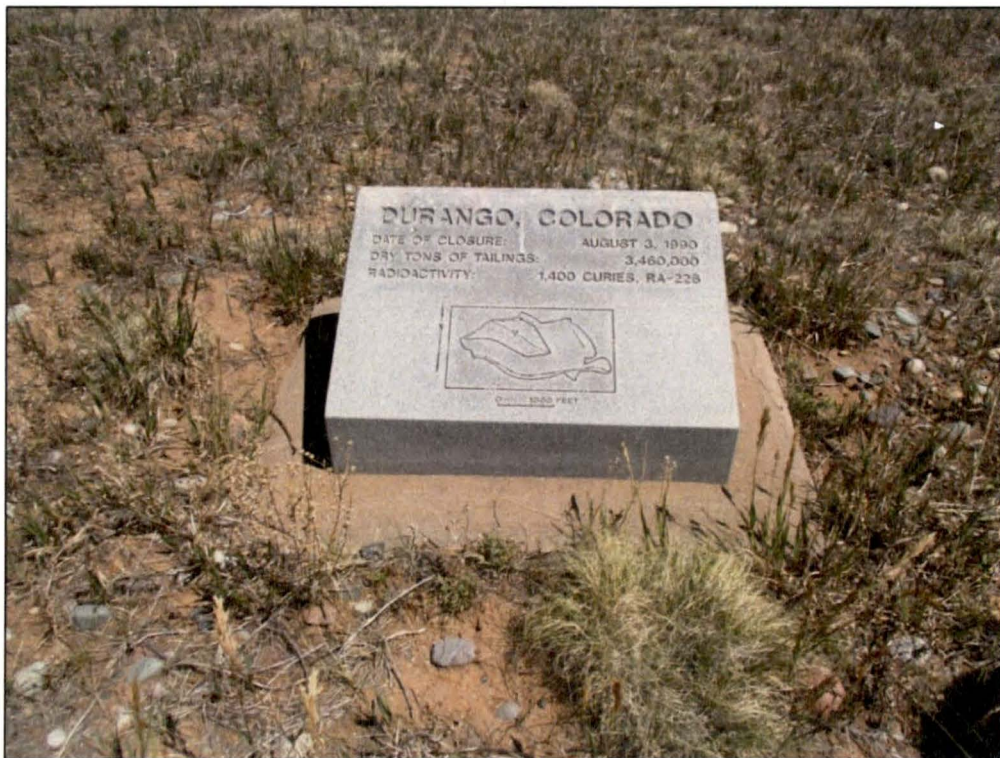
*PL-4. Site Marker SMK-2 on Top of Disposal Cell
(Repaired and Stabilized Following Inspection)*

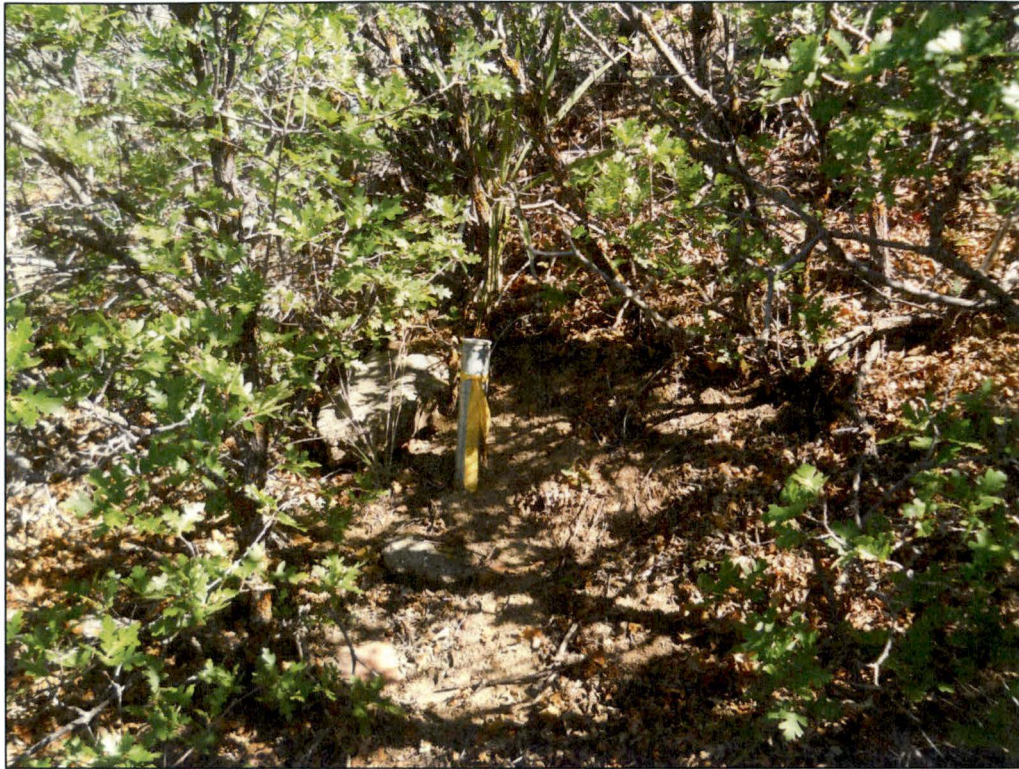
*PL-5. Brush Overgrown Around Boundary Monument BM-1
(Removed Following Inspection)*

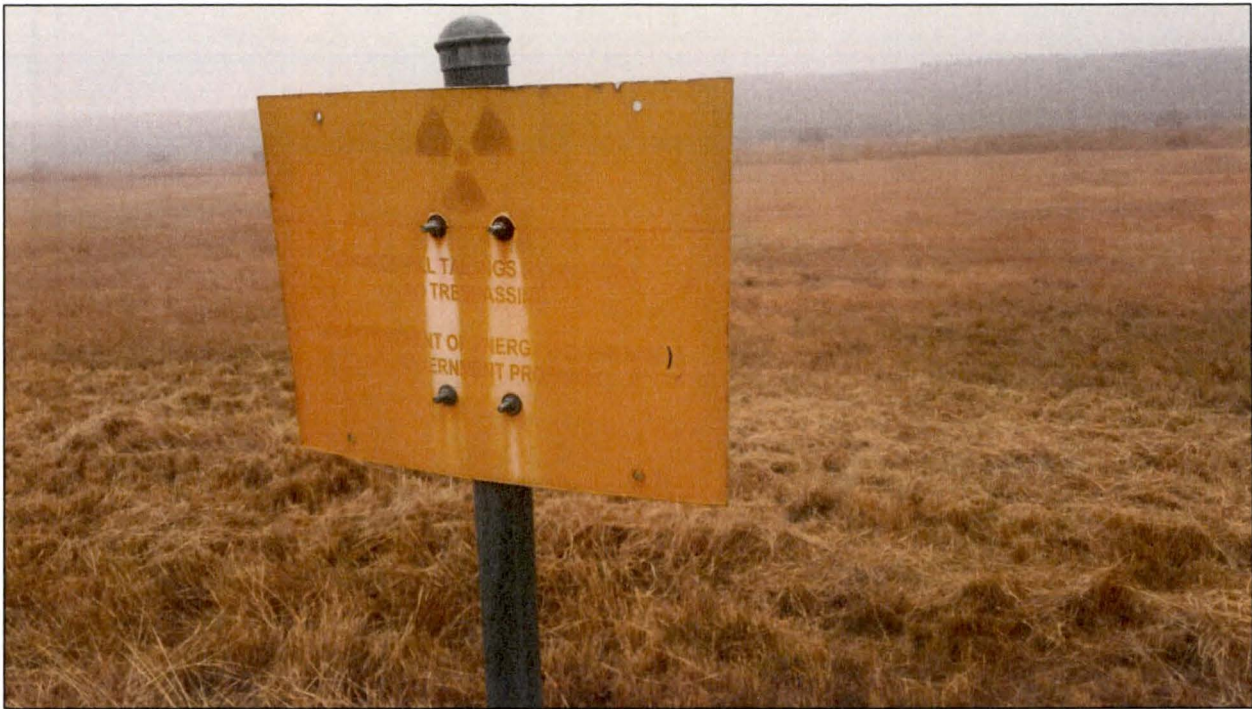
PL-1. Perimeter Sign P3 (Replaced Following Inspection)

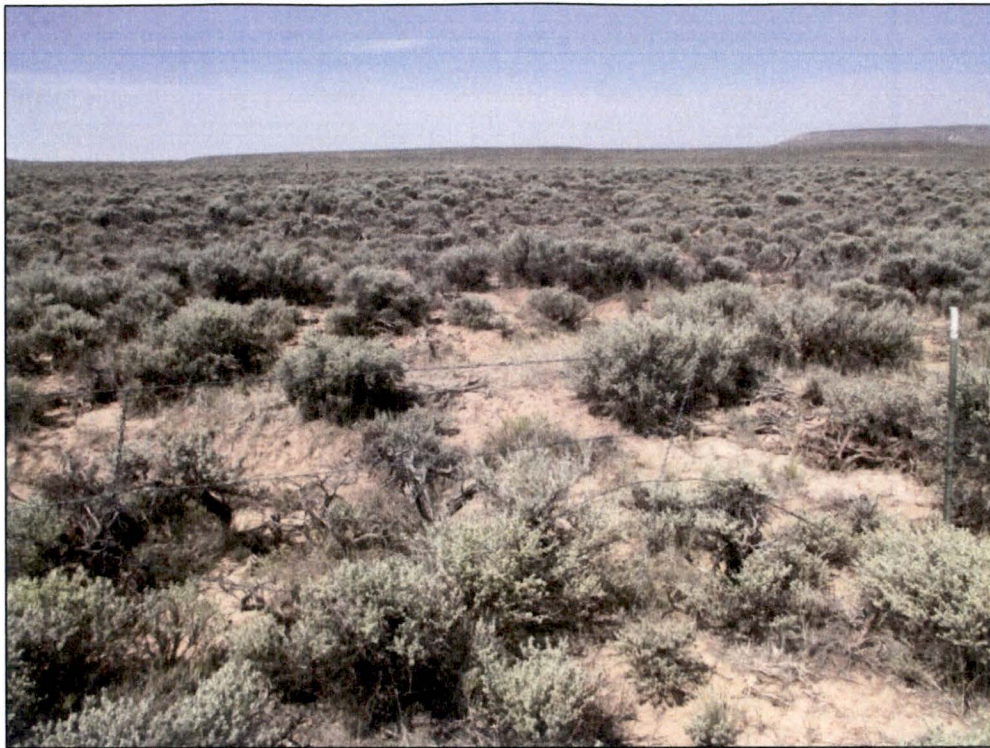
PL-1. Broken Fence Strand near Perimeter Sign P8 (Repaired During Inspection)

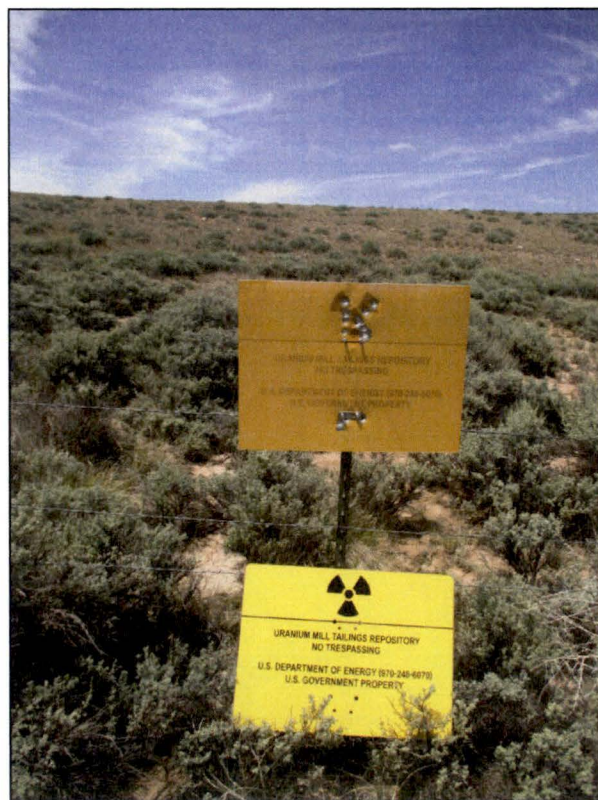
PL-2. Faded and Damaged Perimeter Sign P38 (Replaced During Inspection)

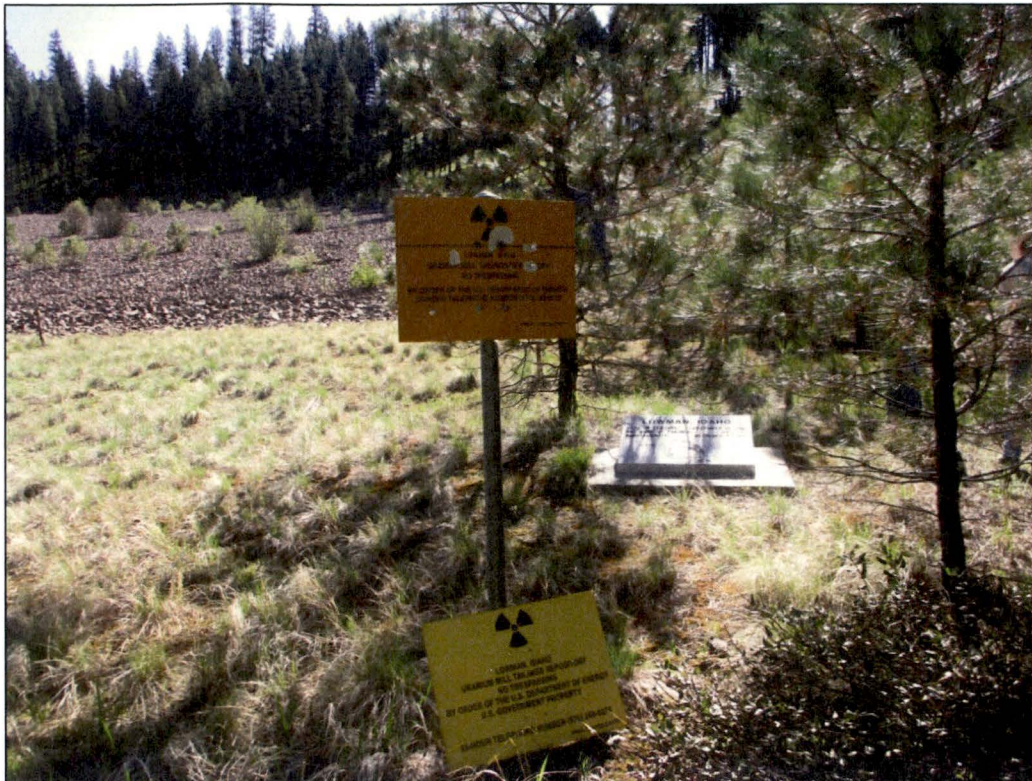
PL-1. Old and New Entrance Sign Before Replacement

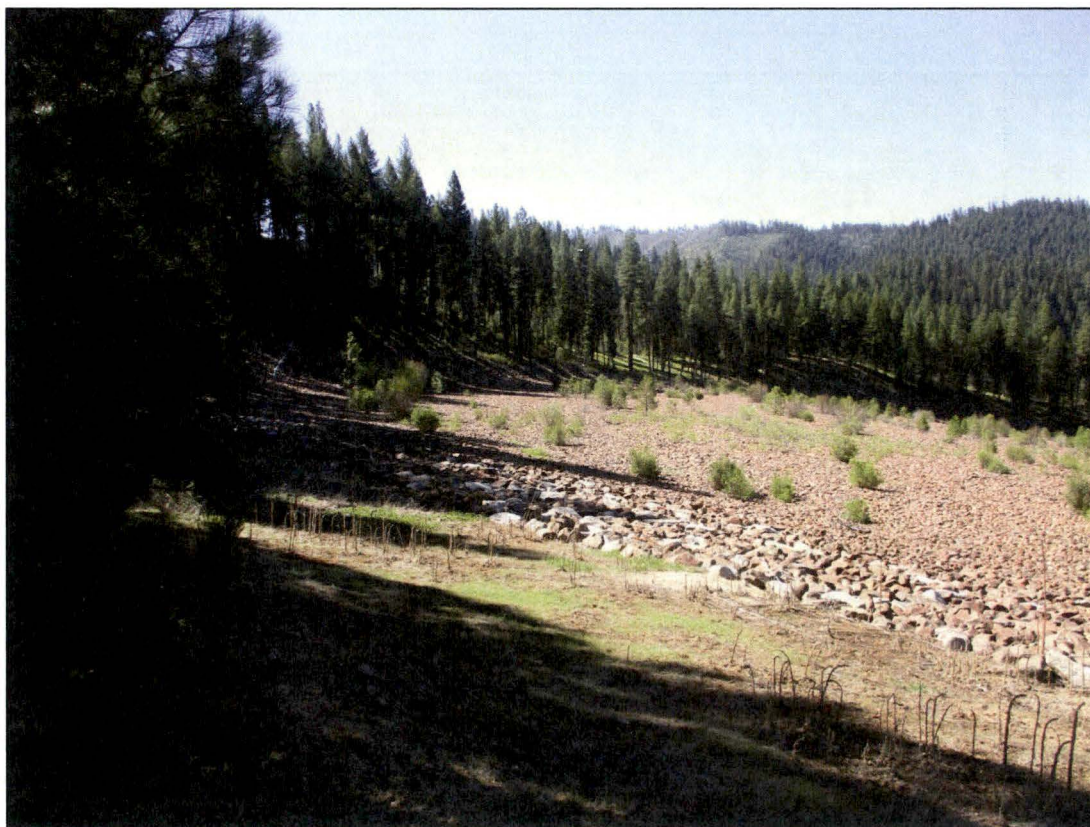
PL-6. Vegetation Encroachment on Disposal Cell and Apron

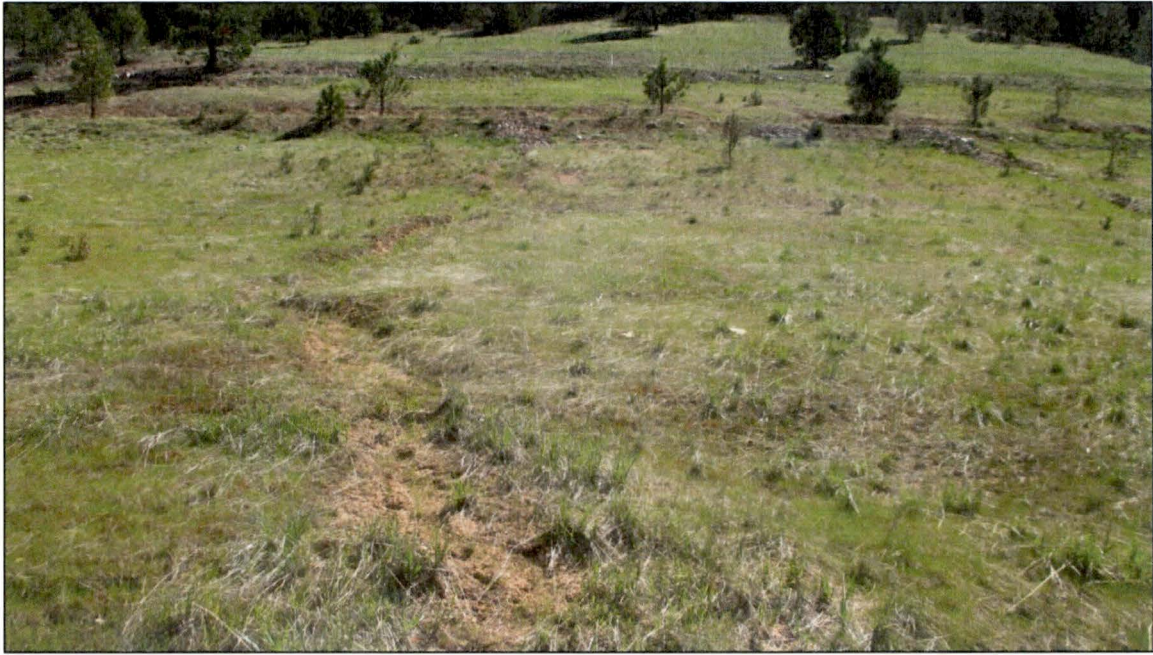
PL11. View Upslope of Repaired Rills on Interceptor Bench 1
