**NEI 99-02 FAQ 19-02
Brunswick RCS Leakage**

Plant: Brunswick Nuclear Power Plant Unit 1

Date of Event: March 28, 2019

Performance Indicator: BI02 - Reactor Coolant System Leakage

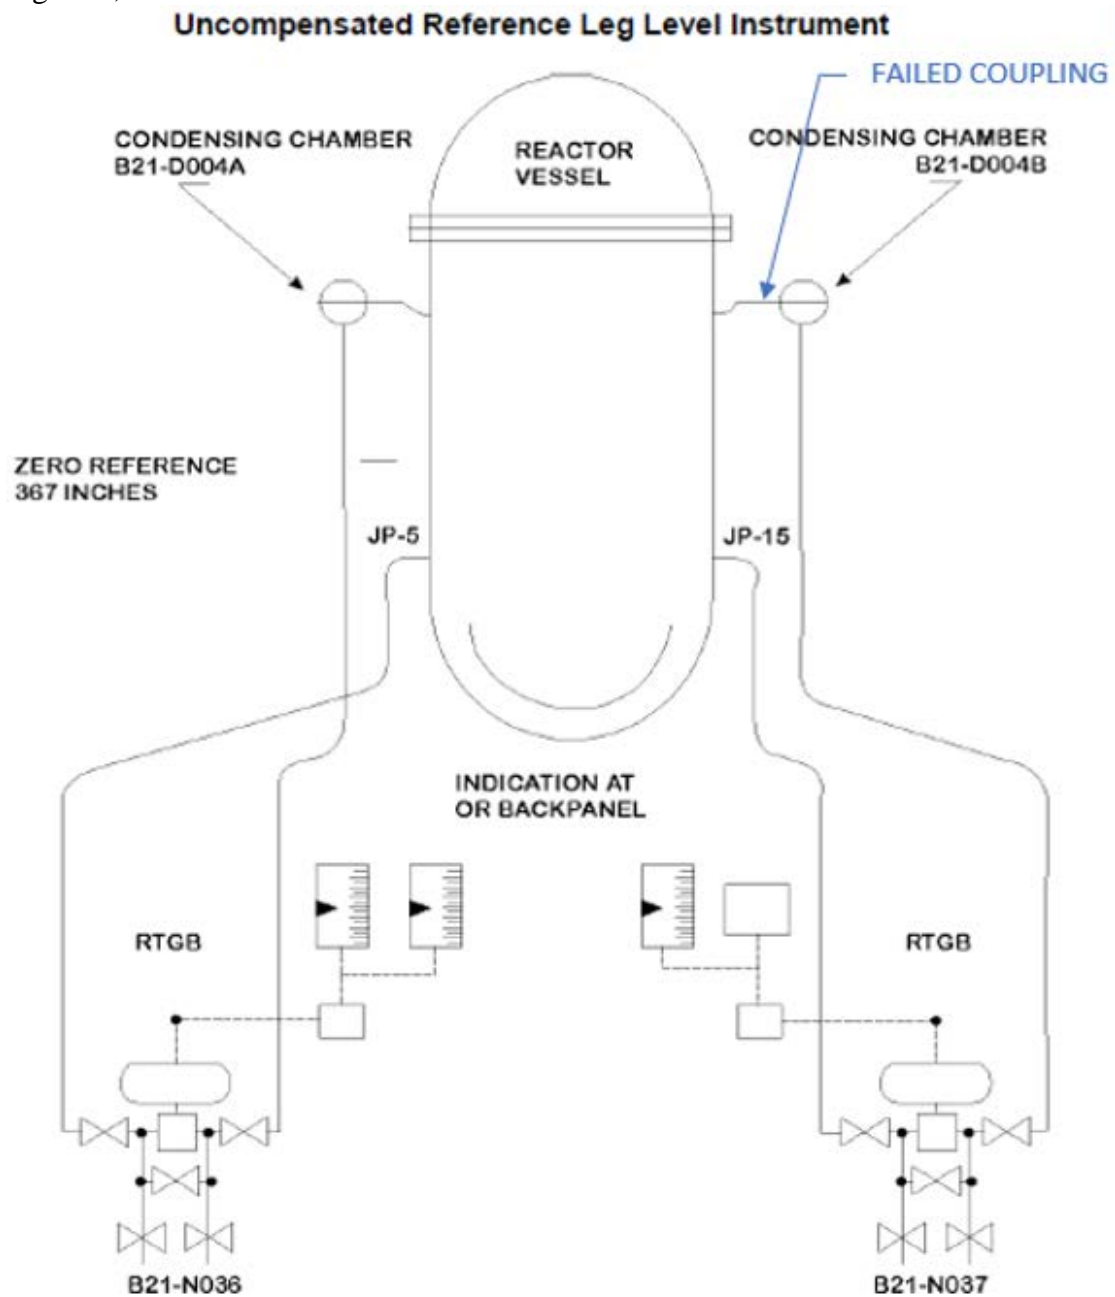
Figure 1, RCS Leak location

Investigation inside containment determined that a 1-inch coupling on line 1-B21-774 located on the steam side of a reactor level condensing chamber experienced a 360° circumferential separation at the approximate center of the coupling as shown in Figures 1 and 2 below. This opened a path for steam from the reactor to leak into the drywell. Reactor water level was maintained in the established level band, below the level of the sensing line nozzle, throughout the event. The impact from the coupling failure has been analyzed by the Duke Probabilistic Risk Assessment staff and determined to be very low safety significance.

An evaluation was performed to address the couplings installed in both units. All couplings exposed to reactor steam (i.e., potentially susceptible) were removed and replaced with welded fittings prior to startup of Units 1 and 2. In addition, the installation procedure for the couplings was placed on hold pending revision, to prevent any further installation of Cryofit couplings.

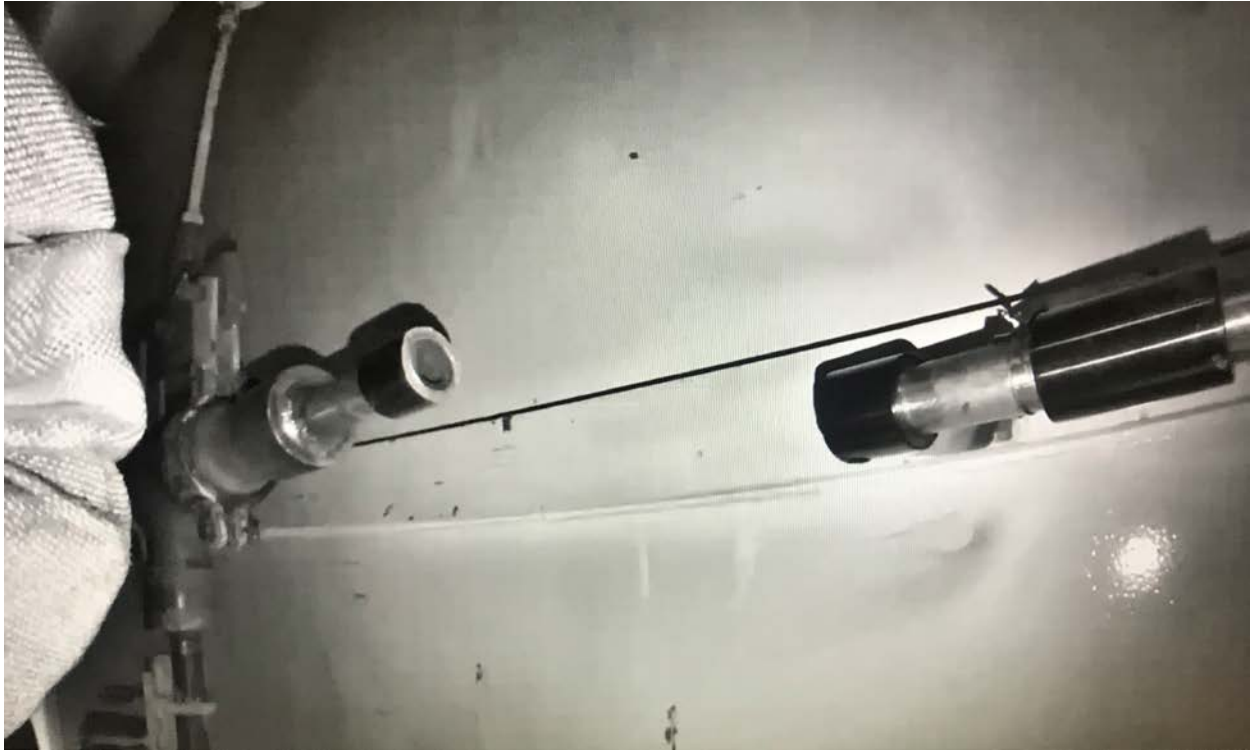
Figure 2, Picture of failed 1-inch coupling:

Contrary to this, the March 28, 2019, Brunswick event resulted from the immediate circumferential separation of a 1-inch coupling on the steam side sensing line for reactor vessel level indication, as shown in Figures 1 and 2. Based on the material of construction and environmental conditions (i.e., temperature, hydrogen), the post-event metallurgical report determined the coupling showed no evidence of localized plastic deformation. The coupling experienced hydrogen embrittlement and did not exhibit a leak-before-break failure mechanism. There were no precursors to this event and the resulting leakage from the break exceeded the Technical Specification (TS) limit. RCS leakage was stable and well below the TS limit before the event. The steam leak could not be isolated from the reactor vessel. Operations took prompt action to reduce power, commence a plant shutdown, and depressurized the reactor to stop the leak. The leakage resulted in the declaration of an Unusual Event (UE). Operations completed an uncomplicated reactor shutdown. It was the last reading taken before entering Mode 4 (i.e., the Mode in which the SR is no longer applicable) that caused the PI to transition from Green to White. RCS leakage was stable and was being appropriately managed before the event. Based on these unique circumstances, Brunswick requests an exemption to exclude reporting the leakage from the event in the RCS Leakage PI. This would result in the PI returning to Green for March 2019.

conditions at the coupling location, the Root Cause Evaluation team determined that the failure was due to hydrogen embrittlement of the Tinel material. This resulted from many years of exposure to high temperature and high levels of hydrogen. This conclusion is supported by the transgranular cleavage, high hardness values in the region exposed to the process fluid, and a hydrogen rich environment, which are all consistent with hydrogen embrittlement.

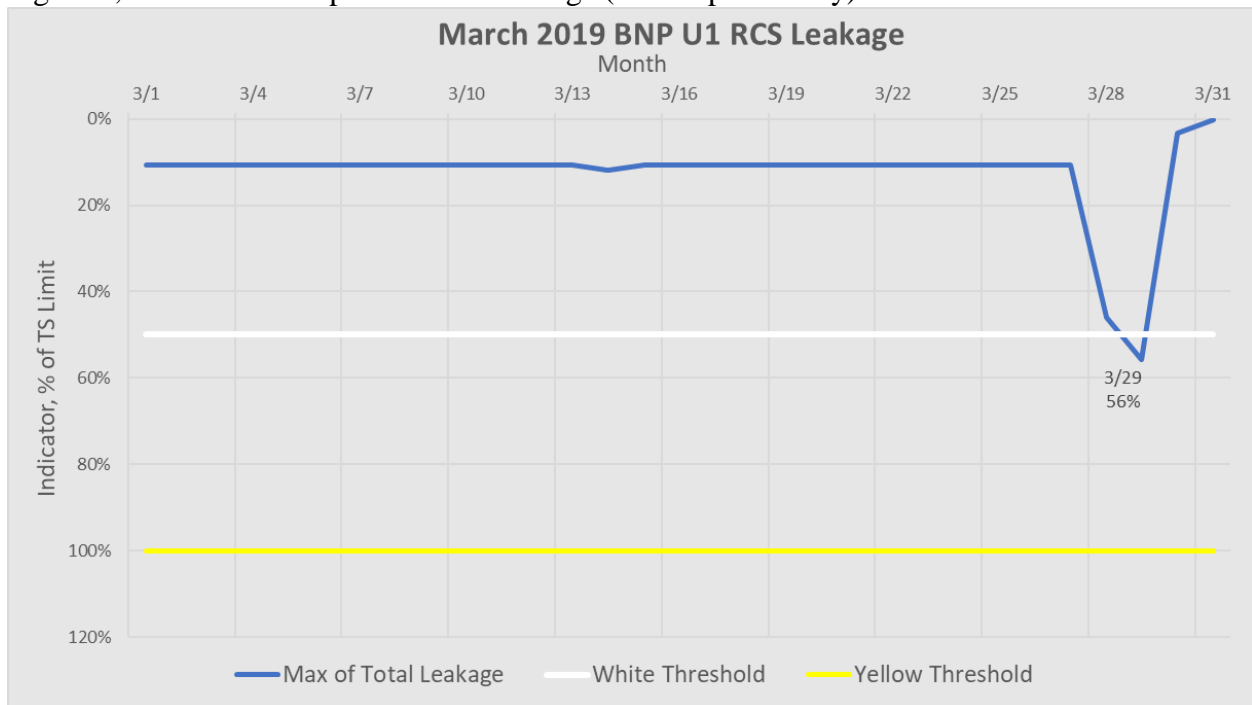
Figure 3, March 2019 Reported RCS Leakage (4-hour periodicity)

The PI is intended to monitor leak-before-break situations that are viewed as precursors of a more catastrophic failure. In the Brunswick event, RCS Total leakage had been steady for the month of March as shown below in Figure 3. There was no advanced indications of degradation or leakage from the coupling and no trend that worsened over time due to operator inaction.

As shown in Figure 3, RCS Leakage trends were stable and low in the Green performance band for the month leading up to the coupling failure. The coupling failure occurred without warning. Drywell leakage and temperature in the vicinity of the coupling did not increase prior to the failure. There was no opportunity for Operations staff to identify this condition in advance of failure. As no precursors were present, no mitigating actions could have been taken in advance of the leak and the actions taken following the leak indicate prompt and conservative response on the part of the licensee. In addition, the location of the leak prevented it from being isolated until the plant was depressurized, which added to the volume of the leakage calculated in the PI. Despite timely operator actions to accomplish this, the volume of leakage calculated in the PI resulted in one calculation data point exceeding the threshold for White. The degradation mechanism of the coupling will be evaluated under other NRC processes.
