**NEI 99-02 FAQ 19-02 (Proposed NRC Response)
Brunswick RCS Leakage**

Plant: Brunswick Nuclear Power Plant Unit 1

Date of Event: March 28, 2019

Performance Indicator: BI02 - Reactor Coolant System Leakage

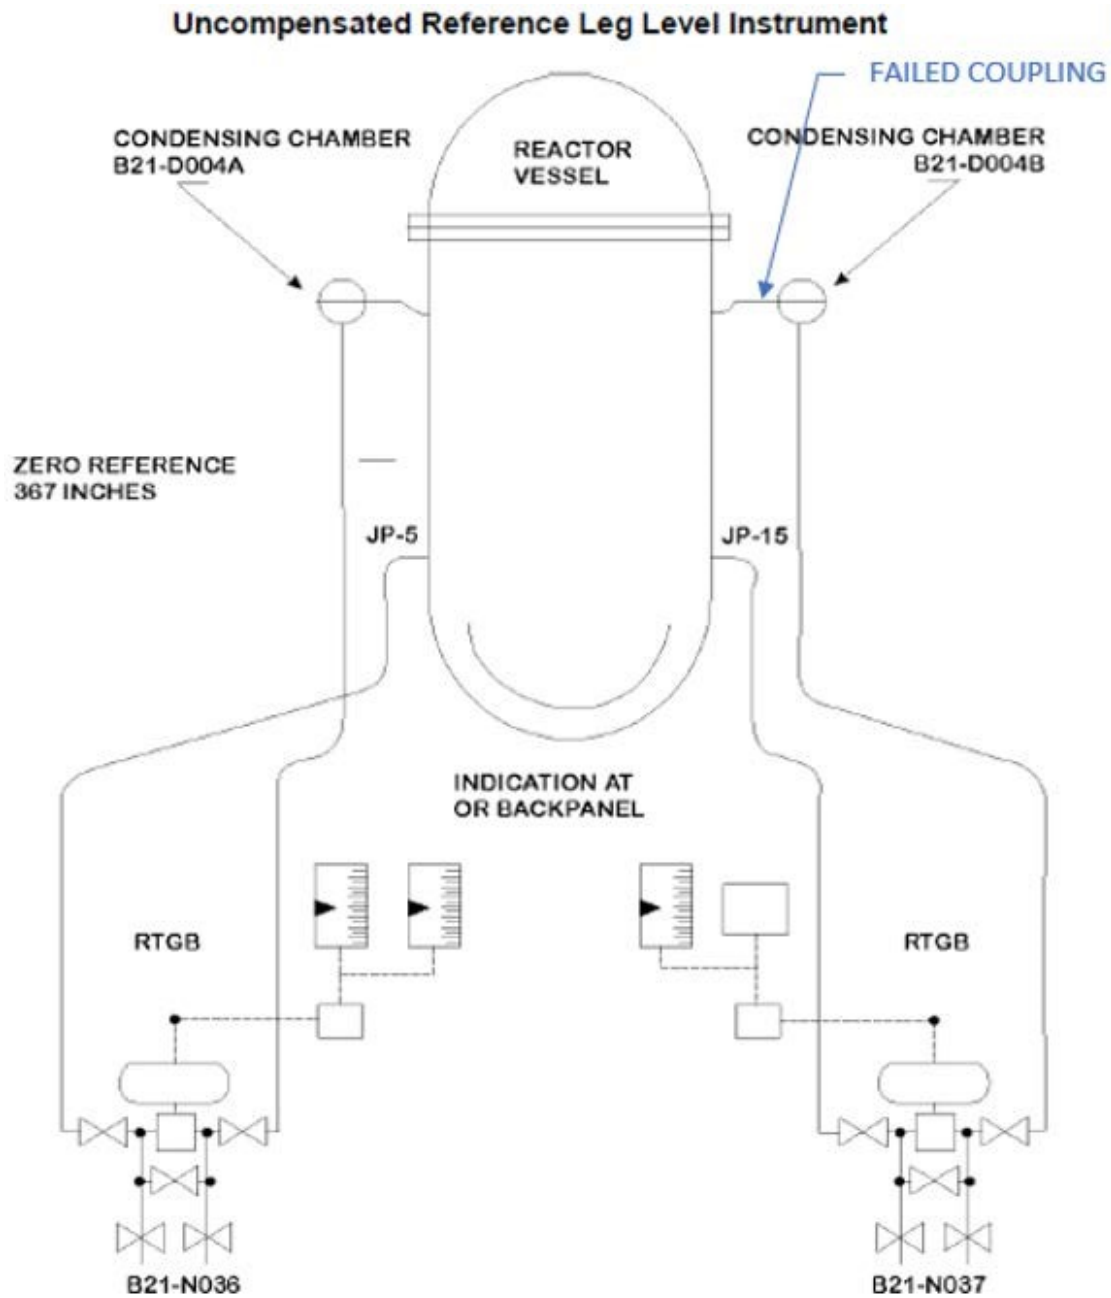
Figure 1, RCS Leak location

Contrary to this, the March 28, 2019, Brunswick event resulted from the immediate circumferential separation of a 1-inch coupling on the steam side sensing line for reactor vessel level indication, as shown in Figures 1 and 2. Based on the material of construction and environmental conditions (i.e., temperature, hydrogen), the post-event metallurgical report determined the coupling showed no evidence of localized plastic deformation. The coupling experienced hydrogen embrittlement and did not exhibit a leak-before-break failure mechanism. There were no precursors to this event and the resulting leakage from the break exceeded the Technical Specification (TS) limit. RCS leakage was stable and well below the TS limit before the event. The steam leak could not be isolated from the reactor vessel. Operations took prompt action to reduce power, commence a plant shutdown, and depressurized the reactor to stop the leak. The leakage resulted in the declaration of an Unusual Event (UE). Operations completed an uncomplicated reactor shutdown. It was the last reading taken before entering Mode 4 (i.e., the Mode in which the SR is no longer applicable) that caused the PI to transition from Green to White. RCS leakage was stable and was being appropriately managed before the event. Based on these unique circumstances, Brunswick requests an exemption to exclude reporting the leakage from the event in the RCS Leakage PI. This would result in the PI returning to Green for March 2019.

Investigation inside containment determined that a 1-inch coupling on line 1-B21-774 located on the steam side of a reactor level condensing chamber experienced a 360° circumferential separation at the approximate center of the coupling as shown in Figures 1 and 2 below. This opened a path for steam from the reactor to leak into the drywell. Reactor water level was maintained in the established level band, below the level of the sensing line nozzle, throughout the event. The impact from the coupling failure has been analyzed by the Duke Probabilistic Risk Assessment staff and determined to be very low safety significance.

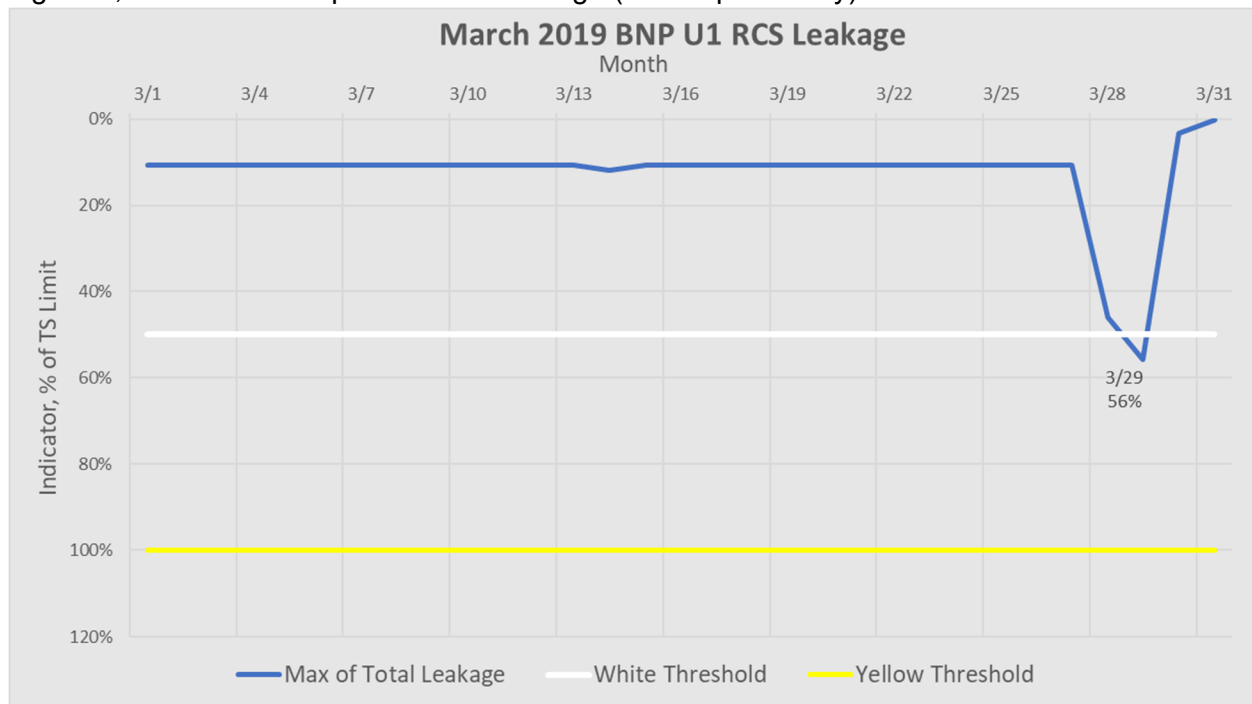
Figure 3, March 2019 Reported RCS Leakage (4-hour periodicity)

The PI is intended to monitor leak-before-break situations that are viewed as precursors of a more catastrophic failure. In the Brunswick event, RCS Total leakage had been steady for the month of March as shown below in Figure 3. There was no advanced indications of degradation or leakage from the coupling and no trend that worsened over time due to operator inaction.

As shown in Figure 3, RCS Leakage trends were stable and low in the Green performance band for the month leading up to the coupling failure. The coupling failure occurred without warning. Drywell leakage and temperature in the vicinity of the coupling did not increase prior to the failure. There was no opportunity for Operations staff to identify this condition in advance of failure. As no precursors were present, no mitigating actions could have been taken in advance of the leak and the actions taken following the leak indicate prompt and conservative response on the part of the licensee. In addition, the location of the leak prevented it from being isolated until the plant was depressurized, which added to the volume of the leakage calculated in the PI. Despite timely operator actions to accomplish this, the volume of leakage calculated in the PI resulted in one calculation data point exceeding the threshold for White. The degradation mechanism of the coupling will be evaluated under other NRC processes.
